WELL NAME: NEW ELK 25-04, API #: 071-09535, INSP. # 716301758

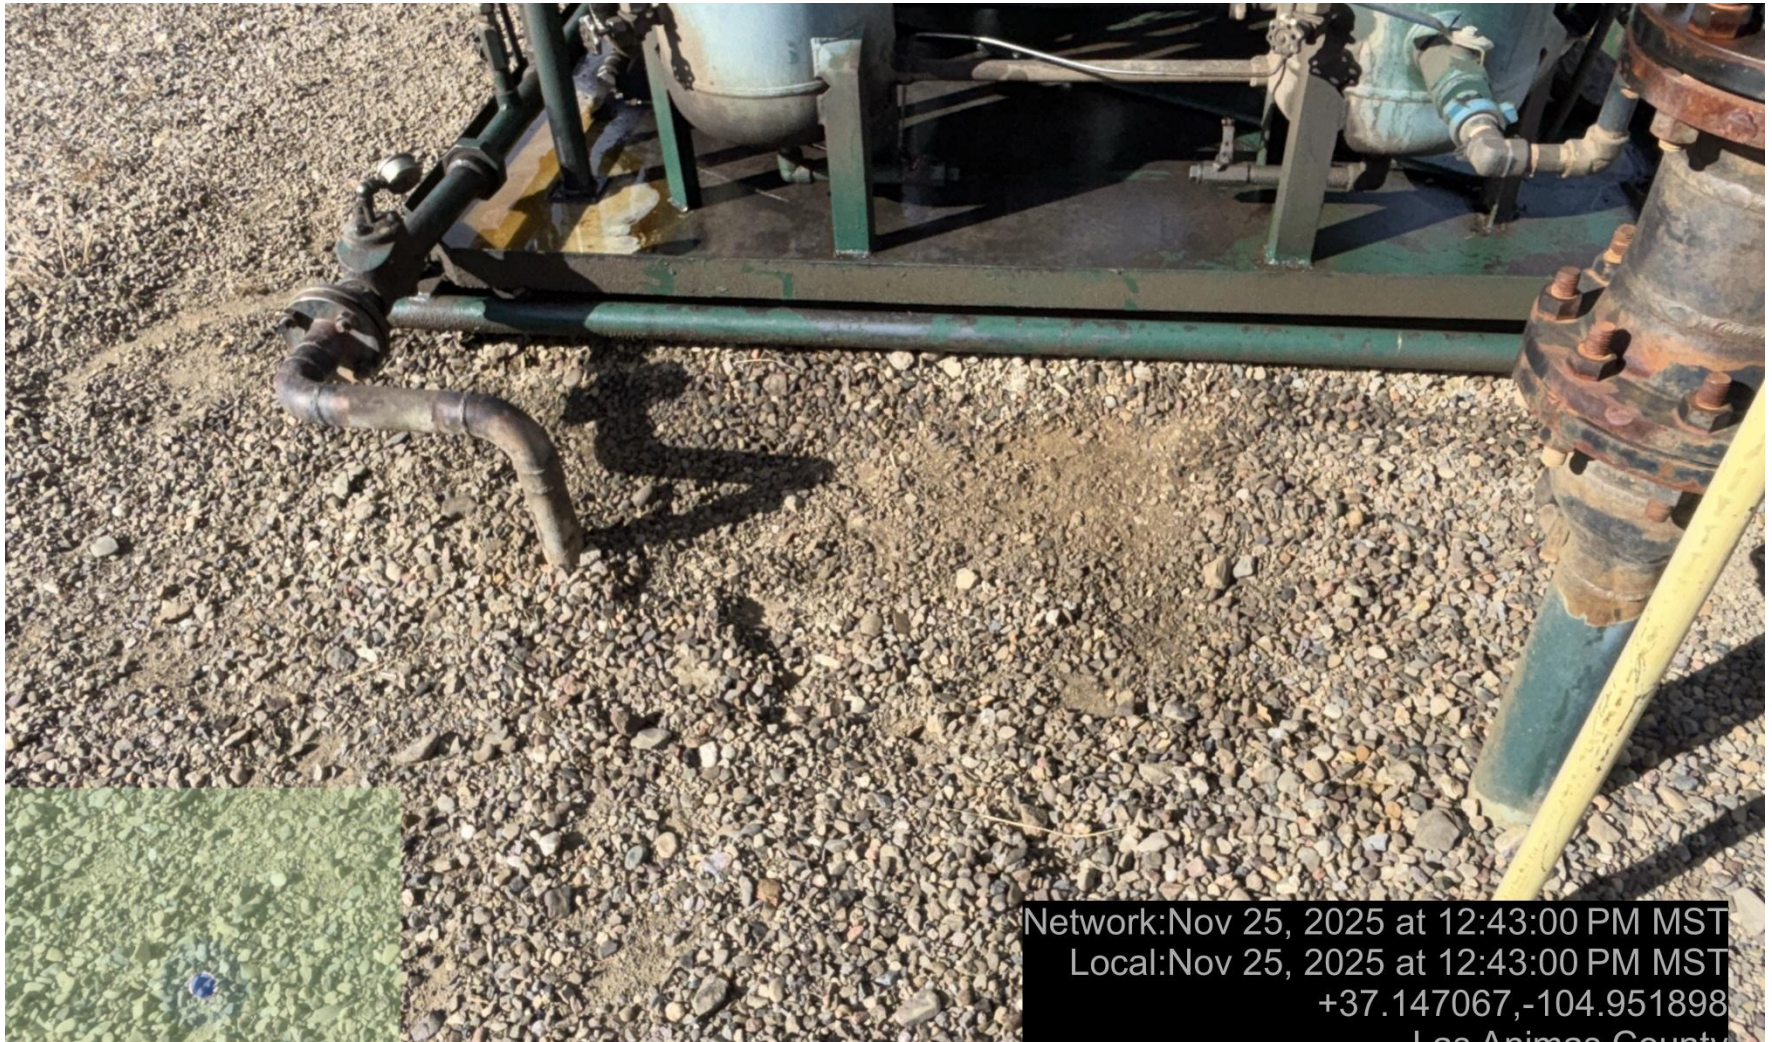
PHOTO 4: Impacted soil identified near compressor skid. Conduct maintenance on equipment, cleanup stained material and review self inspection processes. COMPLY WITH RULE 1002,(2).D. this is the 2nd notice for this corrective action, immediate action is required.

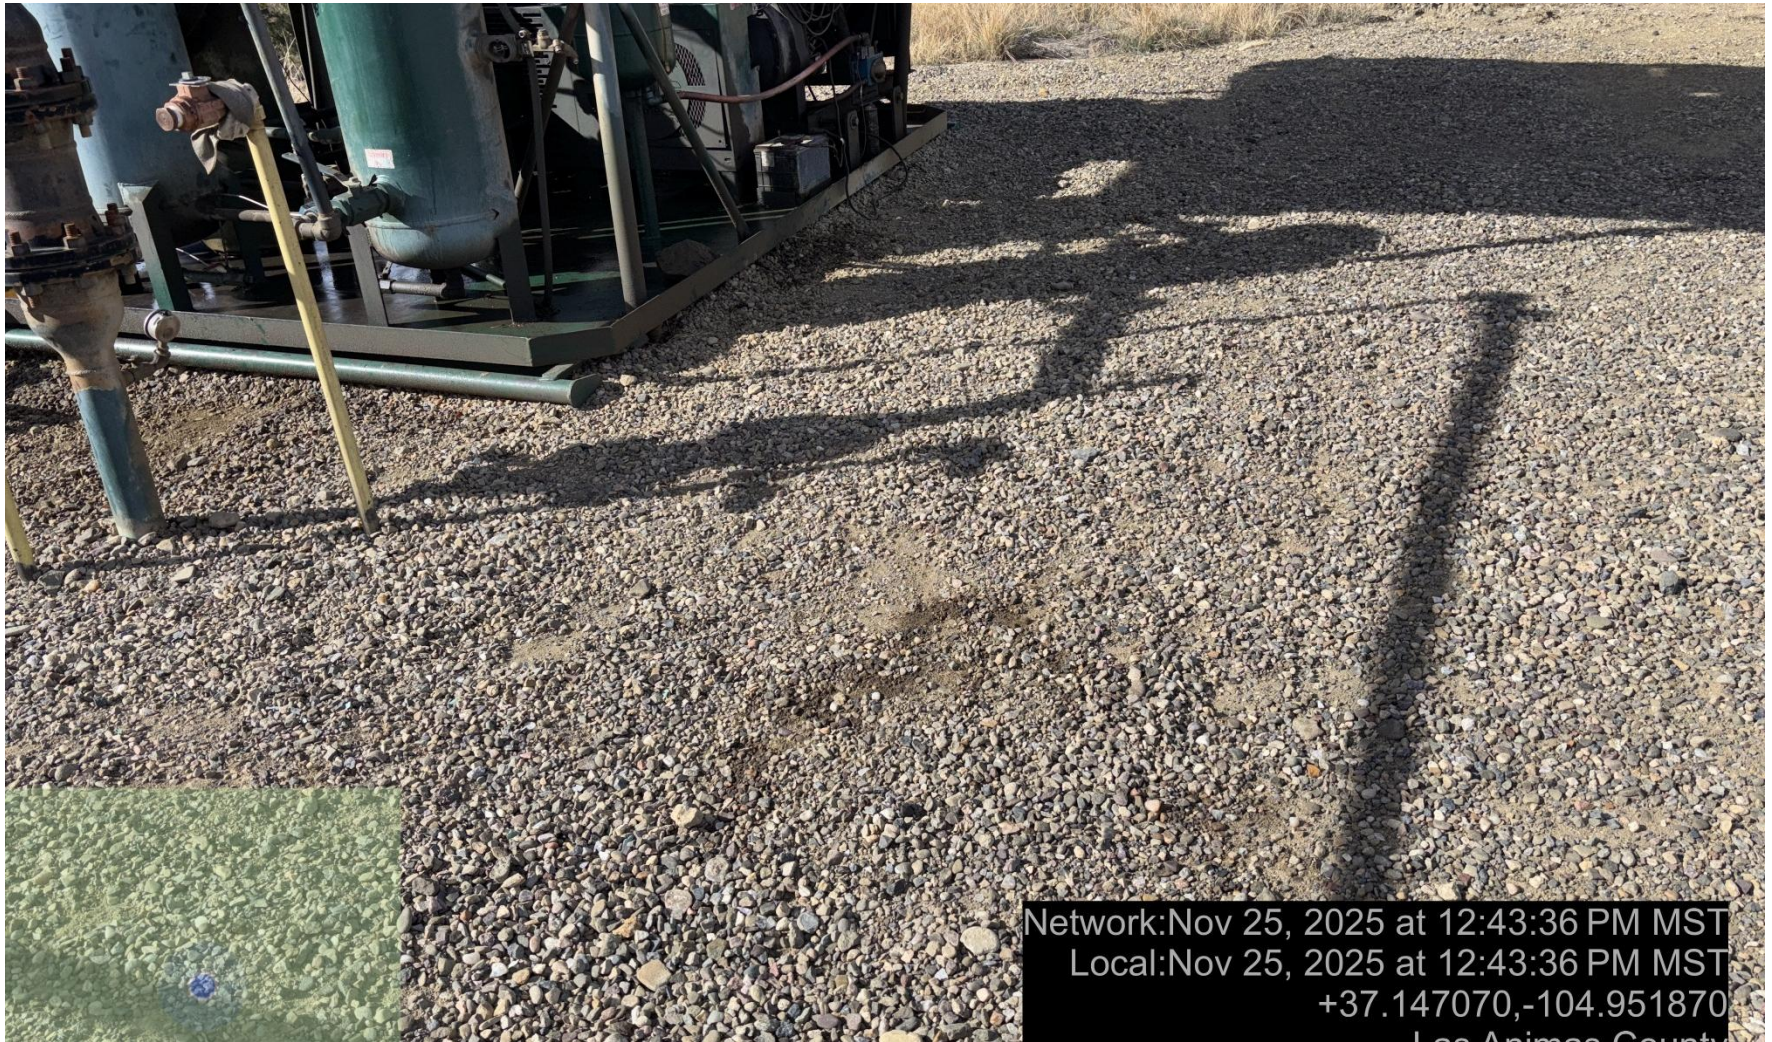
PHOTO 5: Impacted soil identified near compressor skid. Conduct maintenance on equipment, cleanup stained material and review self inspection processes. COMPLY WITH RULE 1002,(2).D. this is the 2nd notice for this corrective action, immediate action is required.

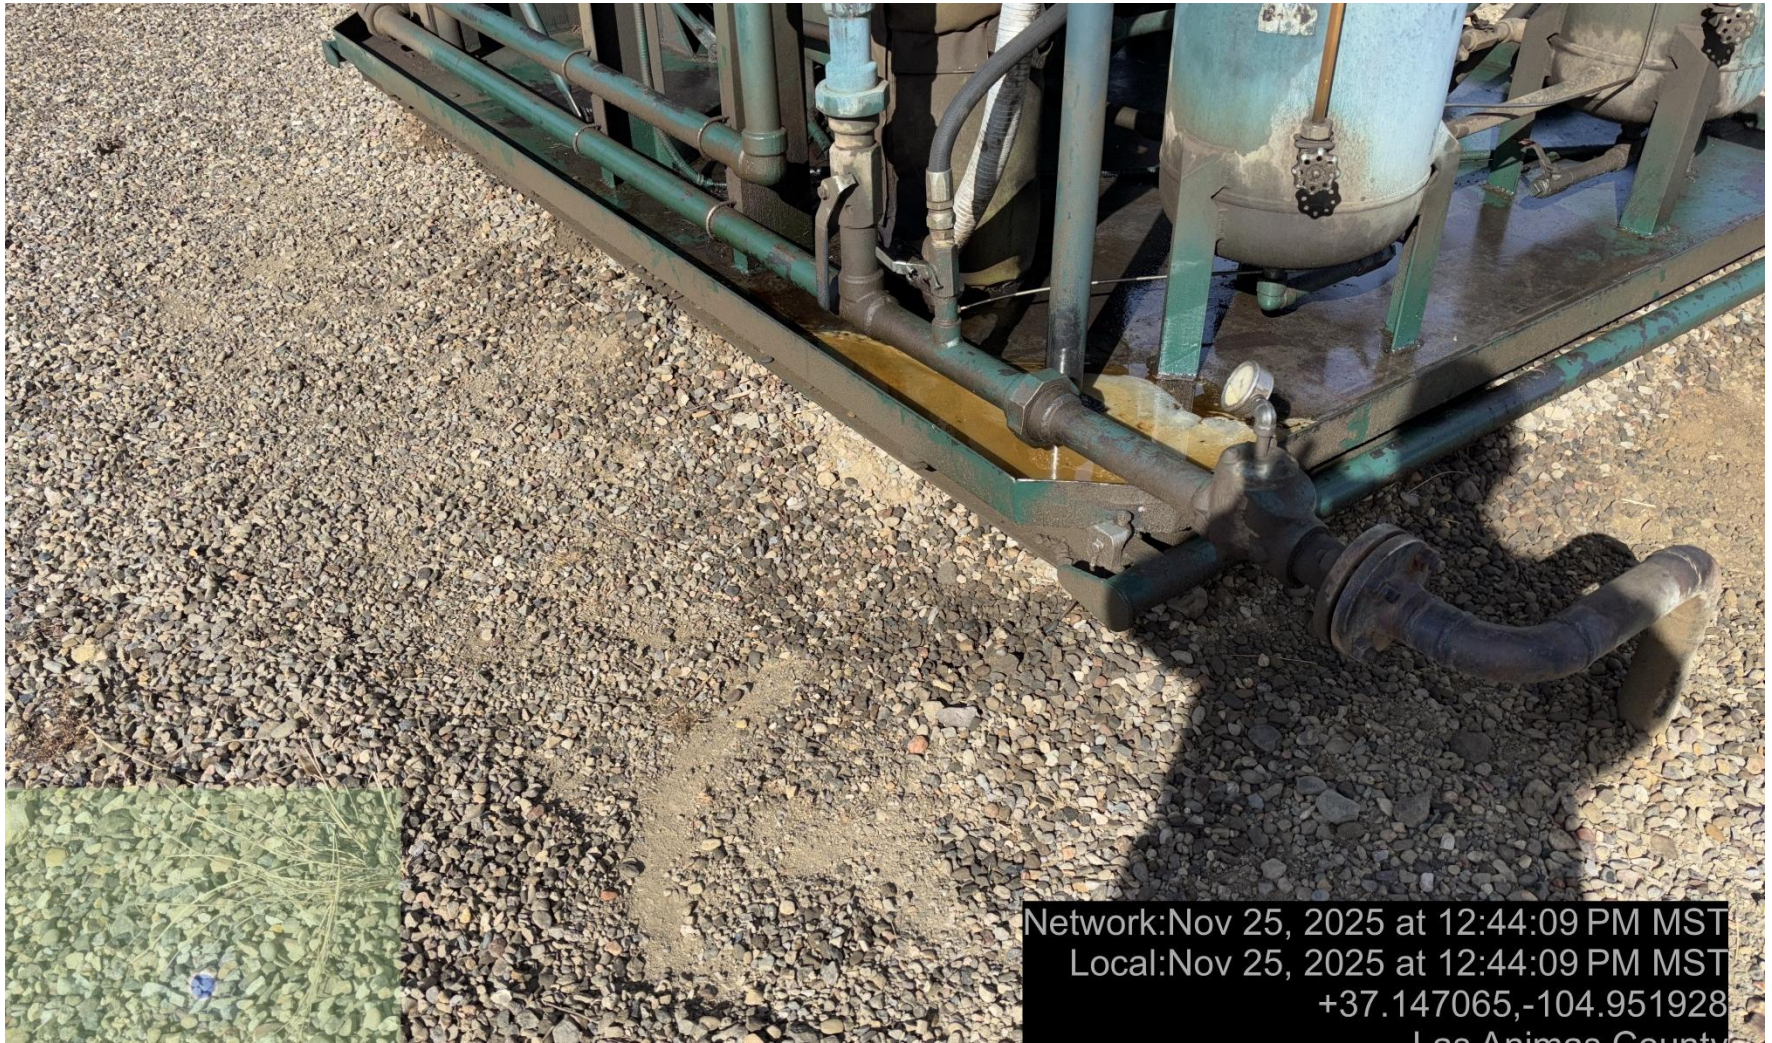
PHOTO 6: Impacted soil identified near compressor skid. Conduct maintenance on equipment, cleanup stained material and review self inspection processes. COMPLY WITH RULE 1002,(2).D. this is the 2nd notice for this corrective action, immediate action is required.

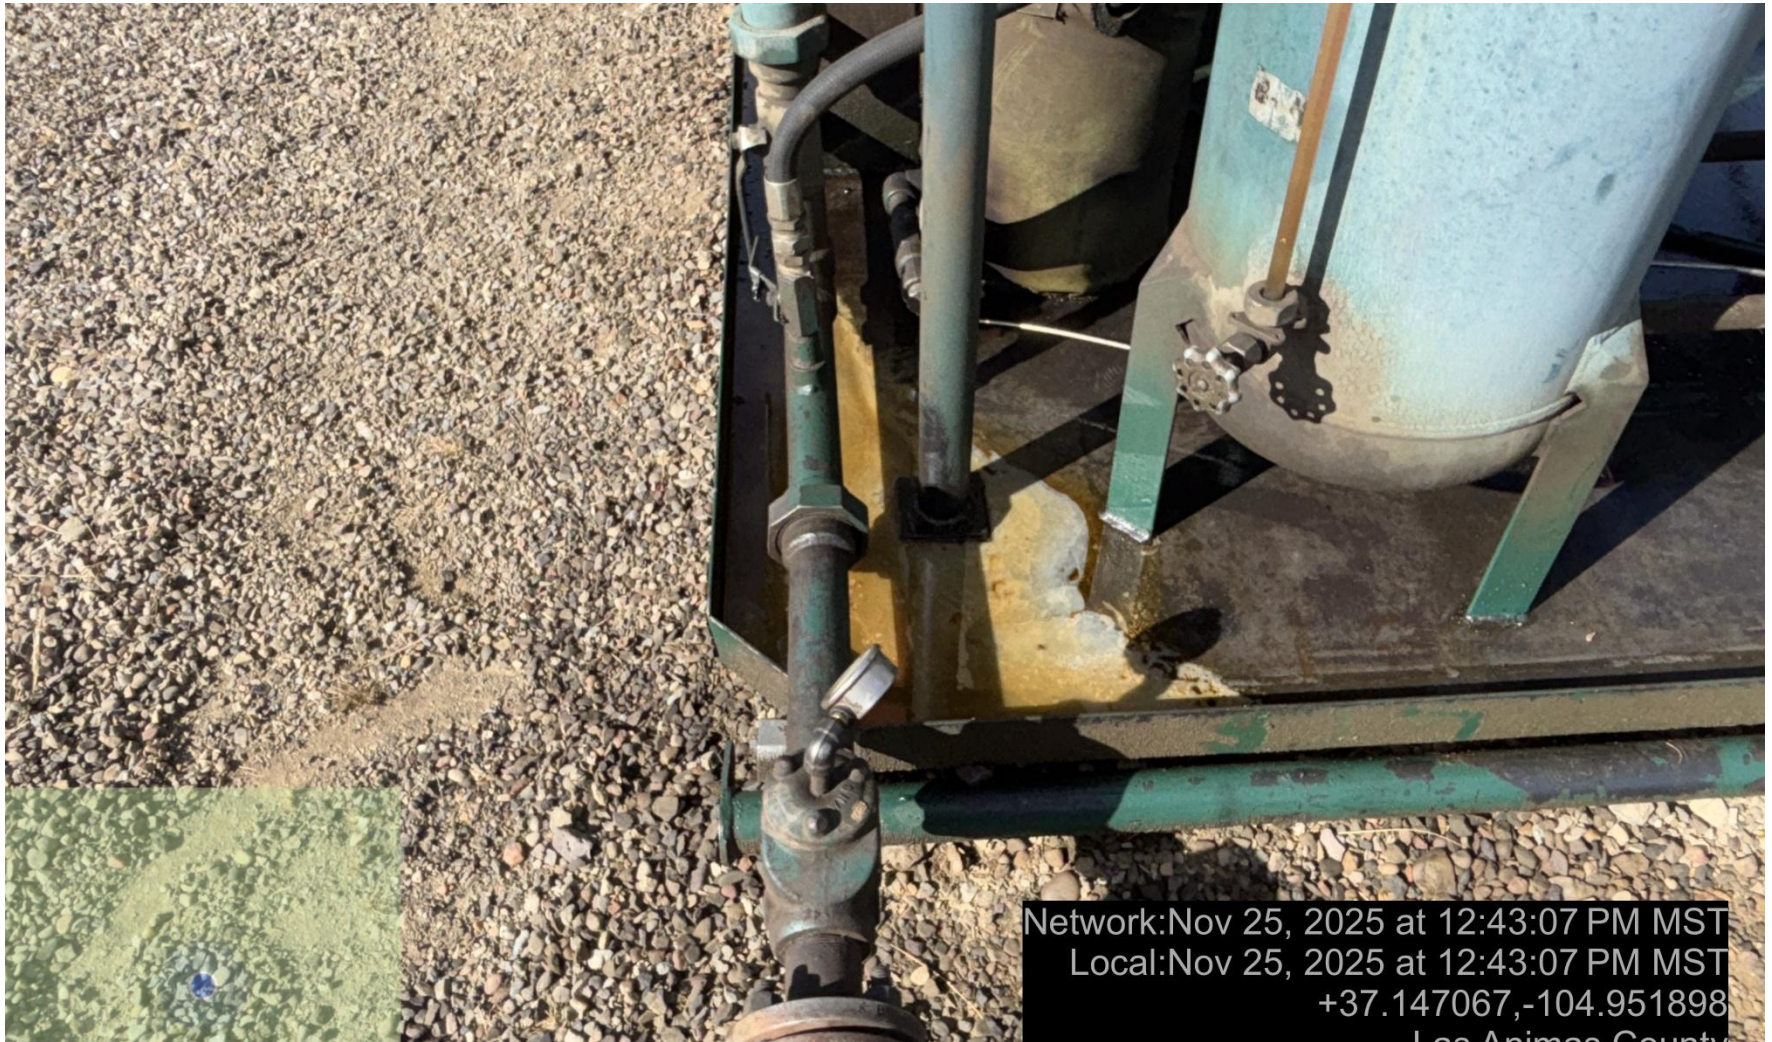
PHOTO 7: OILY WASTE IN COMPRESSOR SKID. DRAIN OILY WASTE REPAIR ALL LEAKS AND REMOVE IMPACTED SOIL PER RULE 1002..(2).D & 1002.f.(2)B, Comply with general provisions of the oil and gas act for wildlife protection AND SB-181. CA DATE 11-26-2025.
