Inspection Photos
Milton Nelson
Spill ID 481725 & 486593/Remediation Project No 23610

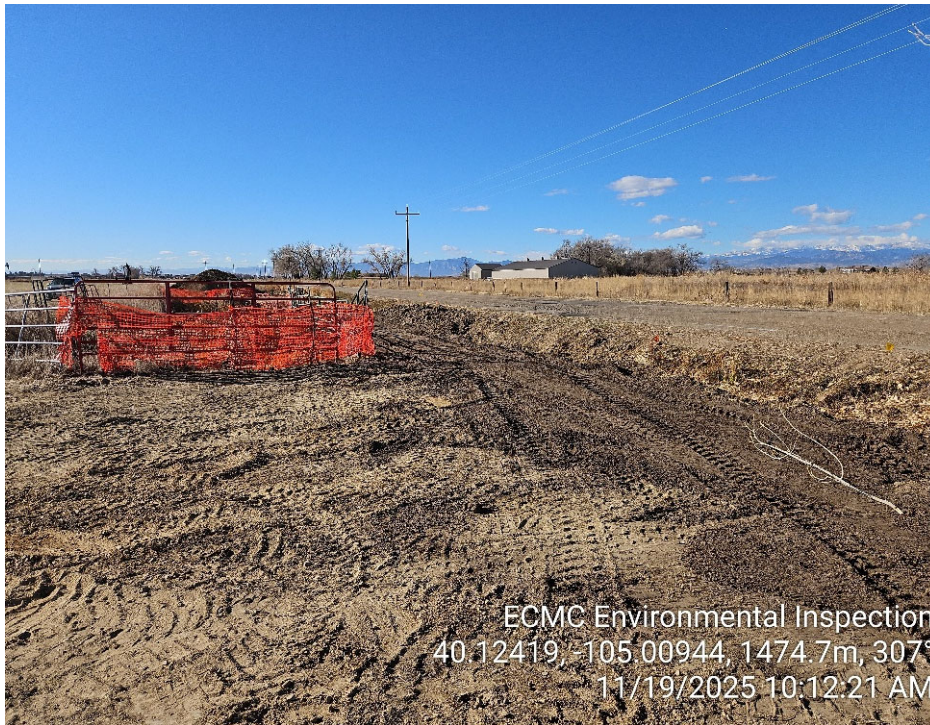
Photo 3 – Backfilled area west of excavation

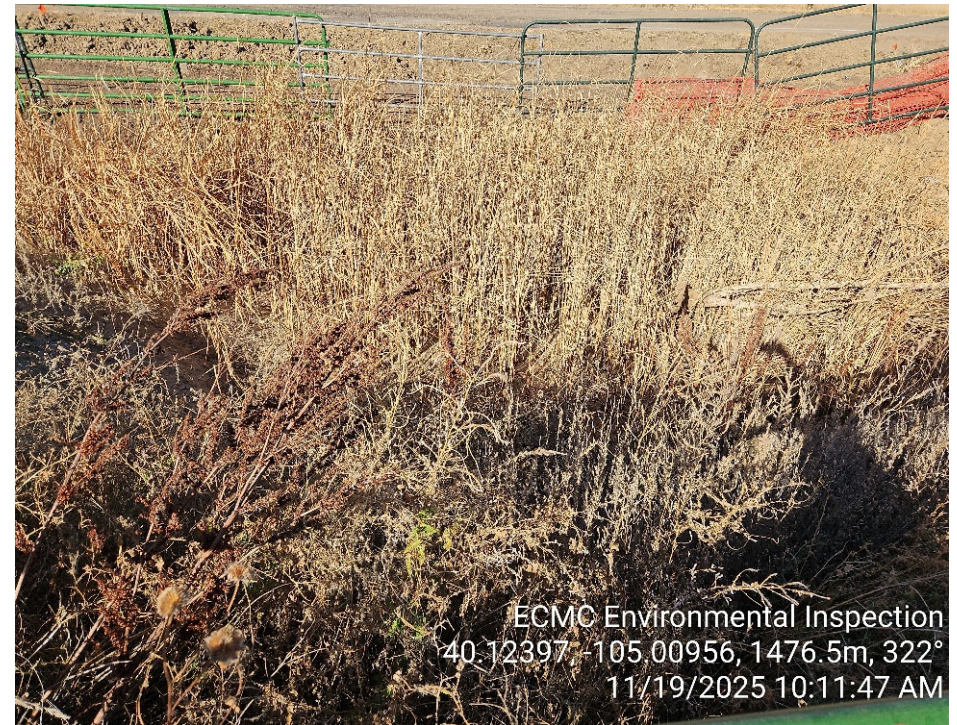
Photo 4 - Weeds in open excavation

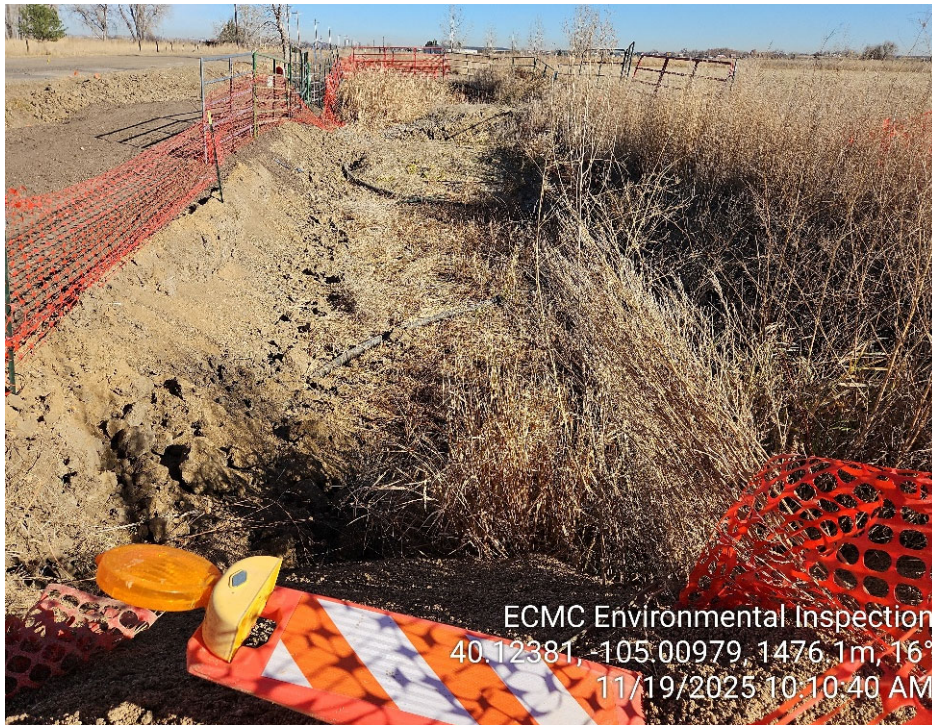
Photo 5 – Open excavation. No groundwater currently present.

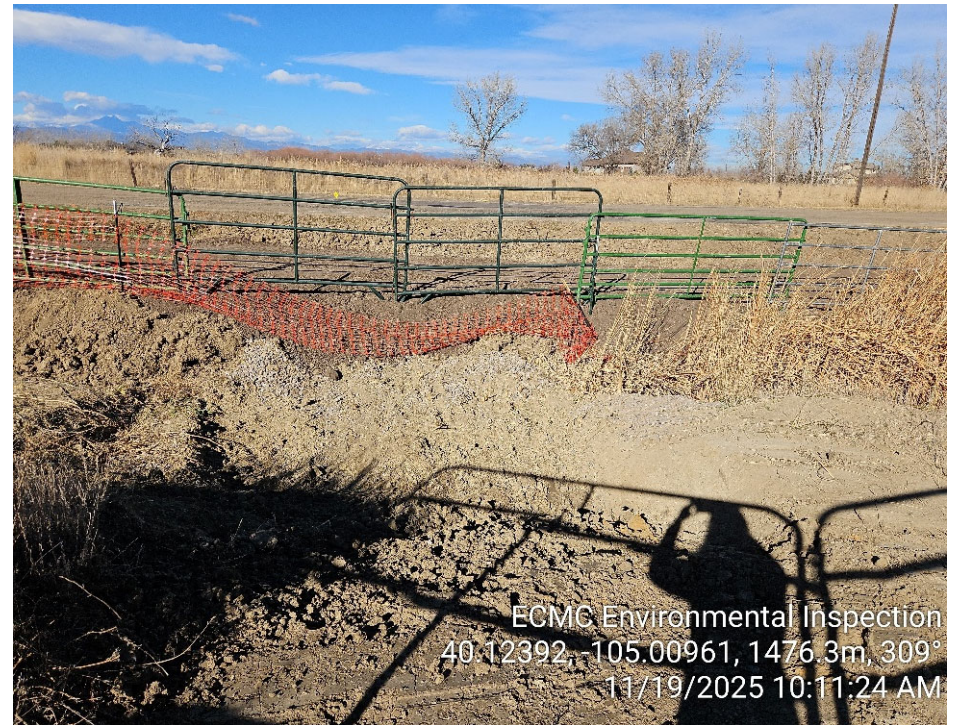
Photo 6 - Open excavation. No groundwater currently present. Excavation appears to have been partially backfilled.

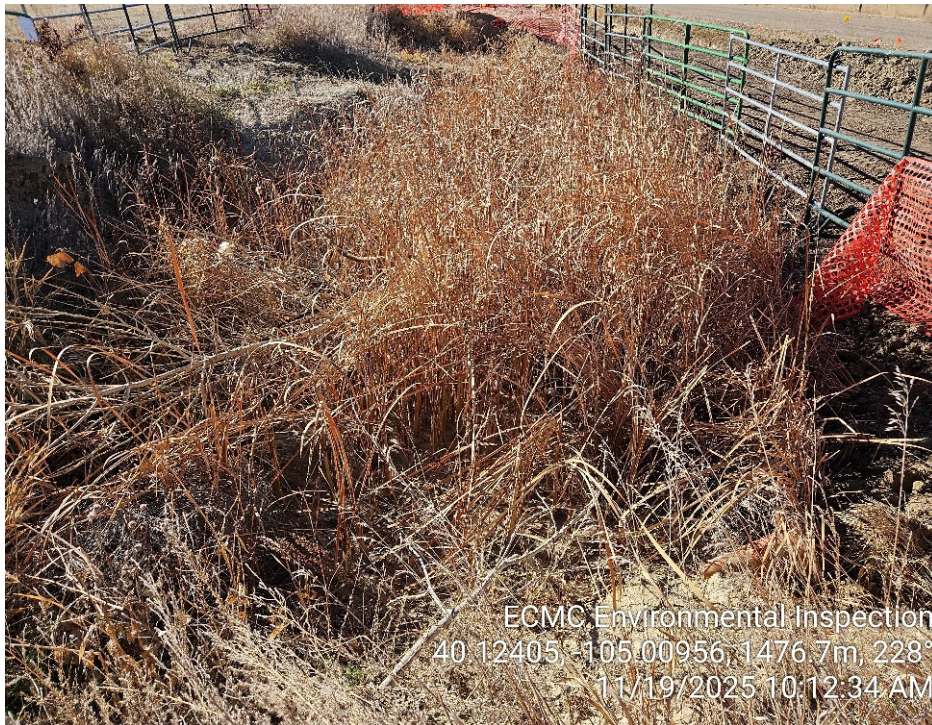
Photo 7 – Weeds in open excavation

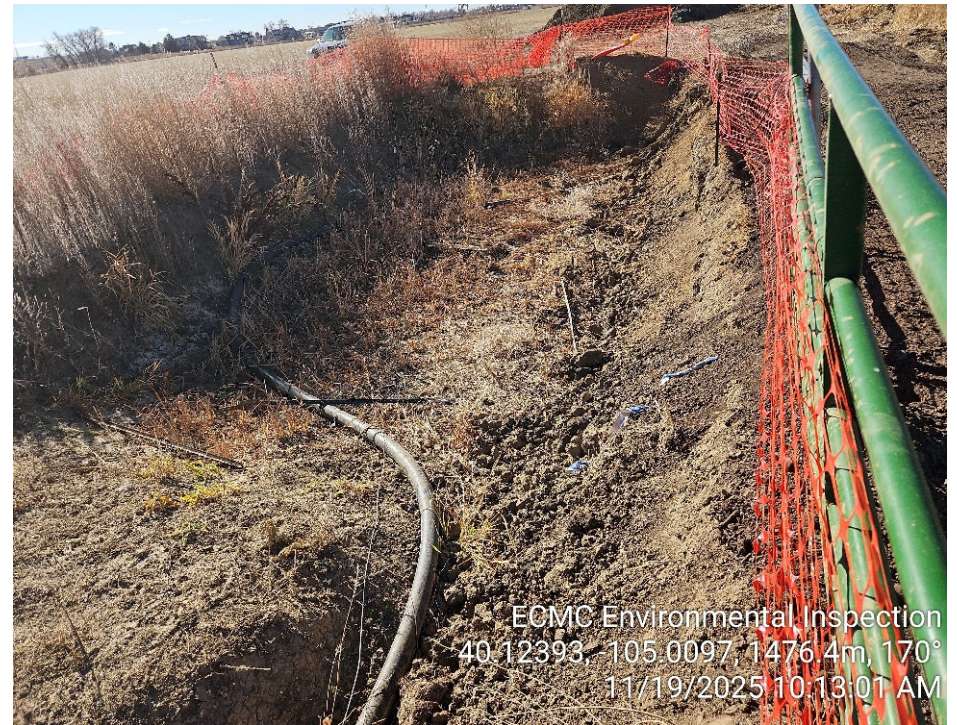
Photo 8 - Open excavation. Weeds in and around open excavation. No groundwater present. Flowline exposed.

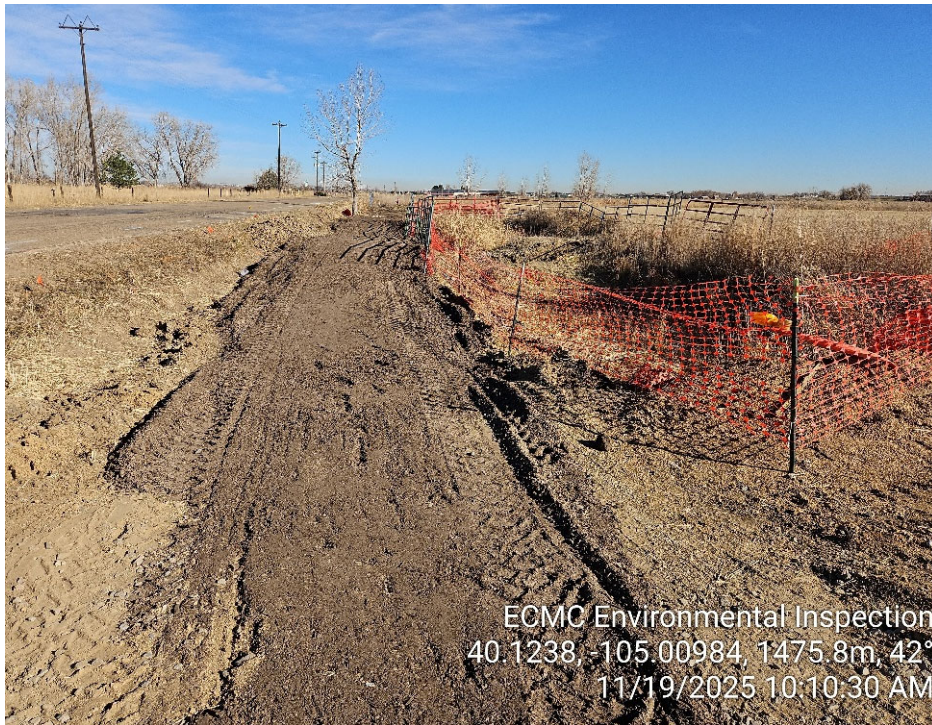
Photo 9 – Backfilled area west of excavation

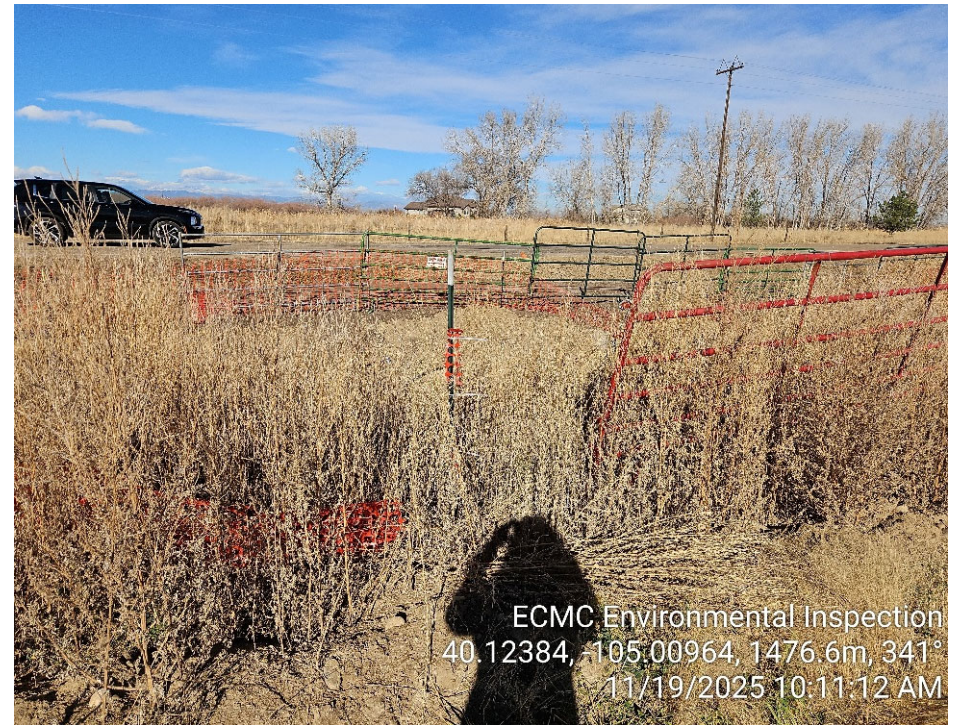
Photo 10 - Fencing down in portions of the excavation.

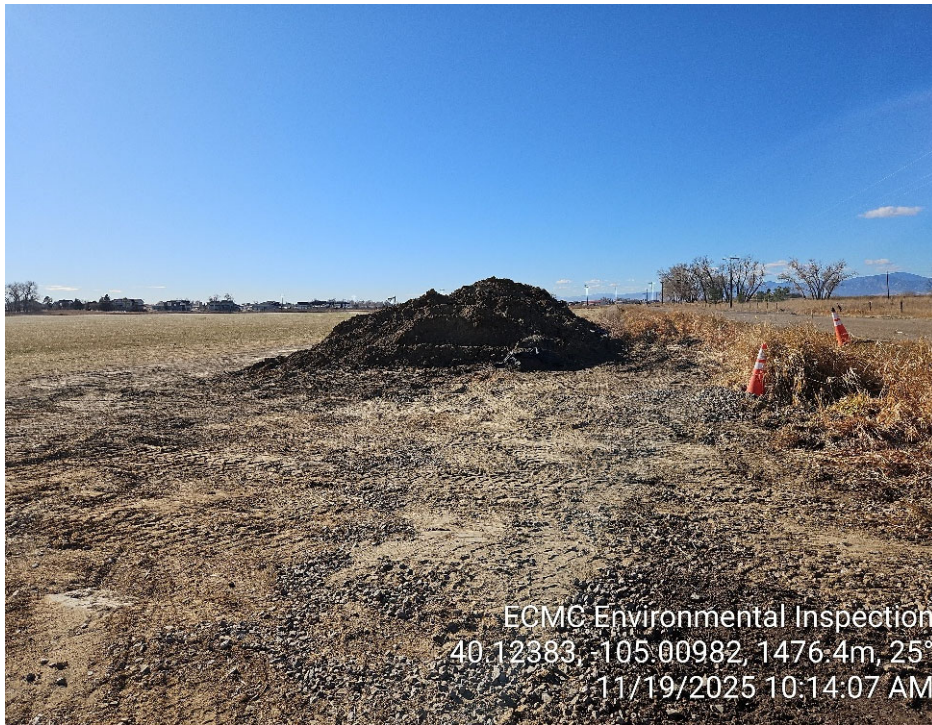
Photo 11 – Soil stockpile.

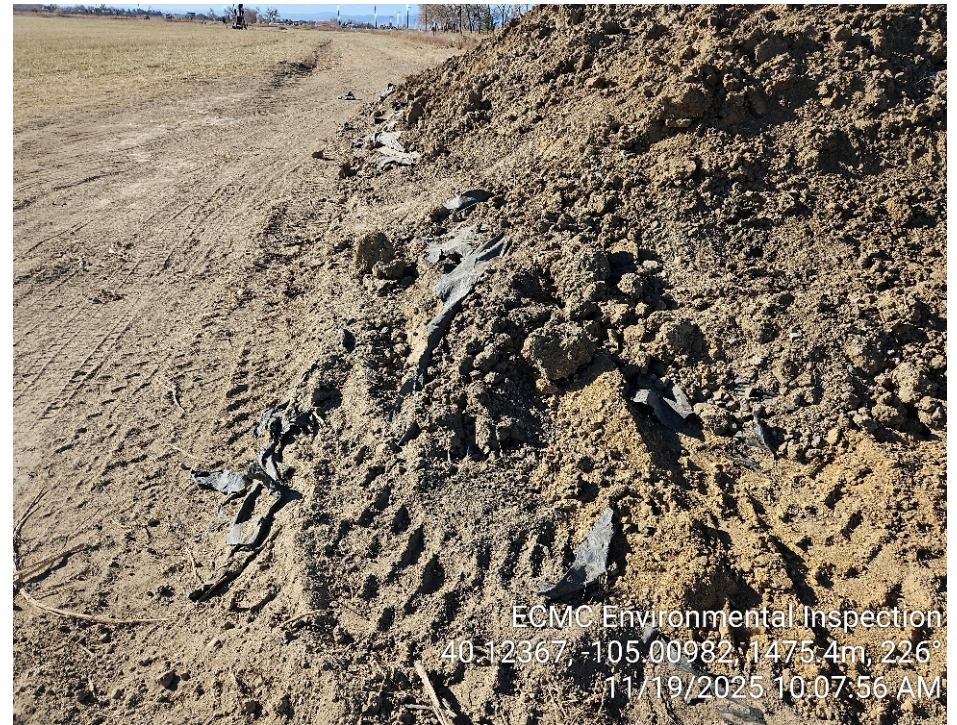
Photo 12 - Soil stockpile. Liner is torn. Stormwater BMPs missing/inadequate.

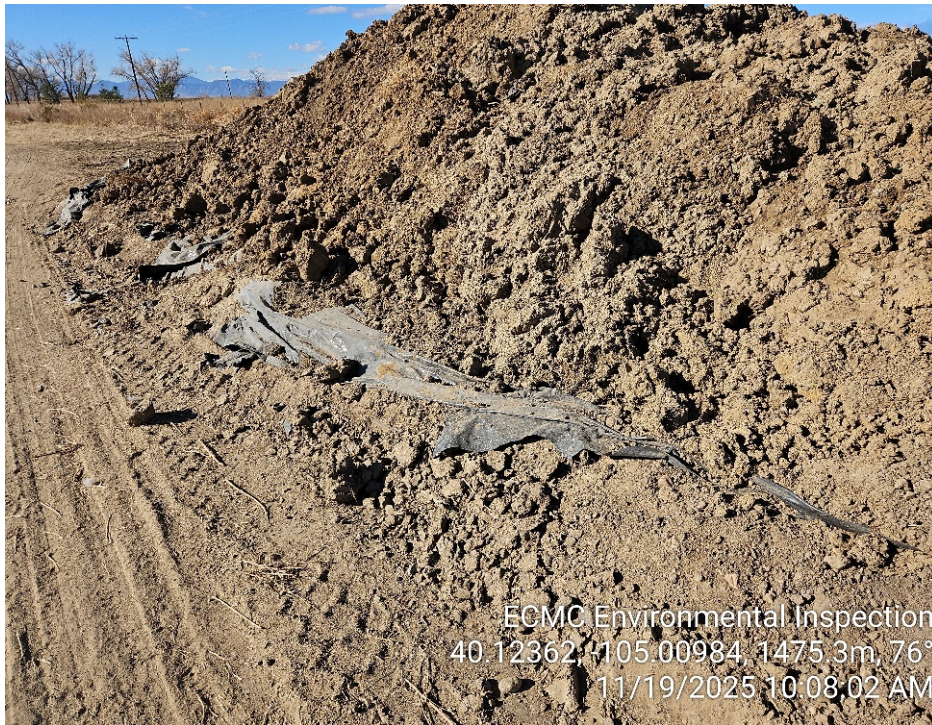
Photo 13 – Soil stockpile. Liner is torn. Stormwater BMPs missing/inadequate.

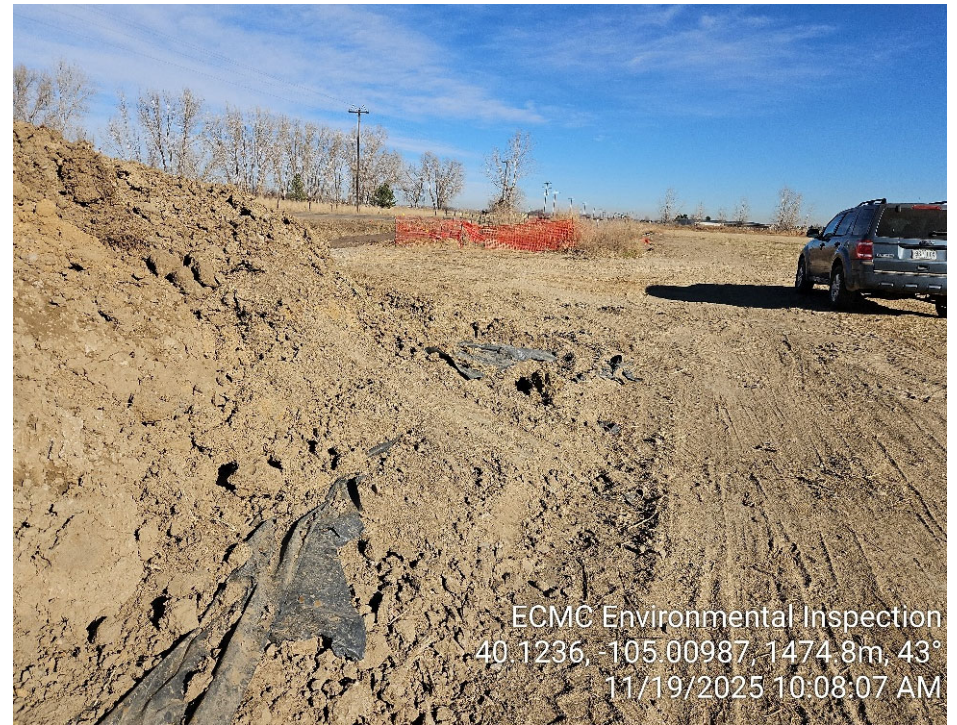
Photo 14 - Soil stockpile. Liner is torn. Stormwater BMPs missing/inadequate.

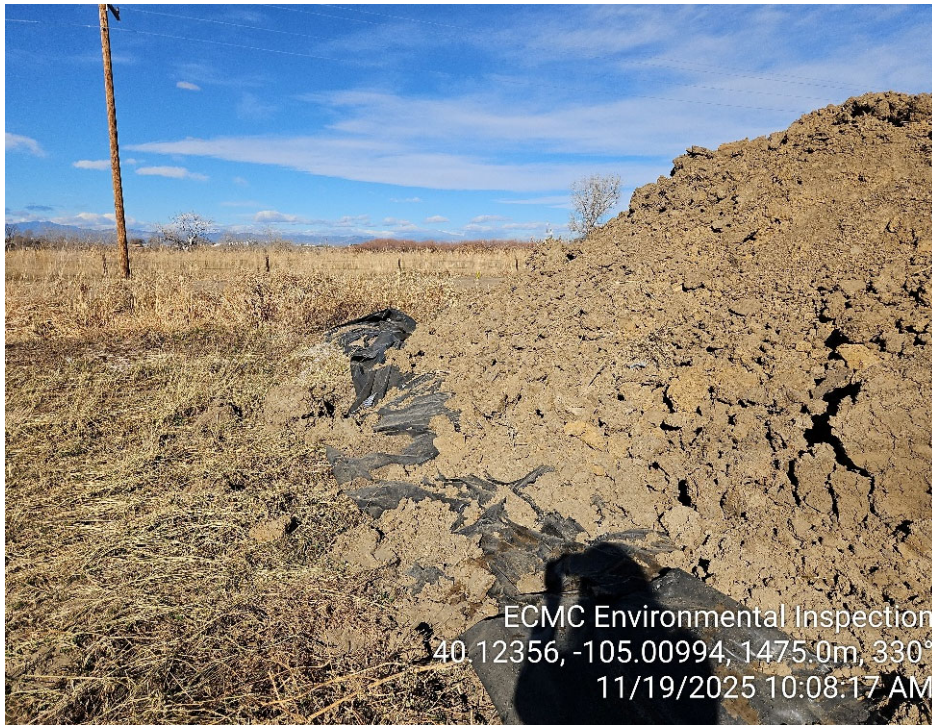
Photo 15 – Soil stockpile. Stormwater BMPs missing/inadequate.

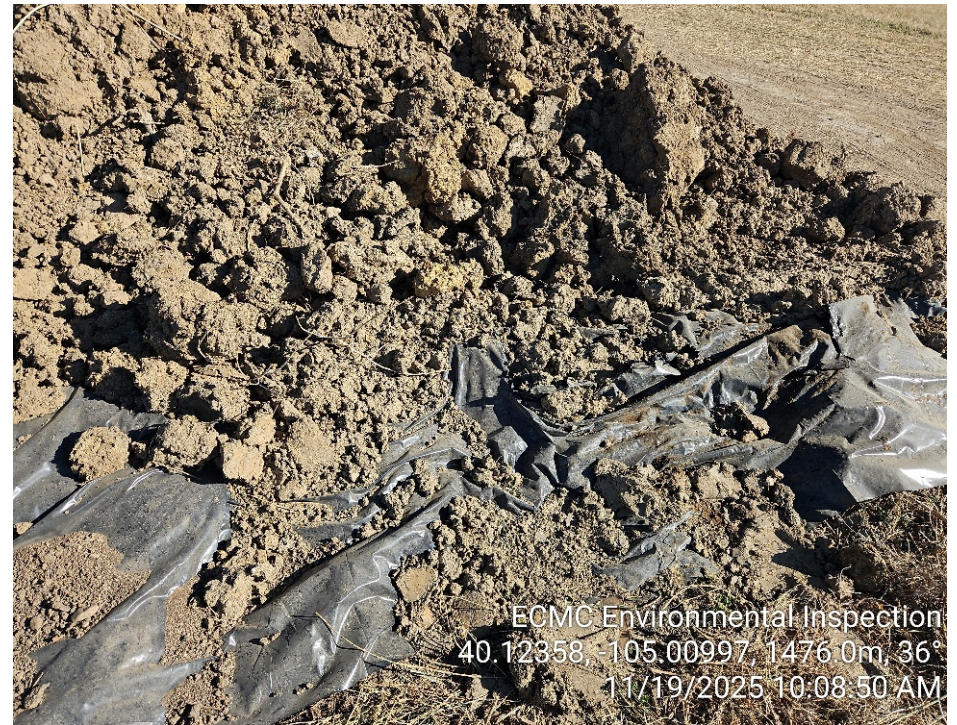
Photo 16 - Soil stockpile. Stormwater BMPs missing/inadequate.

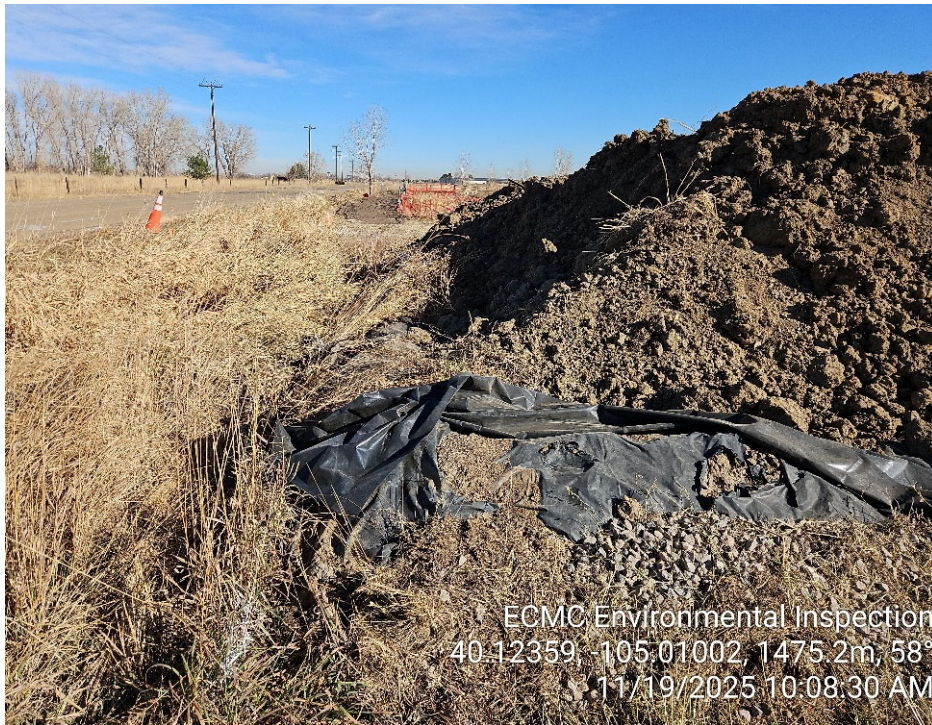
Photo 17 – Soil stockpile. Stormwater BMPs missing/inadequate.

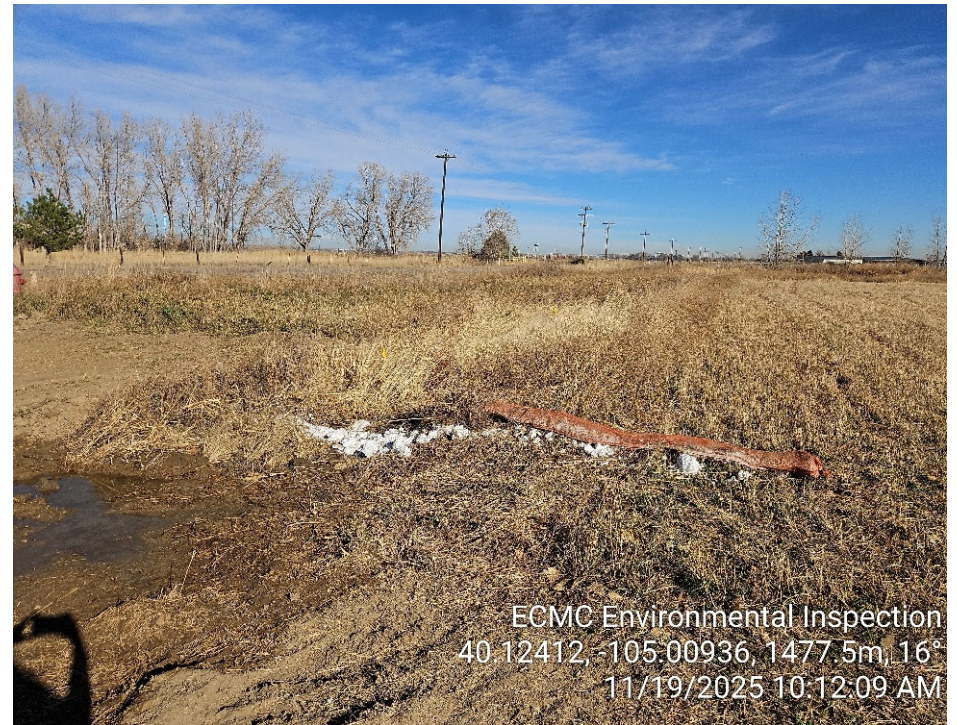
Photo 18 - Stormwater wattle has degraded and become trash.
