Construction and Stormwater Inspection

November 25, 2025

Operator: BISON IV OPERATING LLC- 10670

Location ID: 490641

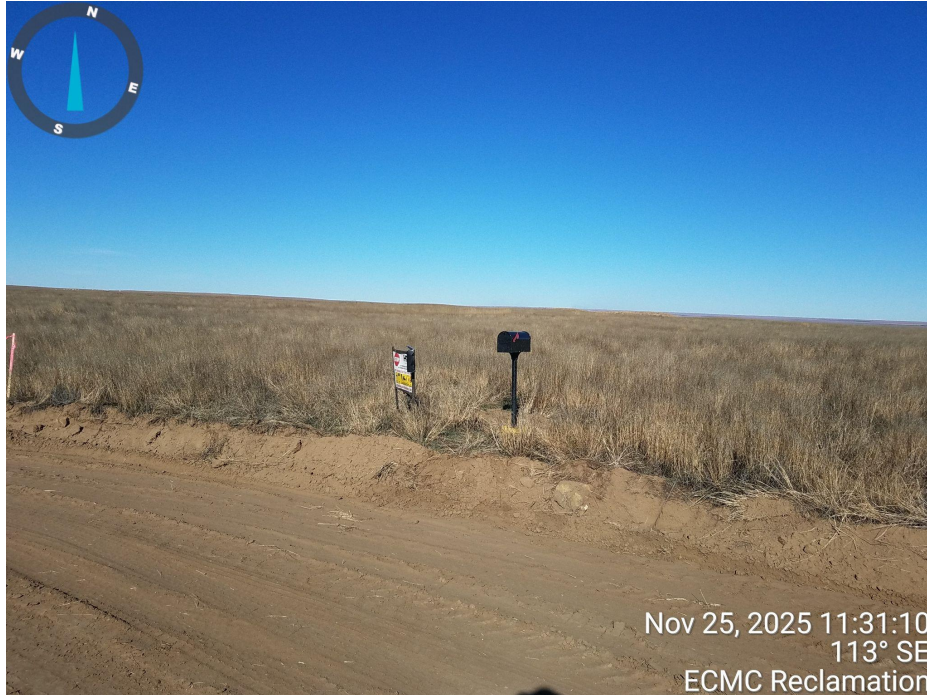
Photo 1. Photo taken from the entrance of location, facing North. Photo illustrates an Operator sign and the mailbox with the required permits.

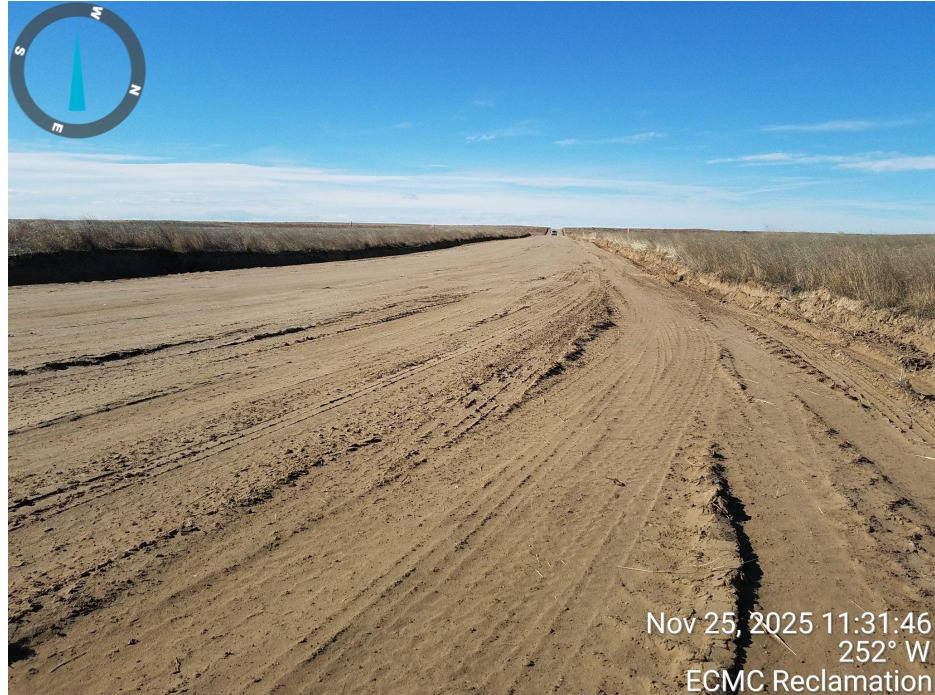
Photo 2. Photo taken from the entrance to location, facing West. Photo illustrates the Operator salvaged topsoil from the access road and is being stored on location.

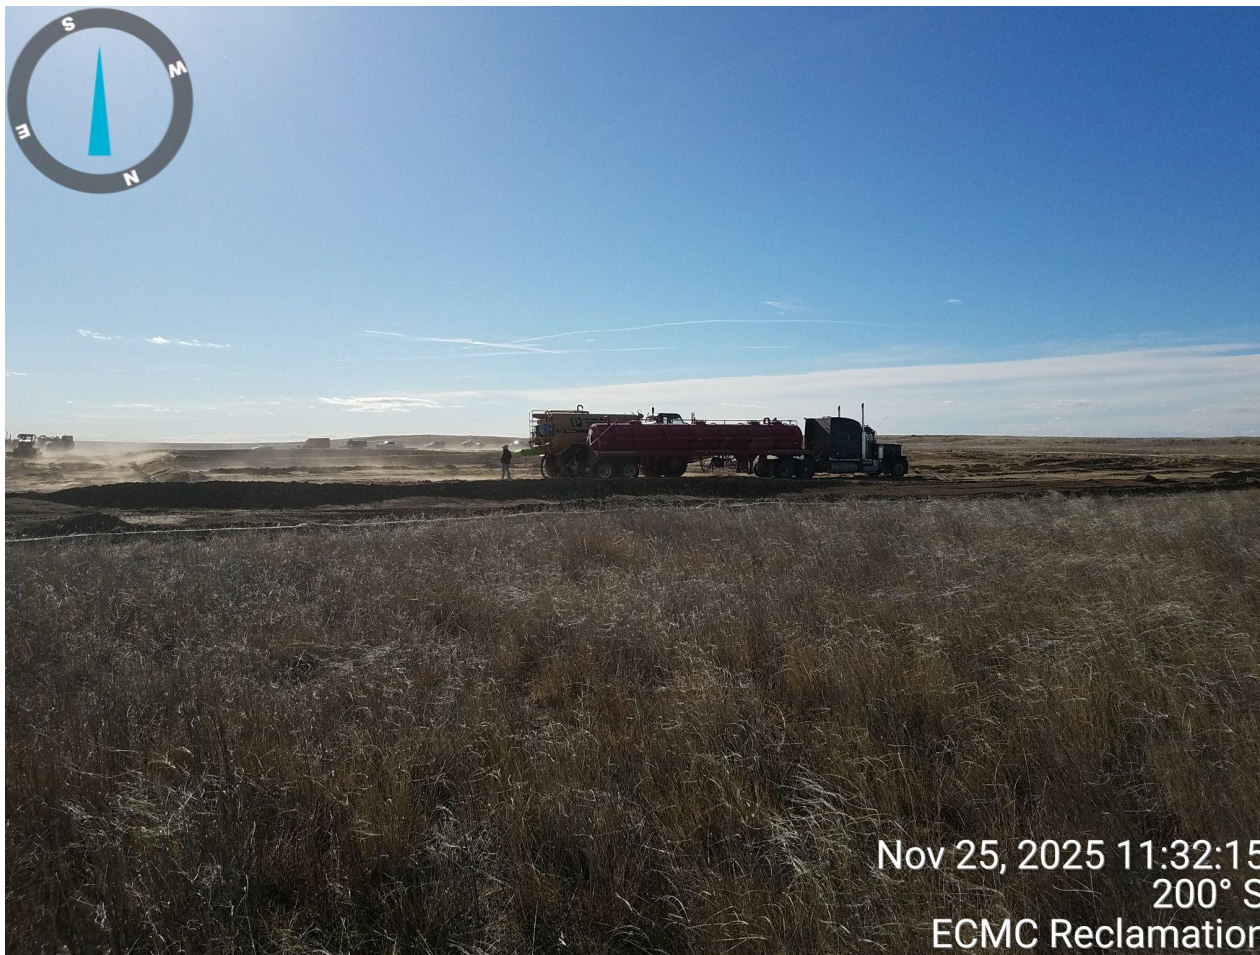
Photo 3. Photo taken of the northwestern location, facing South. Photo illustrates a water supply truck filling up the watering truck used for dust mitigation.

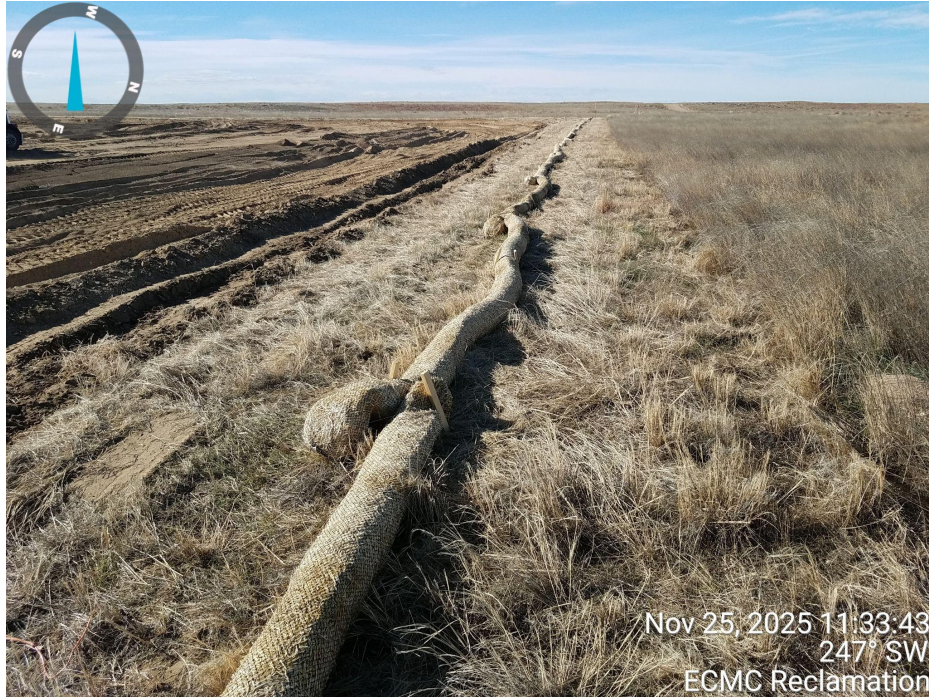
Photo 4. Photo taken from the northwestern perimeter of location, facing West. Photo illustrates the Operator installed a perimeter stormwater BMP around the entire perimeter of the location. However, the stormwater BMP (straw wattle) was not properly installed per good engineering practices.

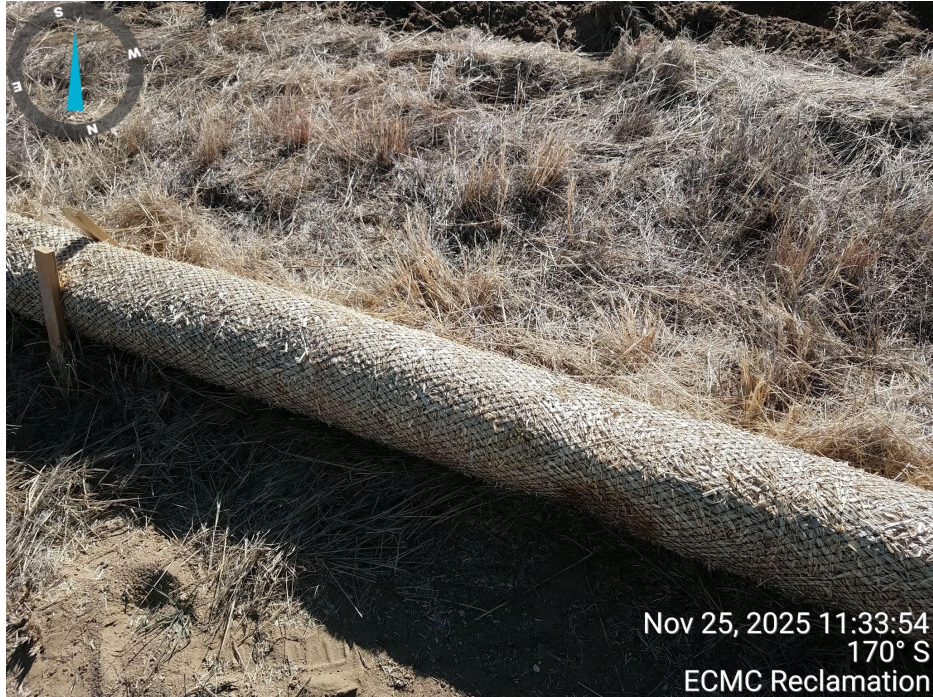
Photo 5. Close up photo taken from a section of the stormwater BMP (straw wattle) illustrating the BMP has not been trenched in per good engineering practices.

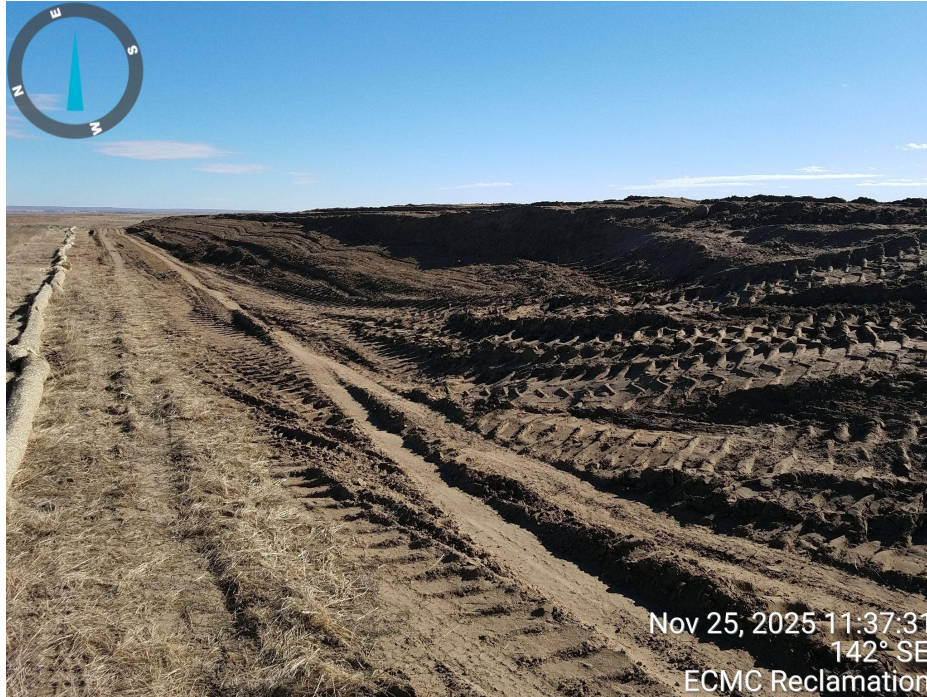
Photo 6. Photo taken from the northern perimeter of location, facing East. Photo illustrates the topsoil stockpile that remains unconsolidated and will be stabilized per the Operator plan.

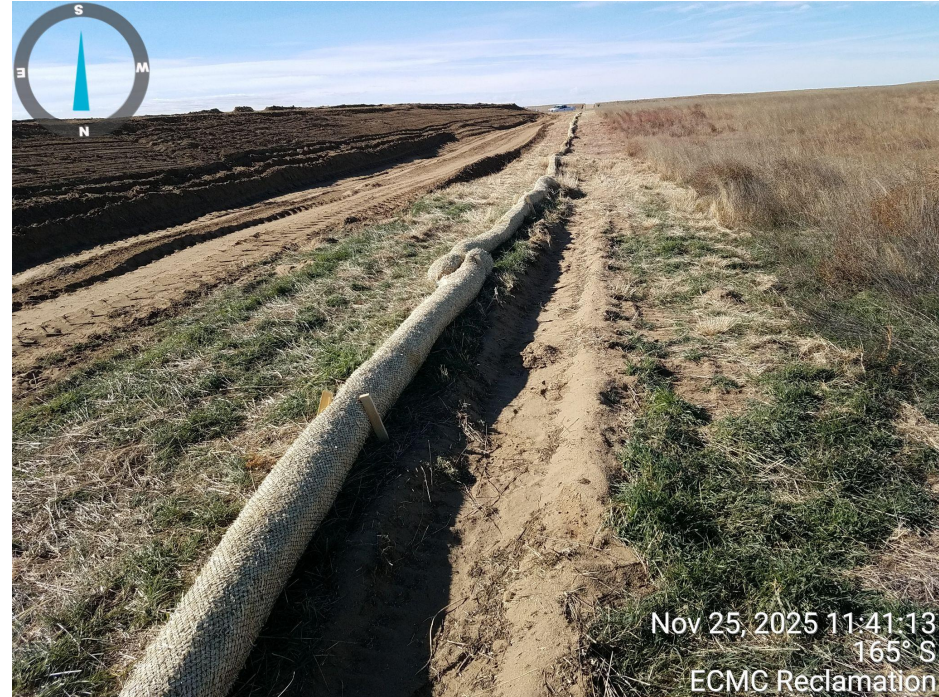
Photo 7. Photo taken from the northern perimeter of location, facing West. Photo illustrates a section of the stormwater BMP (straw wattle) illustrating the BMP has not been trenched in per good engineering practices. It appears that a trench was installed, yet the straw wattle was not placed within the trench. Note- the trench may be too deep for the straw wattle.

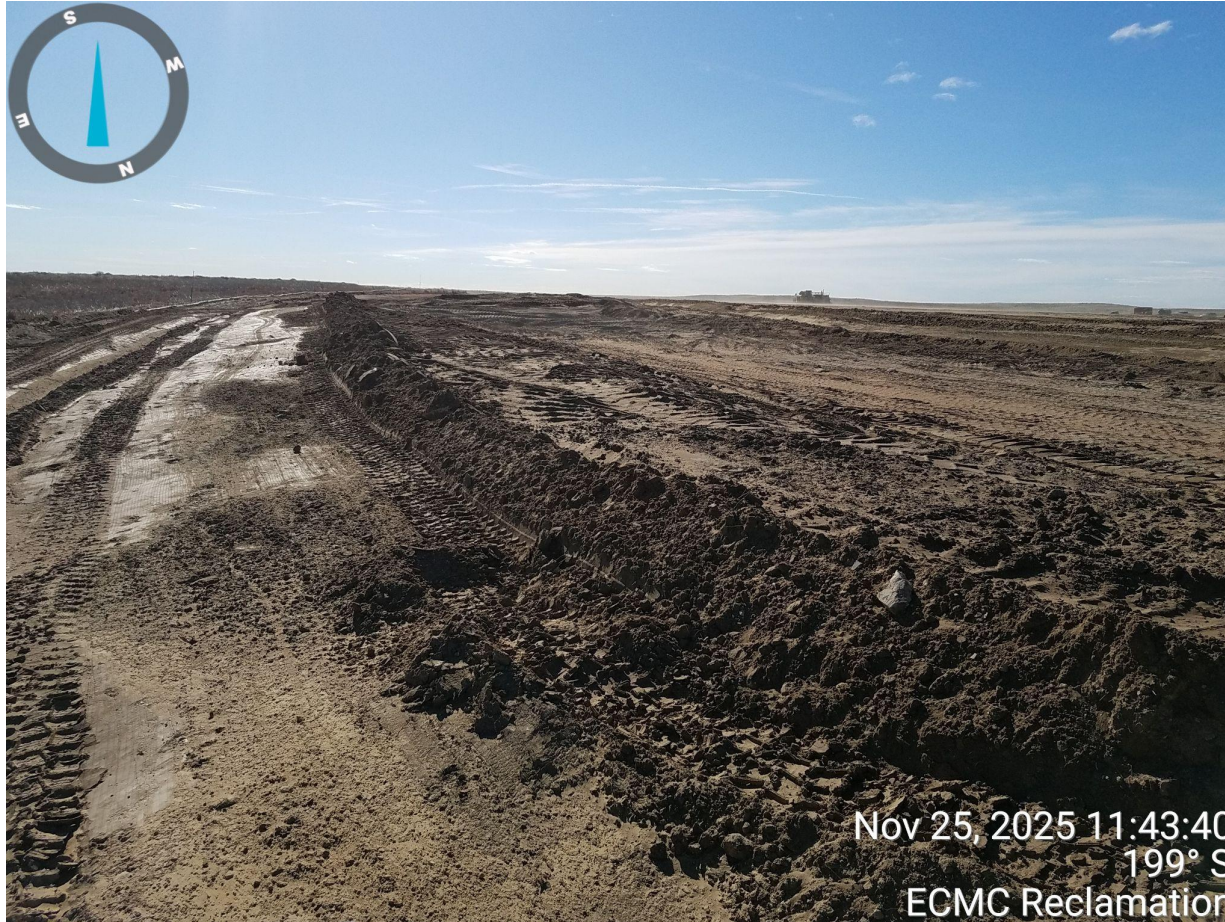
Photo 8. Photo taken from the northeastern location, facing South. Photo illustrates the detention pond is under construction and remains in-process.

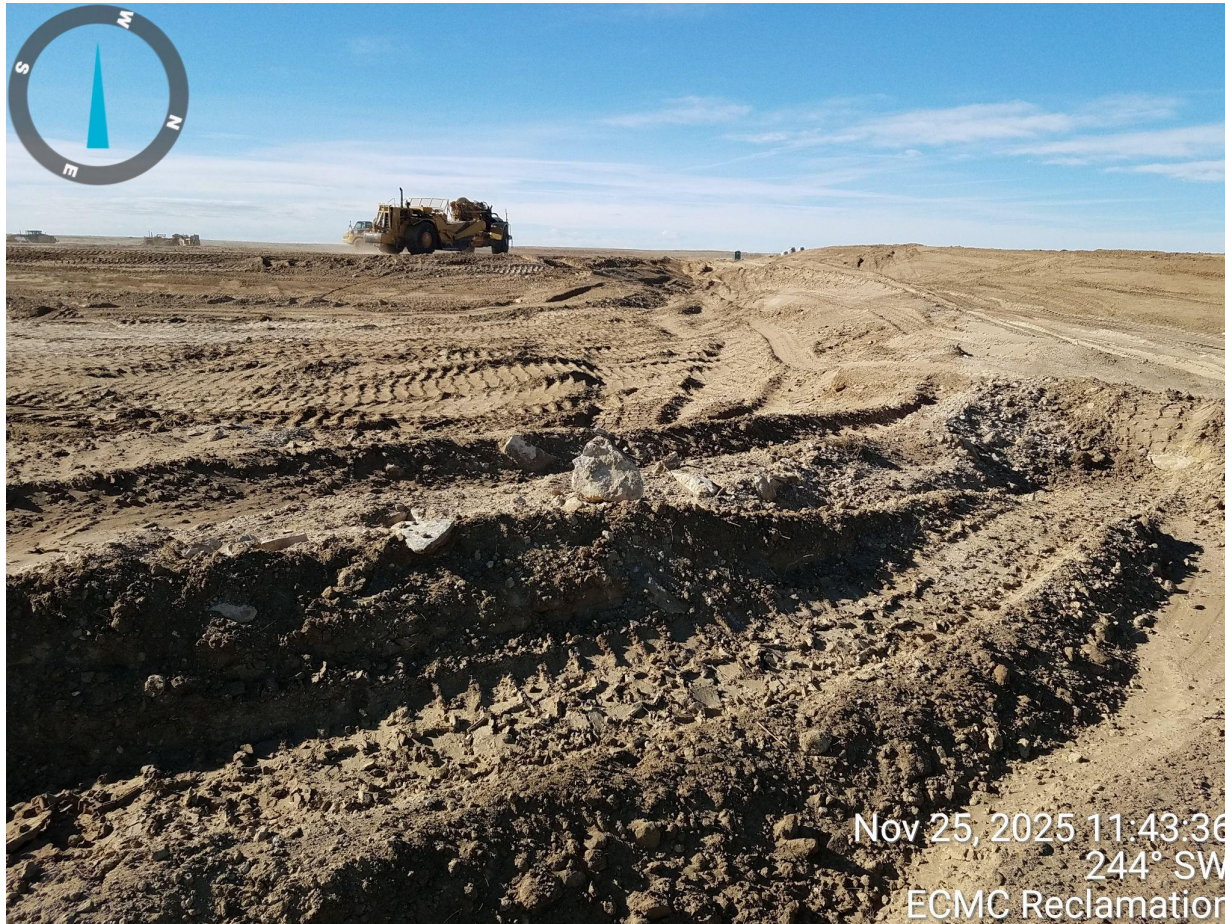
Photo 9. Photo taken from the northeastern location, facing West. Photo illustrates the Operator has completed topsoil salvage operations and is leveling out (cut/fill) the location.
