Inspection Photos

Location: Slip Rock 11-13 and Slip Rock 11-13 TR

Location ID: 334186

API # 05-071-06807 and 05-071-09199

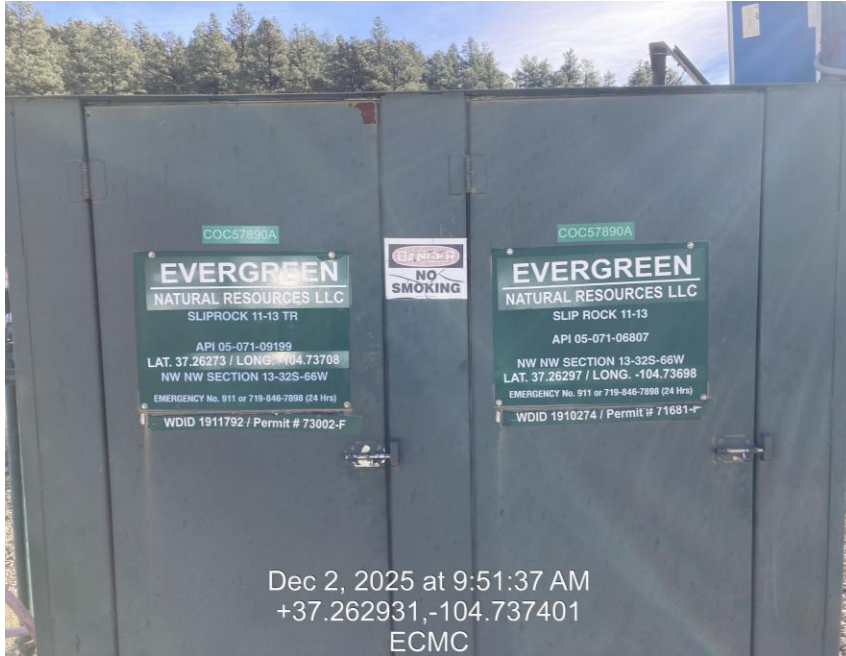
Photo 1 – Well Placard

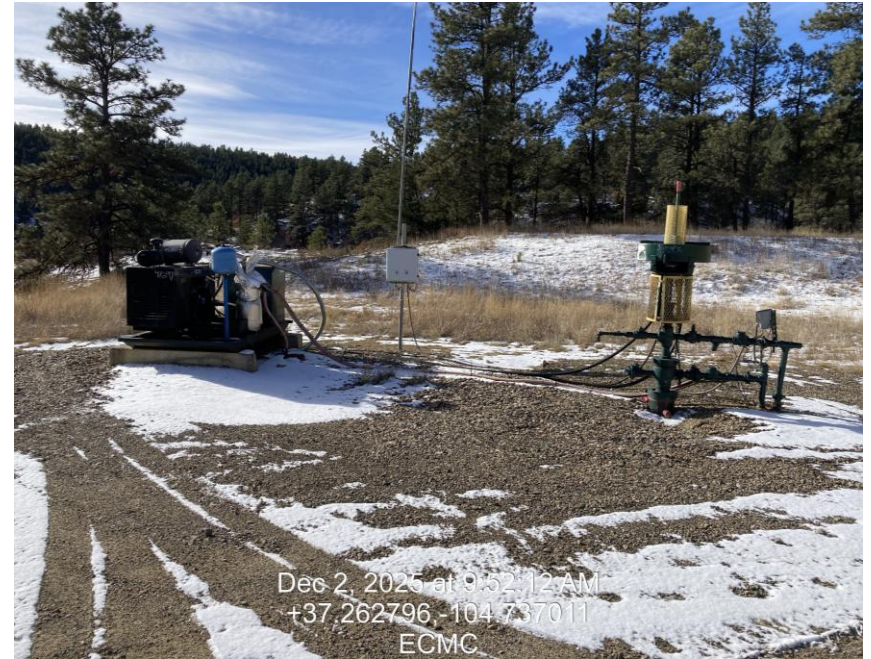
Photo 2 – TR wellhead

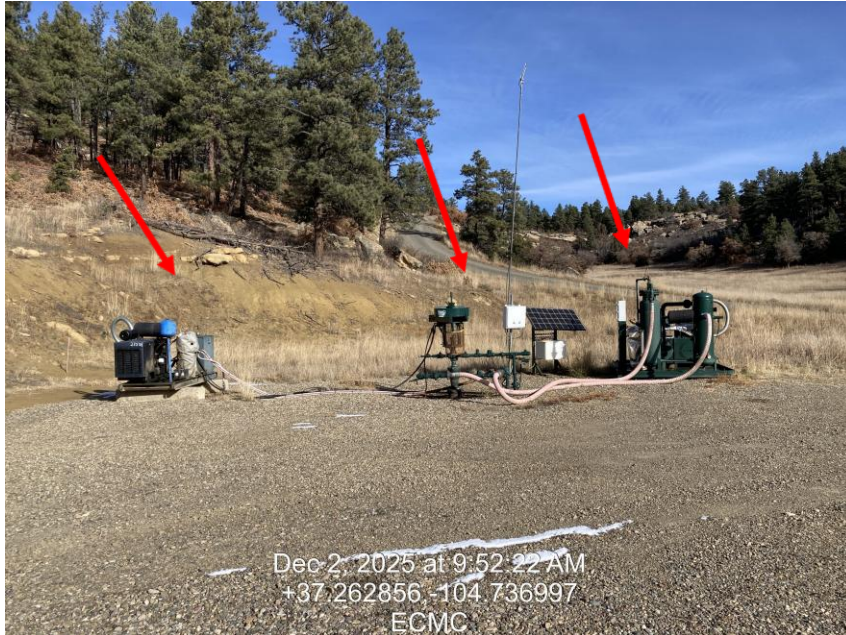
Photo 3 – KV wellhead and equipment

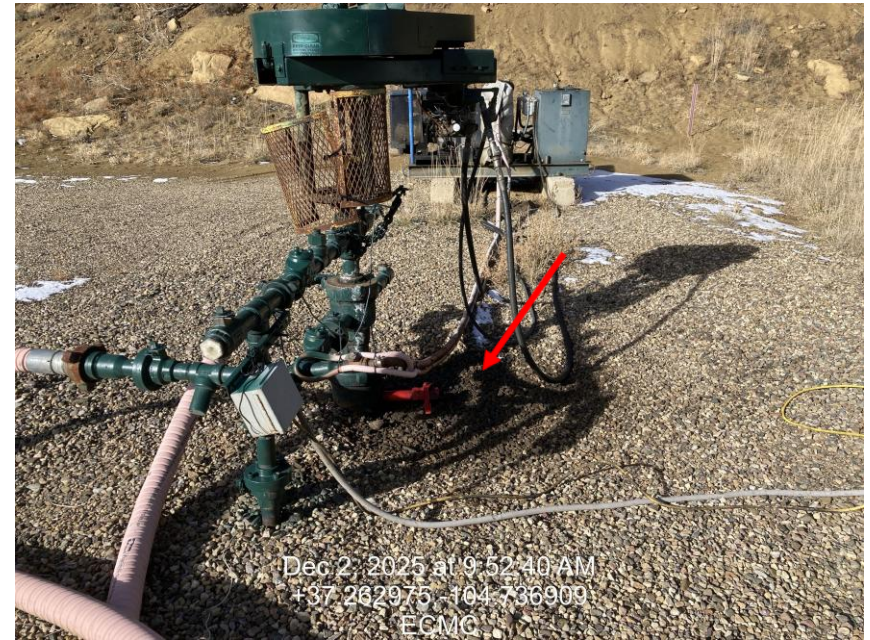
Photo 4 – Stained soils at base of wellhead

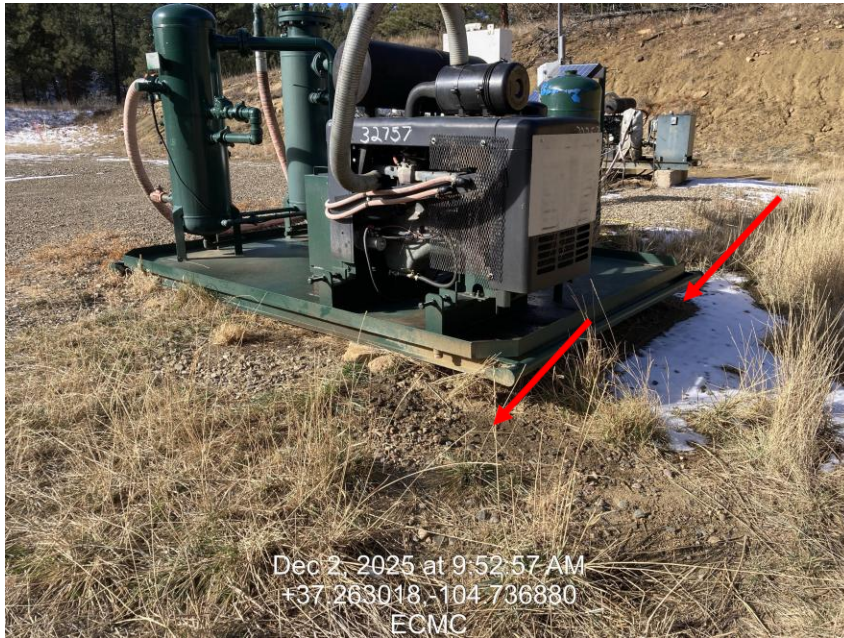
Photo 5 – Stained soils at base of skid.
