Final Reclamation Inspection

Operator: Kerr McGee Oil & Gas Onshore - 47120

Location ID: 317894

Inspection Document #: 714002799

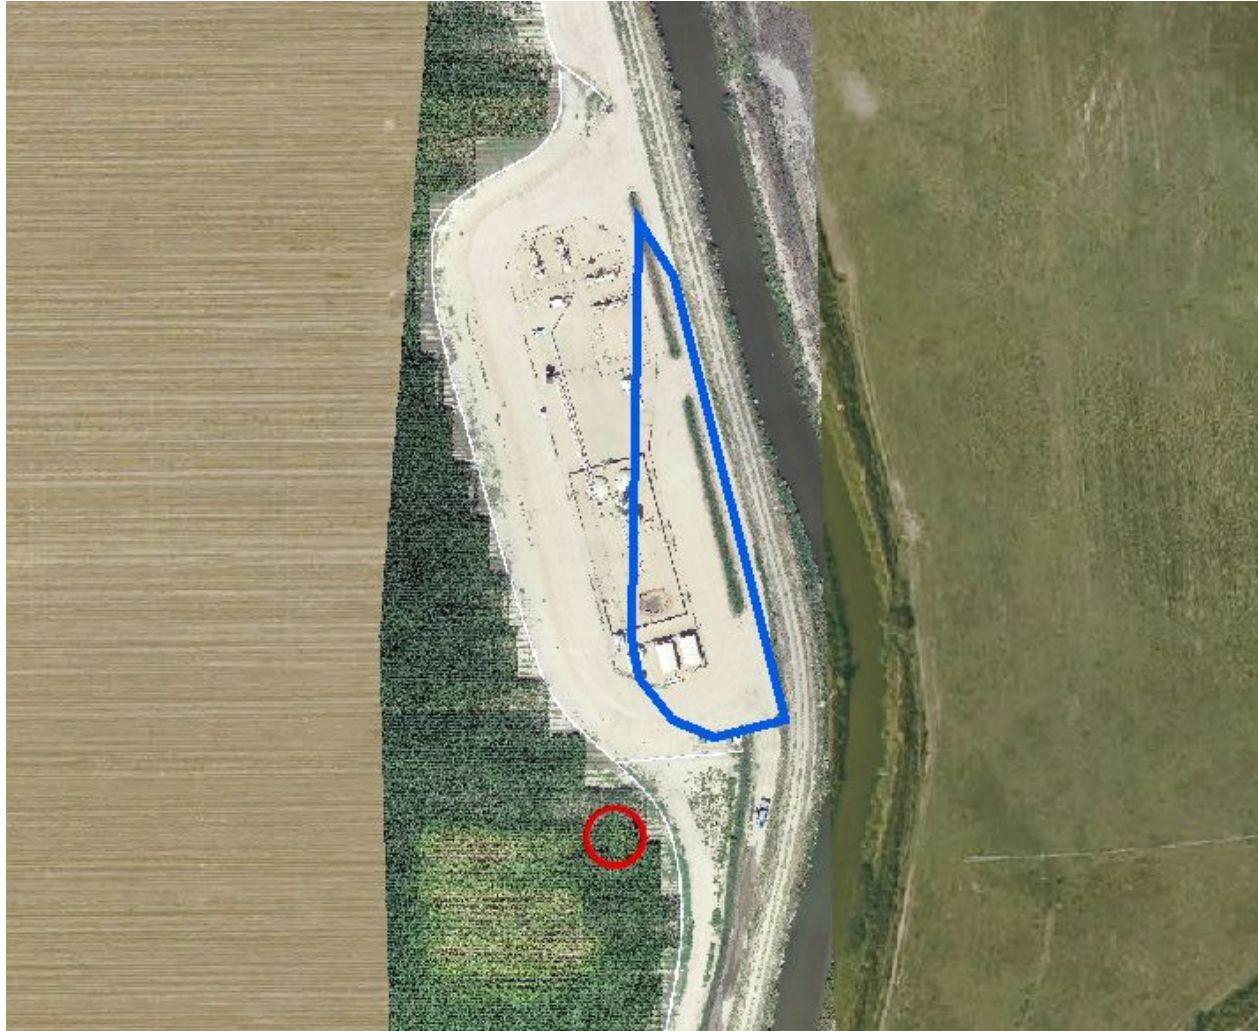
Photo 2. Orthomosaic (drone) imagery taken 8/20/2025 and NAIP aerial imagery (2023) illustrating the well location (red circle) and associated tank battery (blue polygon). Note: Historical imagery shows a new tank battery facility was built over the old tank battery disturbance.

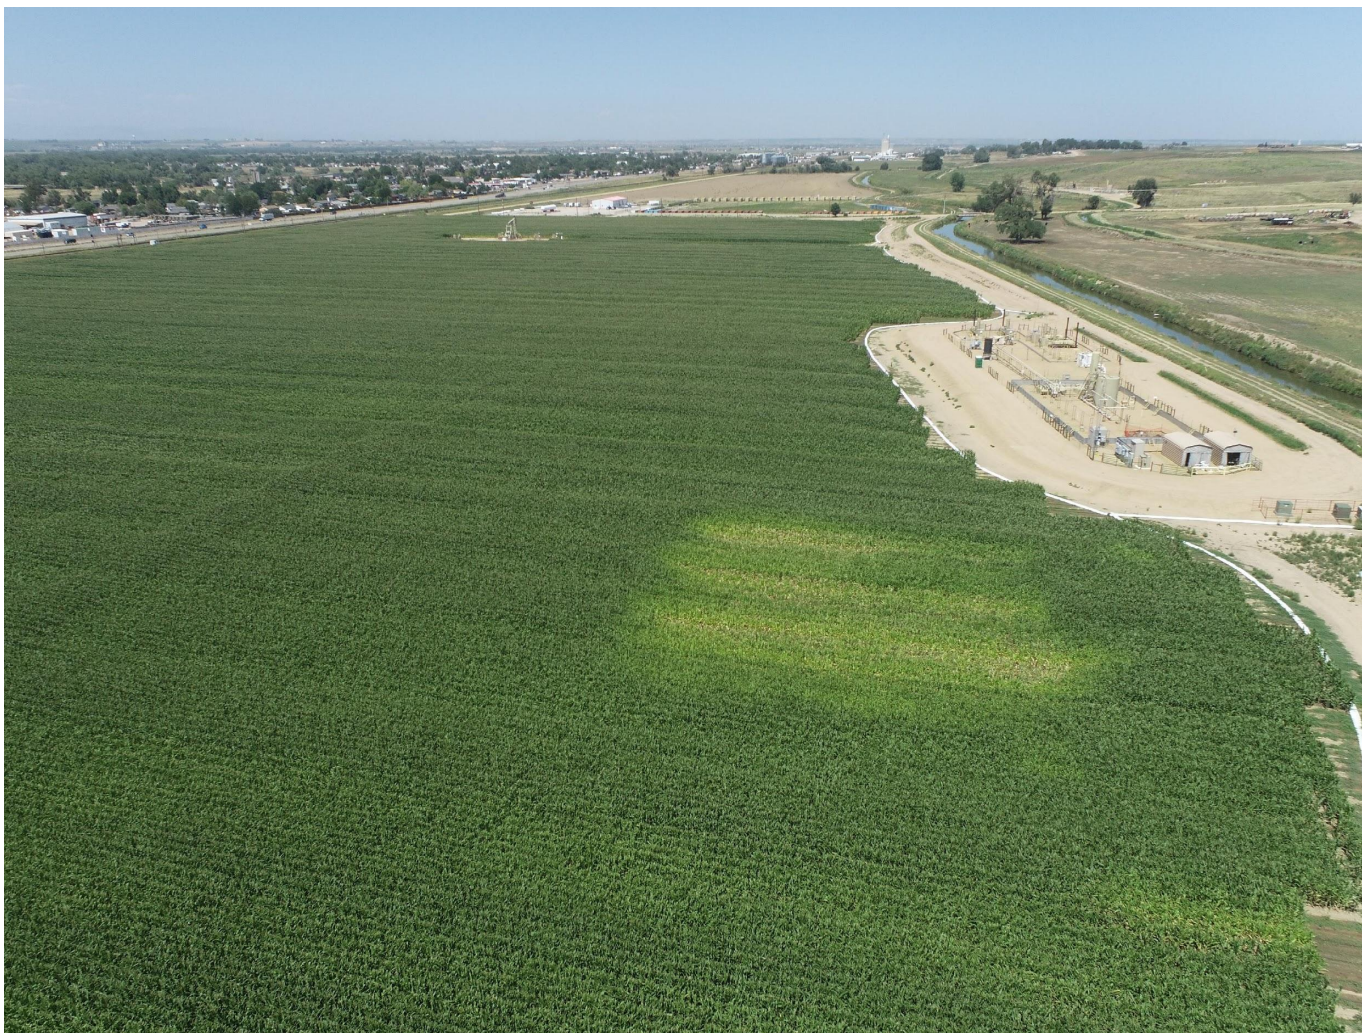
Photo 3. Drone aerial imagery taken south of well location, facing north (displaying the well, well access roads, and presumed flowline).

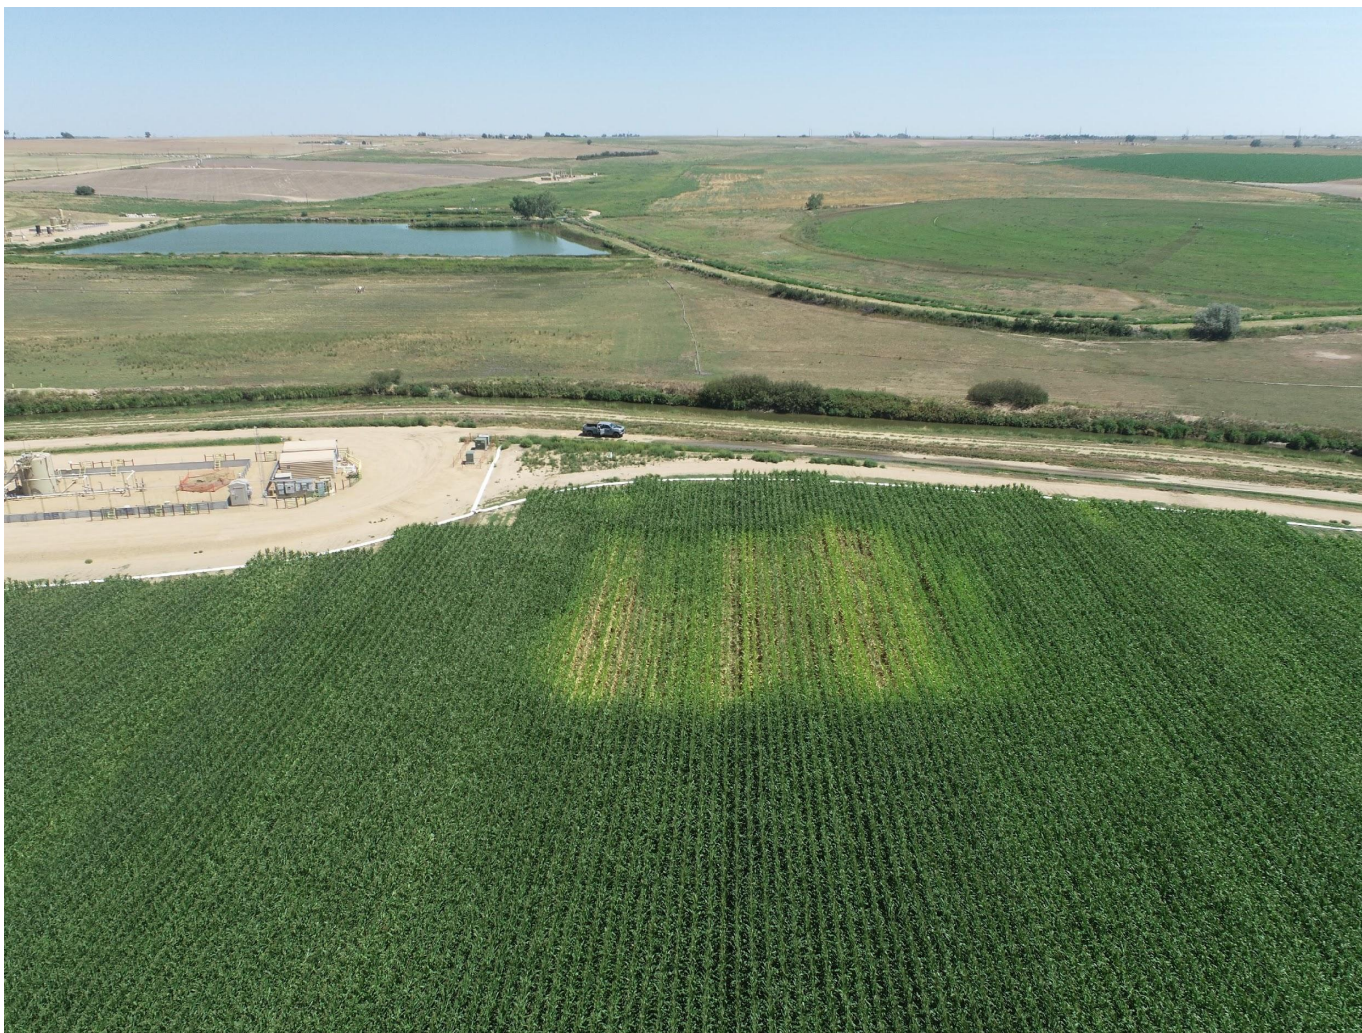
Photo 4. Drone aerial imagery taken west of well location, facing east (displaying the well, well access roads, and presumed flowline).

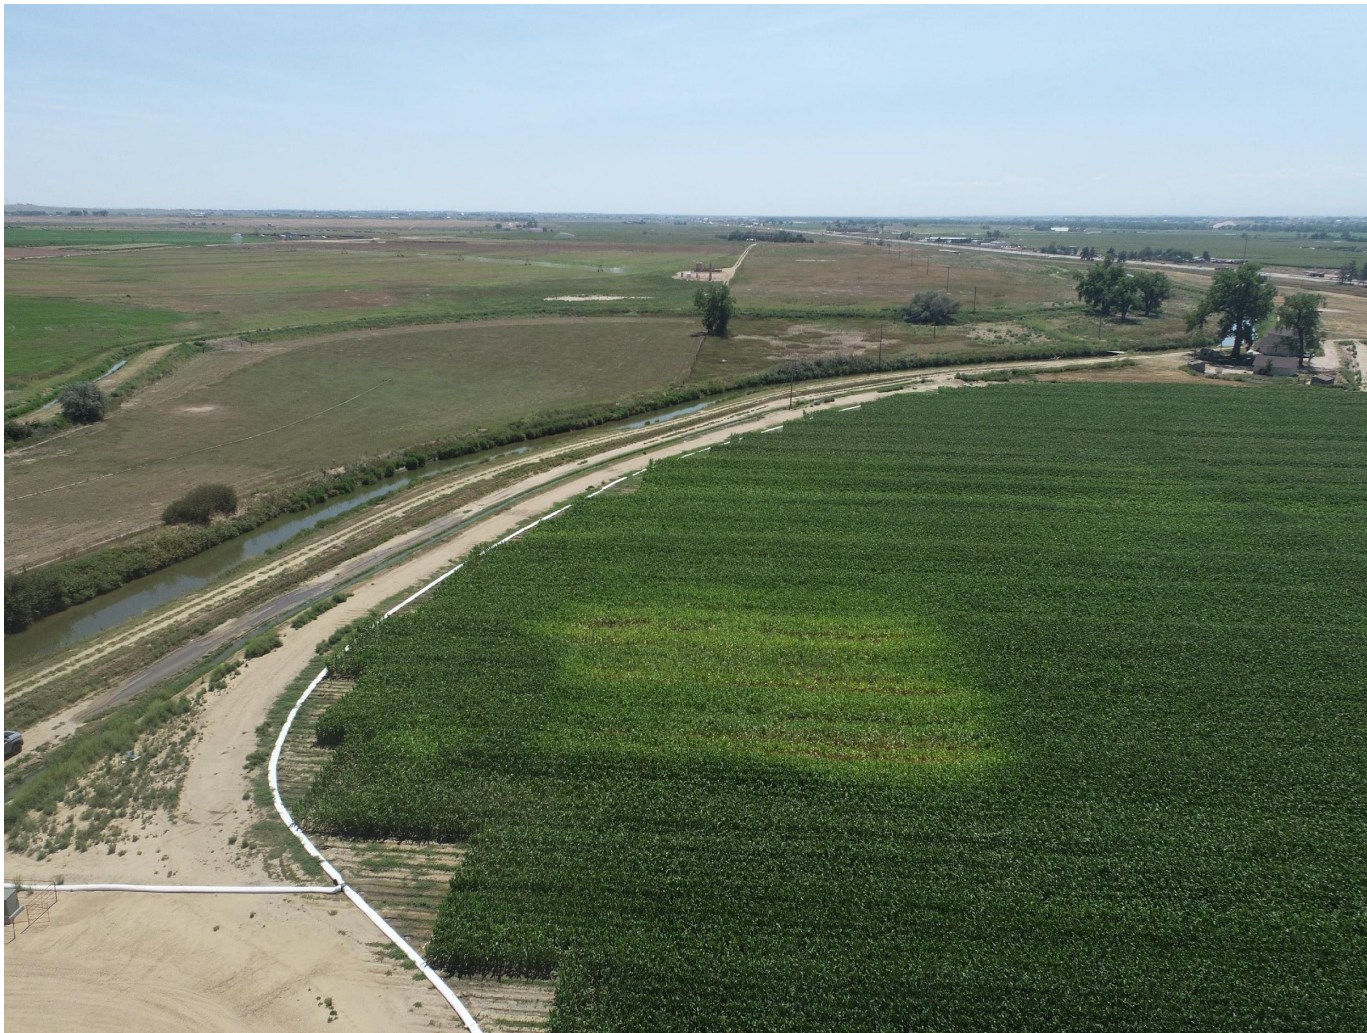
Photo 5. Drone aerial imagery taken north of well location, facing south (displaying the well, well access roads, and presumed flowline).

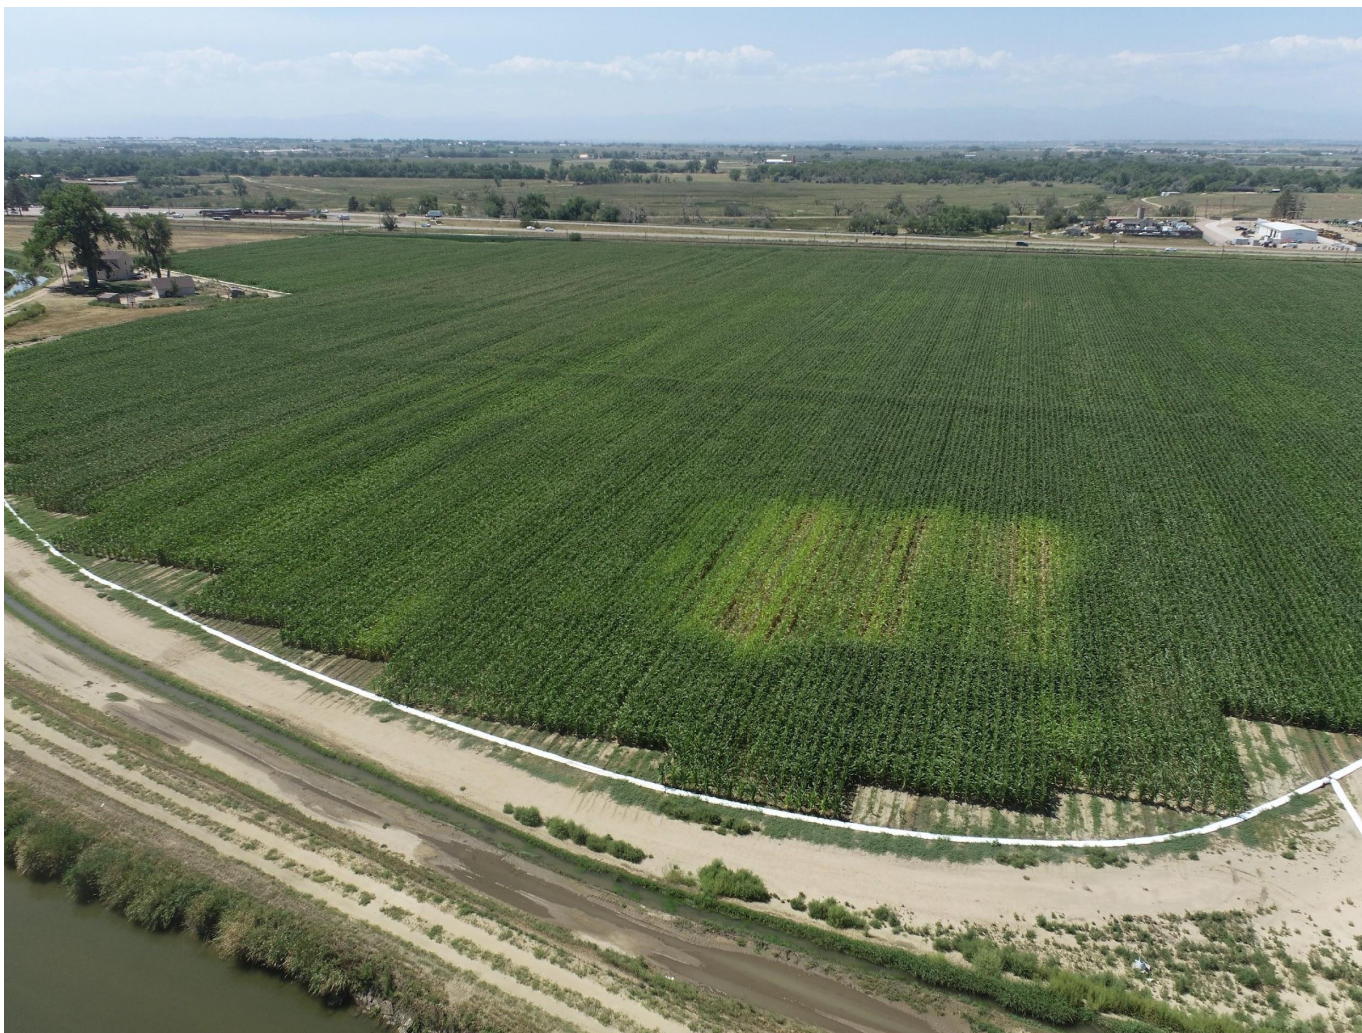
Photo 6. Drone aerial imagery taken east of well location, facing west (displaying the well, well access roads, and presumed flowline).

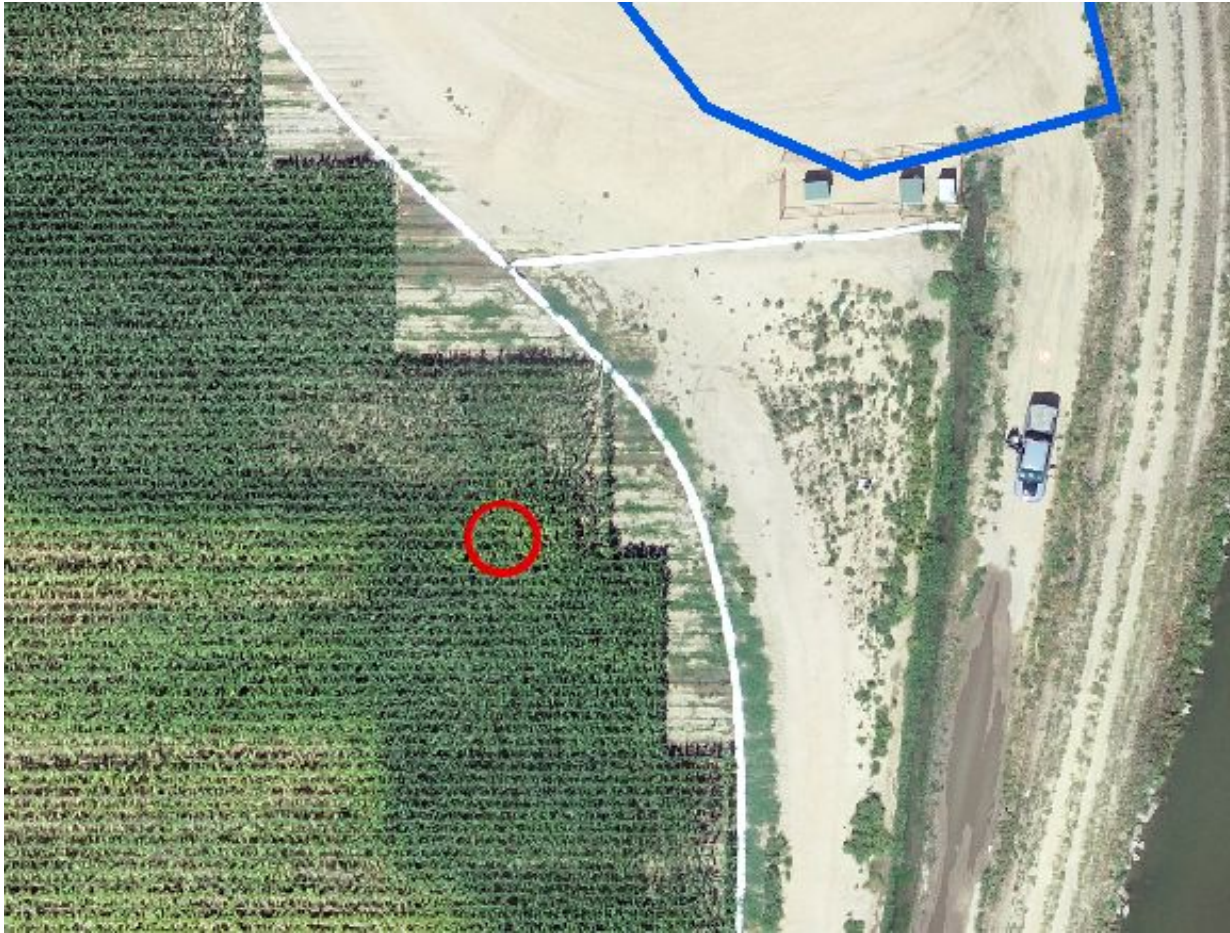
Photo 7. Close-up orthomosaic (drone) imagery taken 8/20/2025 illustrating the well location (red circle), well access roads, presumed flowline, and a portion of the associated tank battery (blue polygon).

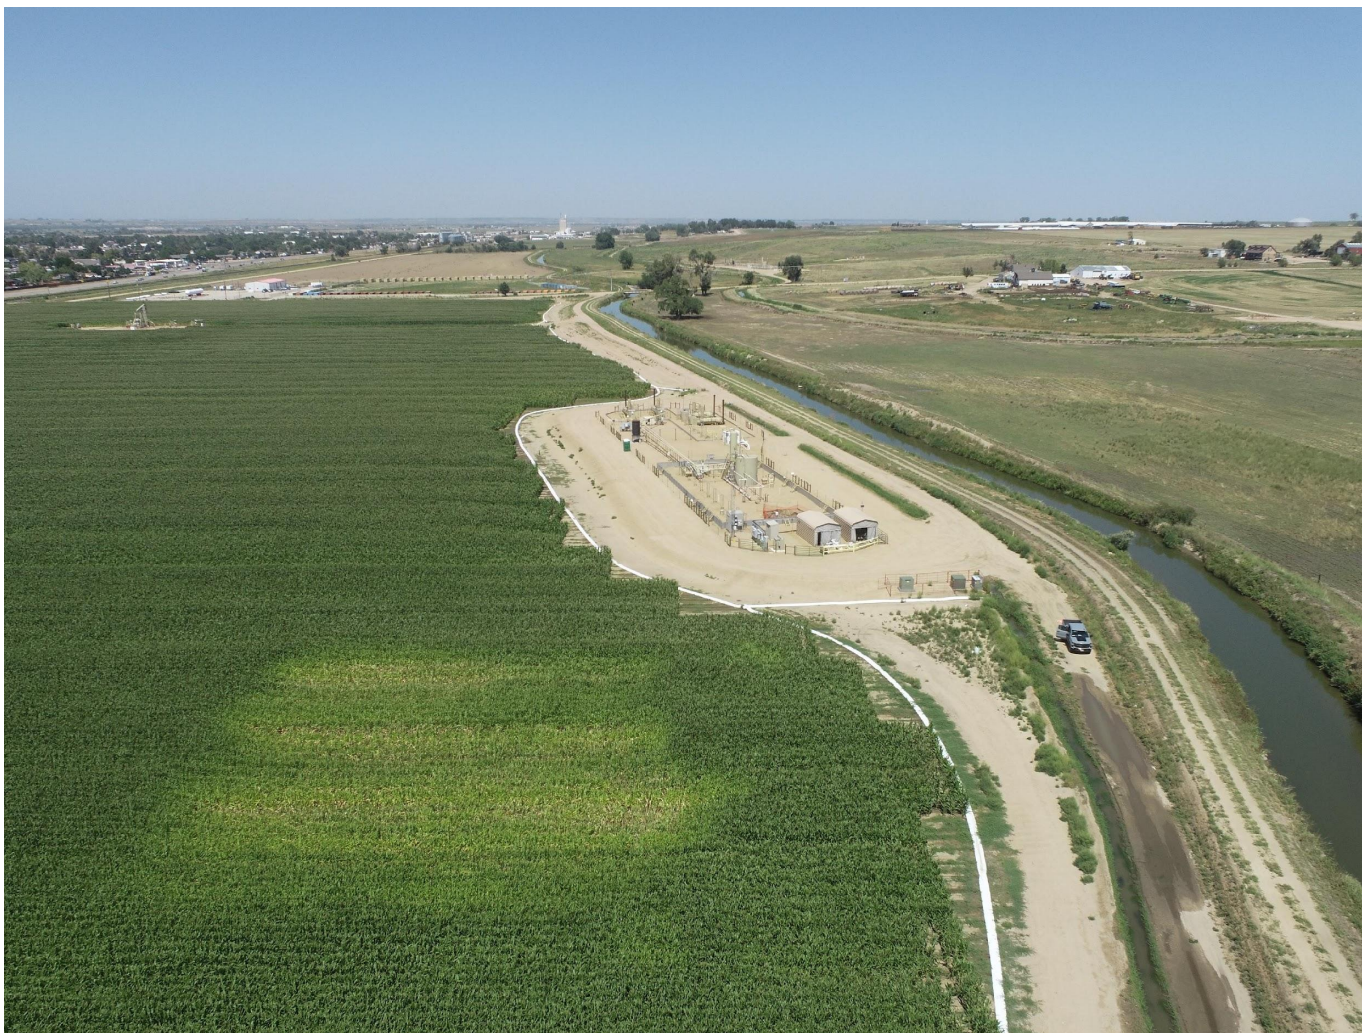
Photo 8. Drone aerial imagery taken south of the tank battery location, facing north (displaying the TB). Sunted crop to the west of the well pad disturbance is not related to oil and gas operations.

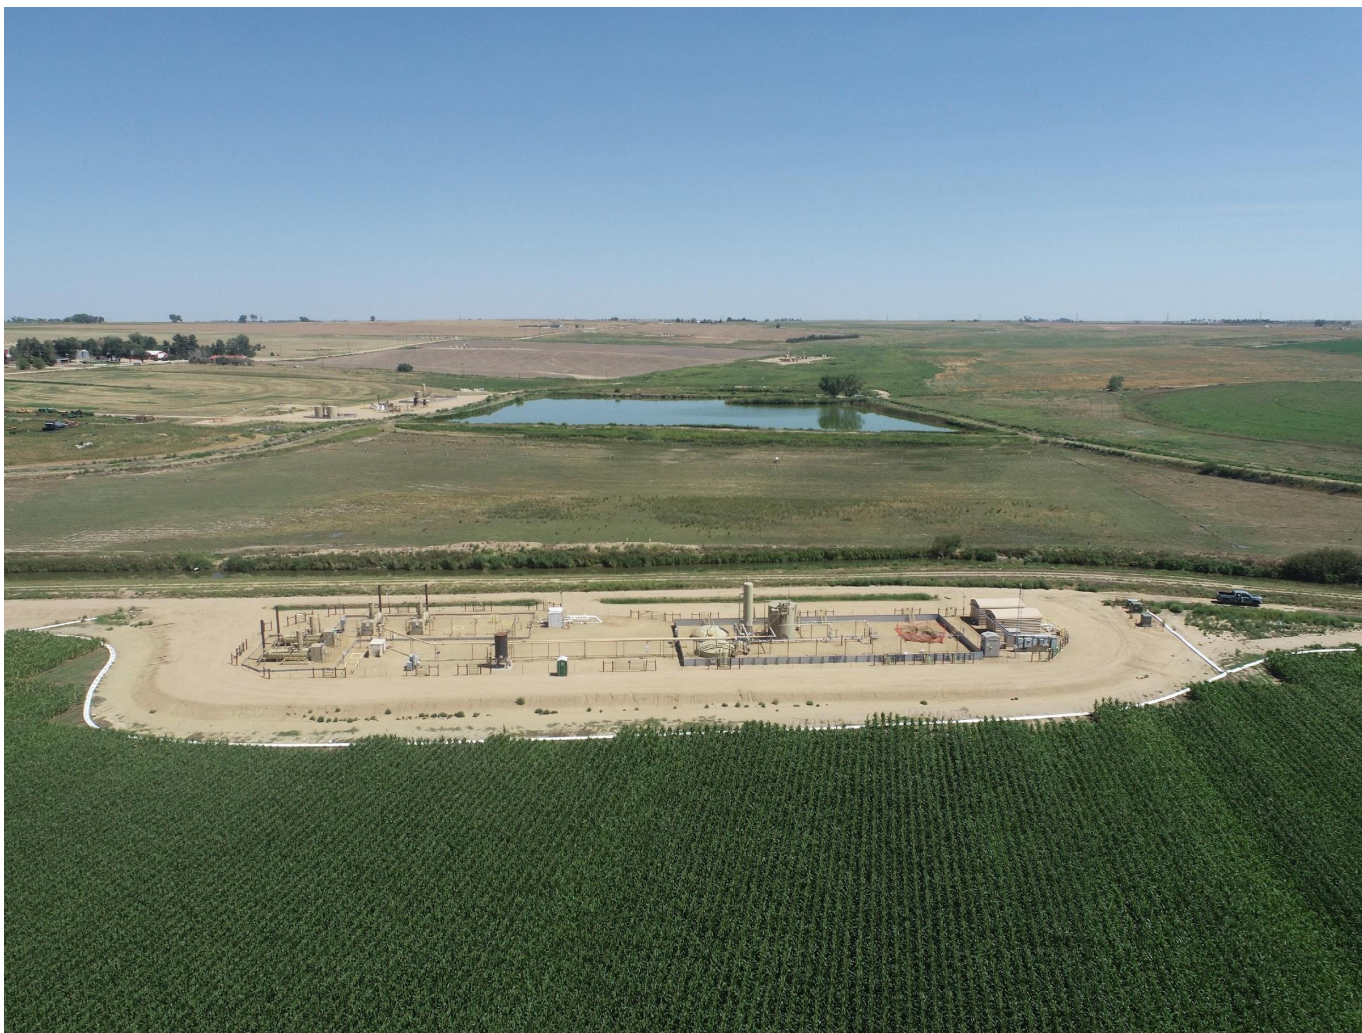
Photo 9. Drone aerial imagery taken west of the tank battery location, facing east (displaying TB).

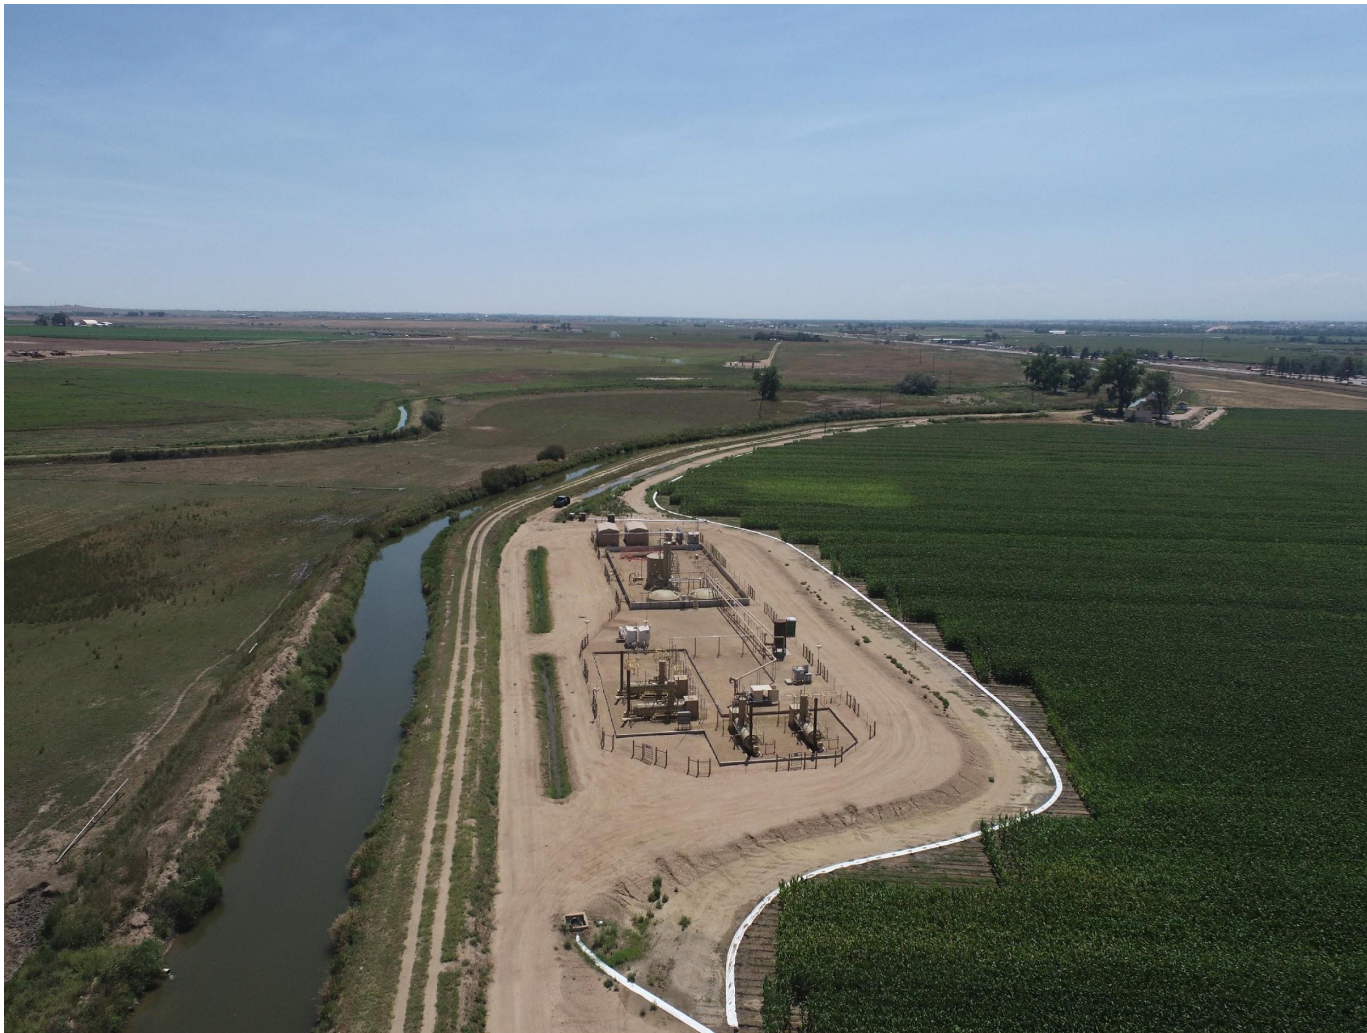
Photo 10. Drone aerial imagery taken north of the tank battery location, facing south (displaying the TB).

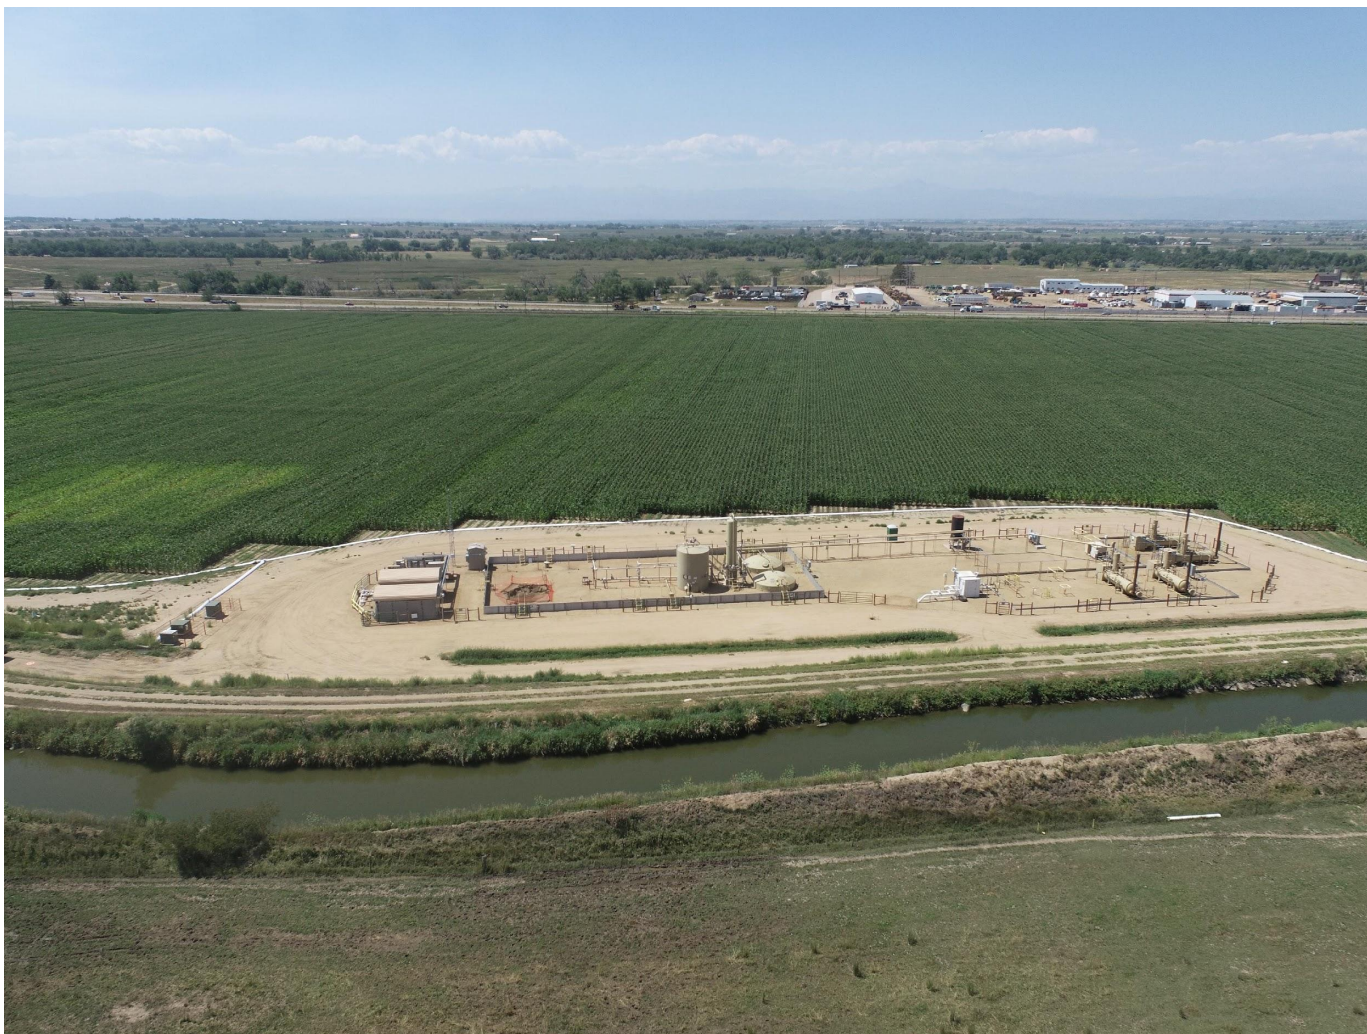
Photo 11. Drone aerial imagery taken east of the tank battery location, facing west (displaying the TB). No evidence of previous tank battery disturbance observed at newly built tank battery facility.
