## Audit Photos

Location Name: QB ENERGY OPERATING LLC, CEDAR BENCH FEDERAL-66S100W/20NESE

Location ID: 323807

Date: 11/25/2025

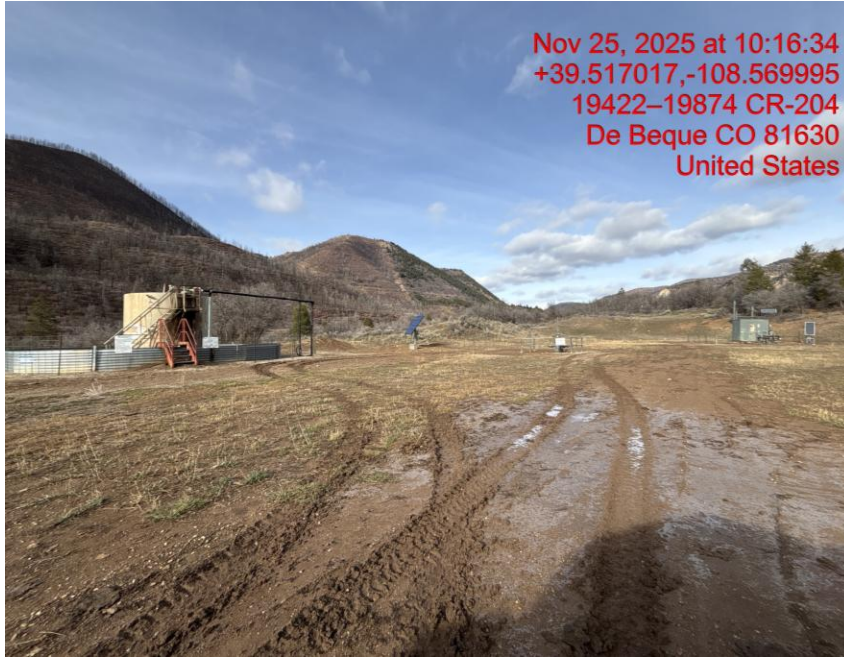
Location Overview/Lack of Stabilization – Photo #01723

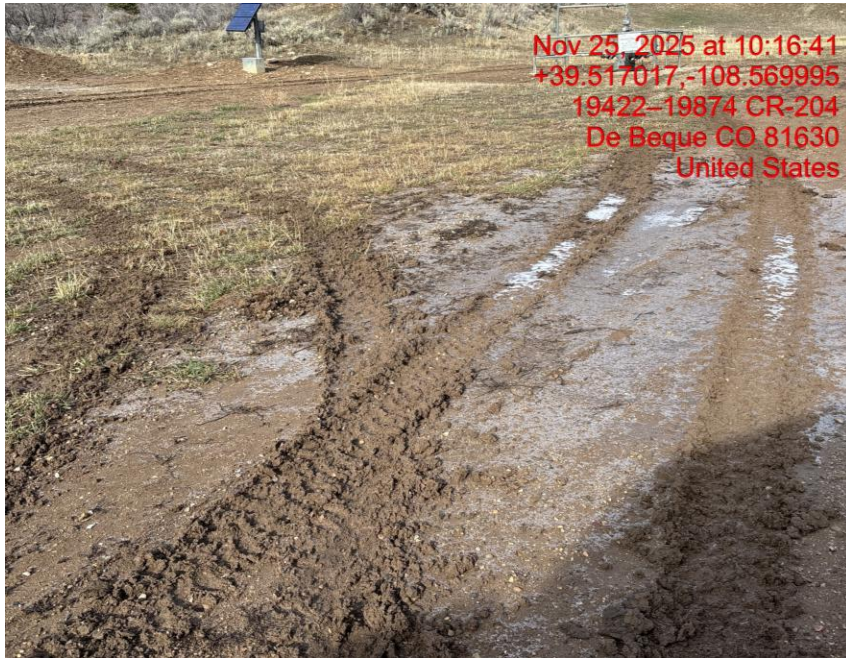
Lack of Stabilization – Photo #01724

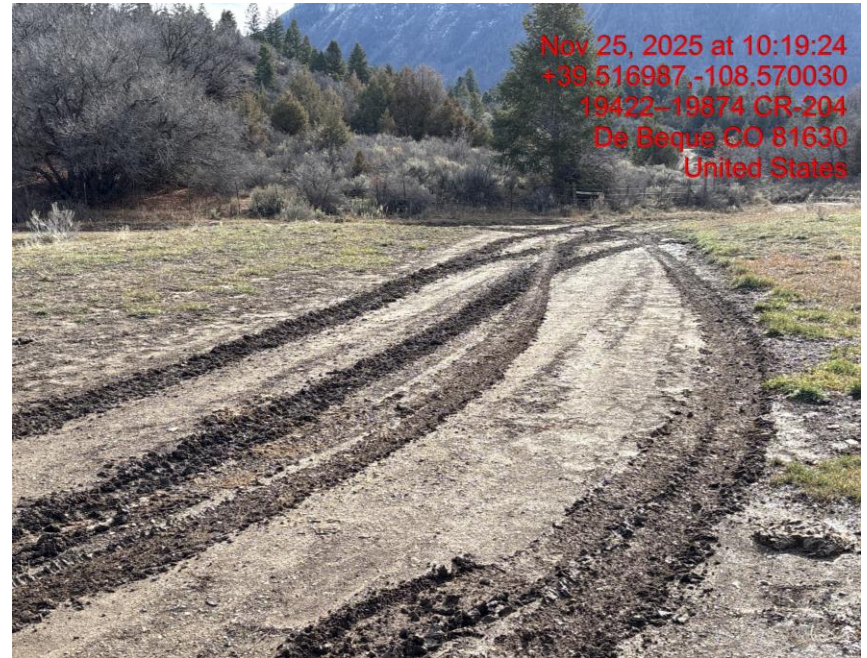
Lack of Stabilization/Insufficient Tracking BMPs – Photo #01729

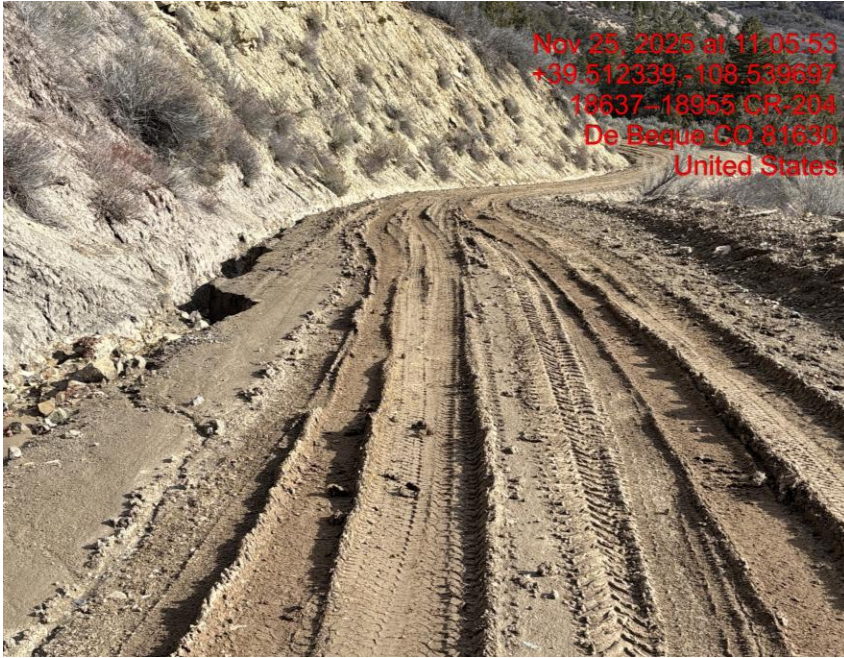
Lack of Stabilization on Lease Road – Photo #01774

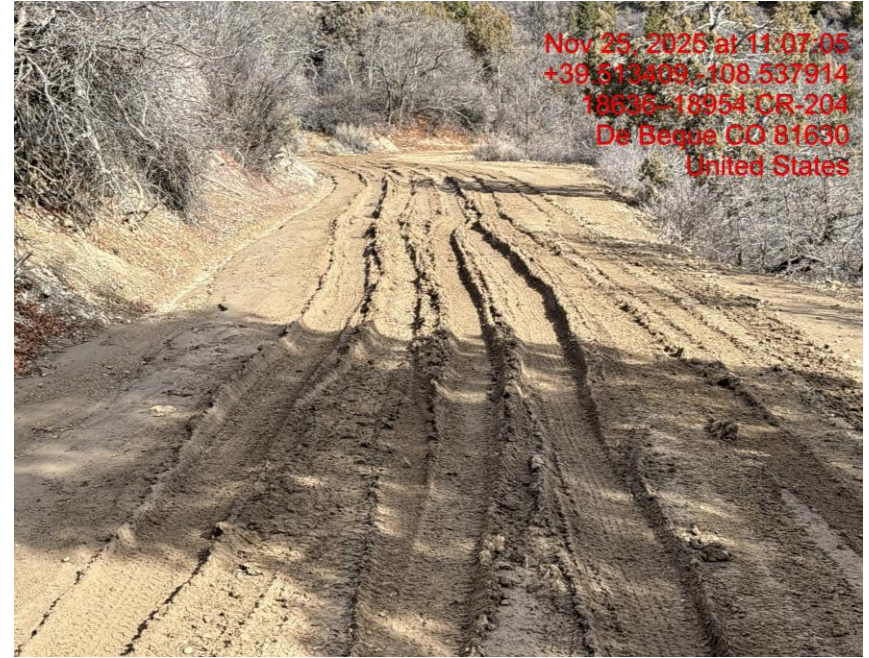
Lack of Stabilization on Lease Road – Photo #01775
