Photo Log: Harper USX EE27-07D Multi Location ID 423538

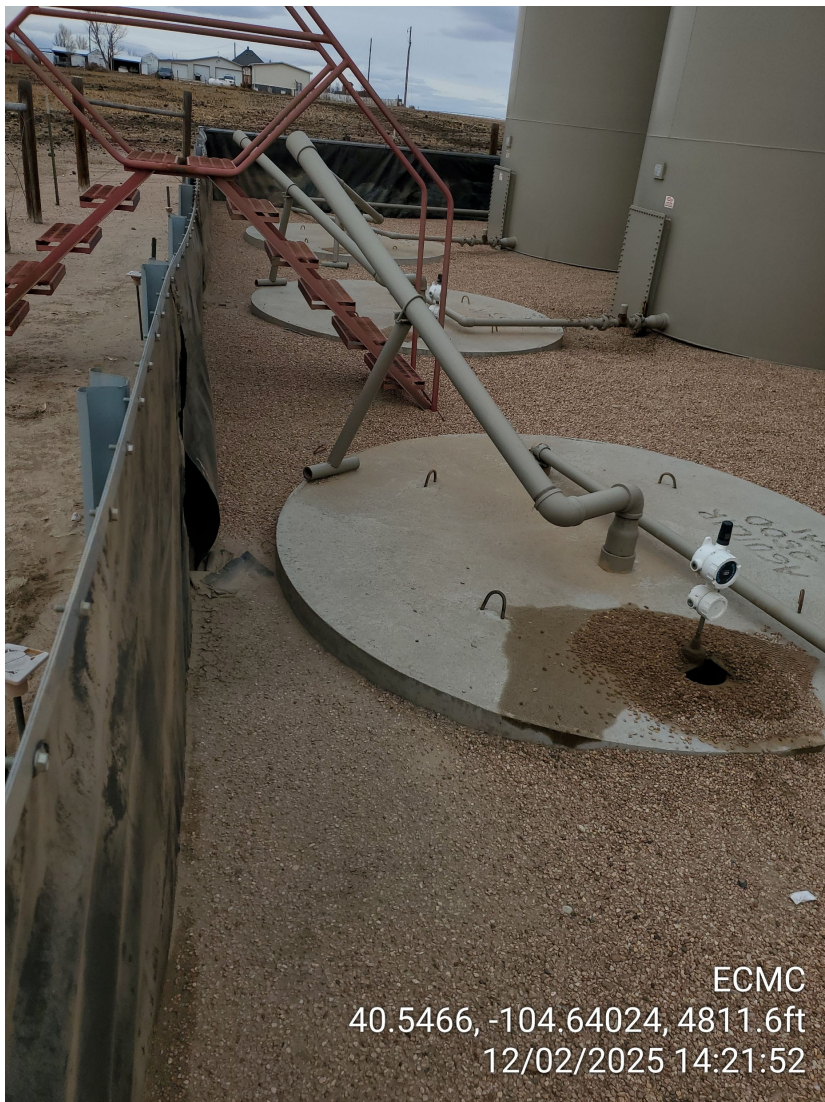
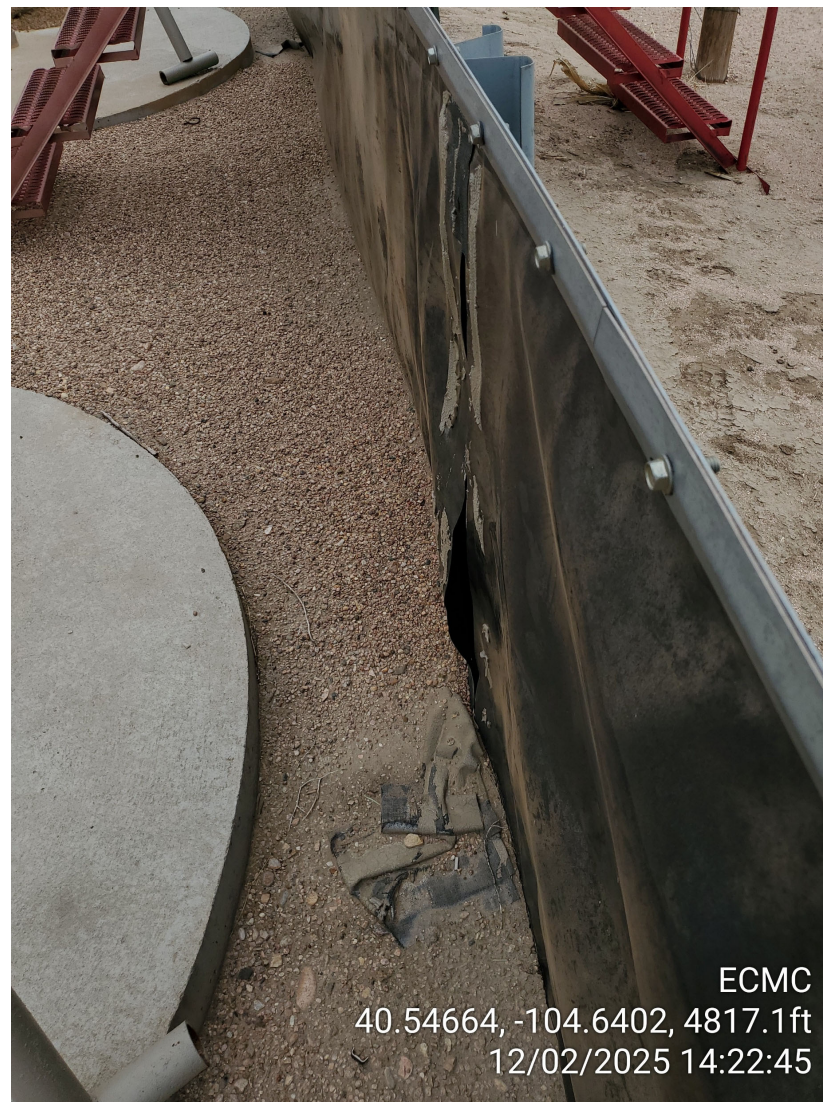
Evidence of overfill at produced water vessel. At least two tears in the liner are observed near the southern and northern most produced water vessels.

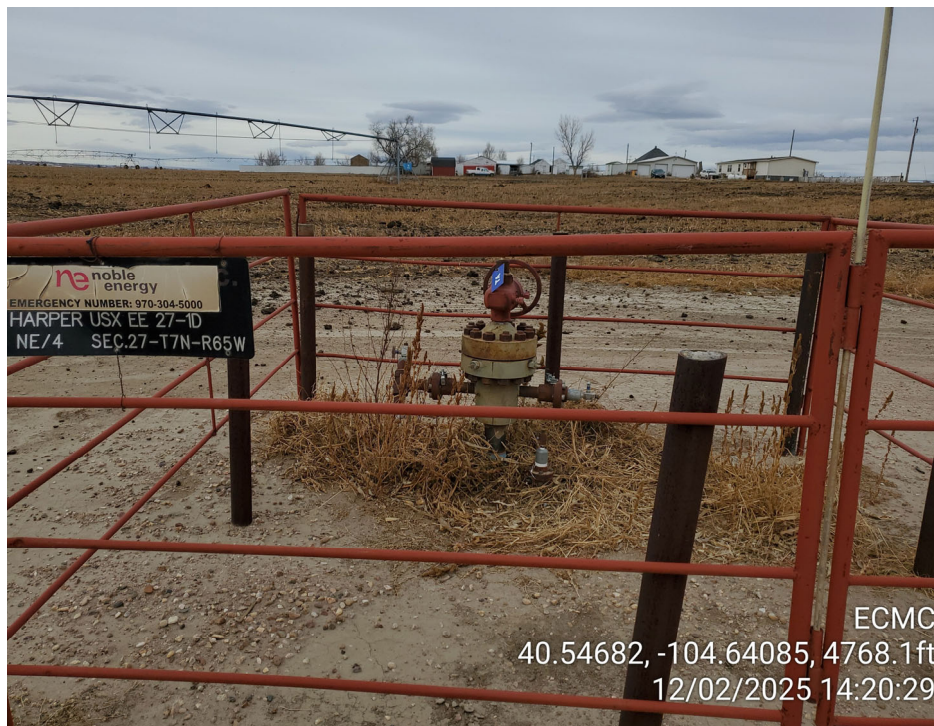
Harper USX EE 27-1D, with TA status

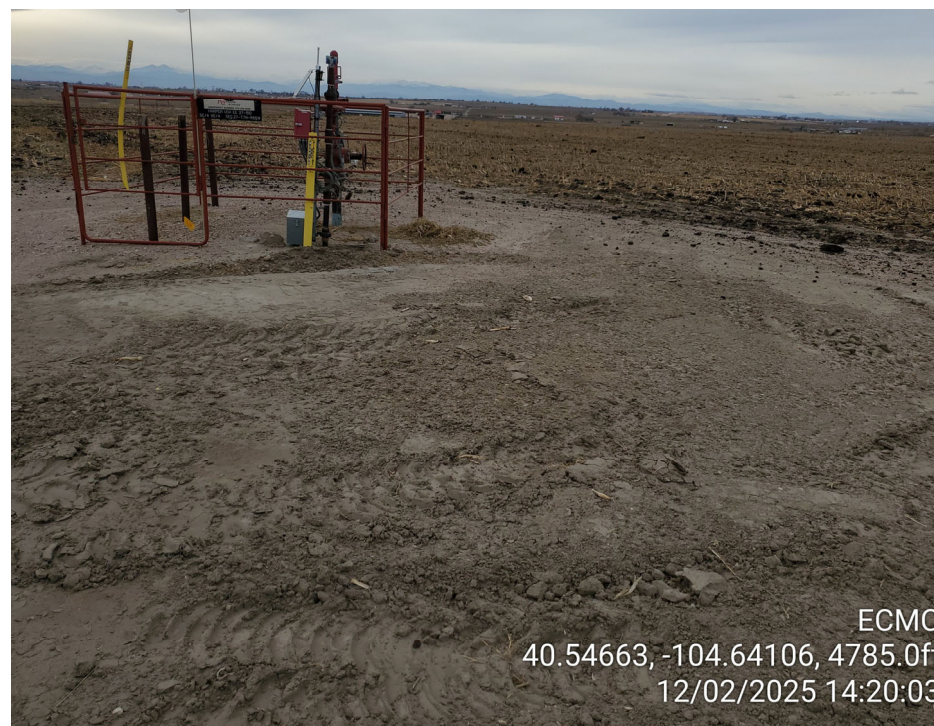
Location of Harper USX EE27-23D, which is plugged and buried; Harper USX EE27-15D is in background
