Inspection Photos

Loc: 483009

Operator: BNL (ENTERPRISE) INC

Inspection Date: 12/2/2025

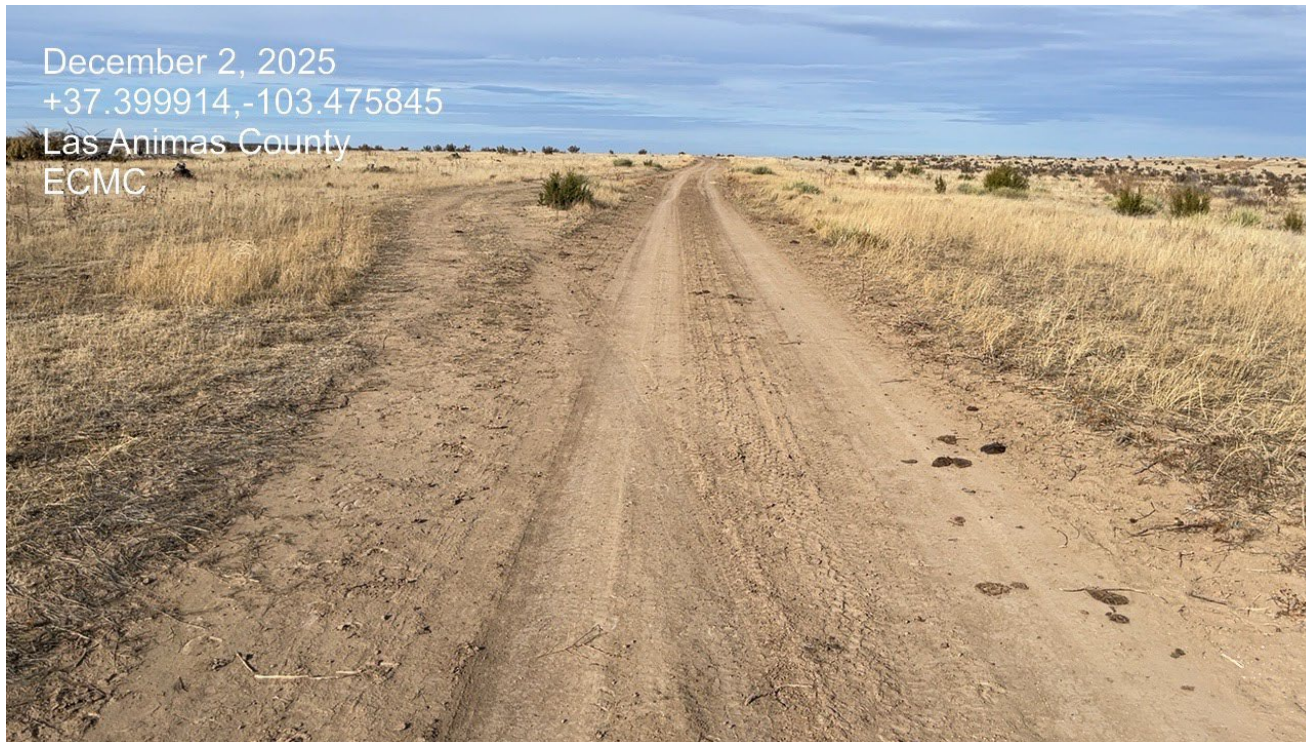
Photo 1. Facing northeast along the access road. Vehicles are driving outside of the road causing unnecessary disturbance. The road needs to be repaired and maintained. Previous CA was not completed.

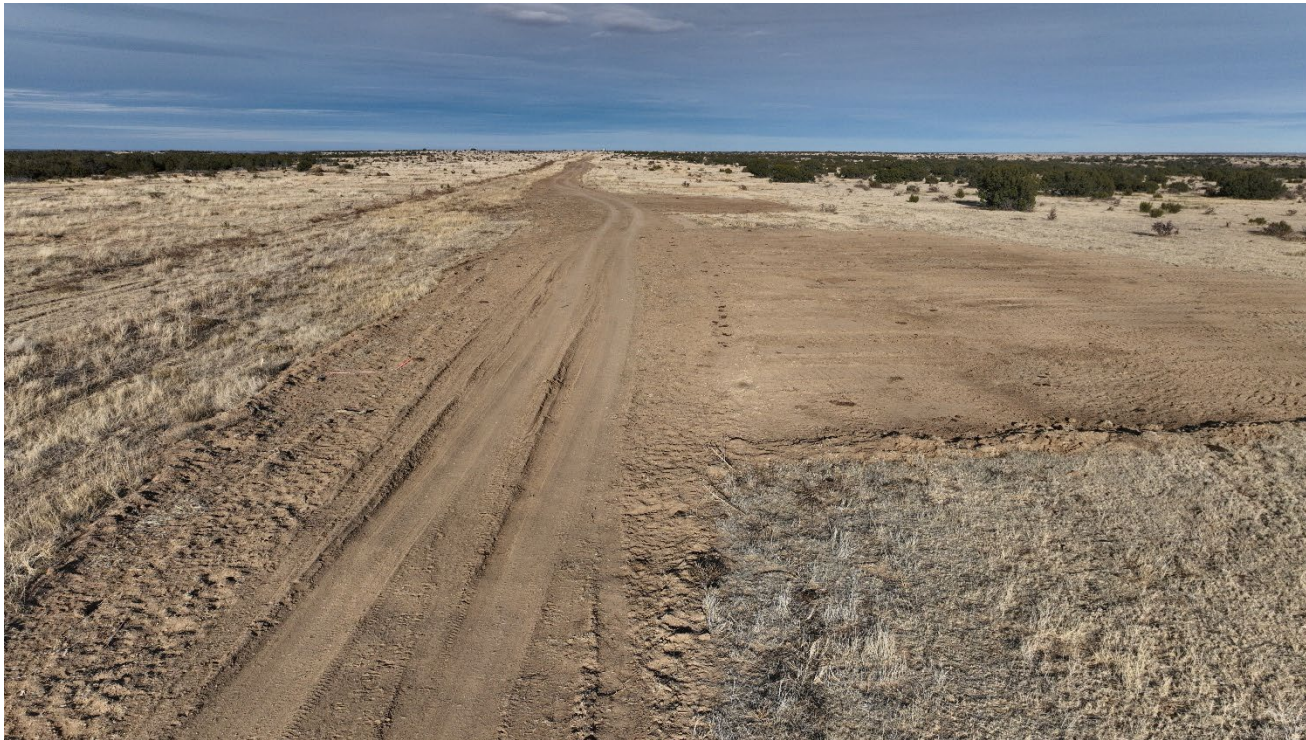
Photo 2. Facing north along the access road. This area has been disturbed with a dozer pushing topsoil up onto the road. The topsoil is loose and not adequate for stabilization of the road.

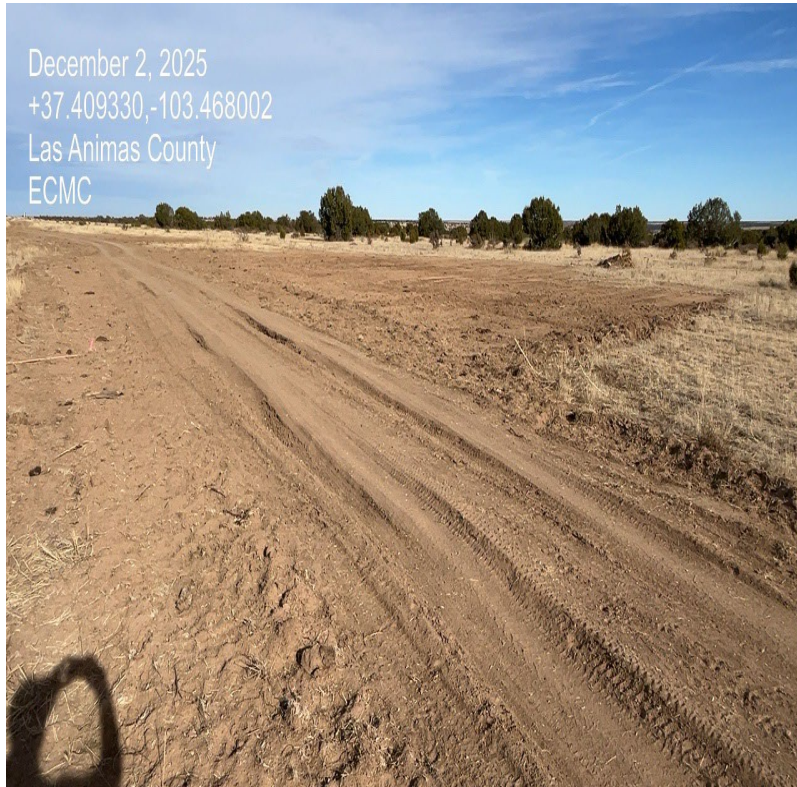
Photo 3. Facing toward the area where topsoil was pushed onto the road. The topsoil is loose and is not an adequate road base material.

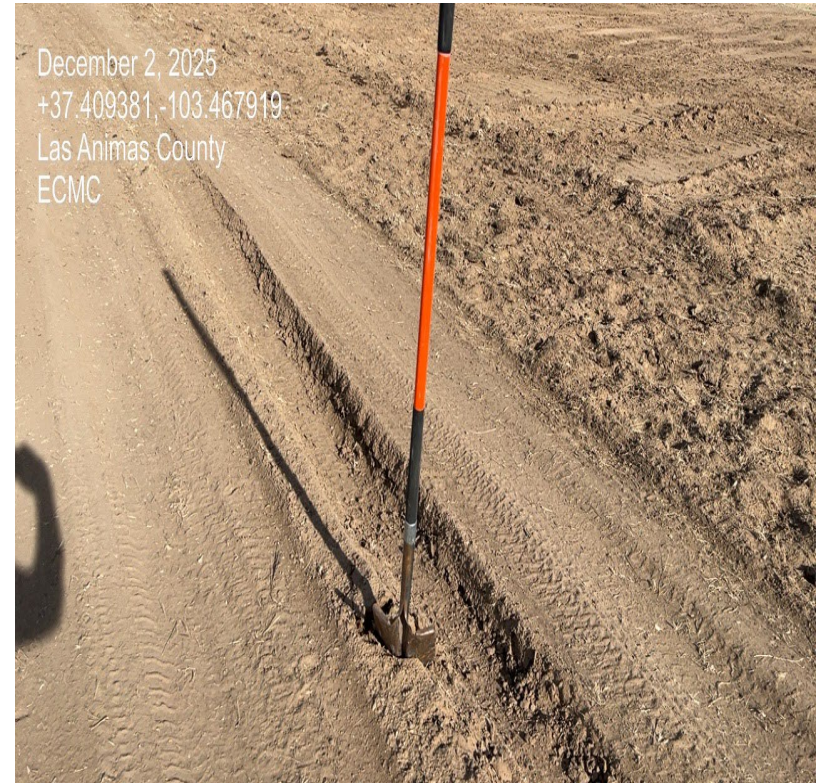
Photo 4. The soil is loose which will cause dust and vehicle tracking.

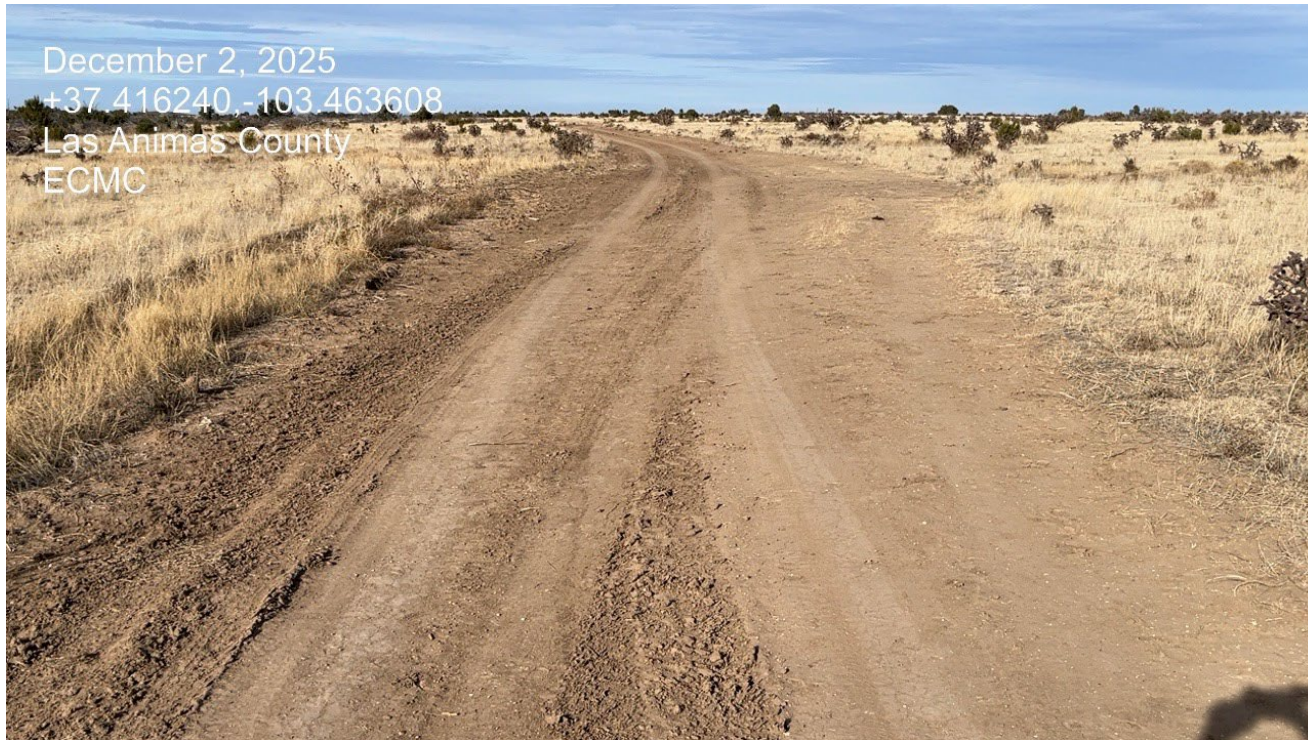
Photo 5. Facing north along the access road. Vehicles are driving outside of the road causing unnecessary disturbance.

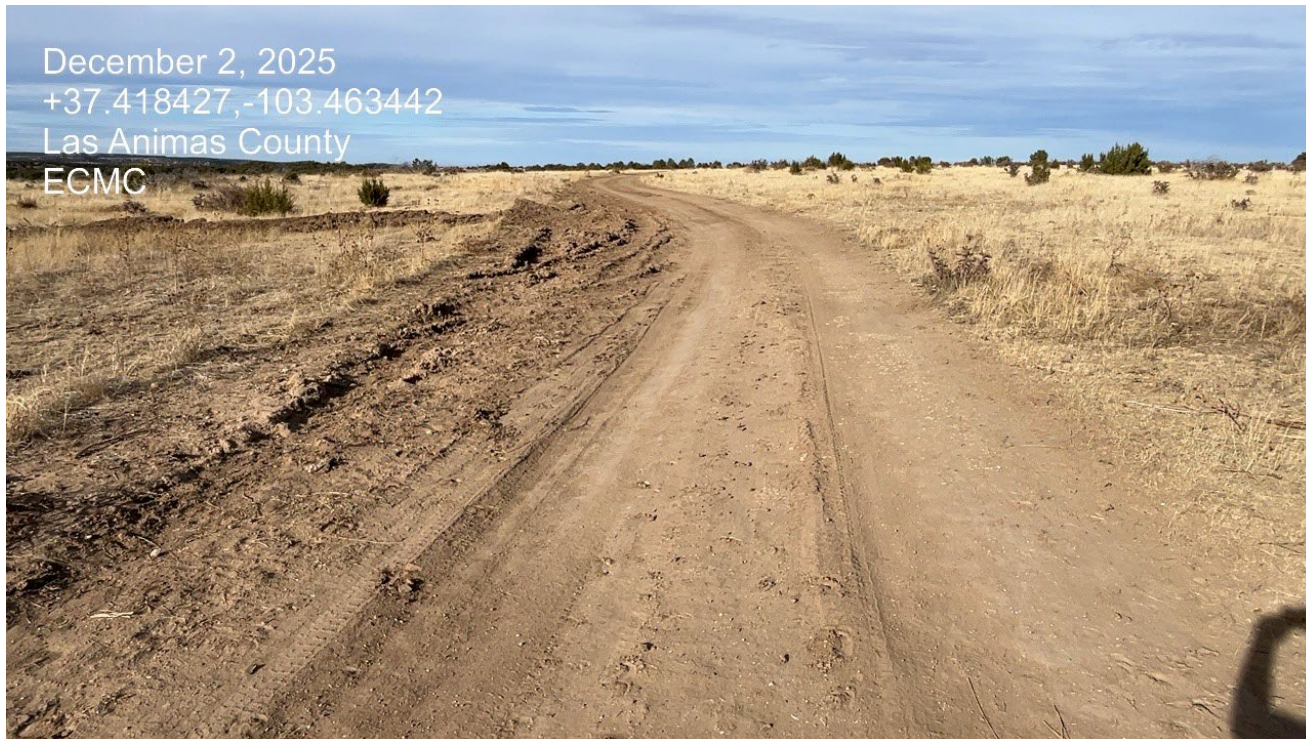
Photo 6. Facing north along the access road. Vehicles are driving outside of the road causing unnecessary disturbance. Vehicle tracking is occurring along the road.

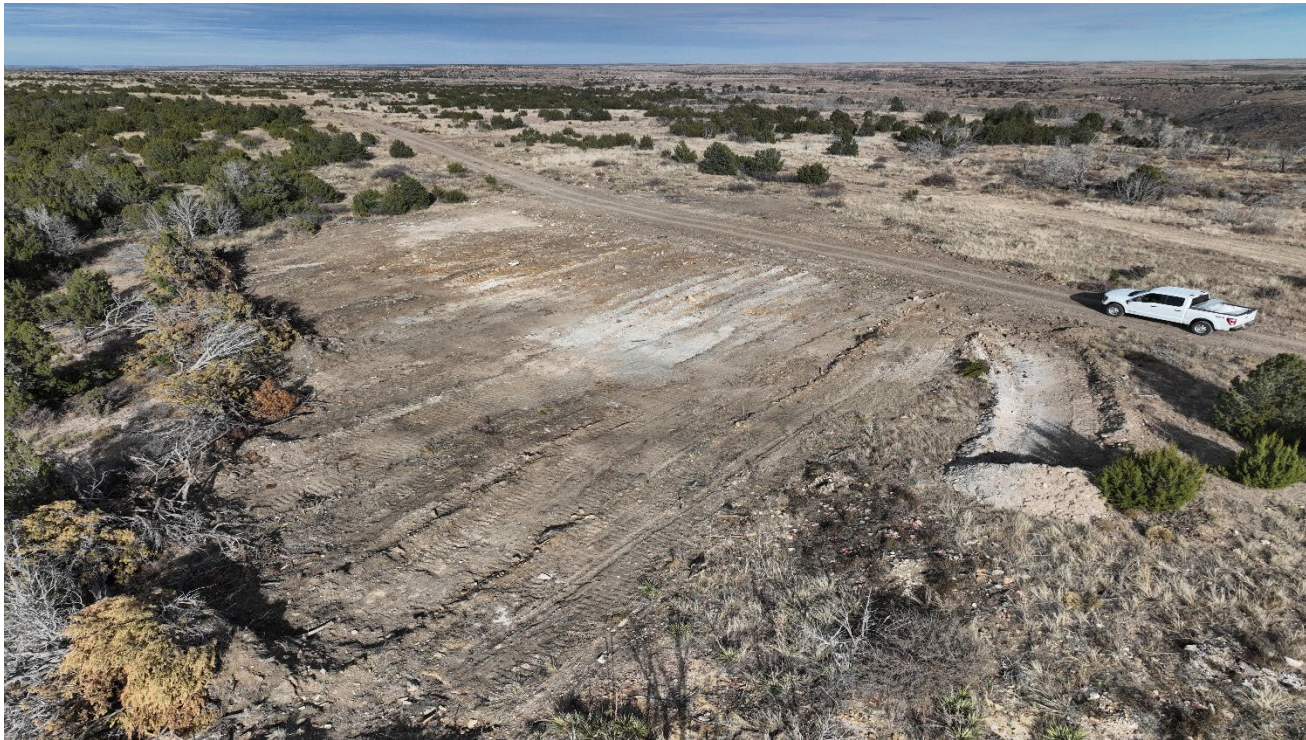
Photo 7. Facing northeast. Topsoil was mixed and pushed up to the road which is not sufficient material to stabilize the road.

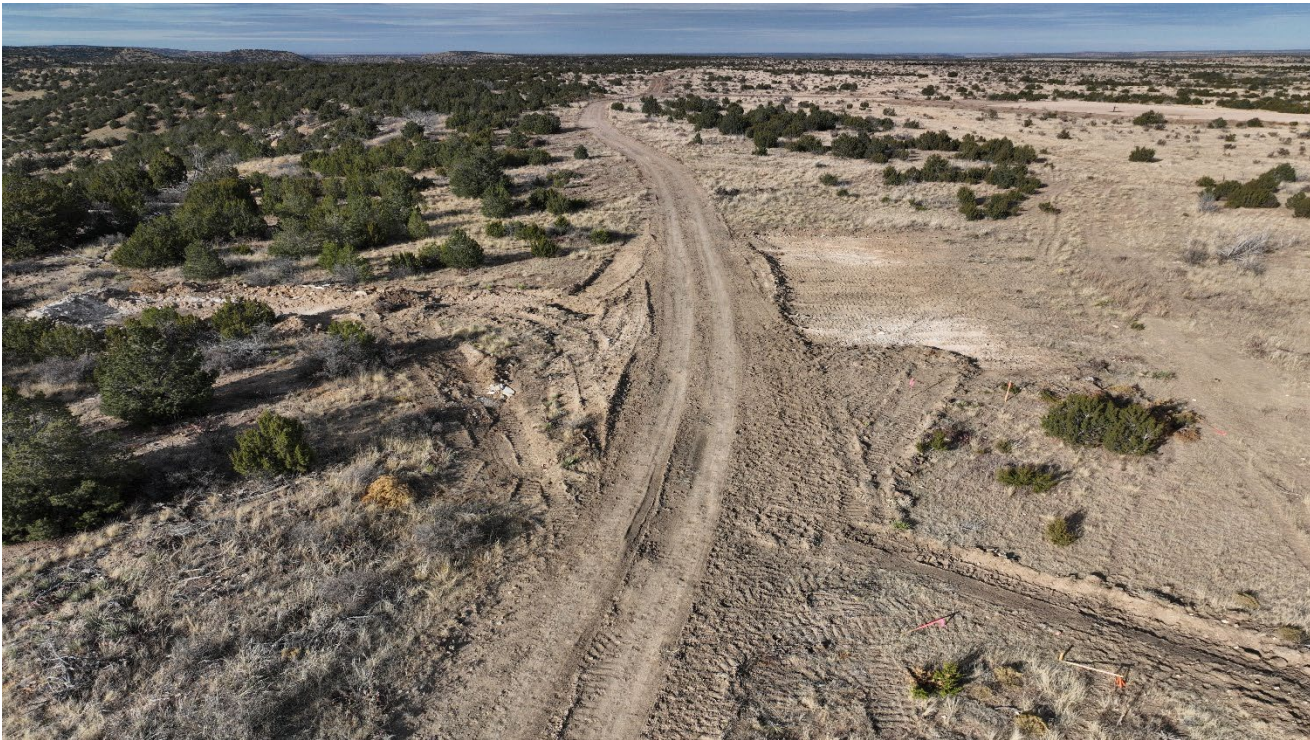
Photo 8. Drone aerial photo facing north along the road.

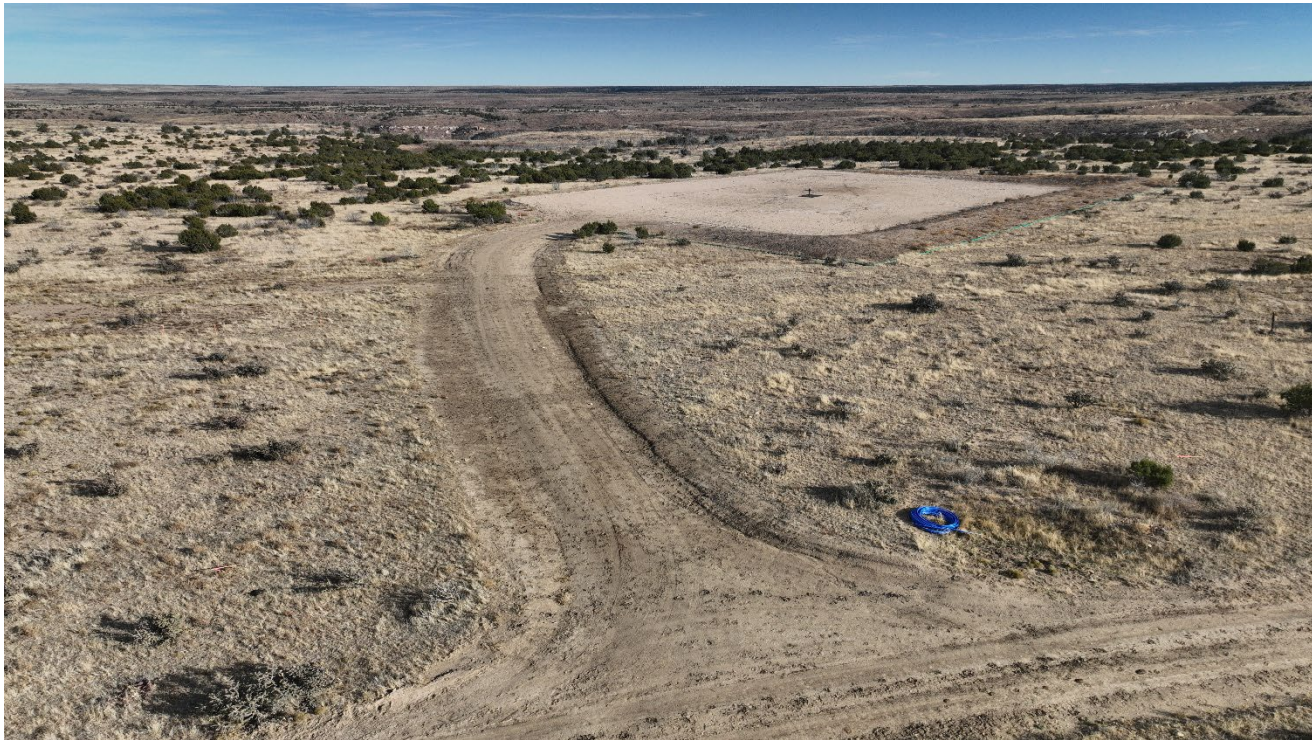
Photo 9. Drone aerial photo facing southeast toward the location.

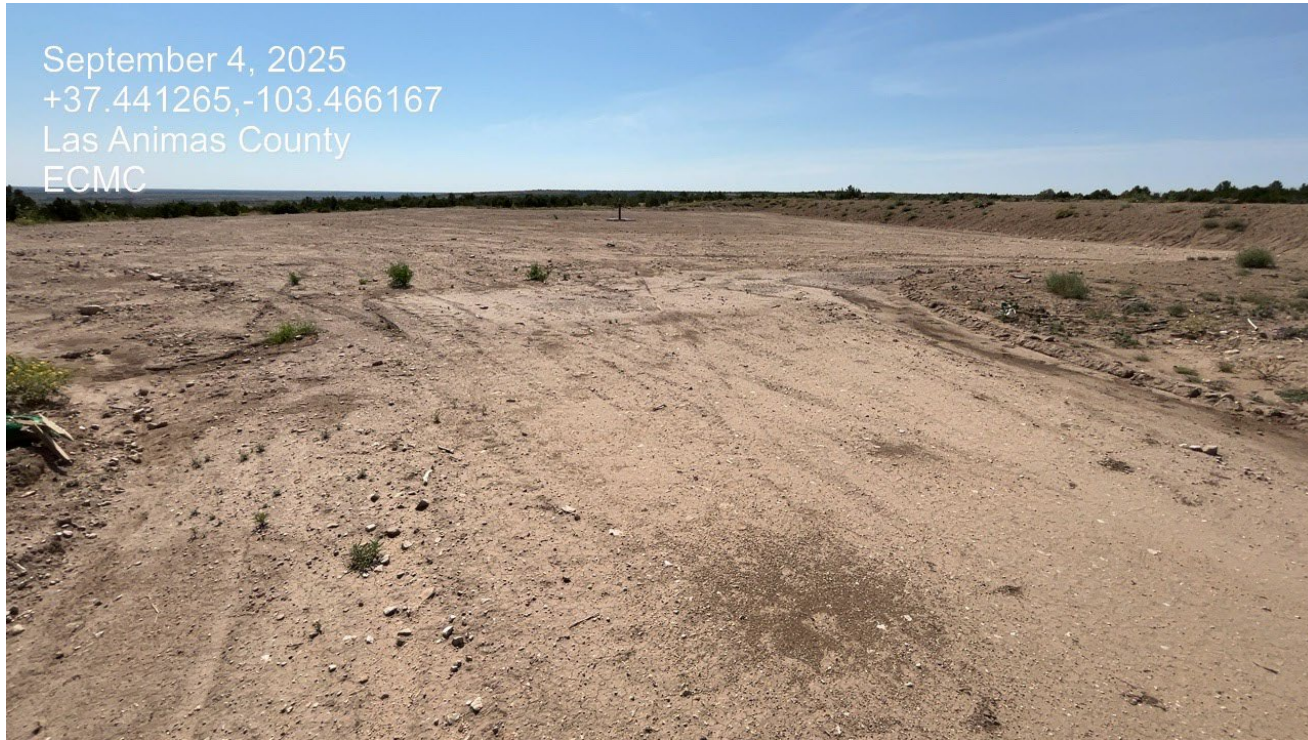
Photo 10. Facing south toward the well pad location..

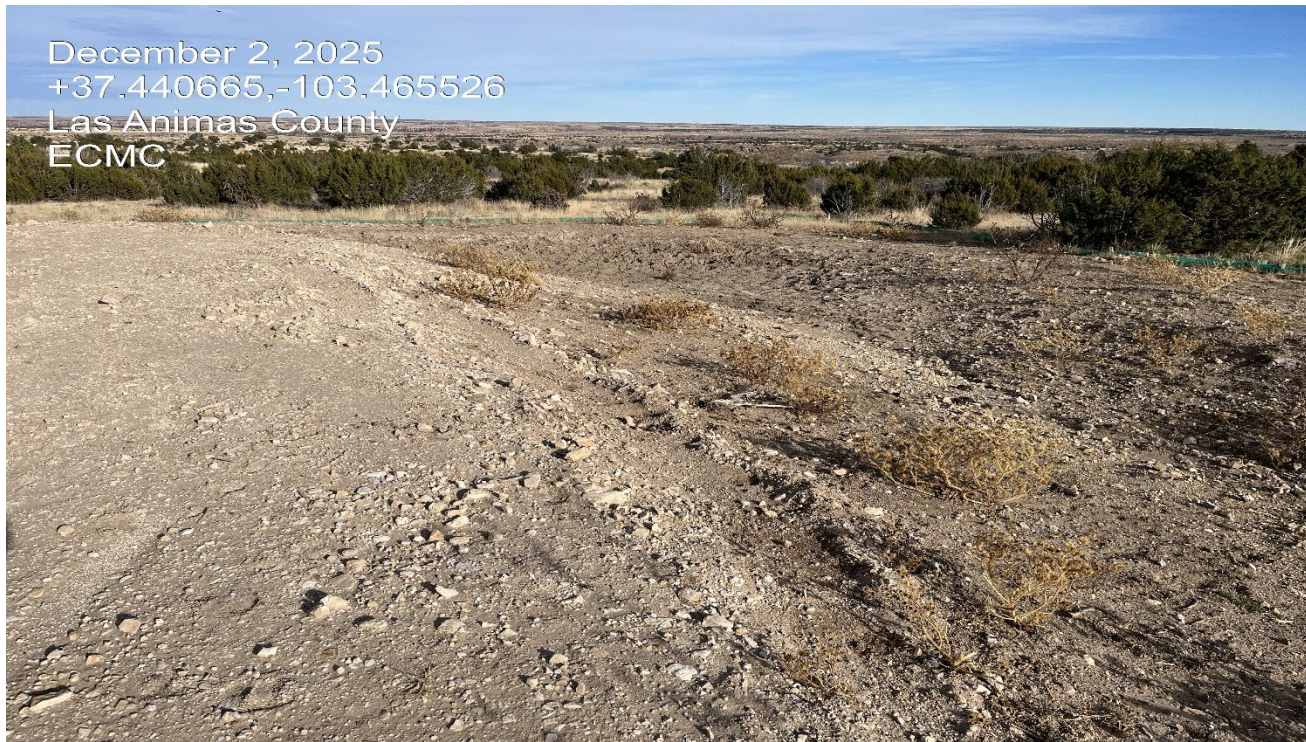
Photo 11. Facing southeast corner of the location. This sediment trap has filled in with sediment and needs to be cleaned out and maintained.

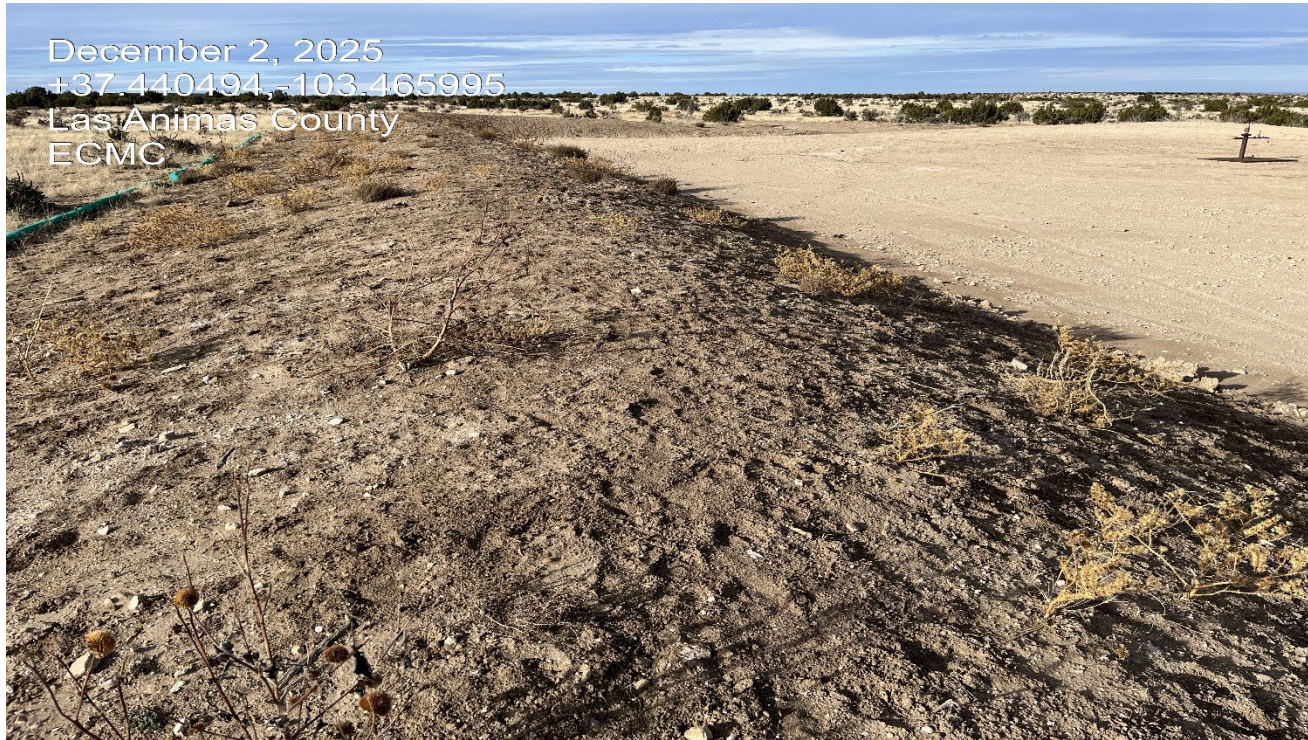
Photo 12. Southwest corner of the location facing north. The topsoil has not been seeded and stabilized.
