Inspection/Audit Photos

Location Name: QB ENERGY OPERATING LLC CHEVRON 1N-4D

Location ID: 335566

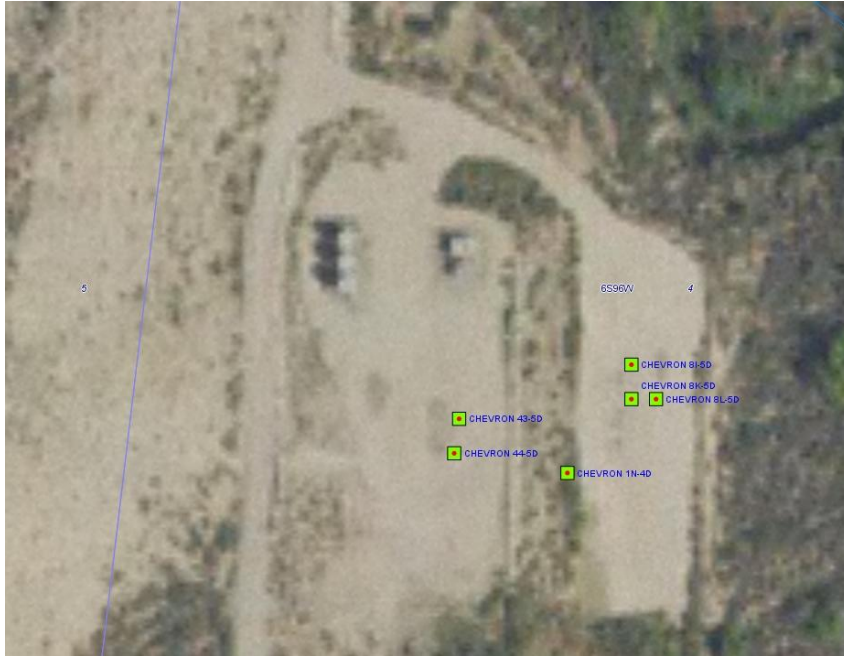
Photo # 1 Scout Card records & Drilling Completion Report coordinates for the CHEVRON 1N-4D well - Coordinates appear to be off by approximately 40 ft (coordinates incorrect/not in compliance with CECMC Rules 216 & 414 – records require updating)

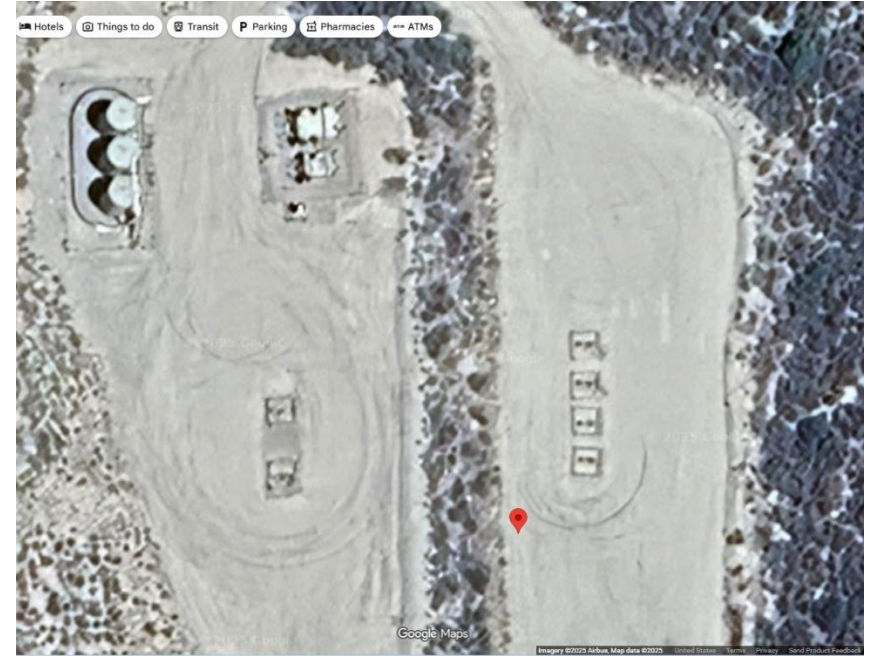
Photo # 2 Scout Card records & Drilling Completion Report coordinates for the CHEVRON 1N-4D well - Coordinates appear to be off by approximately 40 ft (coordinates incorrect/not in compliance with CECMC Rules 216 & 414 – records require updating)

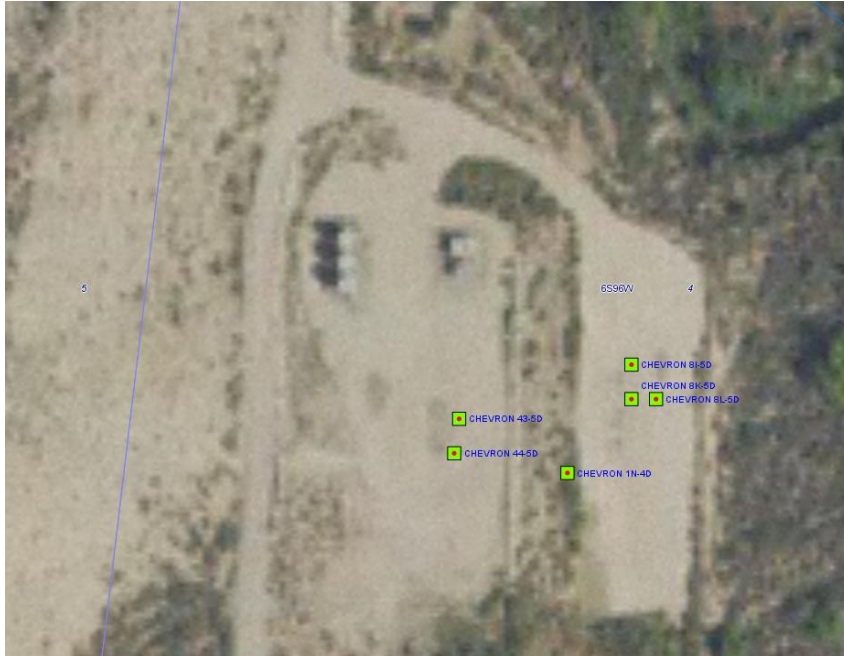
Photo # 3 Scout Card records & Drilling Completion Report coordinates for the CHEVRON 8L-5D well - Coordinates appear to be off by approximately 29 ft (coordinates incorrect/not in compliance with CECMC Rules 216 & 414 – records require updating)

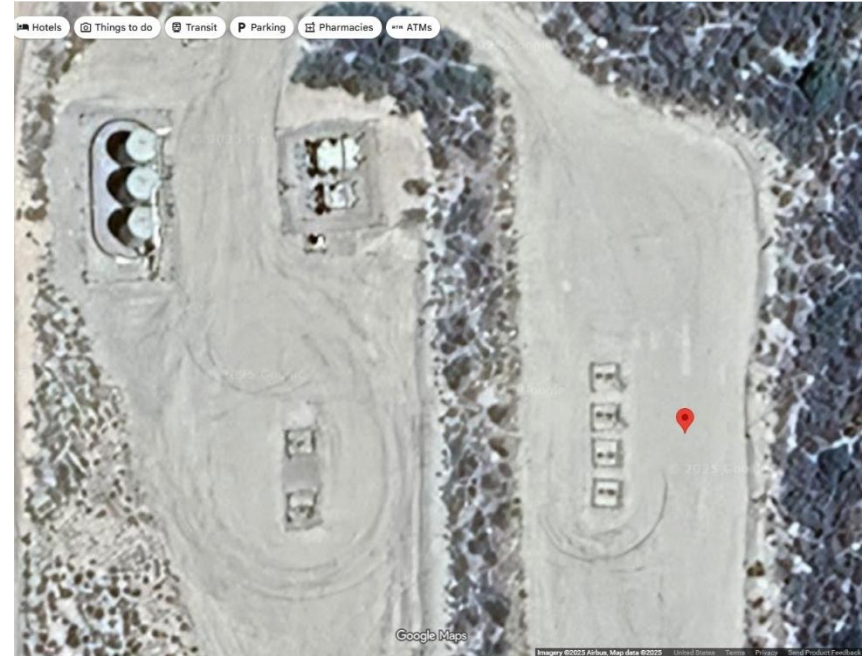
Photo # 4 Scout Card records & Drilling Completion Report coordinates for the CHEVRON 8L-5D well - Coordinates appear to be off by approximately 29 ft (coordinates incorrect/not in compliance with CECMC Rules 216 & 414 – records require updating)

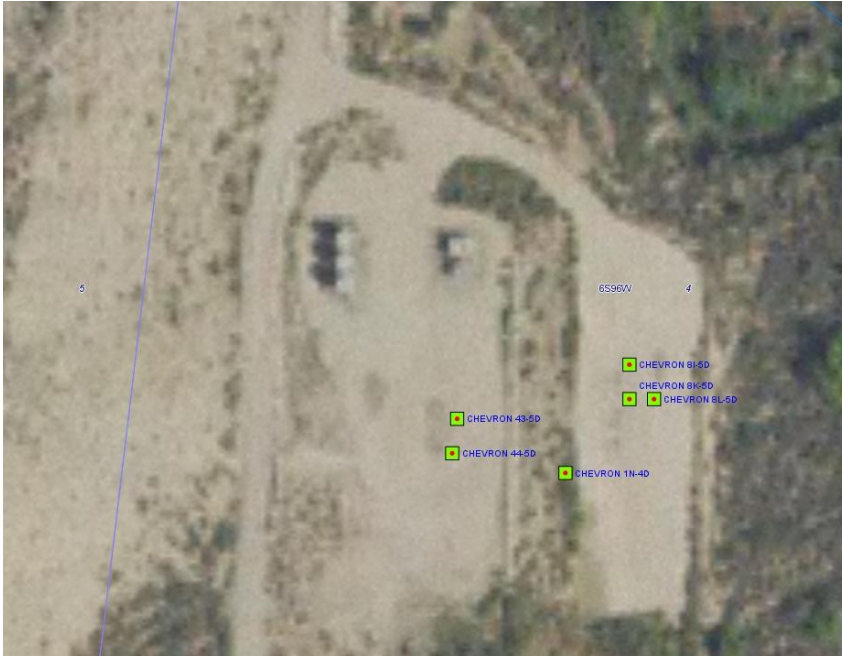
Photo # 5 Scout Card records & Drilling Completion Report coordinates for the CHEVRON 8I-5D well - Coordinates appear to be off by approximately 10-12 ft (coordinates incorrect/not in compliance with CECMC Rules 216 & 414 – records require updating)

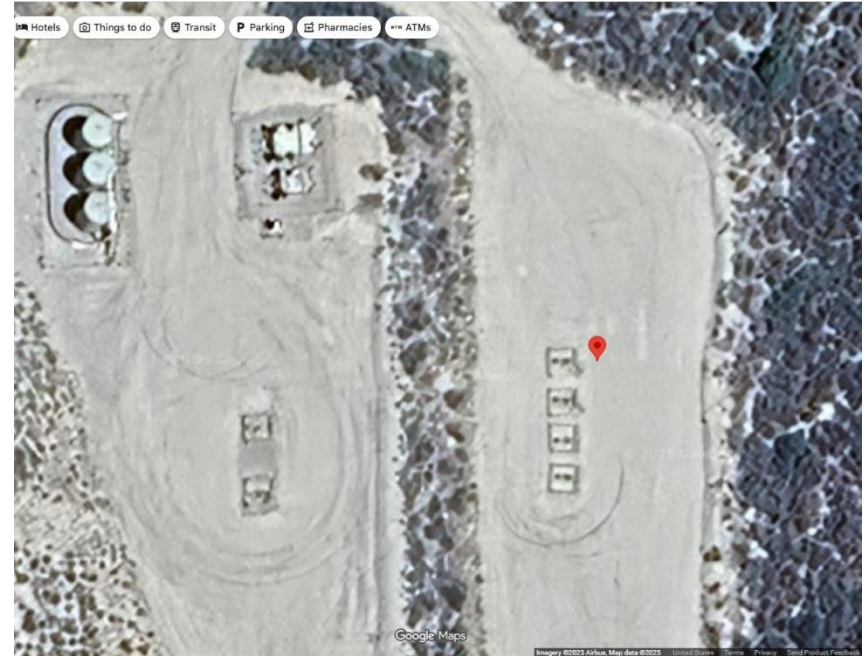
Photo # 6 Scout Card records & Drilling Completion Report coordinates for the CHEVRON 8I-5D well - Coordinates appear to be off by approximately 10-12 ft (coordinates incorrect/not in compliance with CECMC Rules 216 & 414 – records require updating)

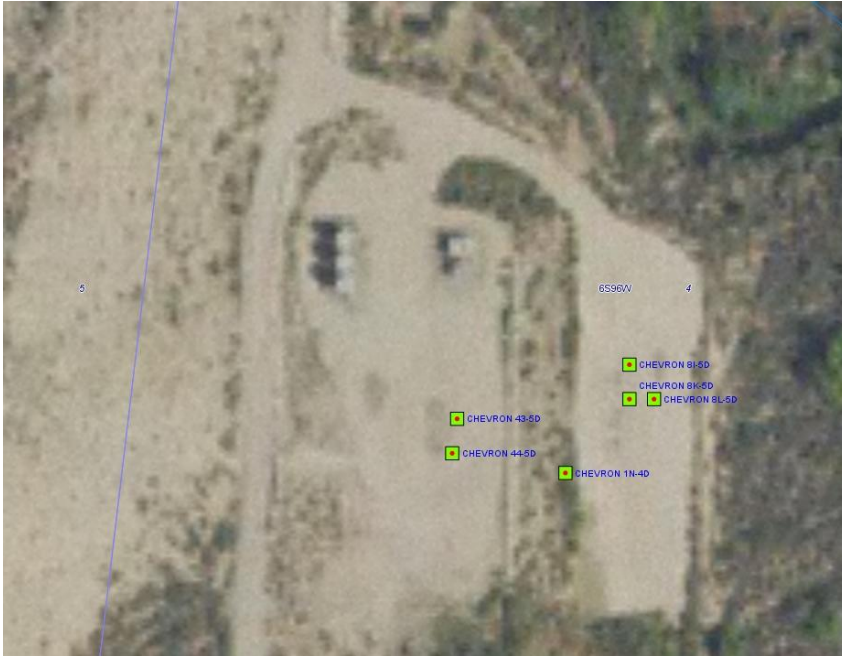
Photo # 7 Scout Card records & Drilling Completion Report coordinates for the CHEVRON 8K-5D well - Coordinates appear to be off by approximately 12-14 ft (coordinates incorrect/not in compliance with CECMC Rules 216 & 414 – records require updating)

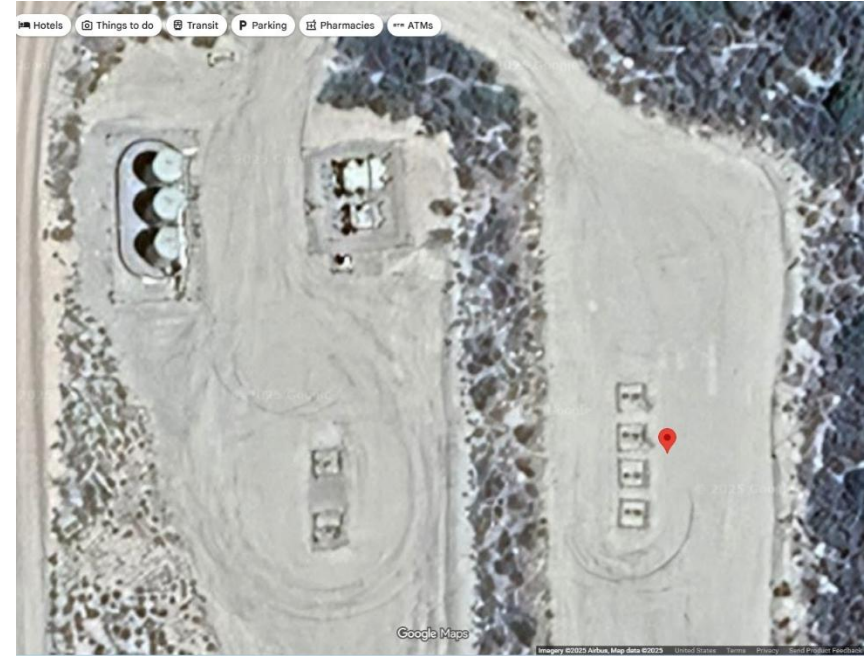
Photo # 8 Scout Card records & Drilling Completion Report coordinates for the CHEVRON 8K-5D well - Coordinates appear to be off by approximately 12-14 ft (coordinates incorrect/not in compliance with CECMC Rules 216 & 414 – records require updating)
