Inspection Photos
Location Name: Shiner 44-22
API Number: 125-11391

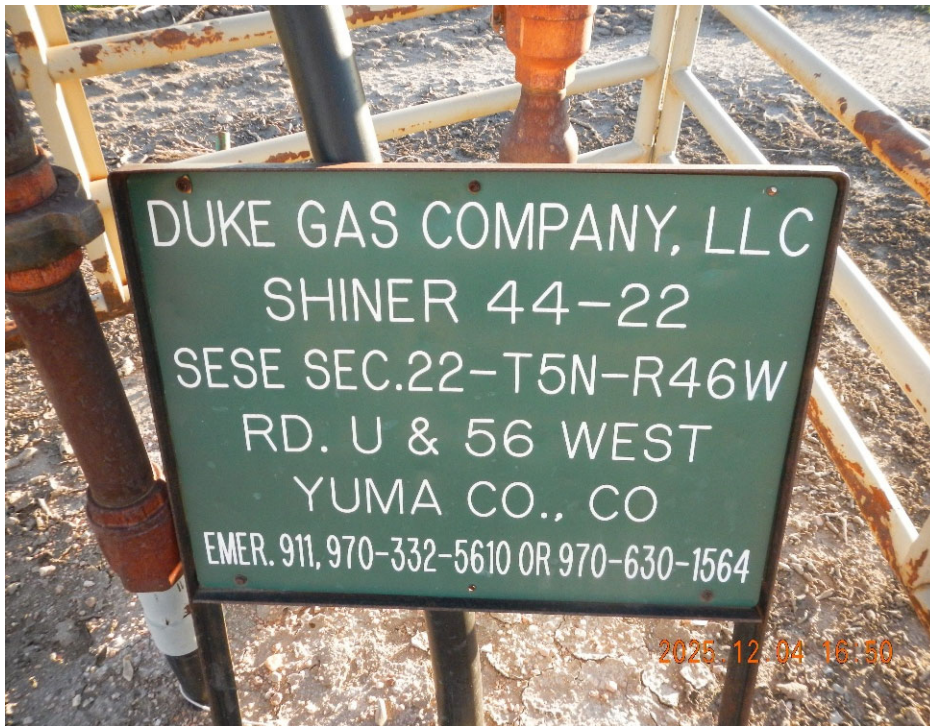
1. Lease sign at well location.

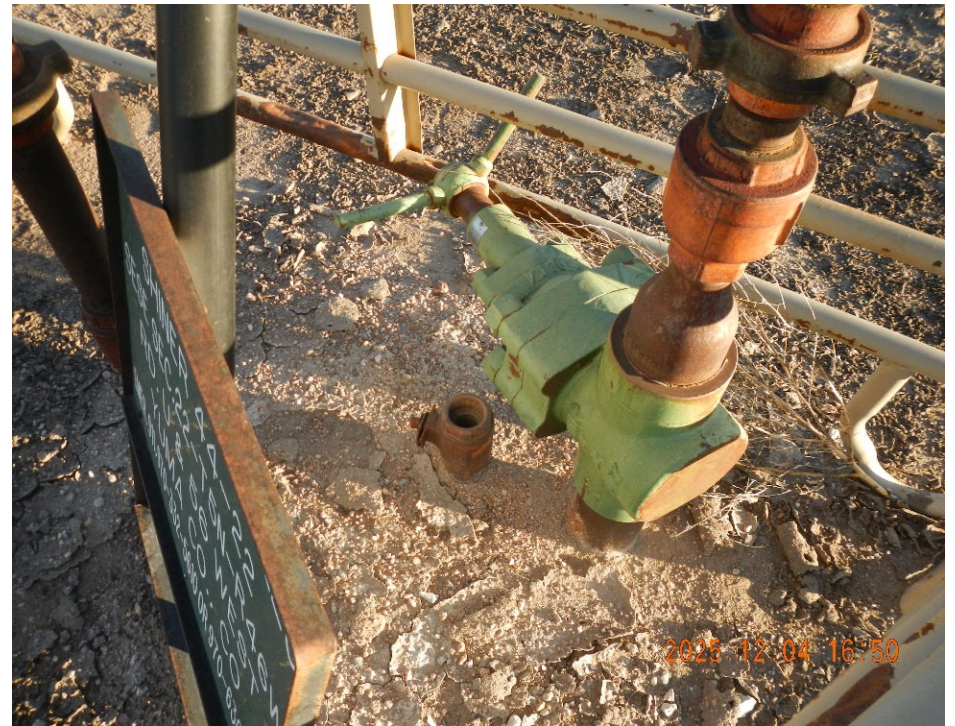
2. View of wellhead. Note Bradenhead valve missing plug.

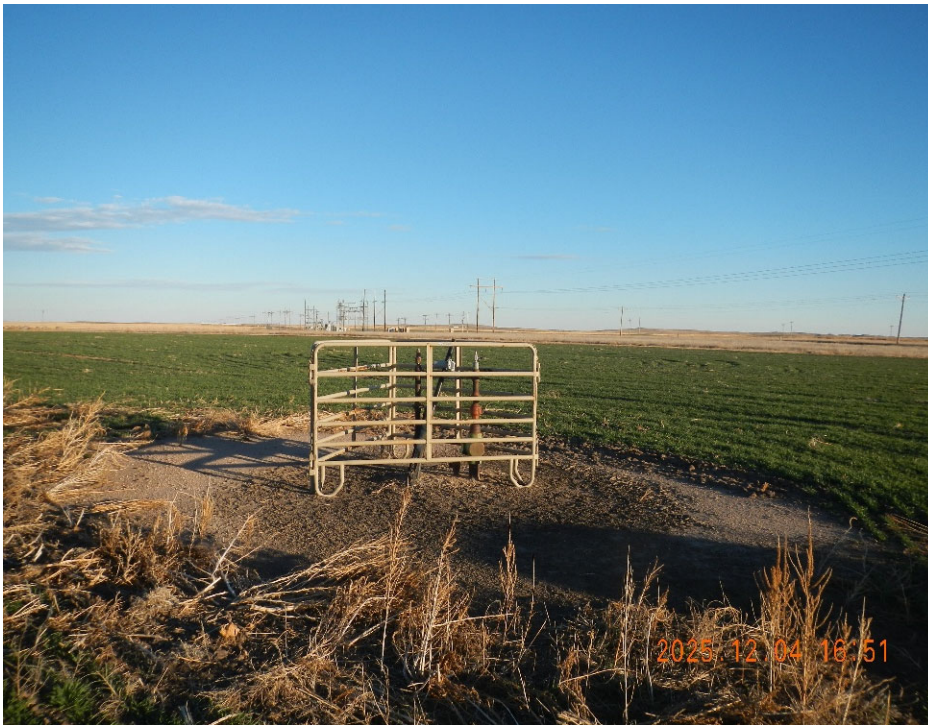
3. Well location overview.

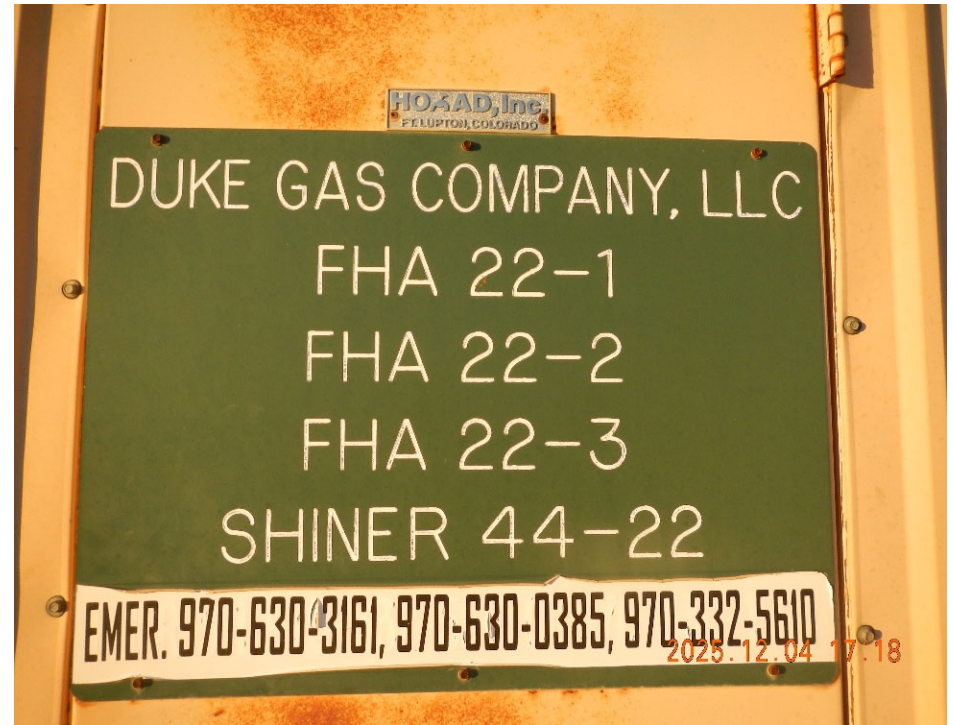
4. Lease sign at gathering location.

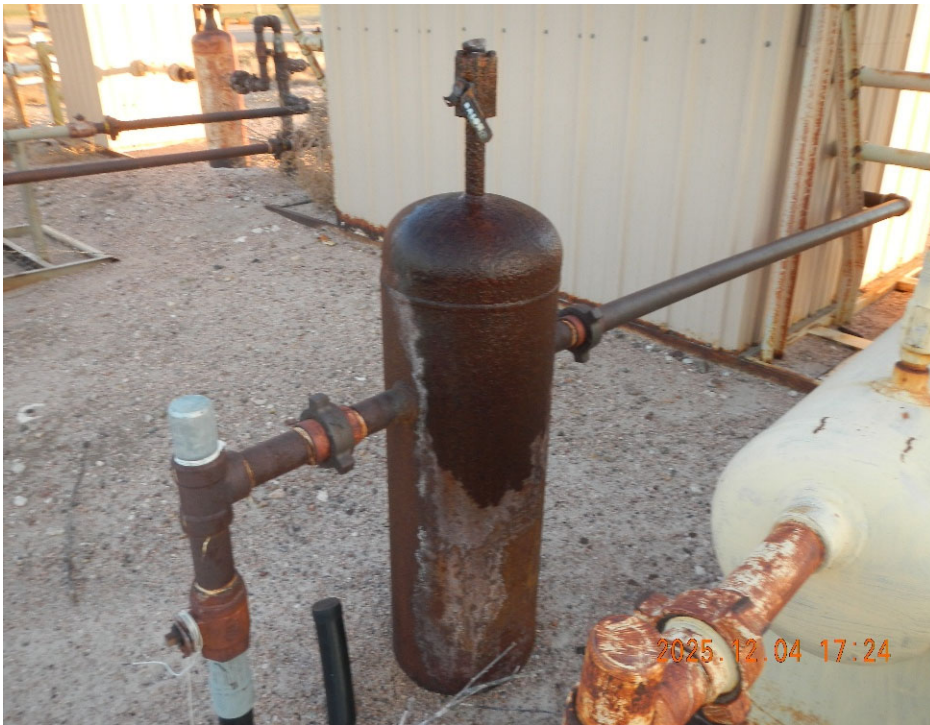
5. View of Dehydrator (Drip Bottle) on gas meter run inlet. Note visible moisture on bottle.

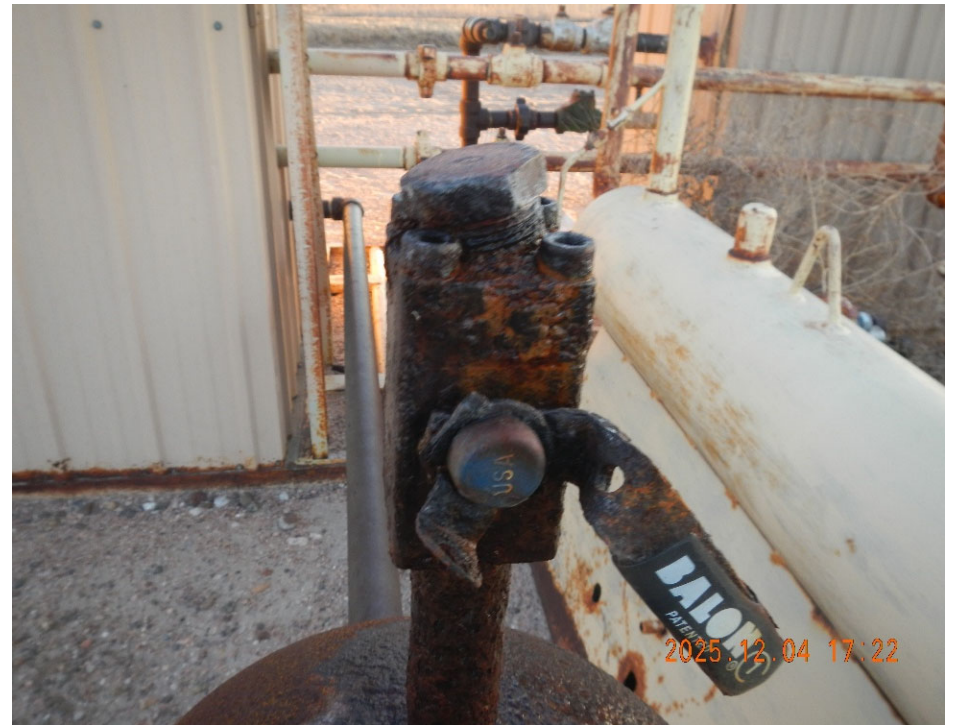
6. View of valve on Dehydrator (Drip Bottle). Valve will not full close and plug seat is cross threaded.

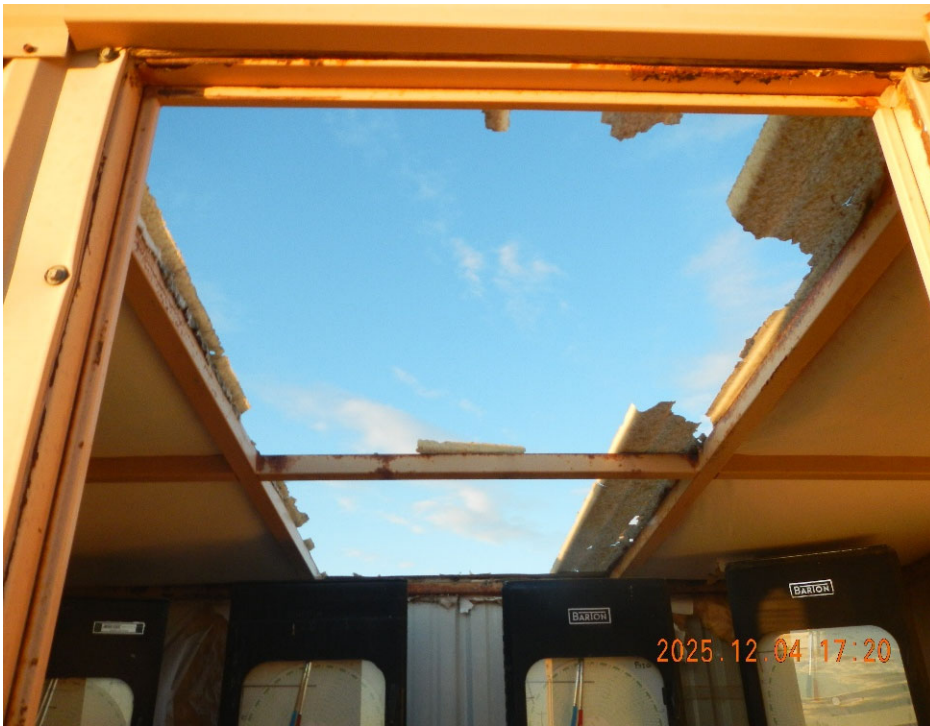
7. Damage to Meter Shed roof.

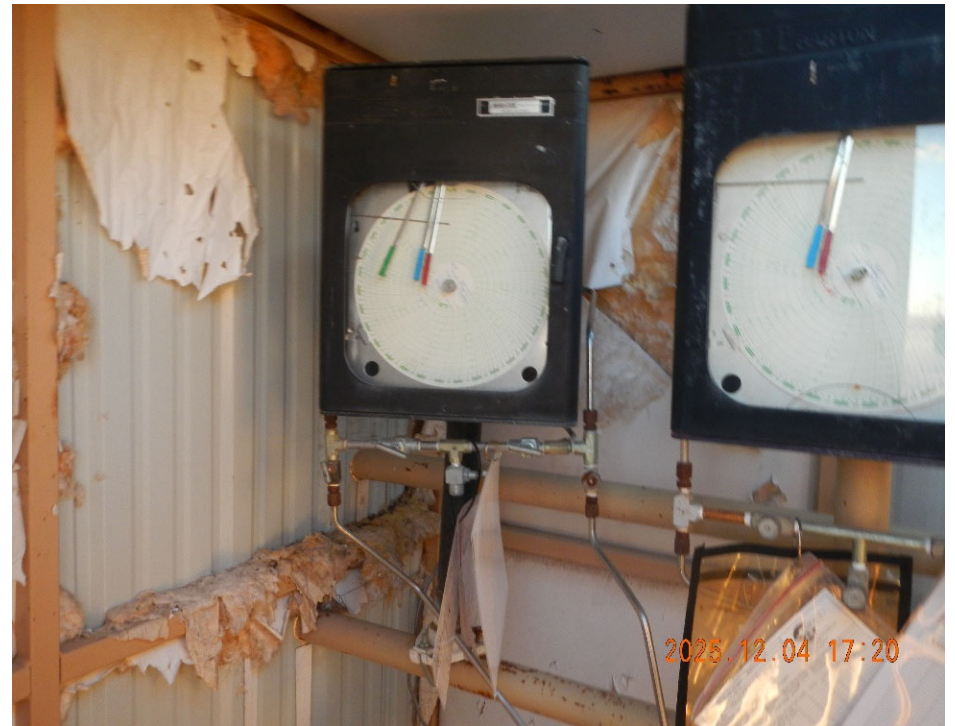
8. Gas meter inside meter shed.

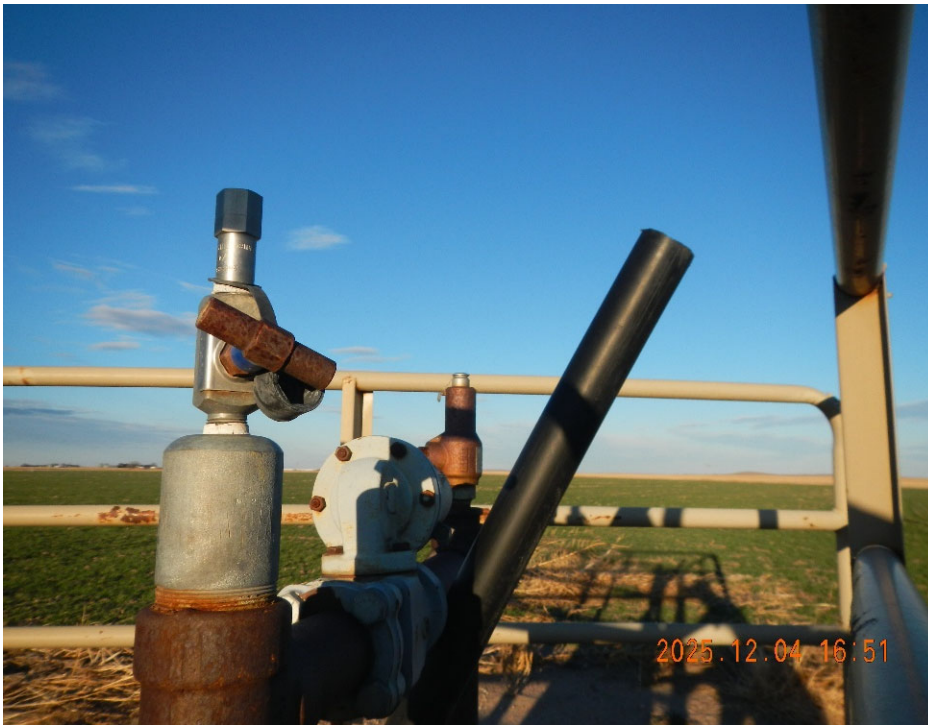
9. View of open ended stubbed up poly pipe at well location.

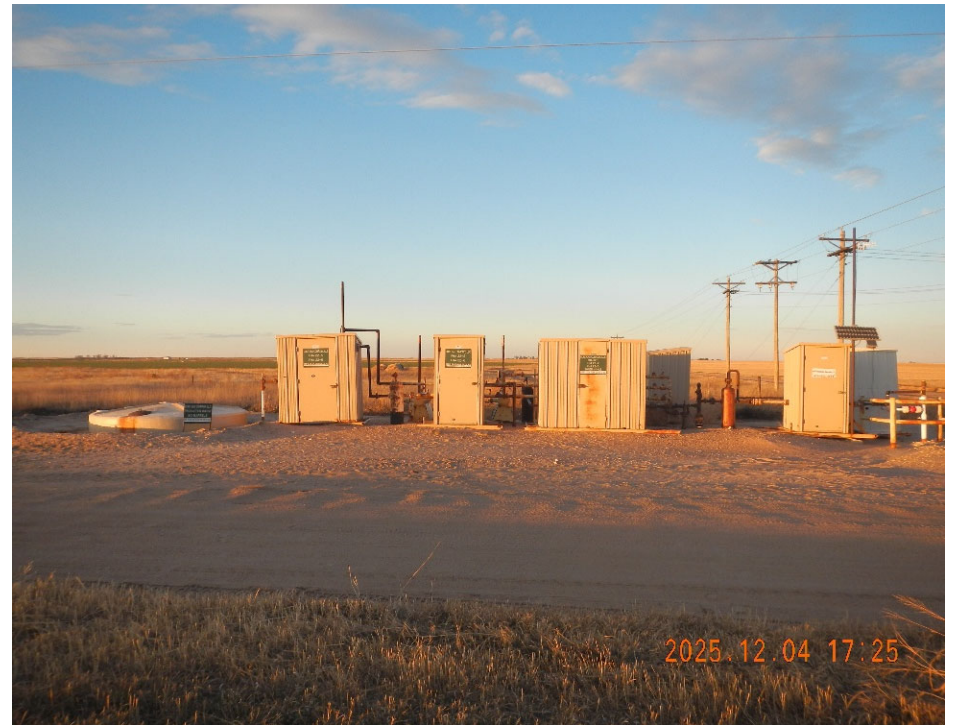
10. Gathering location overview.
