Fort Lupton, CO, United States
Lat 40.174047, Long -104.813846
12/04/2025 08:57 GMT-07:00
ECMC : Environmental Inspection

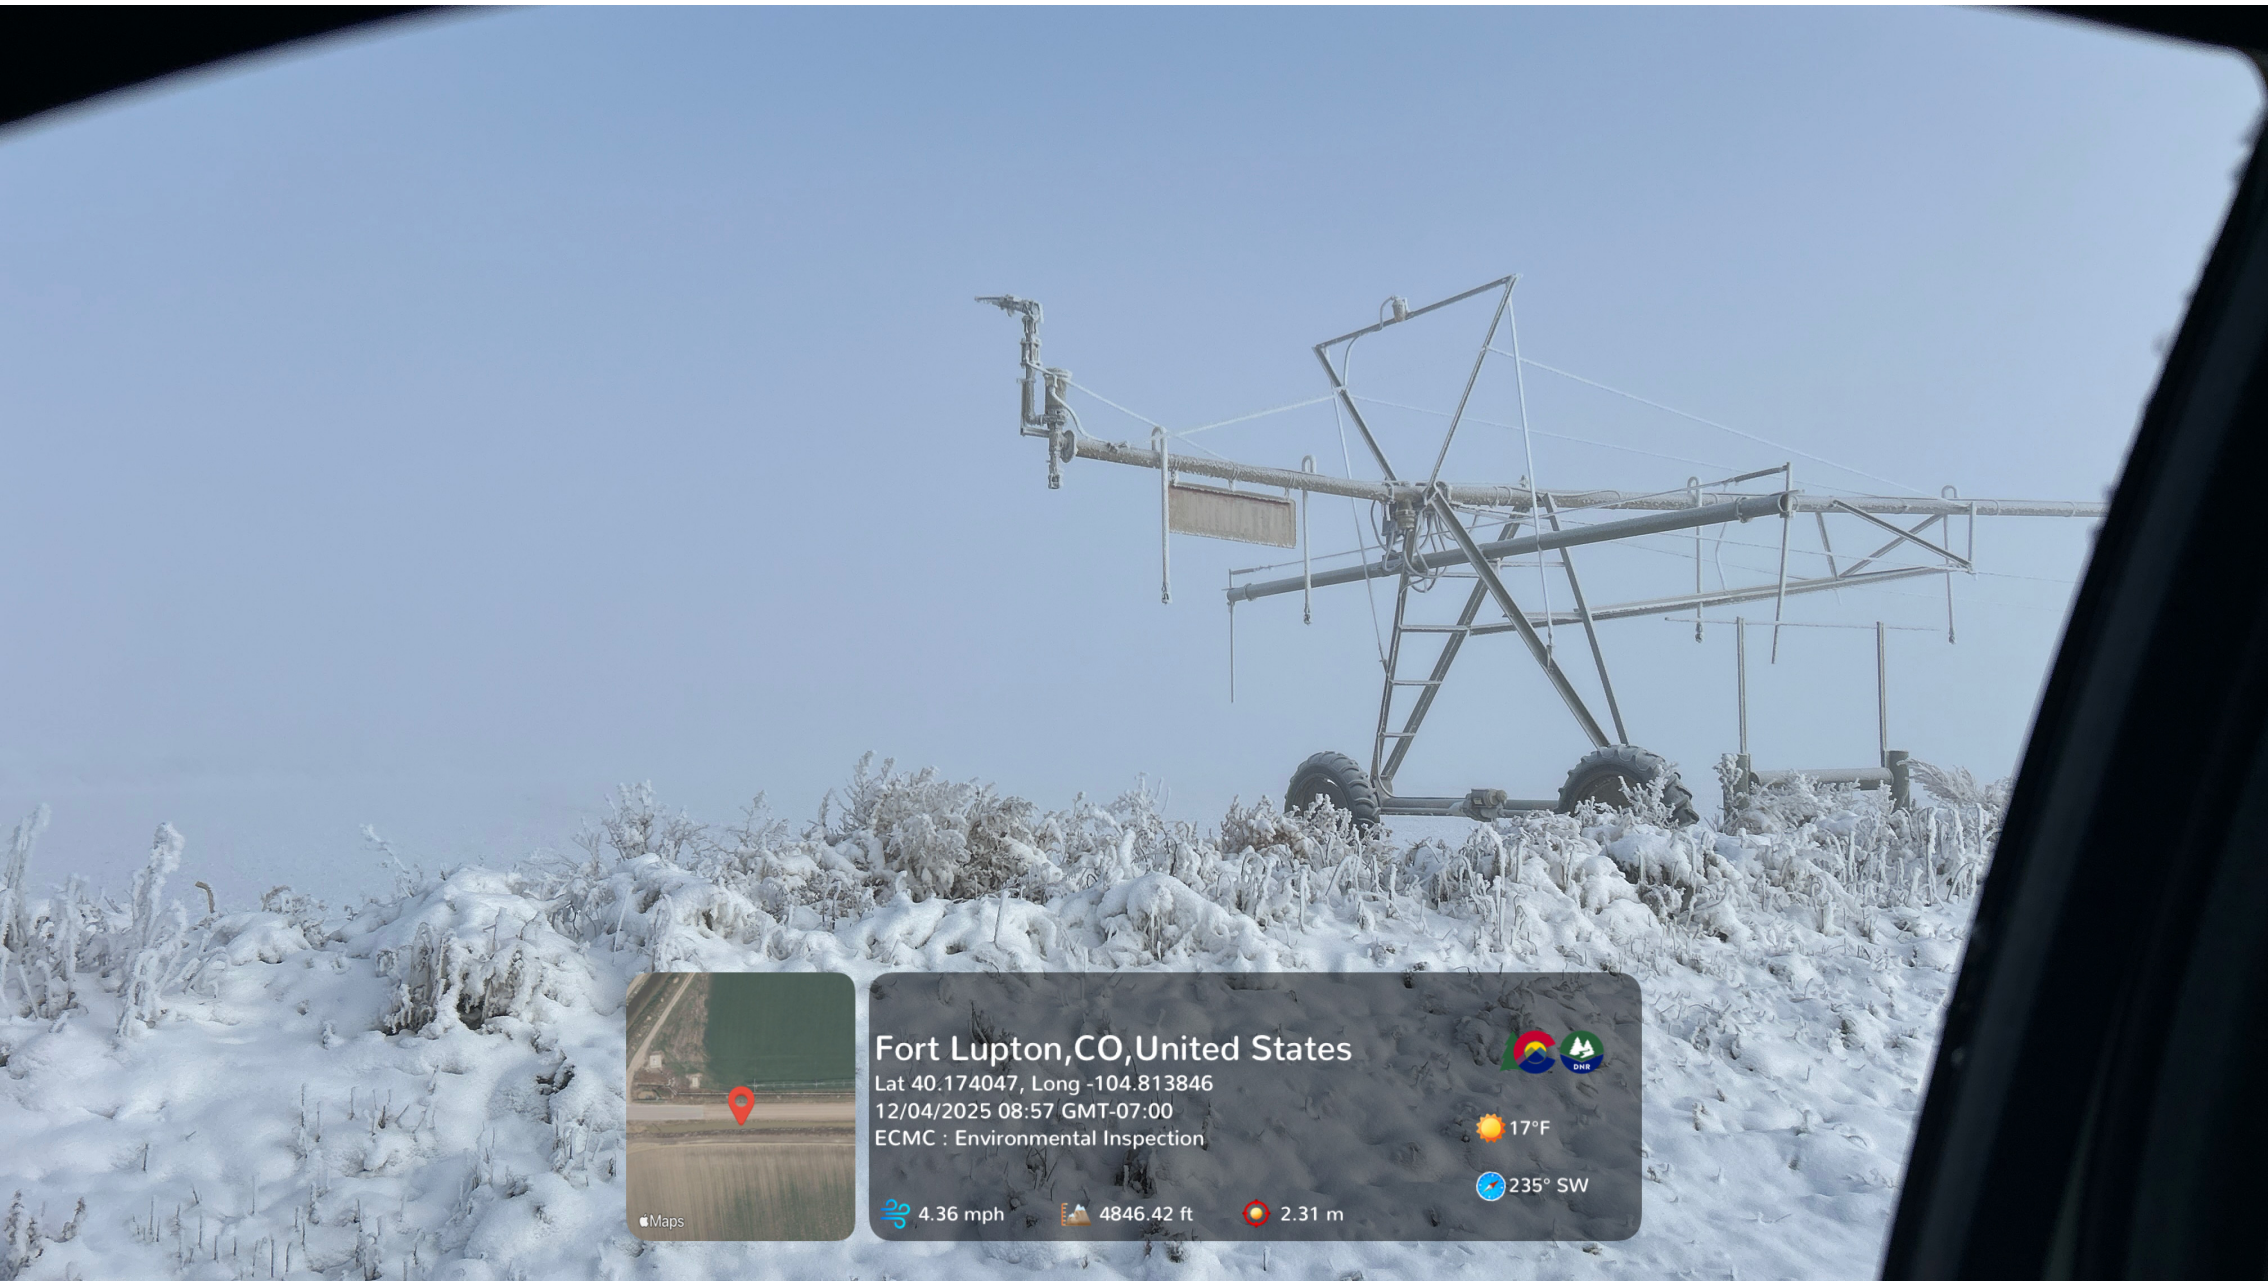
Looking at the irrigation pivot in the field surrounding the flowline. The pivot appears frozen and not currently in operation.

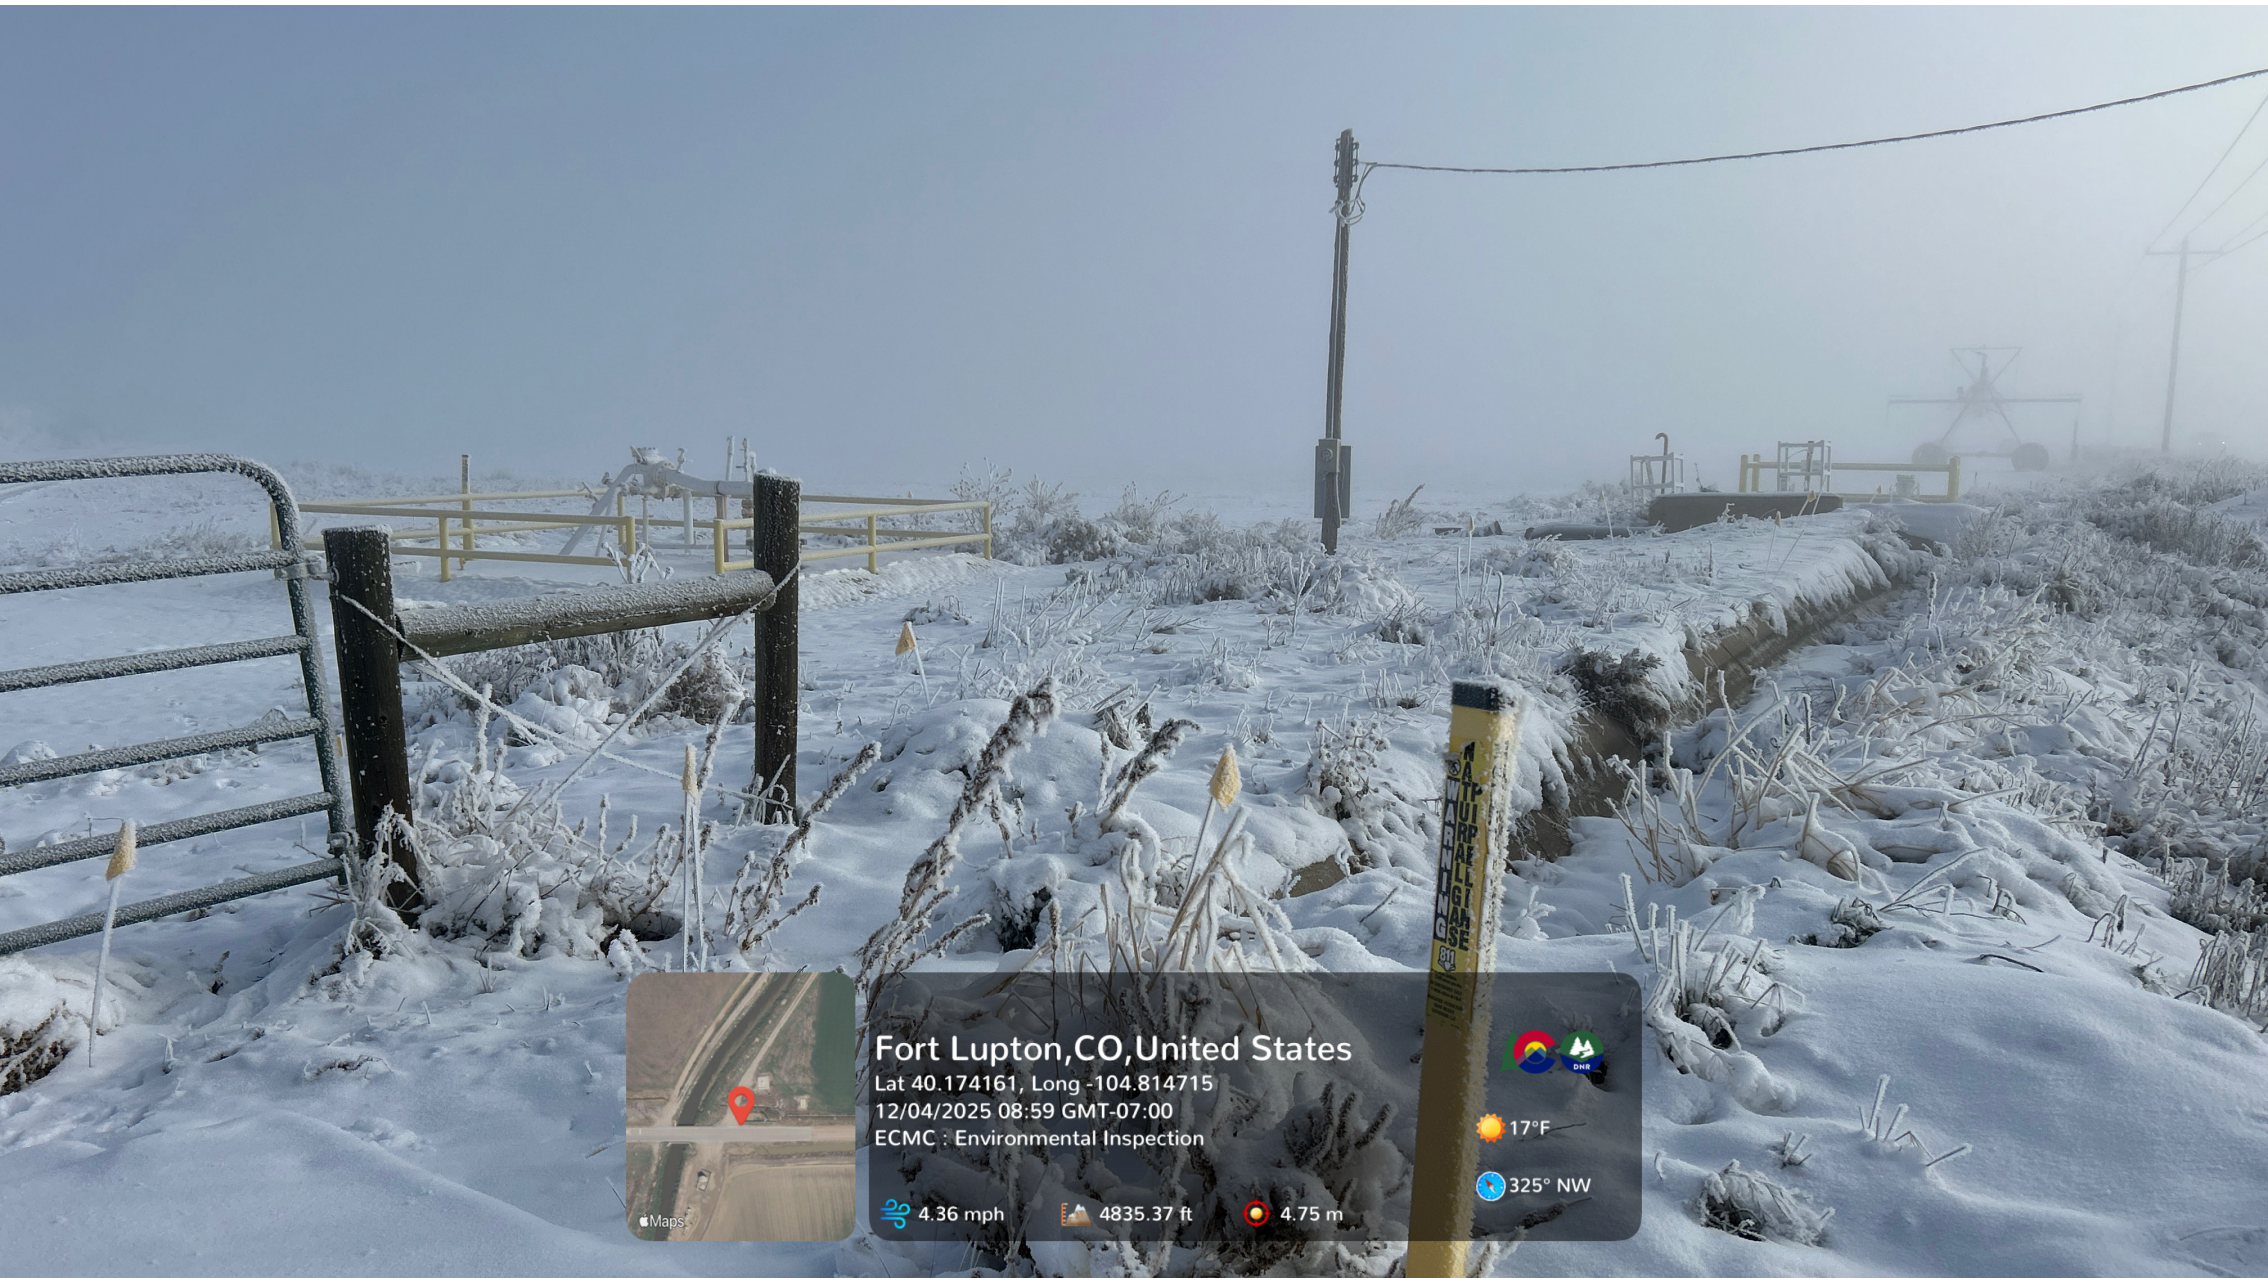
Looking at the irrigation canal at the southwestern edge of the field surrounding the flowline. Snow has accumulated within the irrigation canal.

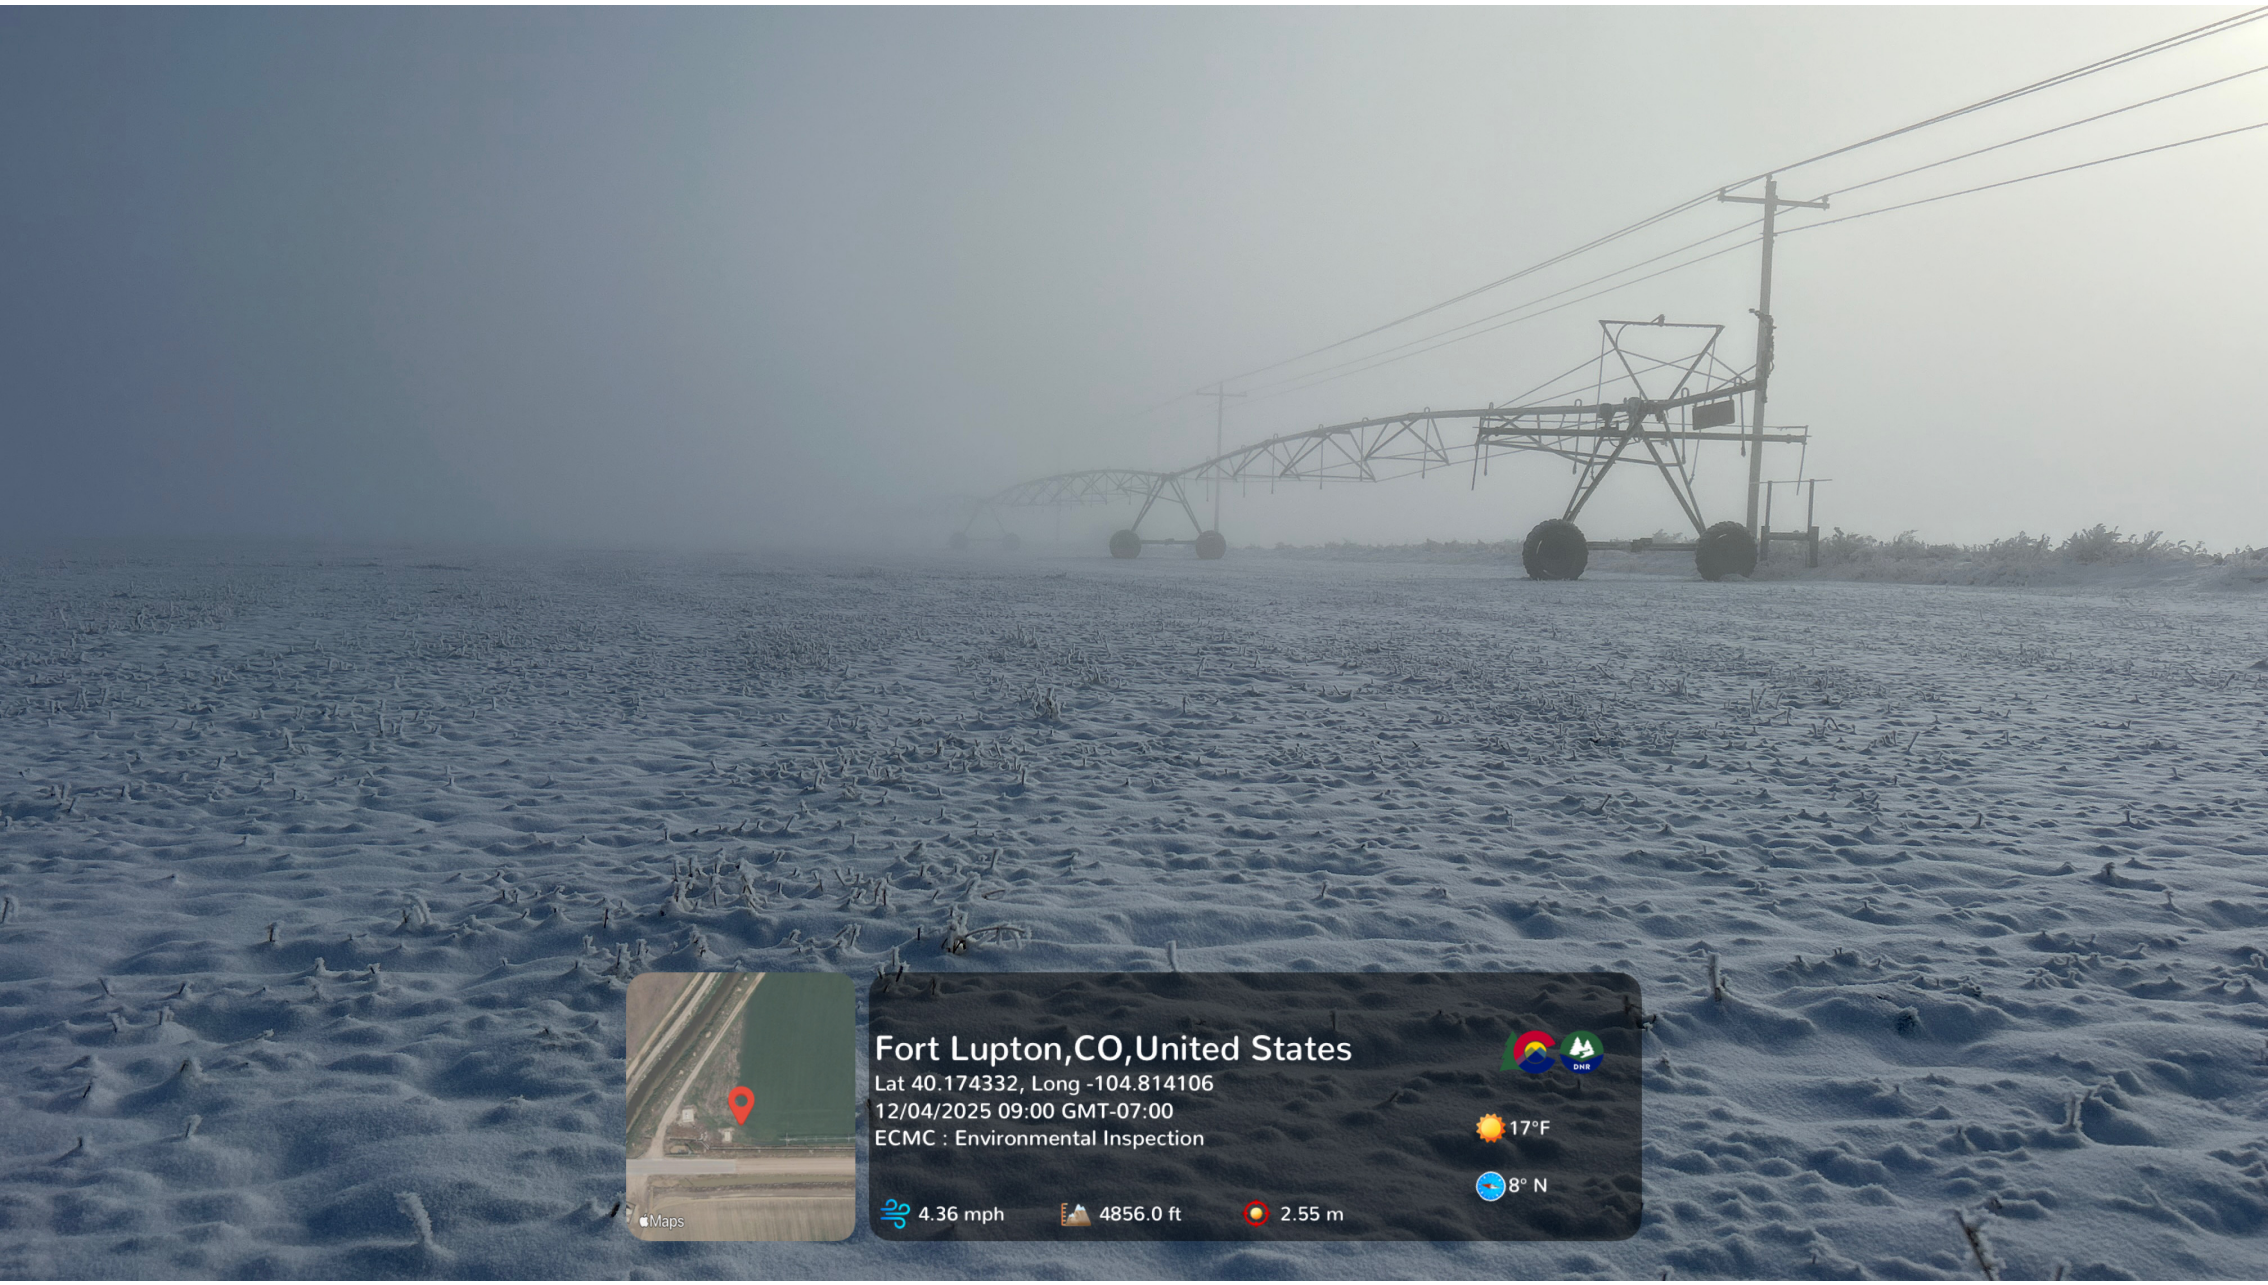
Looking at the field surrounding the flowline from the southwestern corner. Due to access and visibility limitations, the exact spill location and flowline path are not pictured. Crops in the field surrounding the flowline have been harvested; the field is covered with snow.

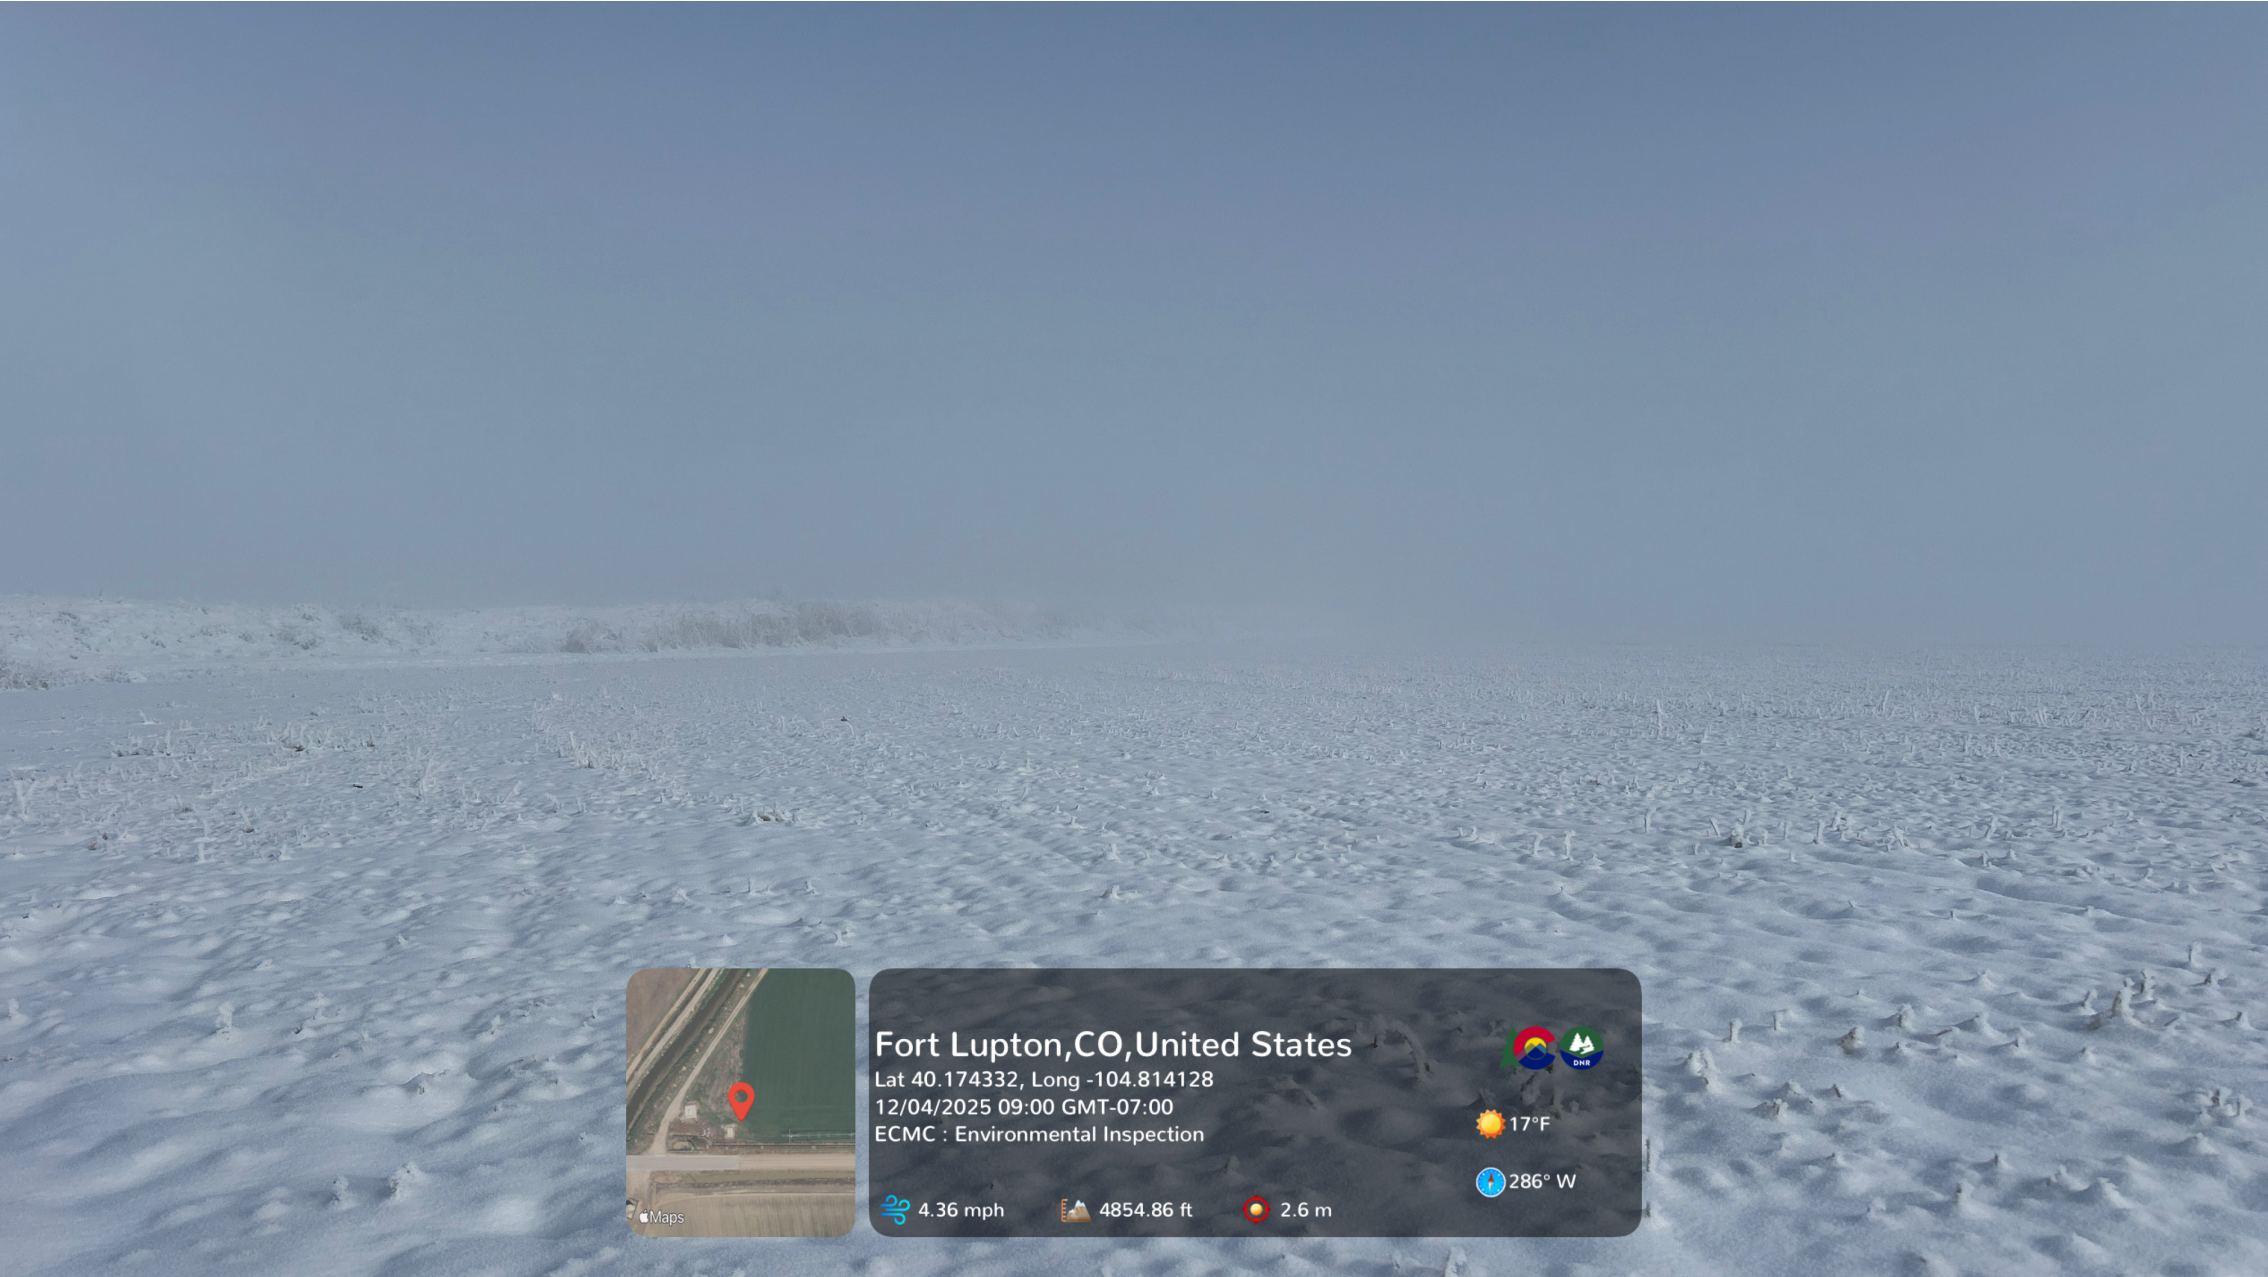
Looking at the field surrounding the flowline from the southwestern corner. Due to access and visibility limitations, the exact spill location and flowline path are not pictured. Crops in the field surrounding the flowline have been harvested; the field is covered with snow.
