Inspection/Audit Photos

Location: SCOUT ENERGY MANAGEMENT LLC D.F. ROOTH #5 & D.F. ROOTH #6 PAD

Location ID: 336541

Date: 11/20/2025

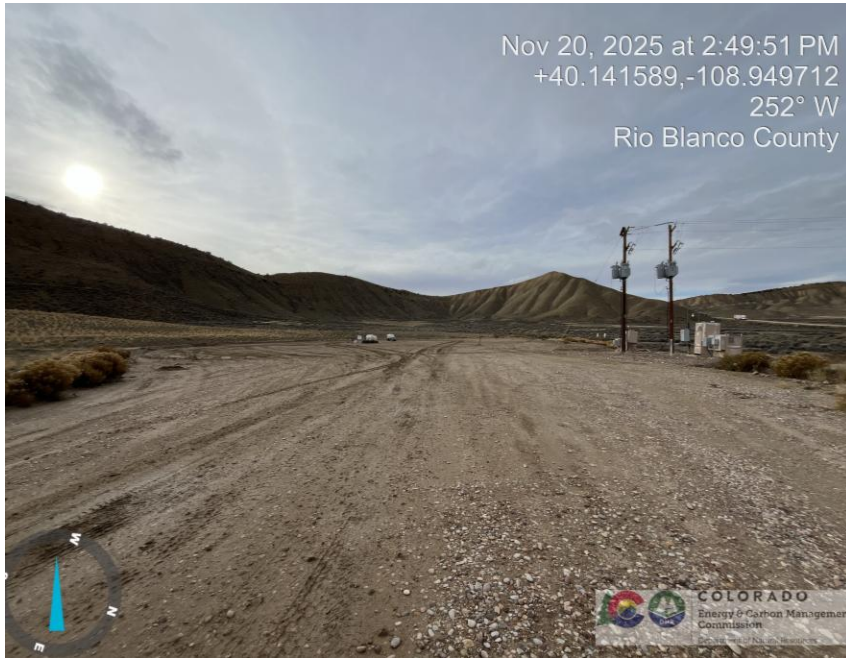
Photo # 4430 Entrance to location

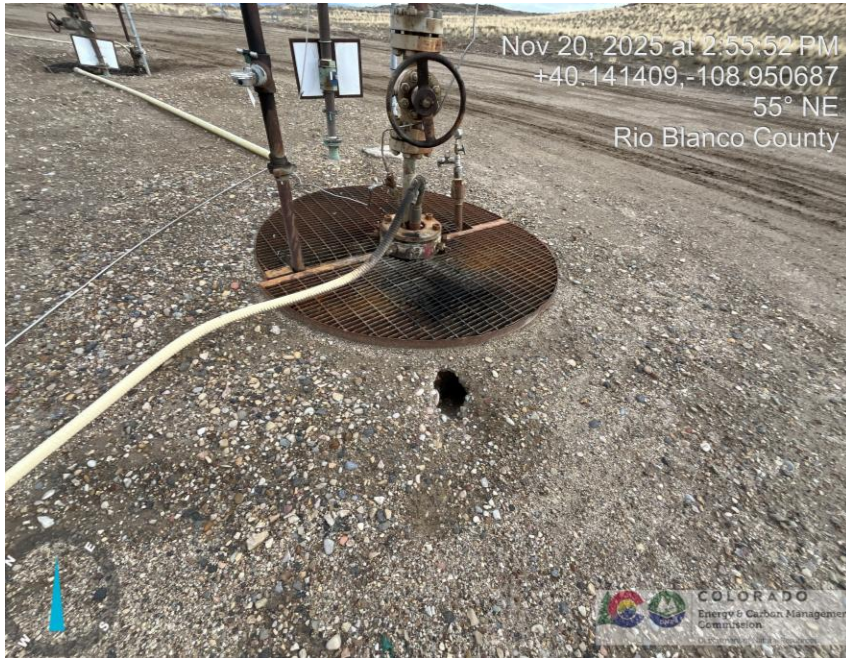
Photo # 4441 Tunnel erosion near D.F. ROOTH #5 wellhead/needs maintenance.

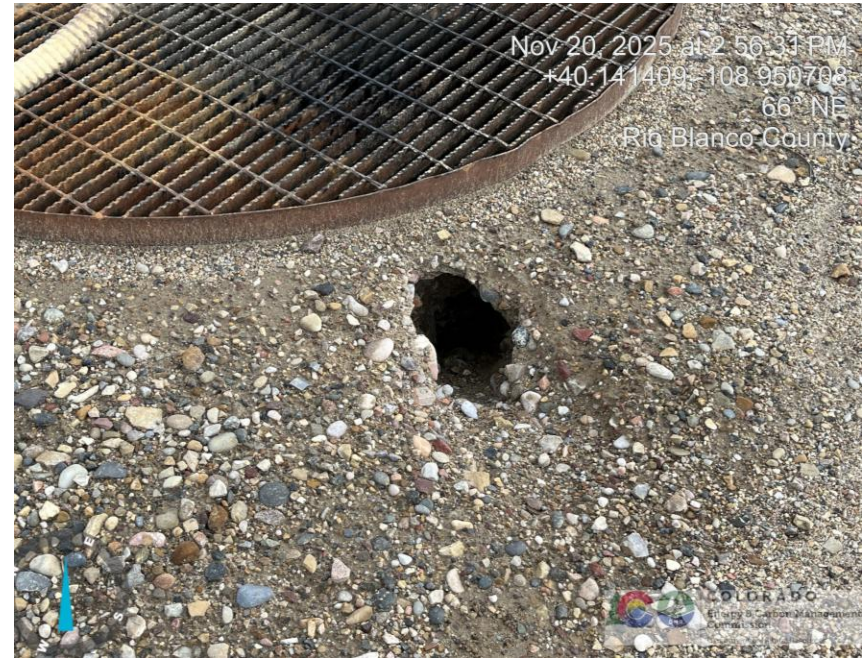
Photo # 4443 Tunnel erosion near D.F. ROOTH #5 wellhead/needs maintenance.
