## Inspection Photos

Location Name: Kinder Morgan McElmo Dome Unit 35-38-19 HE-2

API # 05-083-06387

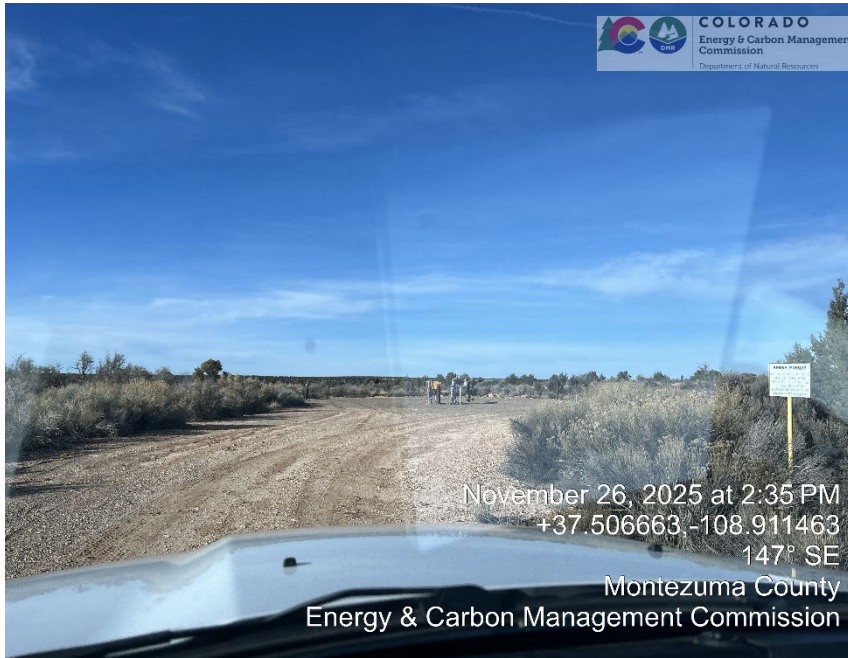
**1. Entrance to well pad.**

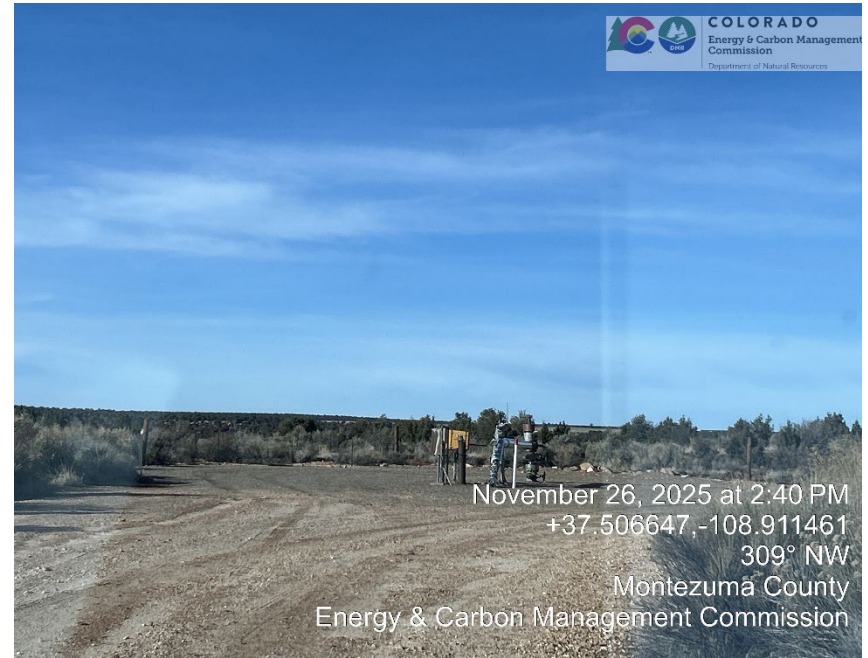
**2. Well head and meter. Down fence is on left.**

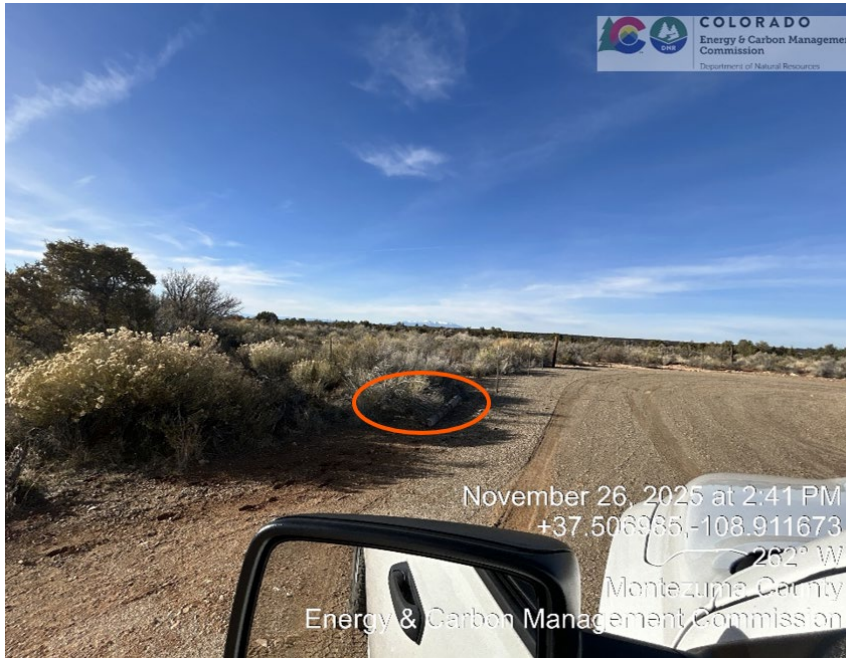
**3. Close up showing down fence in vegetation on left.**

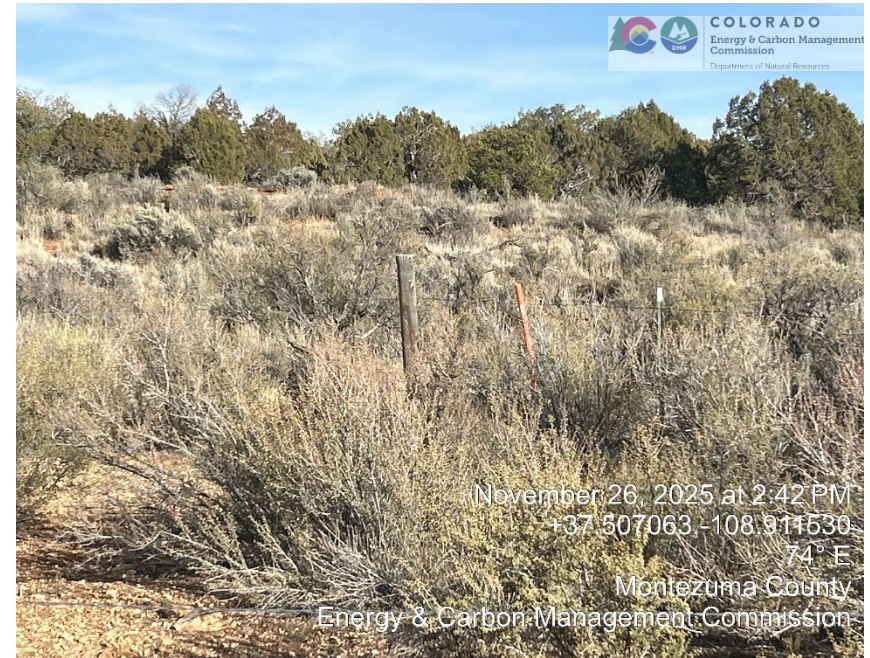
**4. Interim reclamation vegetation in fence off area outside of oval looks healthy, undesirable vegetation not an issue. Note presence of rig tie down marked by orange plastic tubing.**

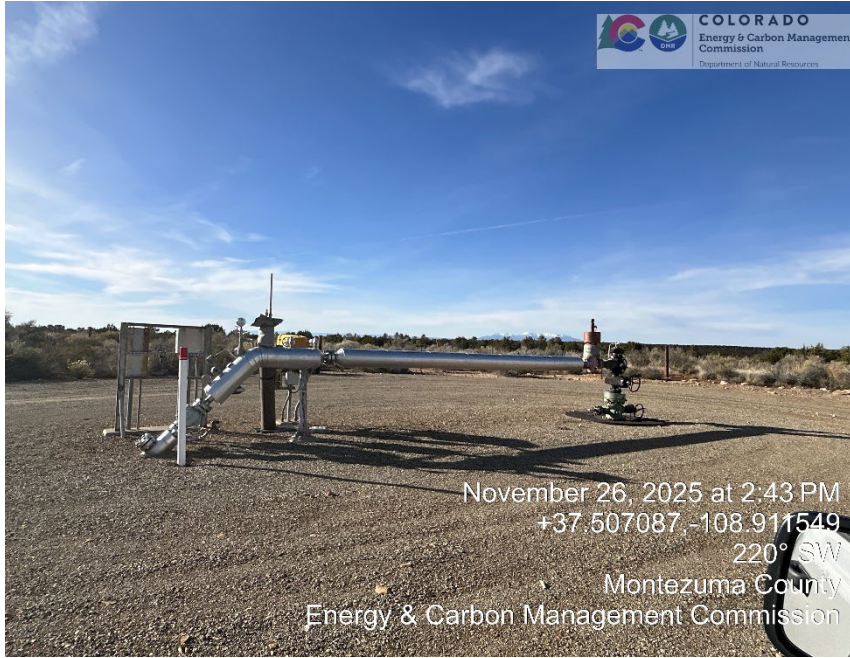
**5. Photo of well head and meter.**
