Inspection Photos

API: 009-06014

Operator: JONES ENERGY LTD

Inspection Date: 12/8/2025

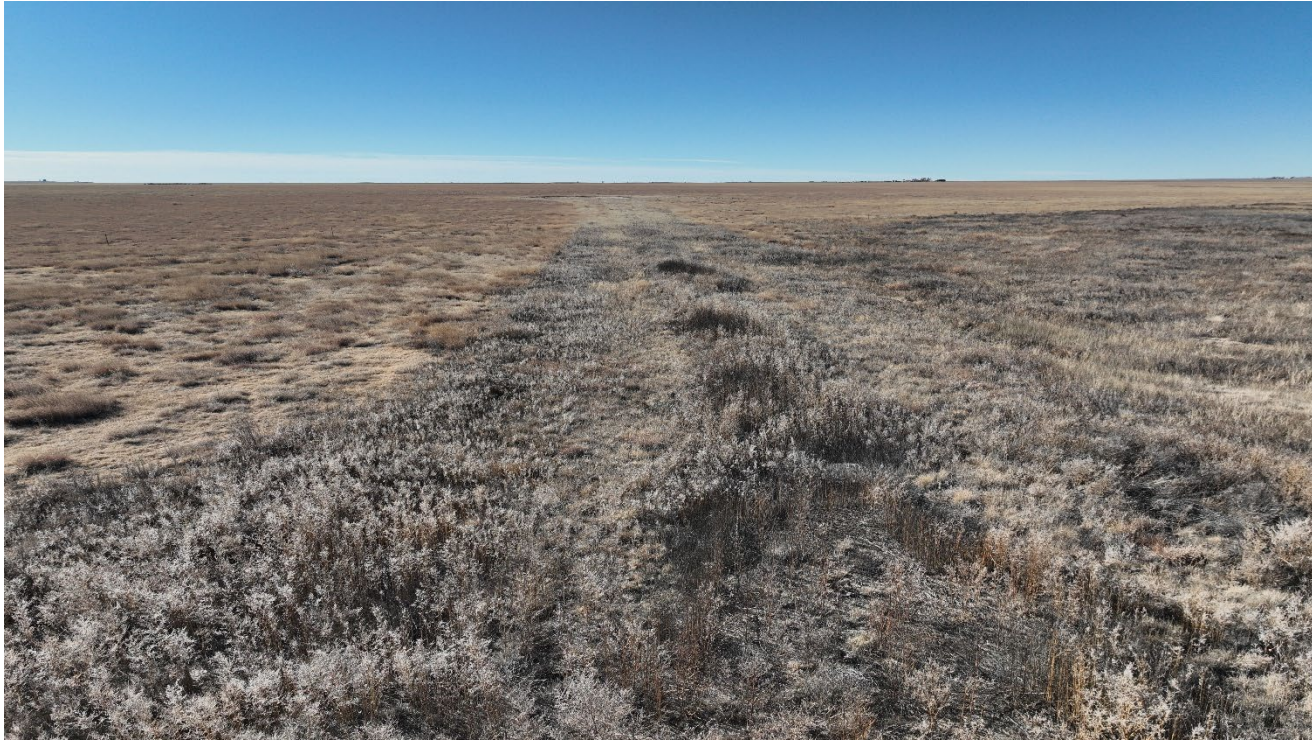
Photo 1. Drone aerial photo facing southwest toward the access road. The dark vegetation in this area is undesirable weeds (Kochia).

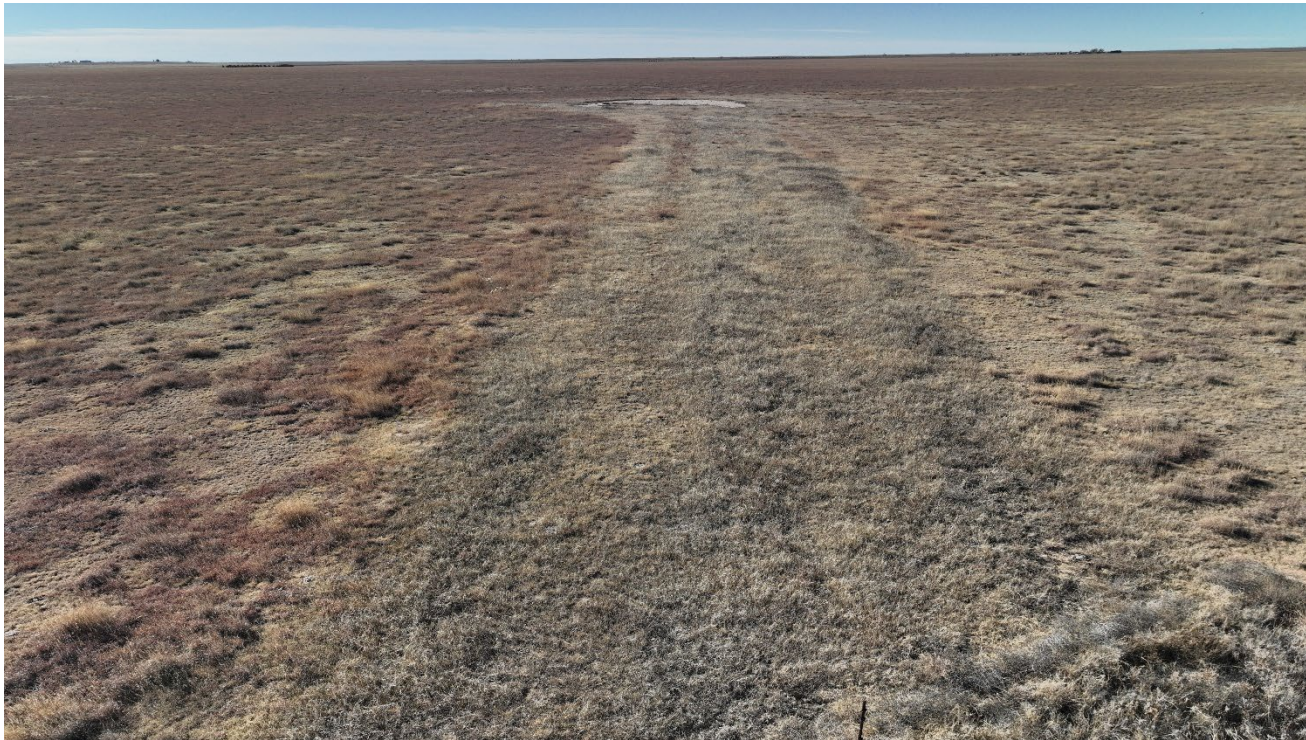
Photo 2. Drone aerial photo facing southwest along the former access road. This portion of the road has re-established desirable perennial vegetation. The lighter colored vegetation is Sand dropseed and Blue grama.

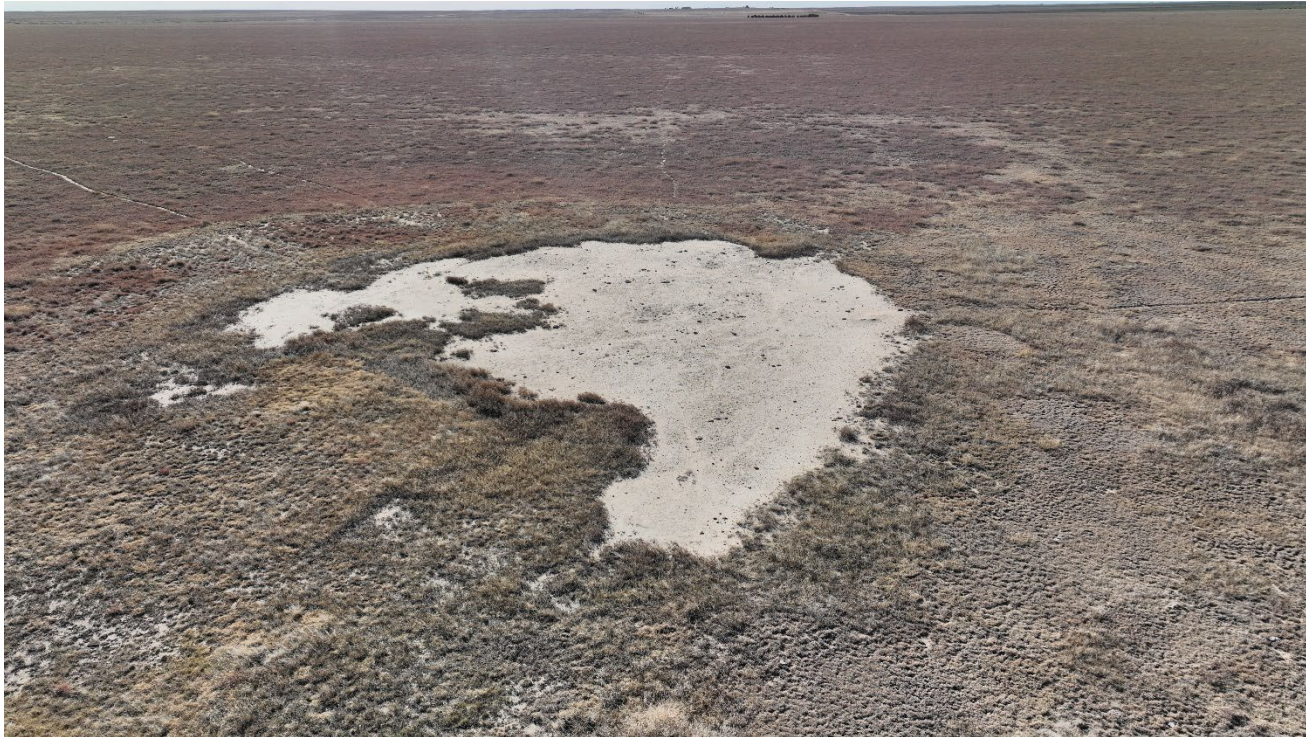
Photo 3. Drone aerial photo facing southwest at the former wellsite. The area is bare of vegetation and appears to be impacted from a historical spill from wellsite operations.

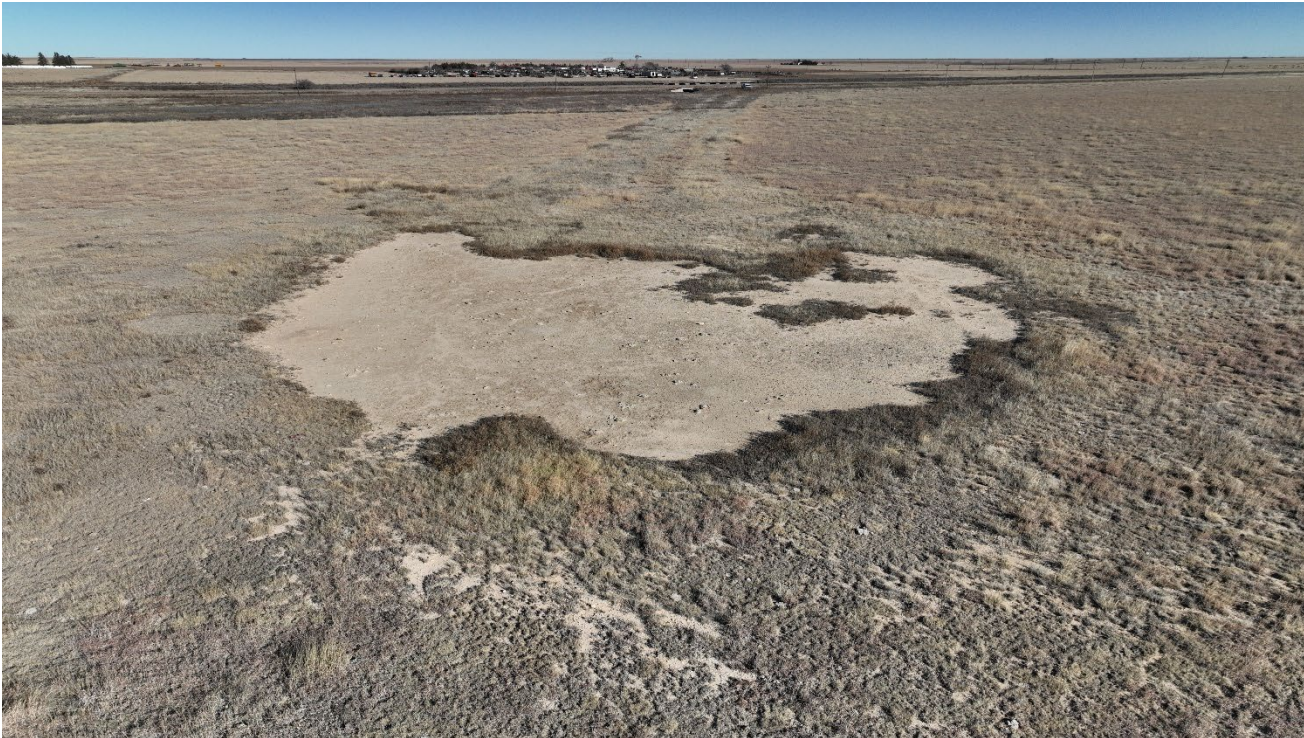
Photo 4. Drone aerial photo facing northeast at the former wellsite. The area is bare of vegetation and appears to be impacted from a historical spill from wellsite operations.

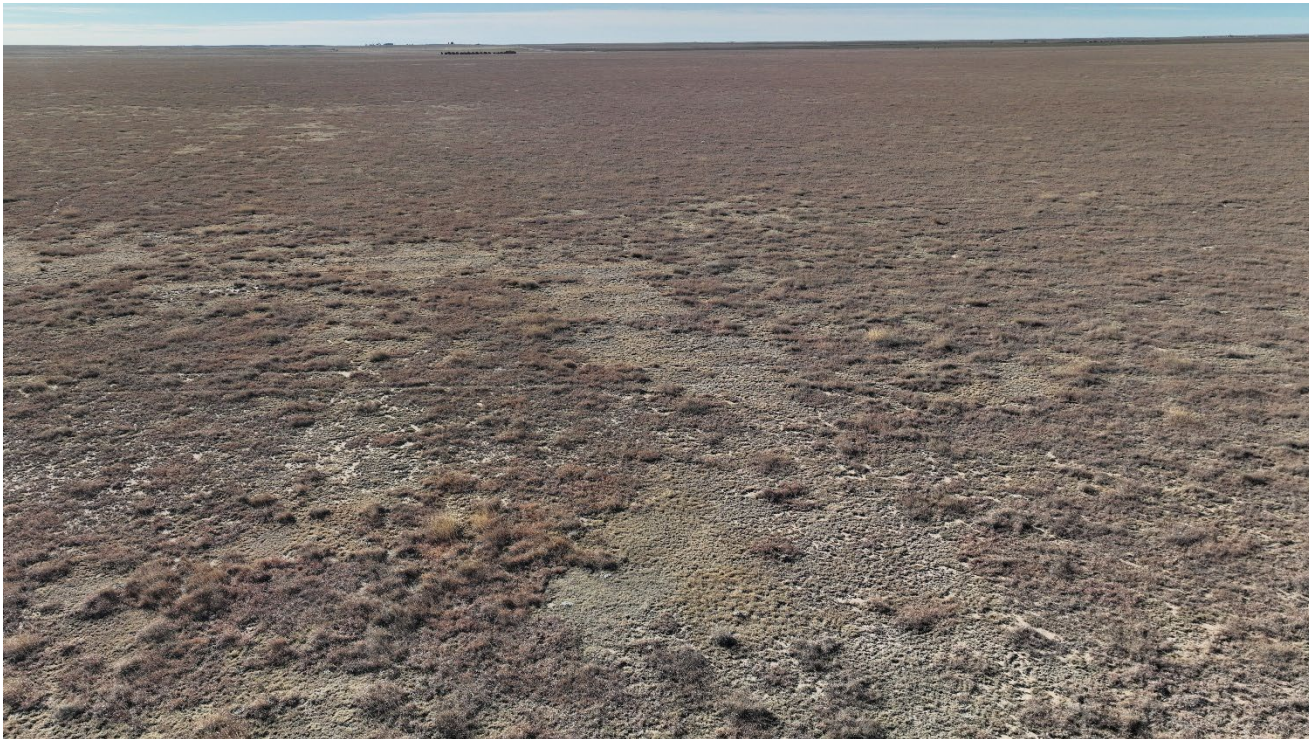
Photo 5. Facing north toward the surrounding native pasture which has a uniform vegetation cover.
