Looking along Flowline Facility ID 476033 trench towards the former STATE #3 well. The flowline appears to have been removed. A rope with orange ribbons has been installed on the east side of the trench. Stockpiled soil is visible along the west side of the trench and east of the former well.

**Frederick, CO, United States**
Lat 40.093578, Long -104.954725
12/02/2025 15:04 GMT-07:00
ECMC : Environmental Inspection

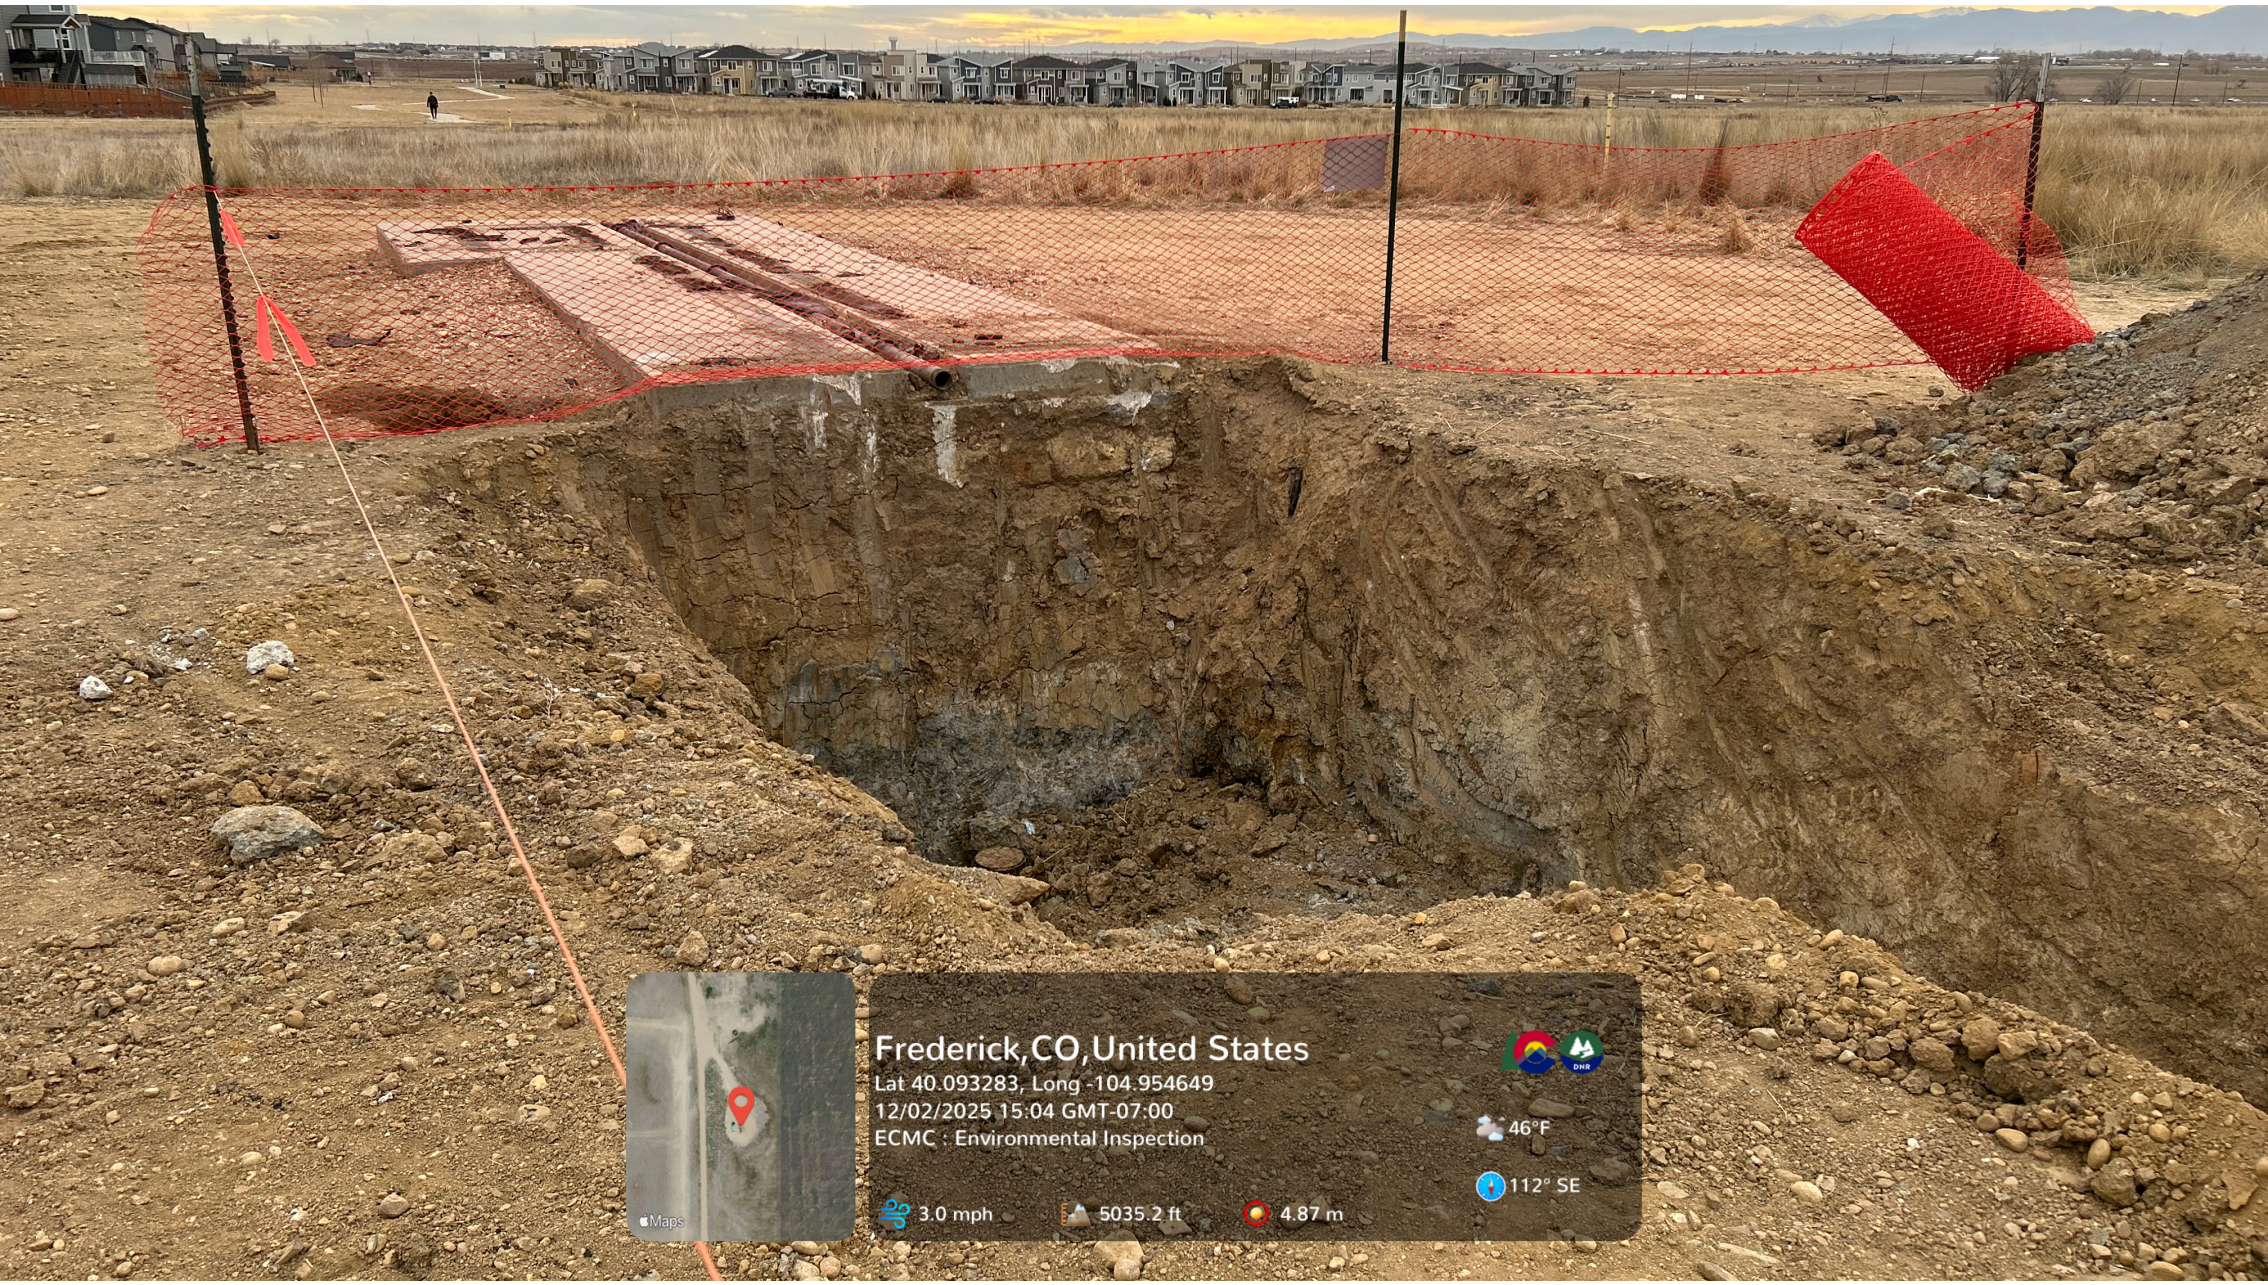
Looking at the former State #3 well. An open excavation is visible. Gray staining is visible in the excavation. Gray staining is visible in the stockpiled soil to the west. A petroleum hydrocarbon odor was observed. The pumping unit has been removed. Multiple residences, a walking path, and a pedestrian are visible in the background.

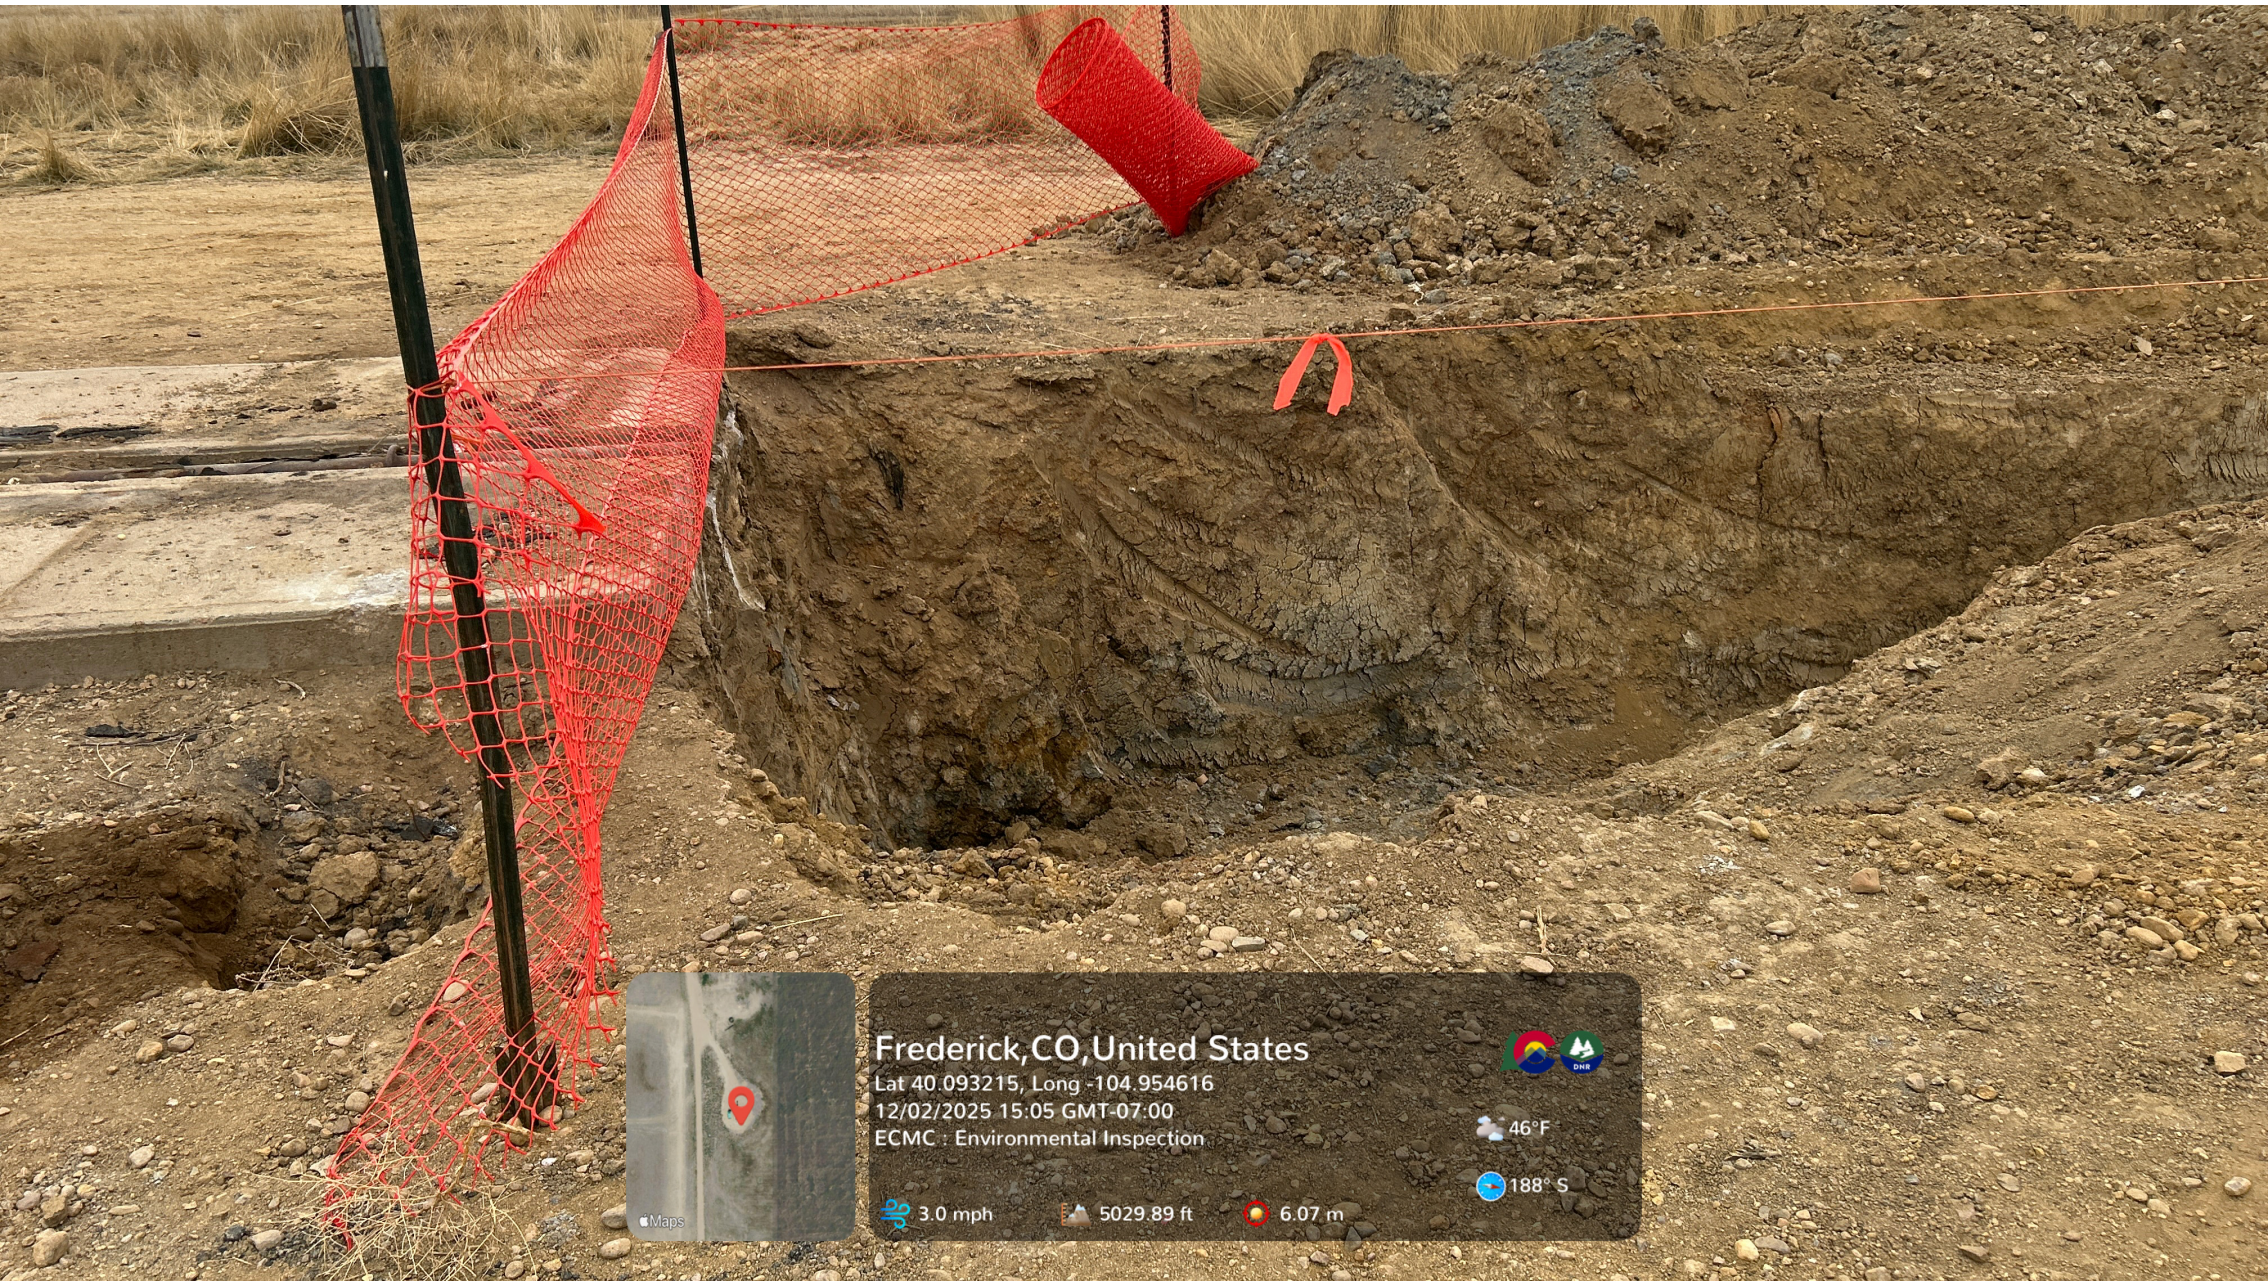
Gray staining is visible in the excavation. Gray staining is visible in the stockpiled soil to the west. A petroleum hydrocarbon odor was observed.

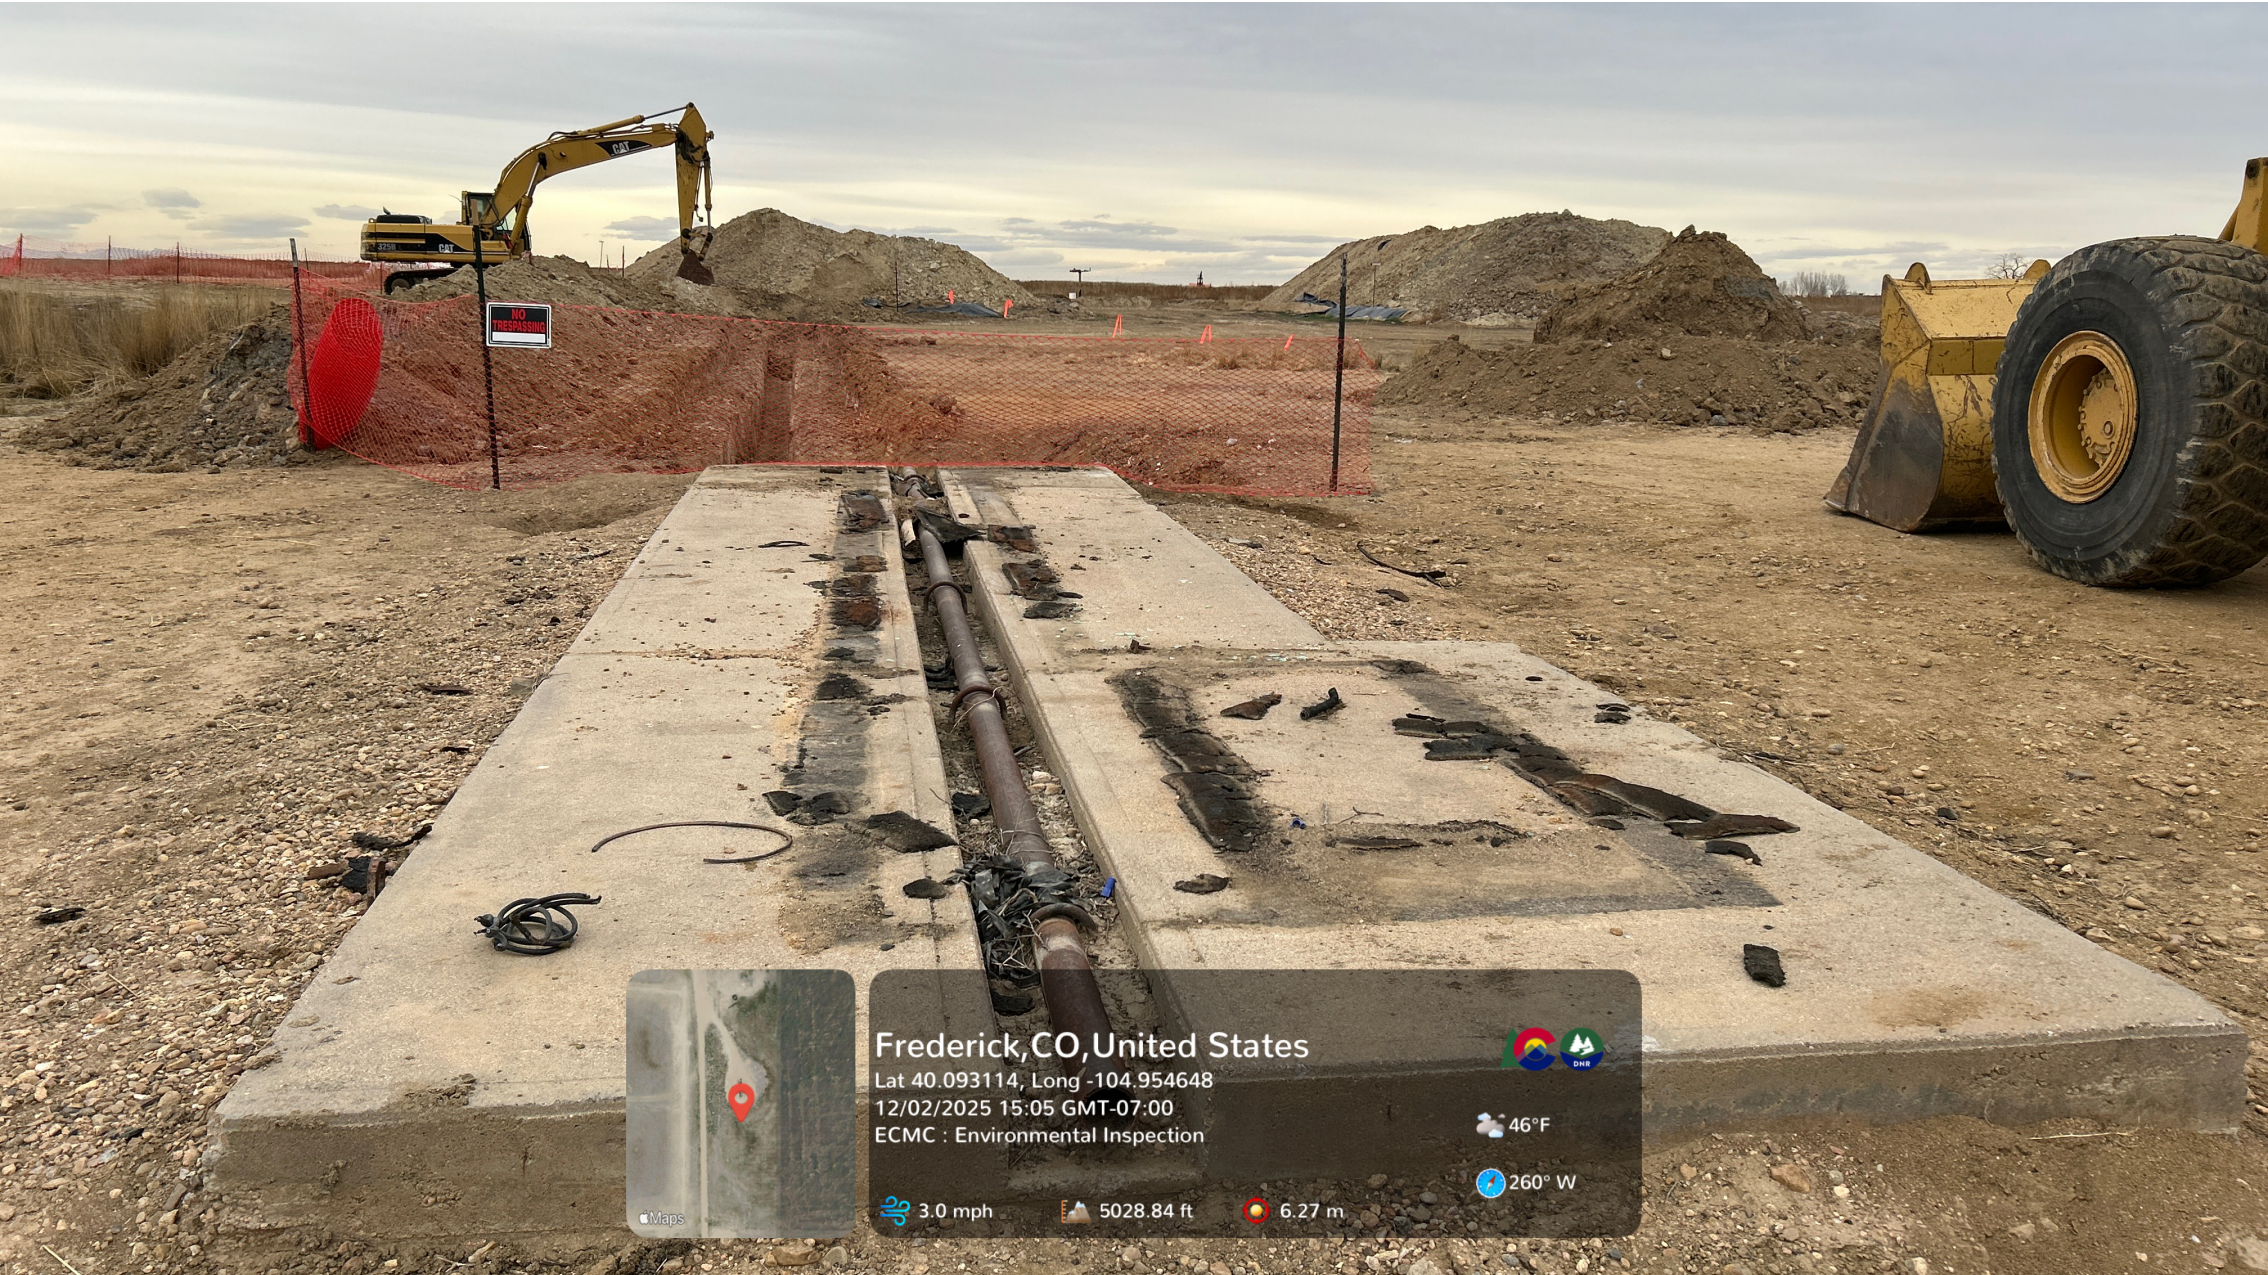
Looking at the former State #3 well and excavation. Orange construction fencing partially surrounds the excavation at the former well. The pumping unit has been removed. Stockpiles associated with Spill ID 490840 are visible in the background and will be addressed in a separate Field Inspection Report.

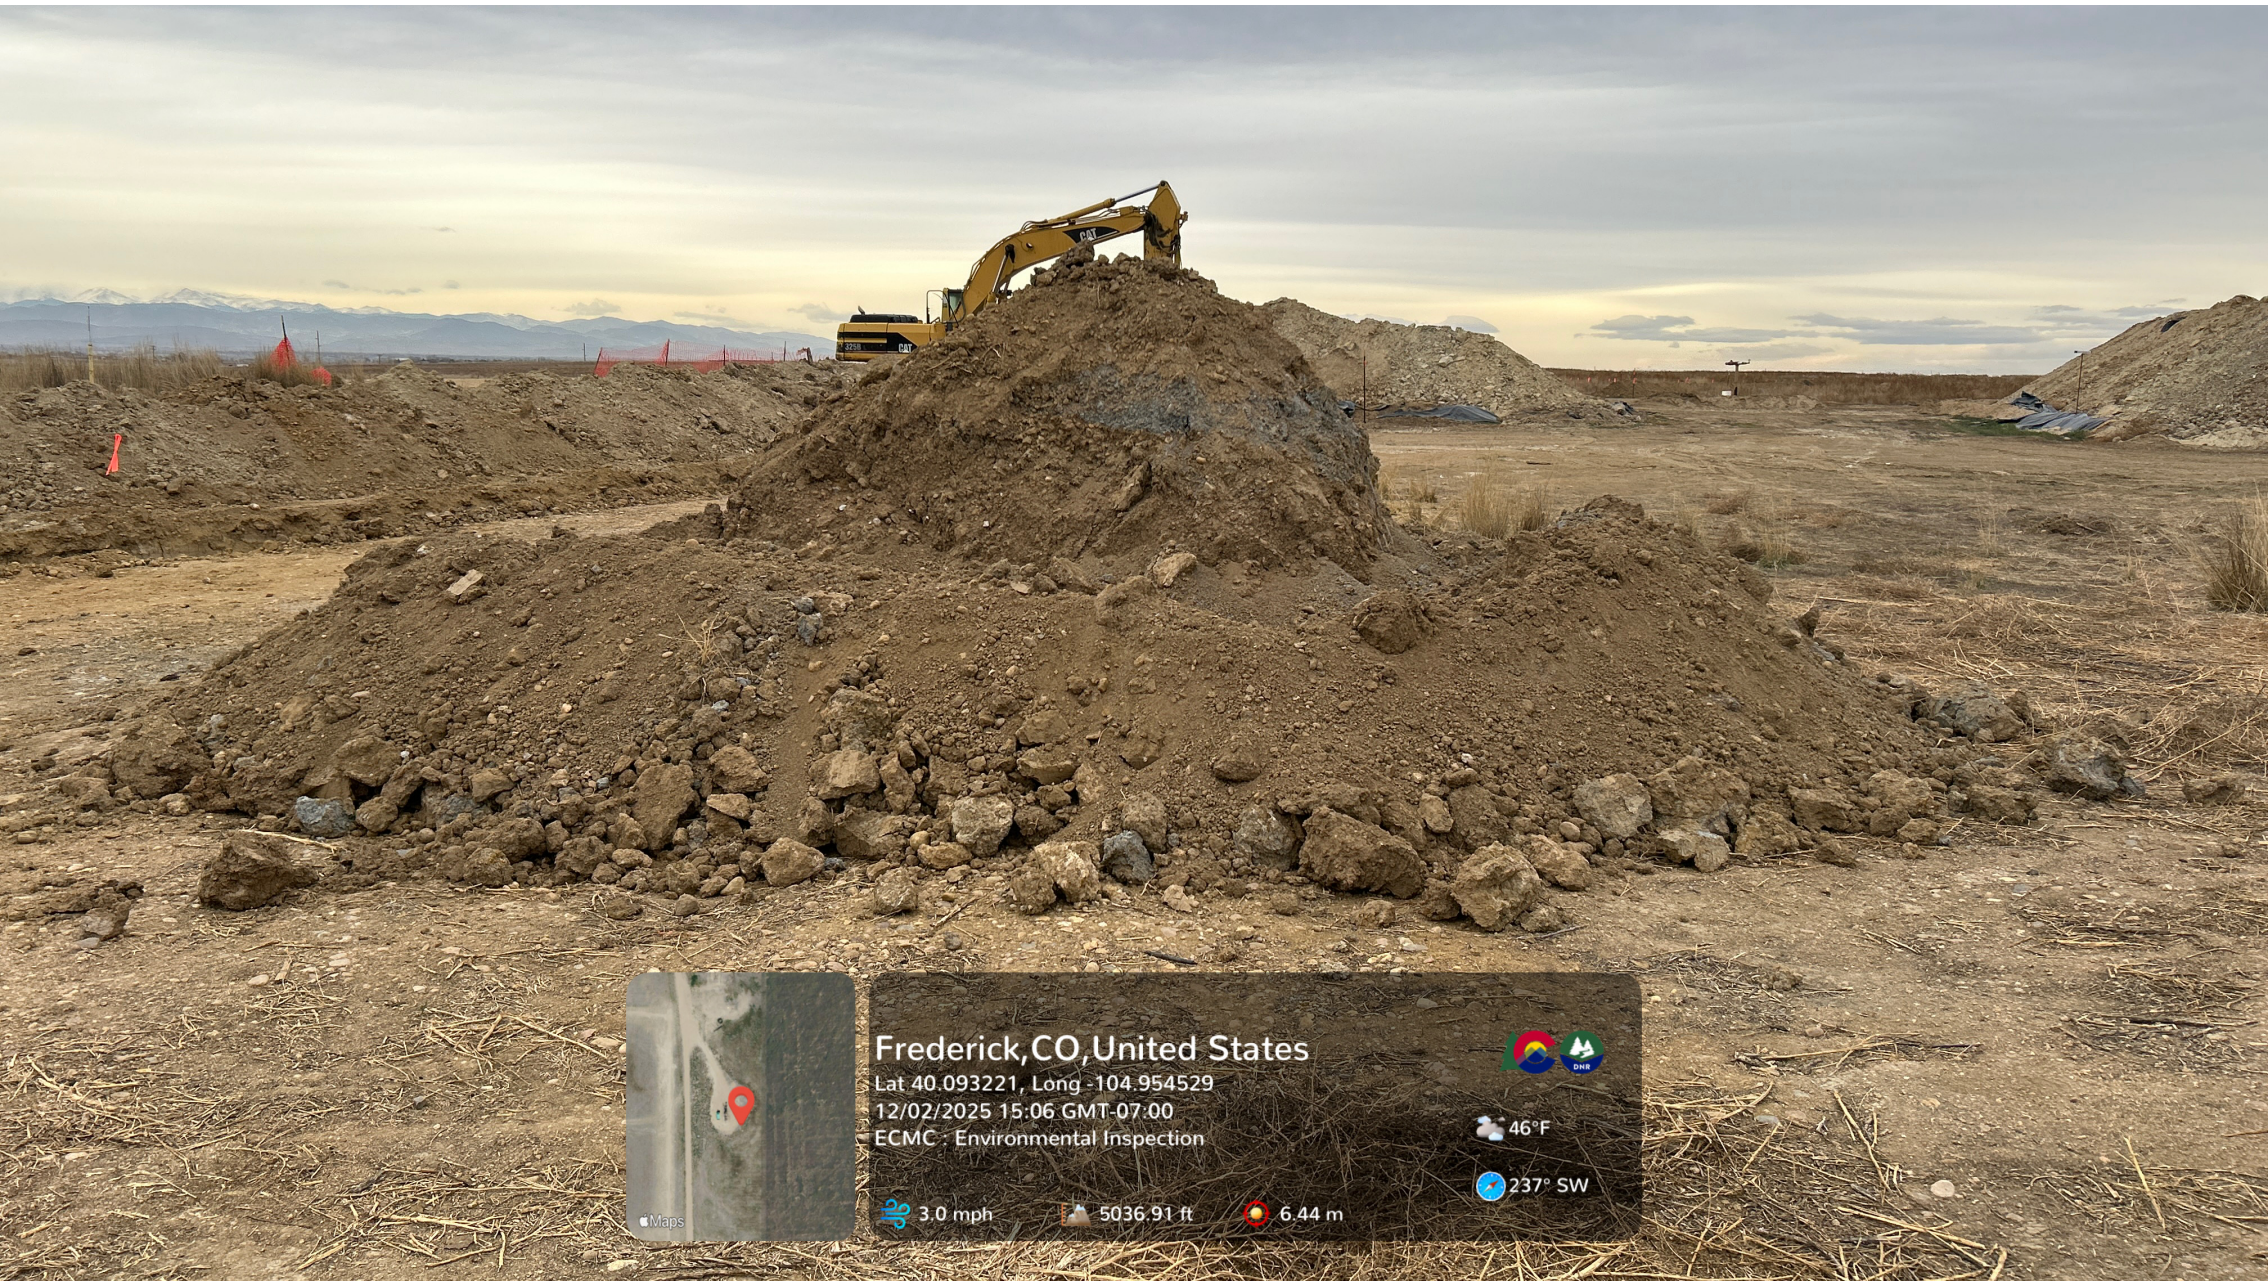
Looking at the soil stockpile adjacent to the State #3 well excavation. Gray staining is visible; a petroleum hydrocarbon odor was observed. No liner is visible. Stormwater BMPs are inadequate.

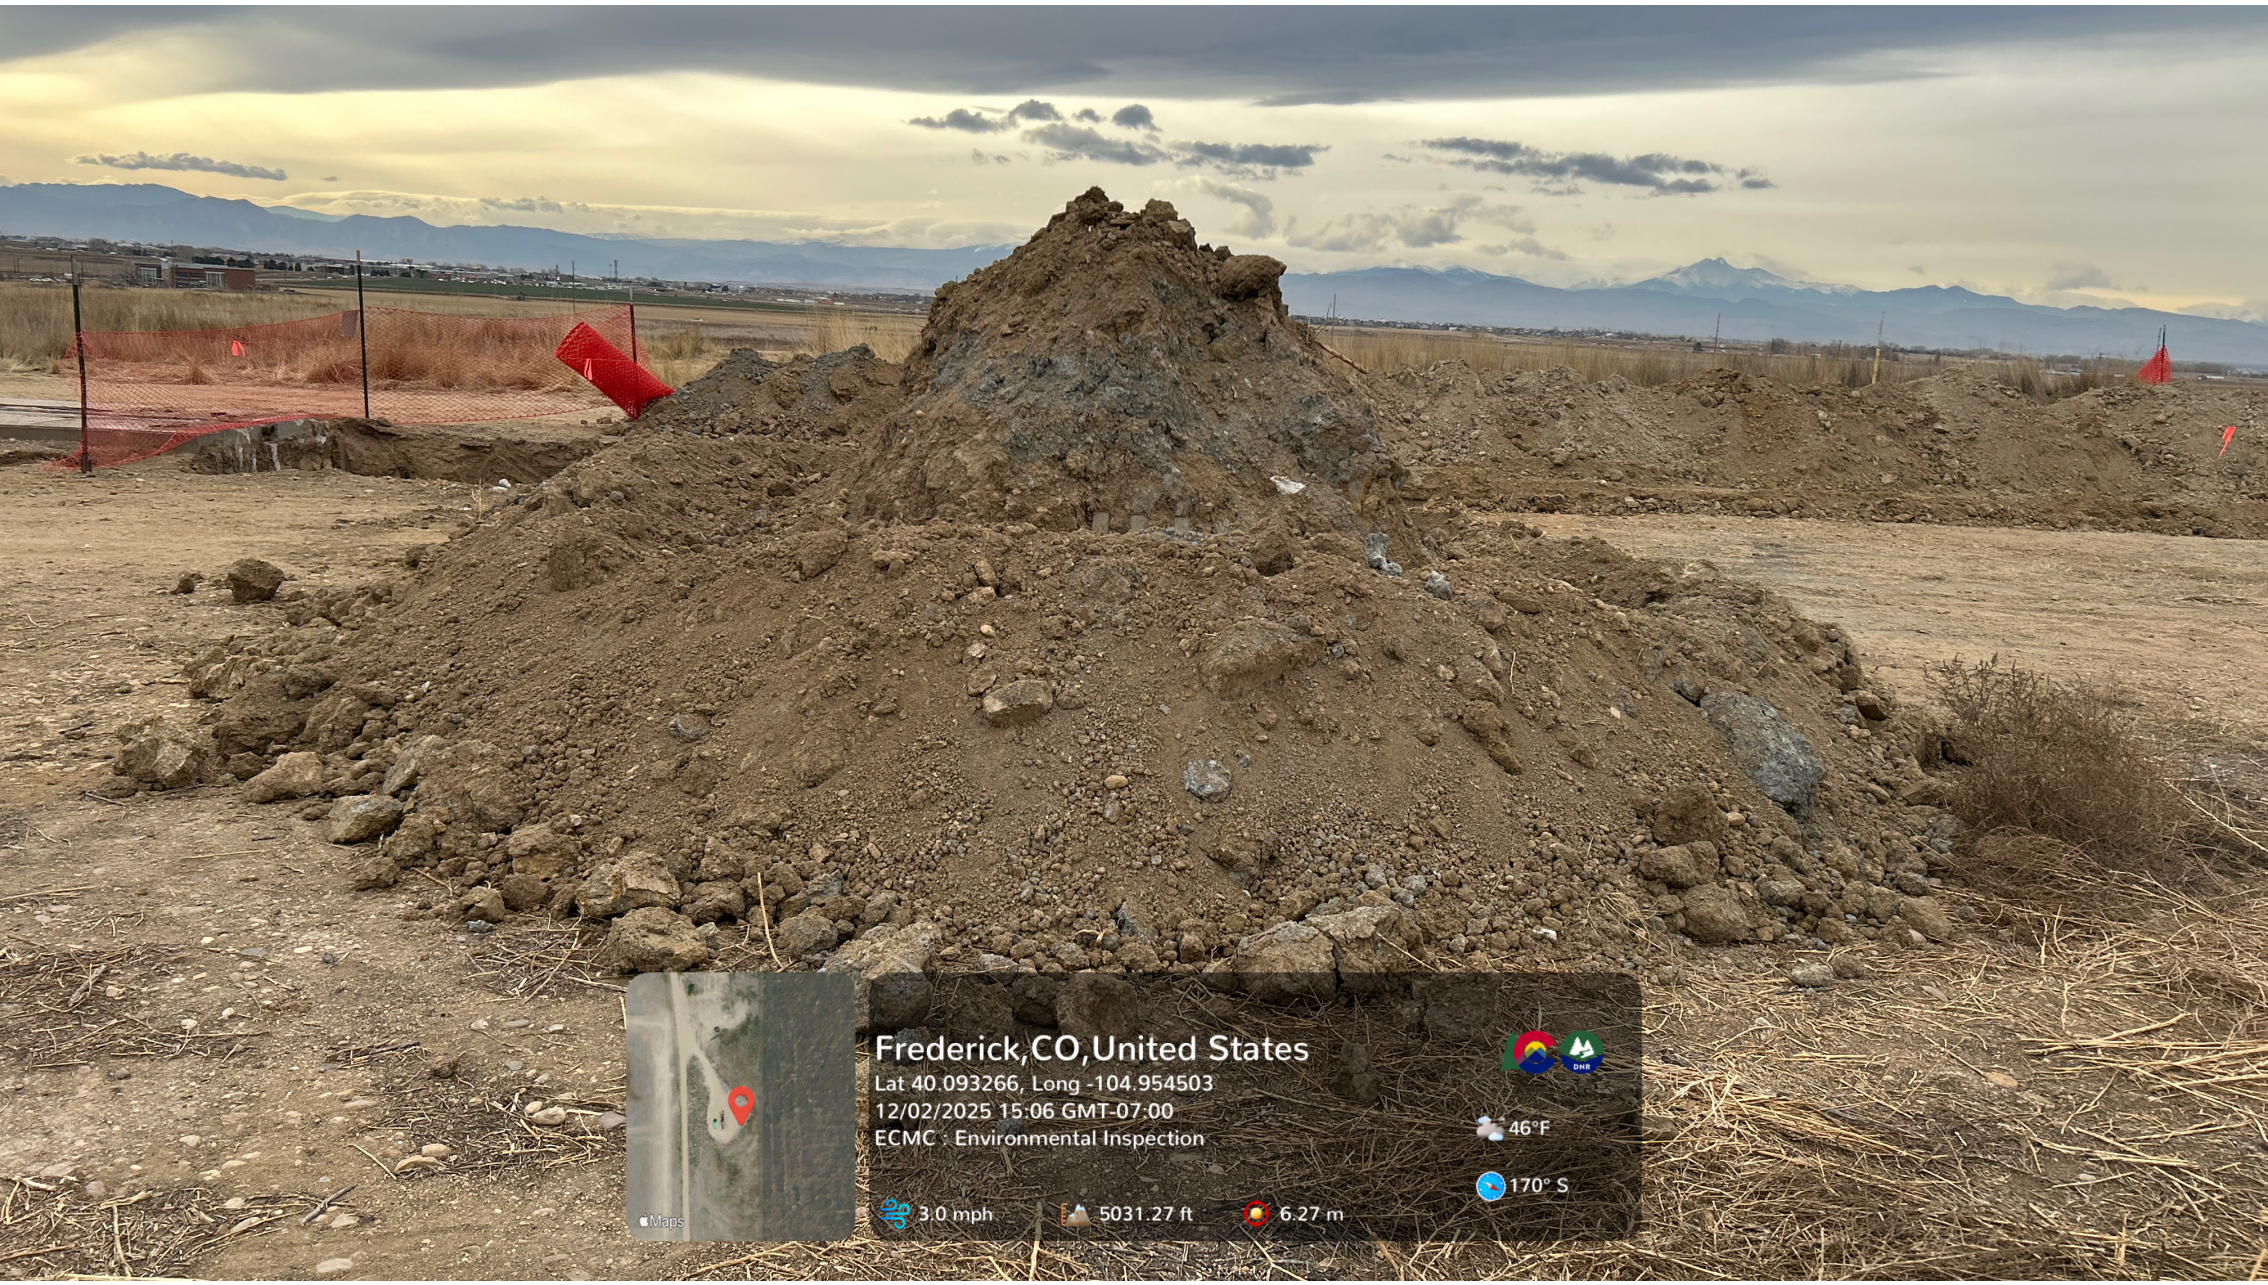
Looking at the soil stockpile adjacent to the State #3 well excavation. Gray staining is visible; a petroleum hydrocarbon odor was observed. No liner is visible. Stormwater BMPs are inadequate.
