Looking south along the Flowline Facility ID 478291 from the State #6 well. Orange construction fencing has been installed along an area of the trench adjacent to the well, but does not continue. A rope with orange ribbons has been installed on both sides of the remaining length of the trench.

ECMC : Environmental Inspection

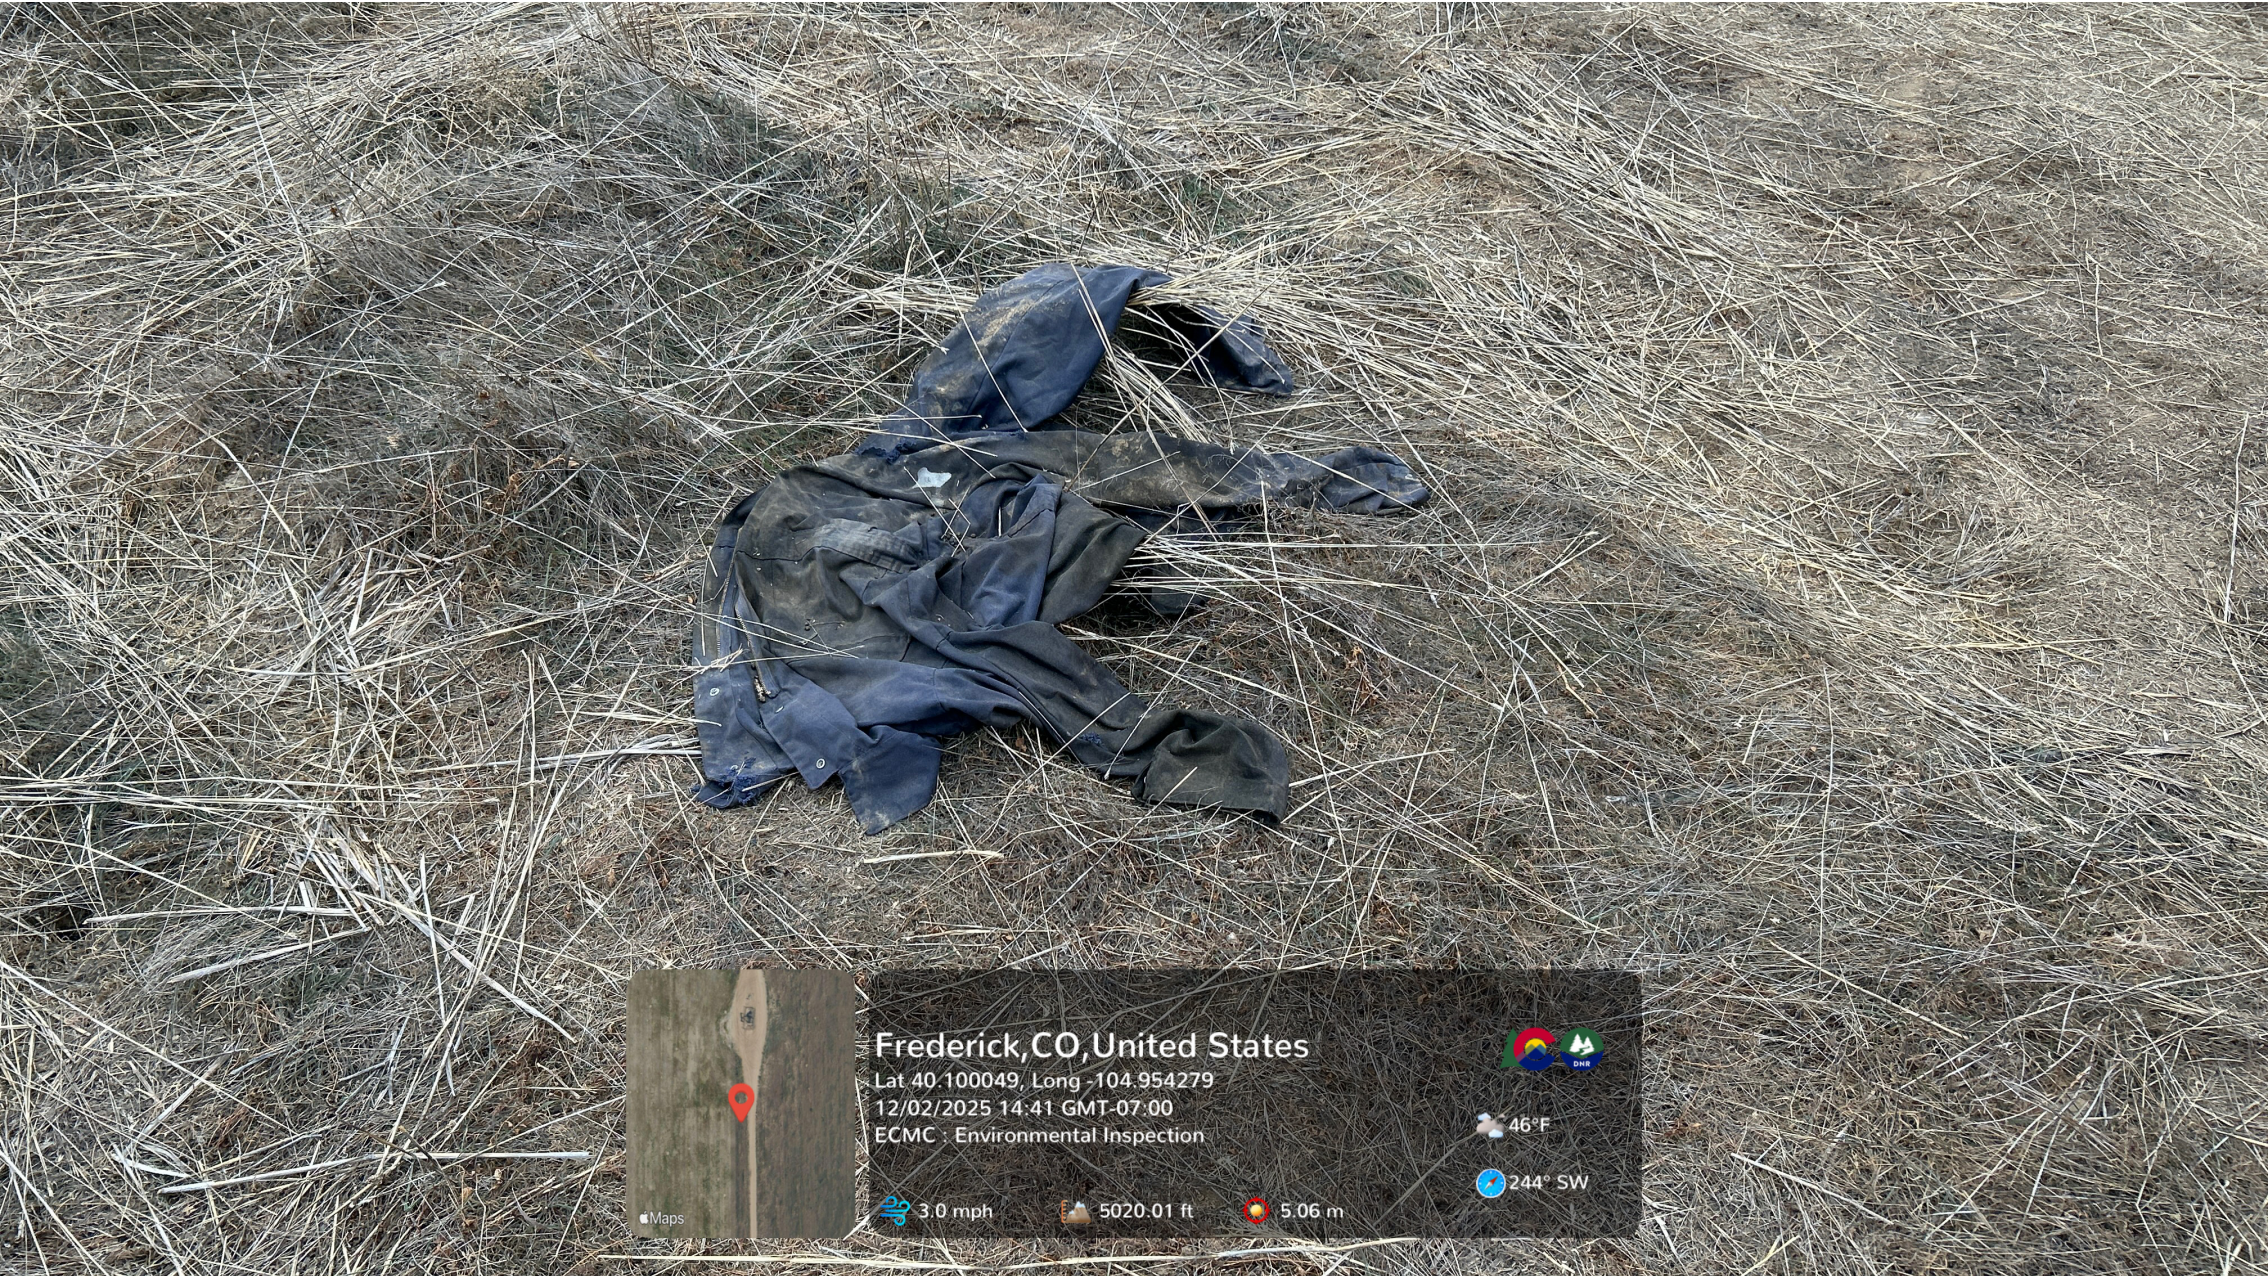
Trash is visible adjacent to the trench.

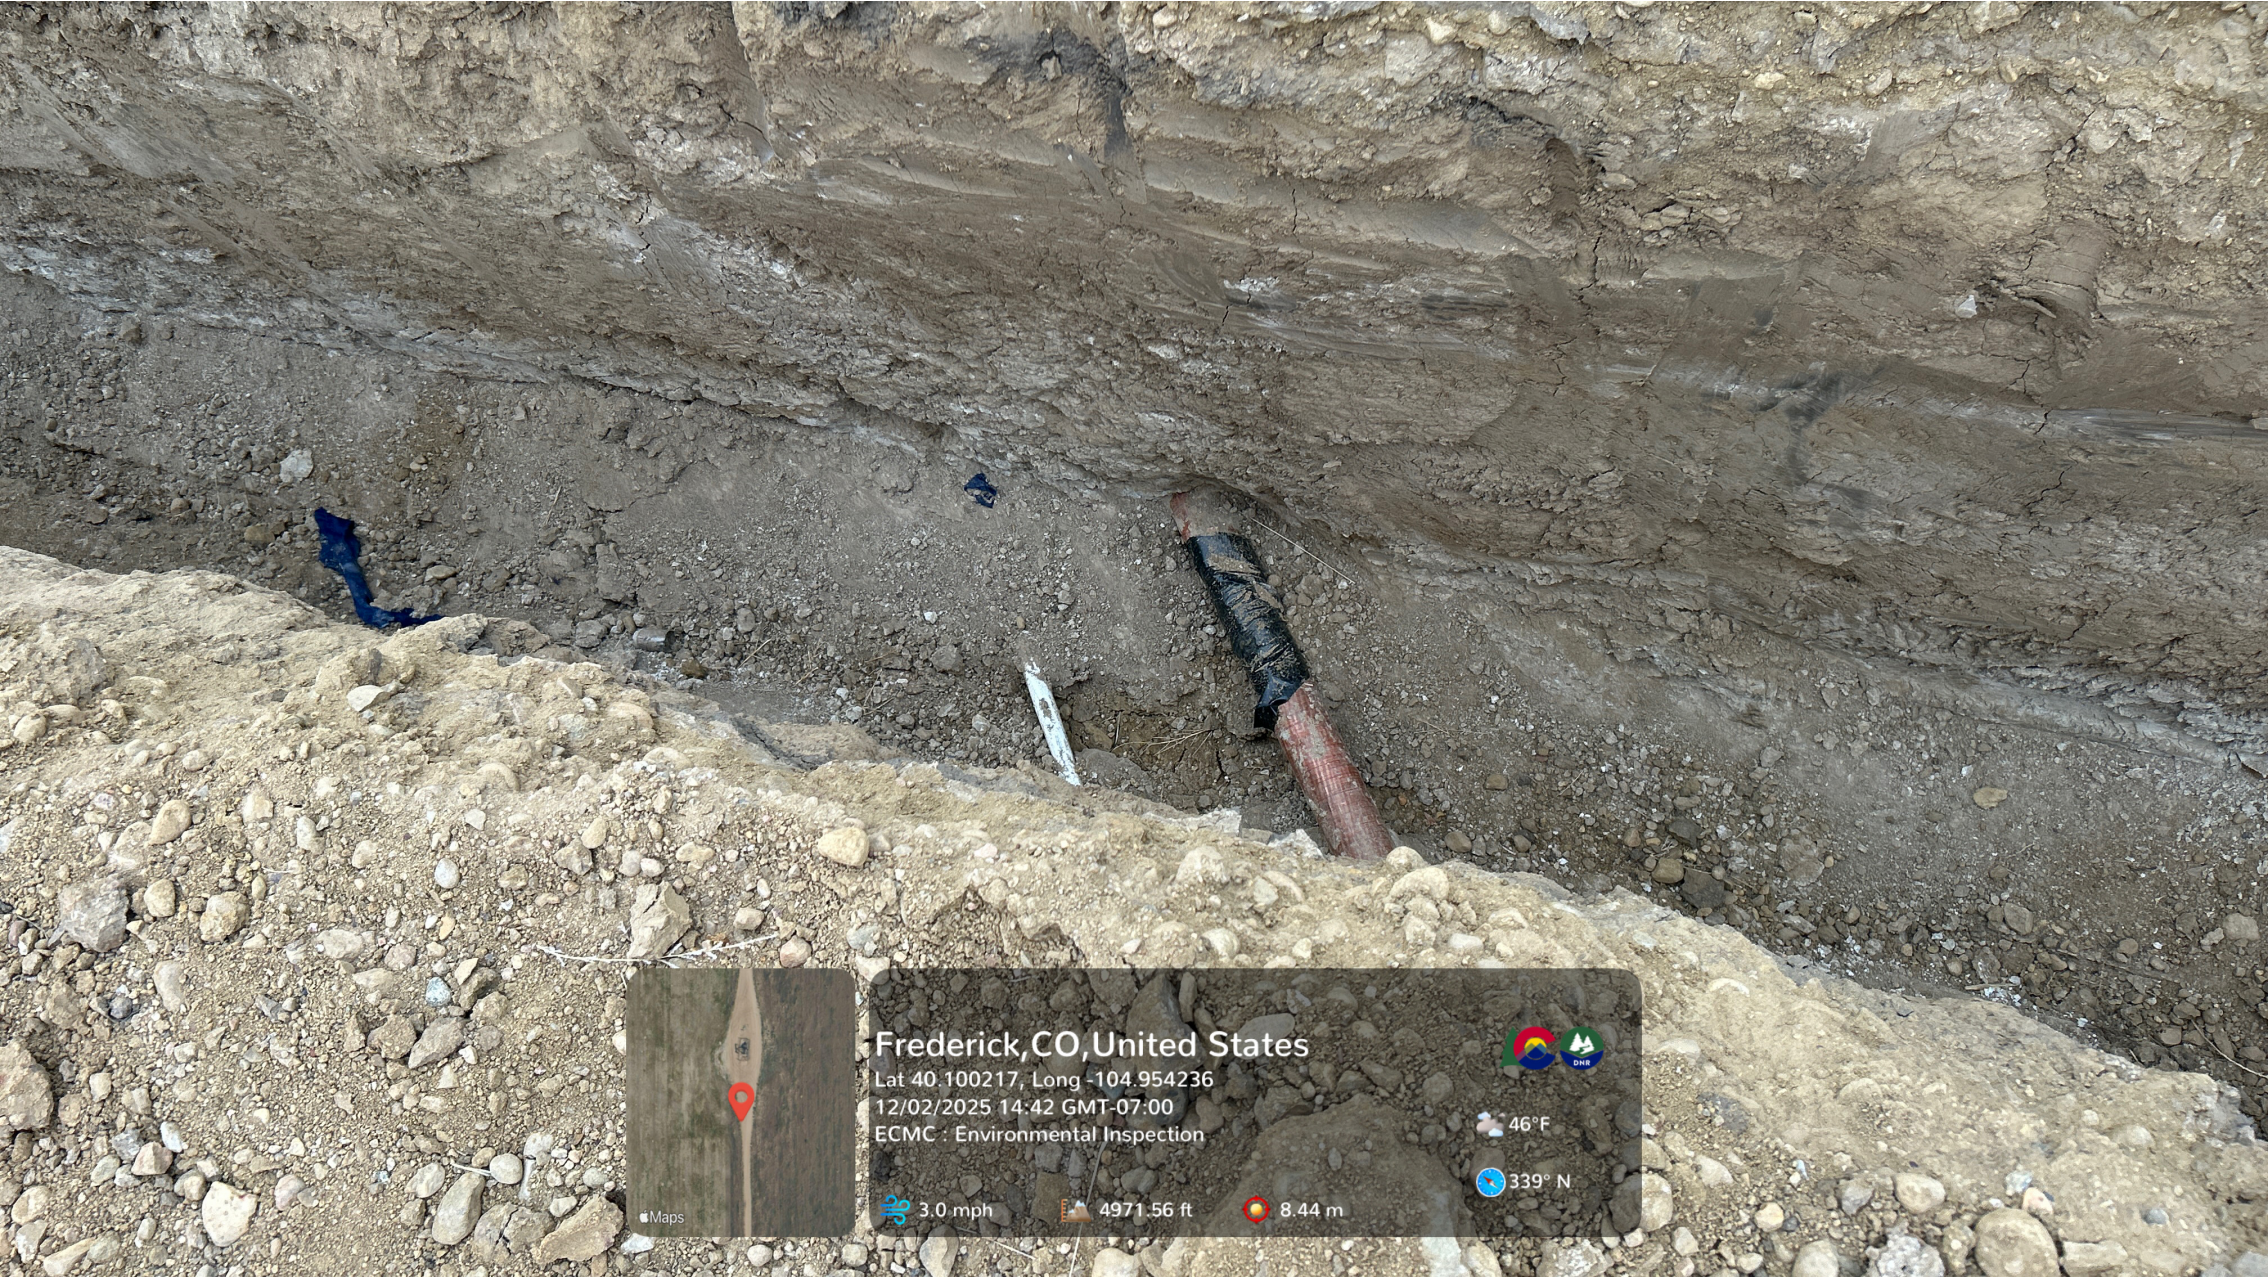
Segments of red fiberglass and white plastic lines oriented approximately east-northeast to west-southwest is visible within the trench. The red fiberglass line appears to have been repaired with black tape.

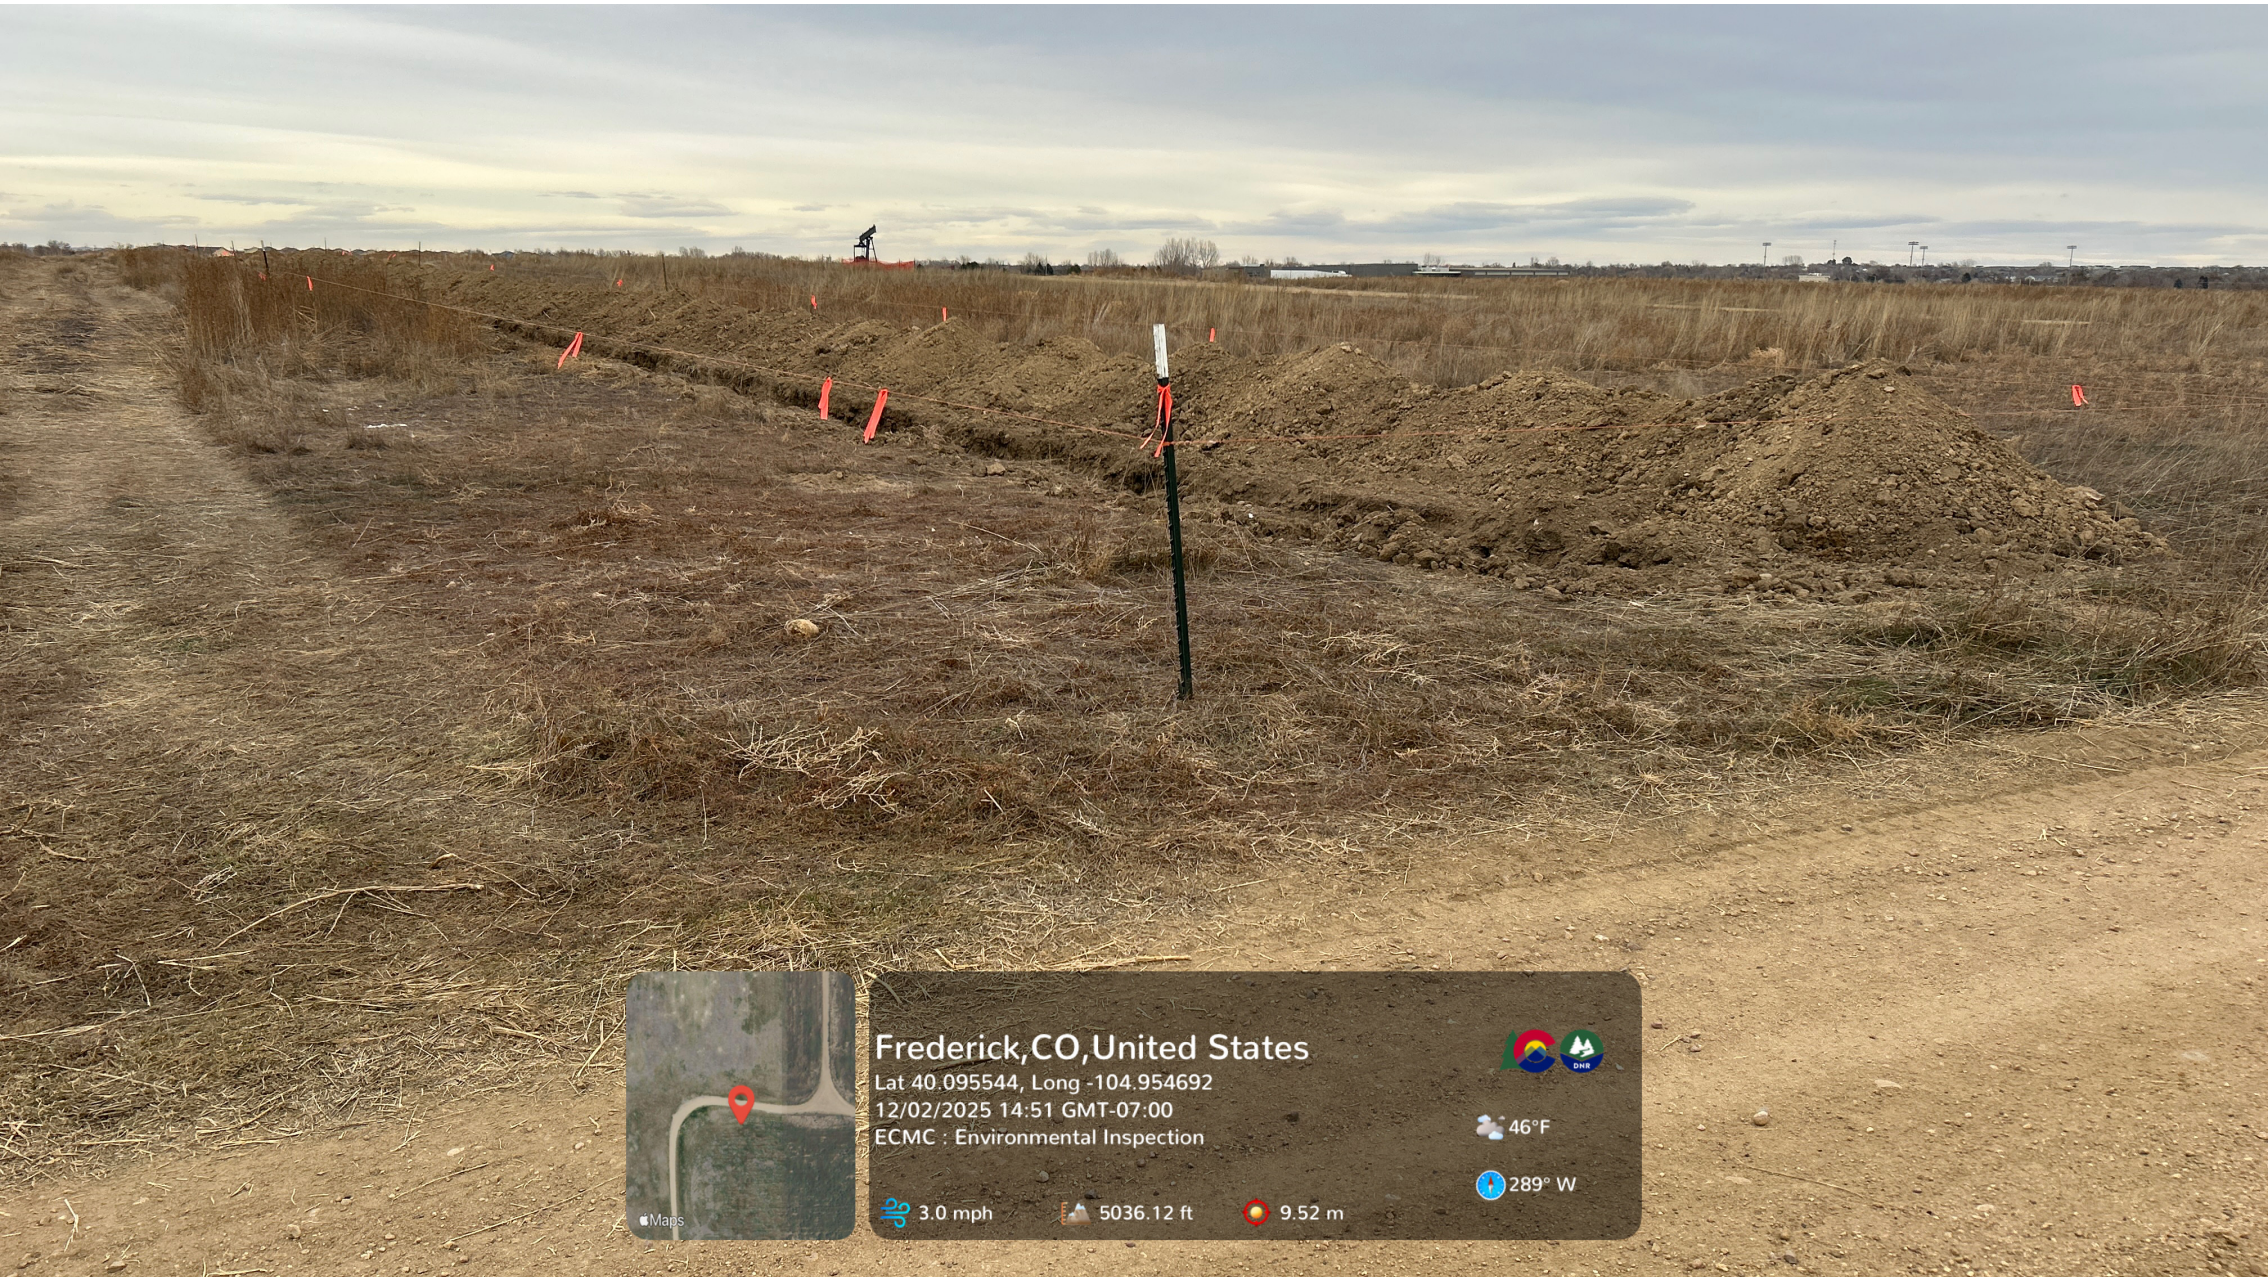
Looking at the trench, which does not extend through an access road.

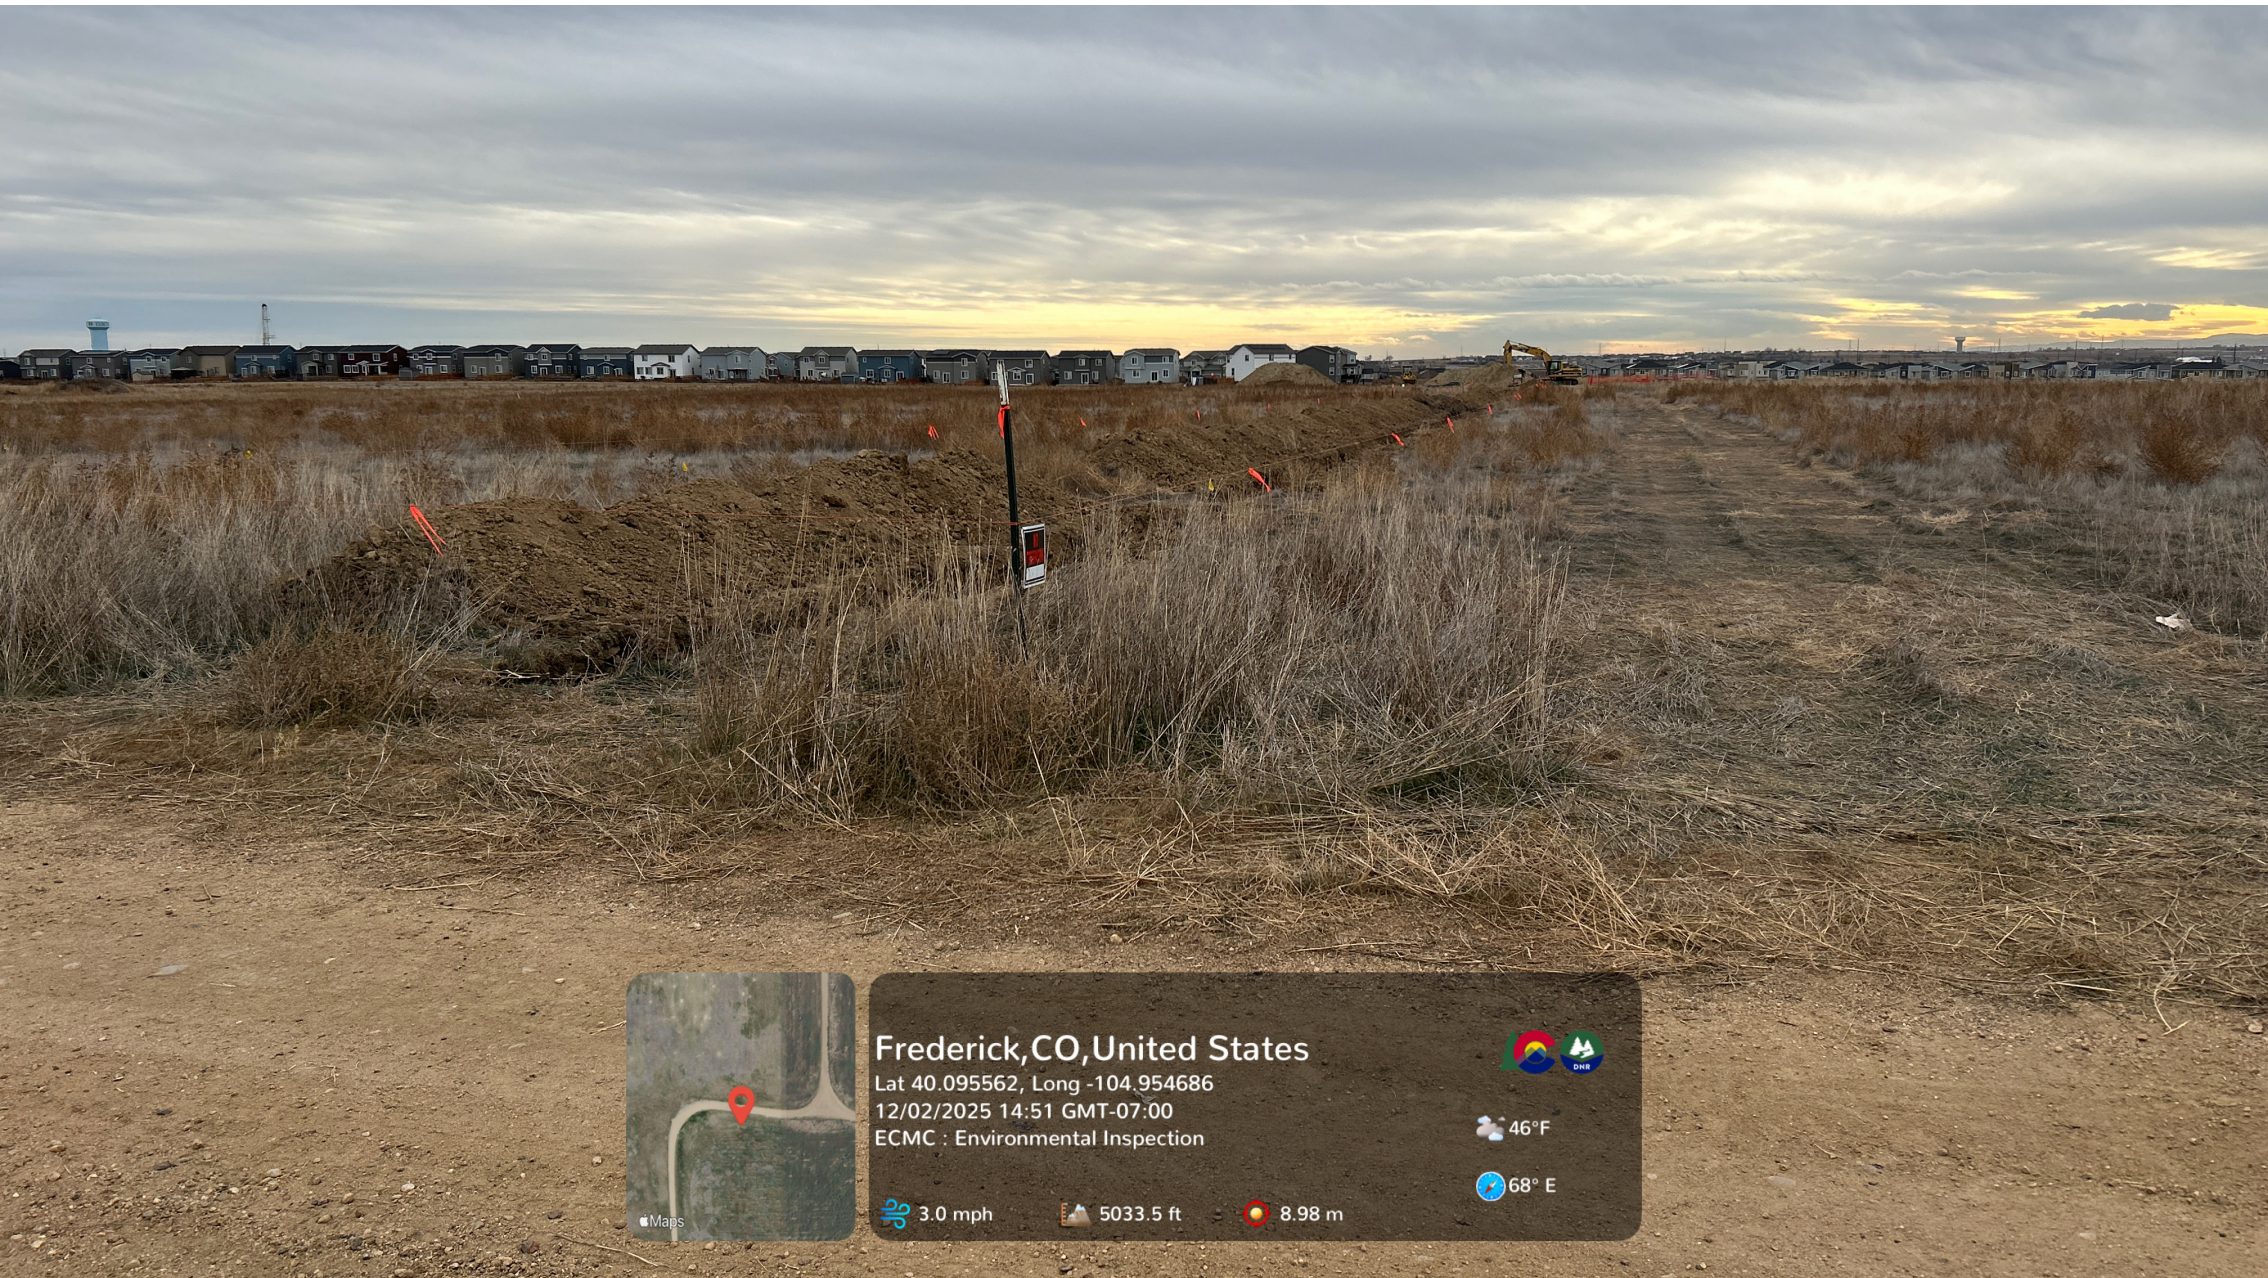
Looking at the trench, which continues on the other side of an access road.

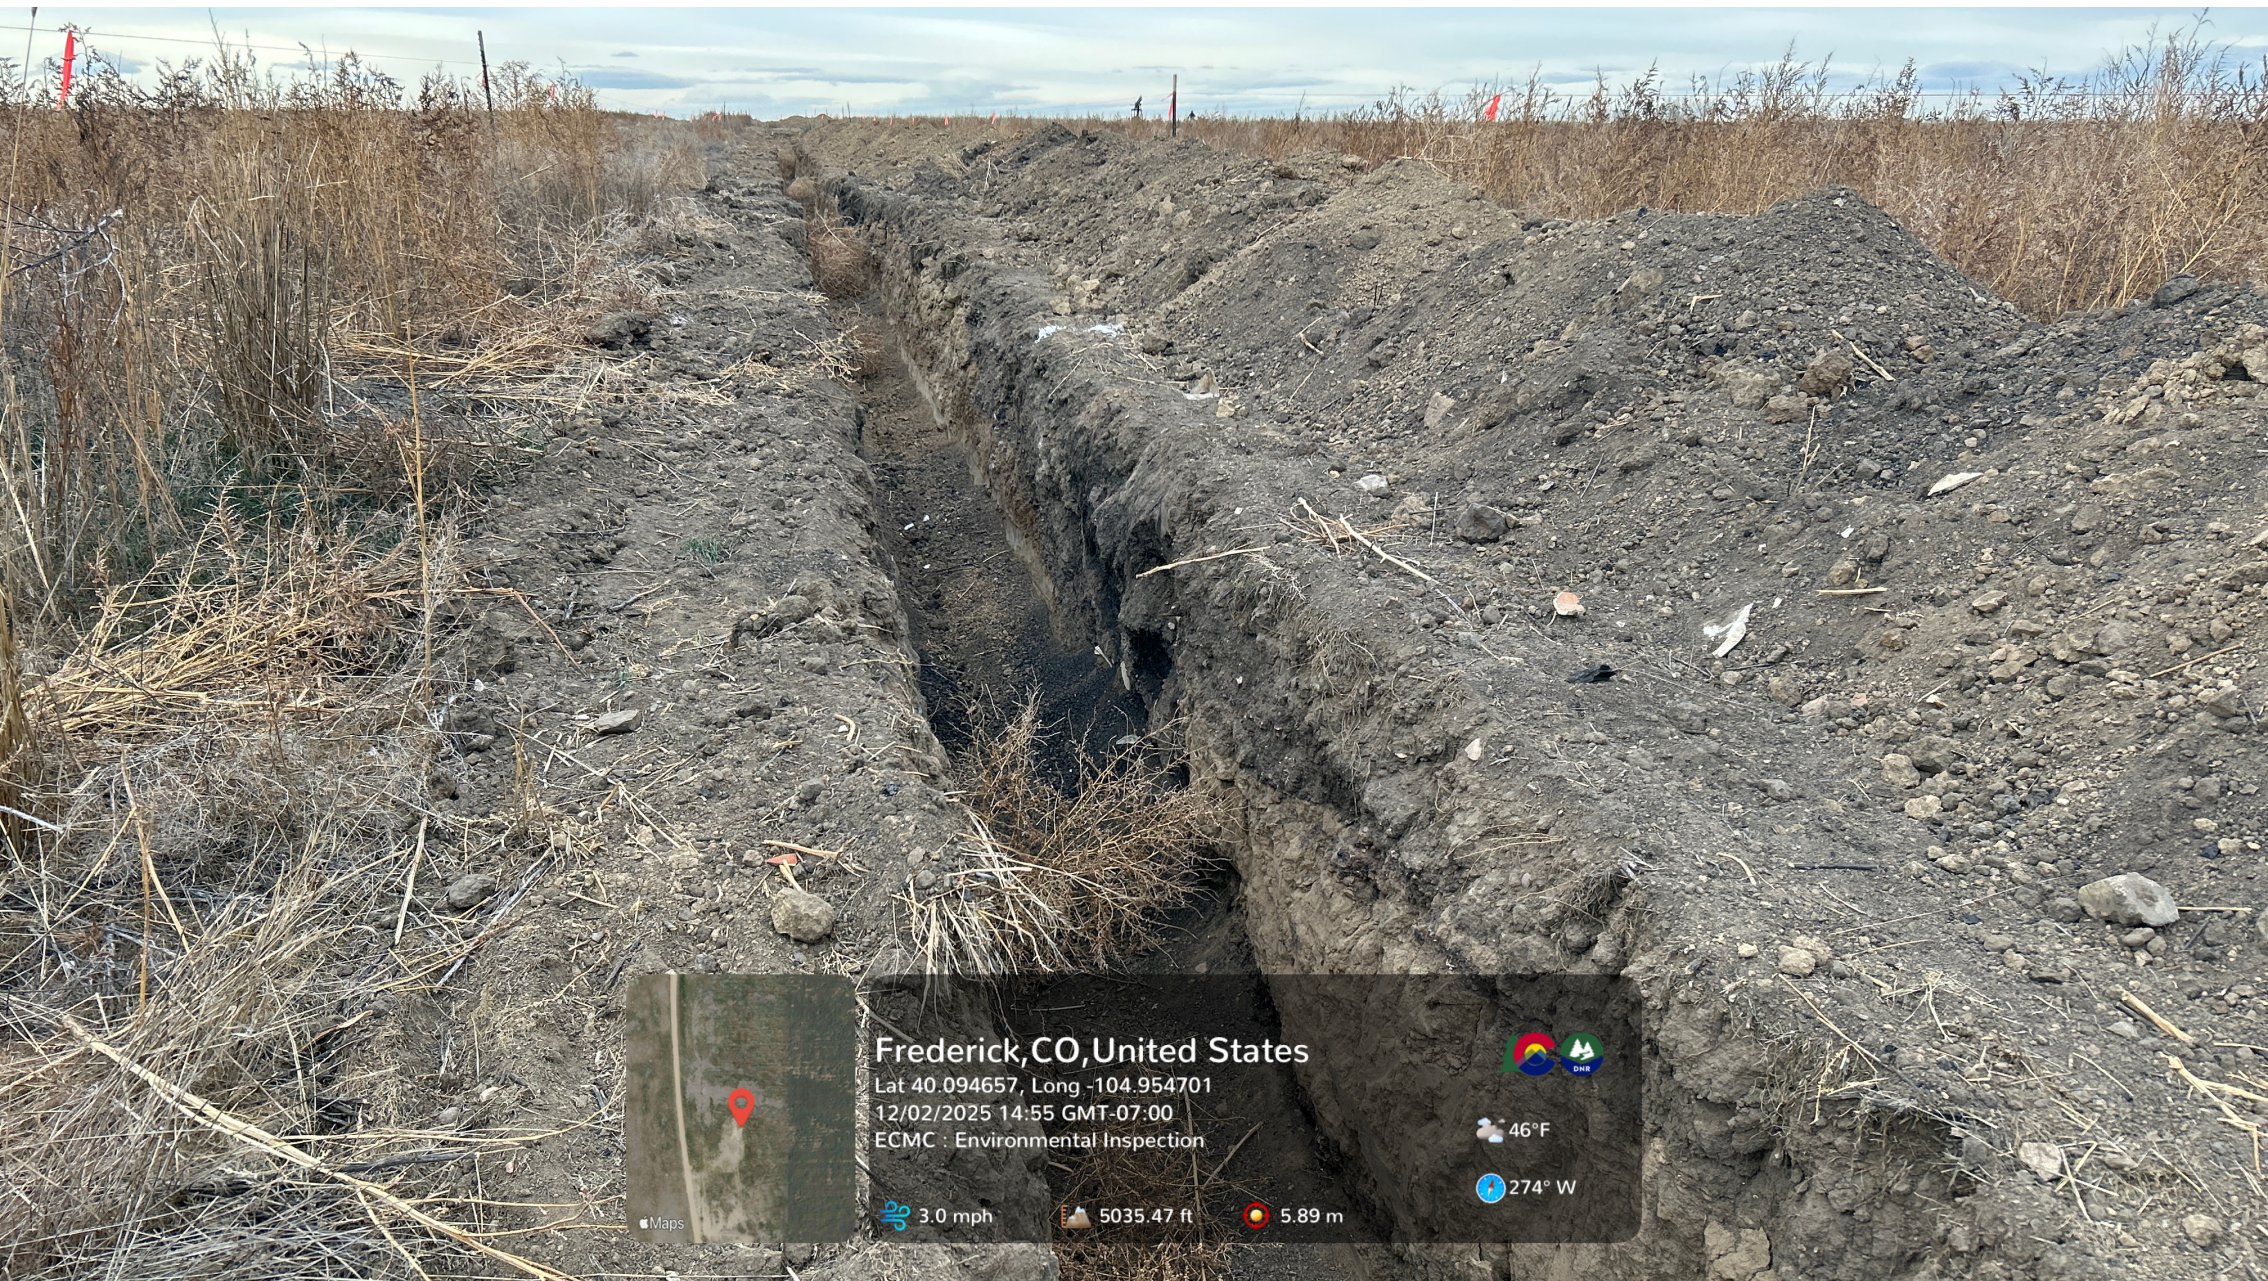
Areas of black soil are visible.

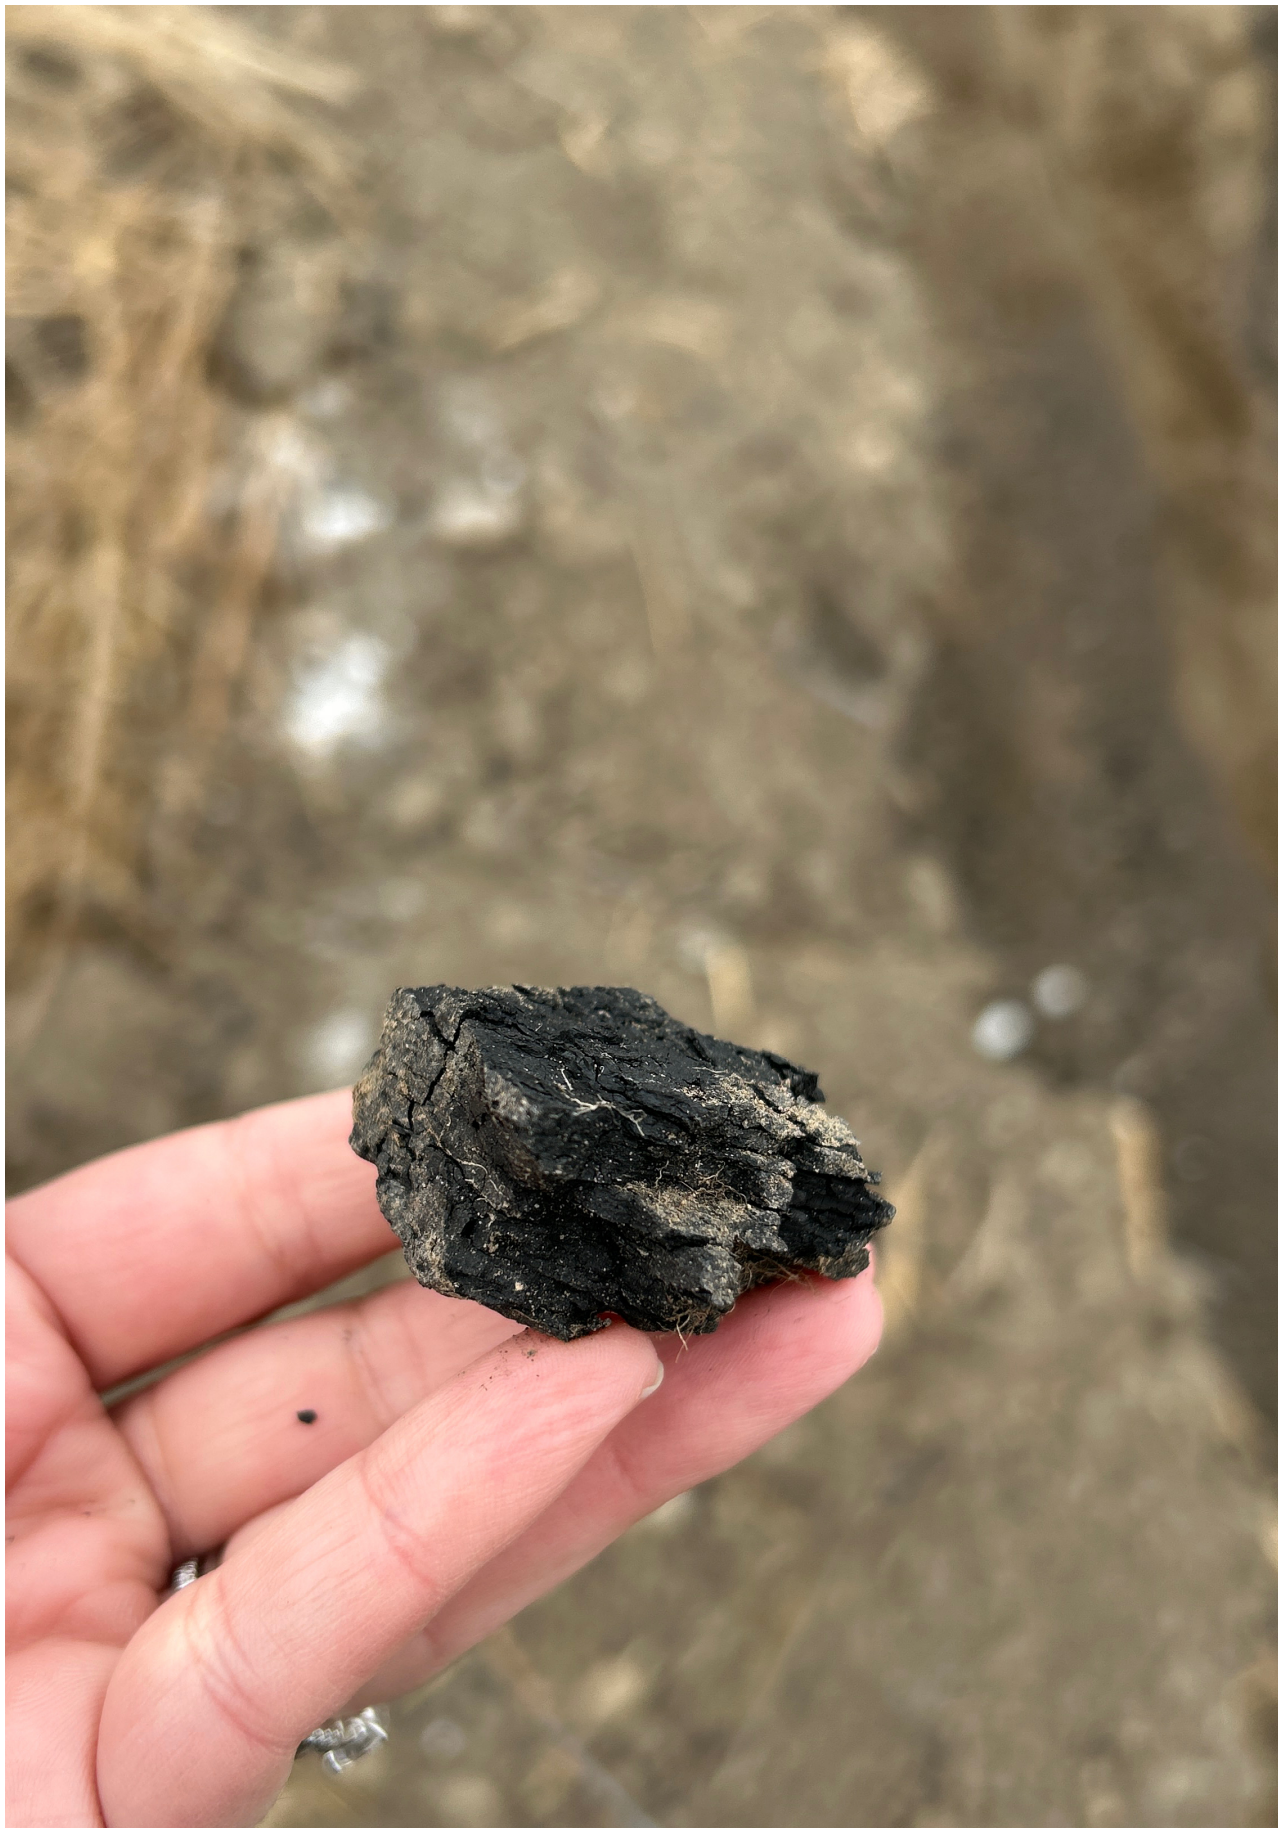
Looking at a piece of black soil. The material was friable; no odor was observed. Further characterization is necessary.

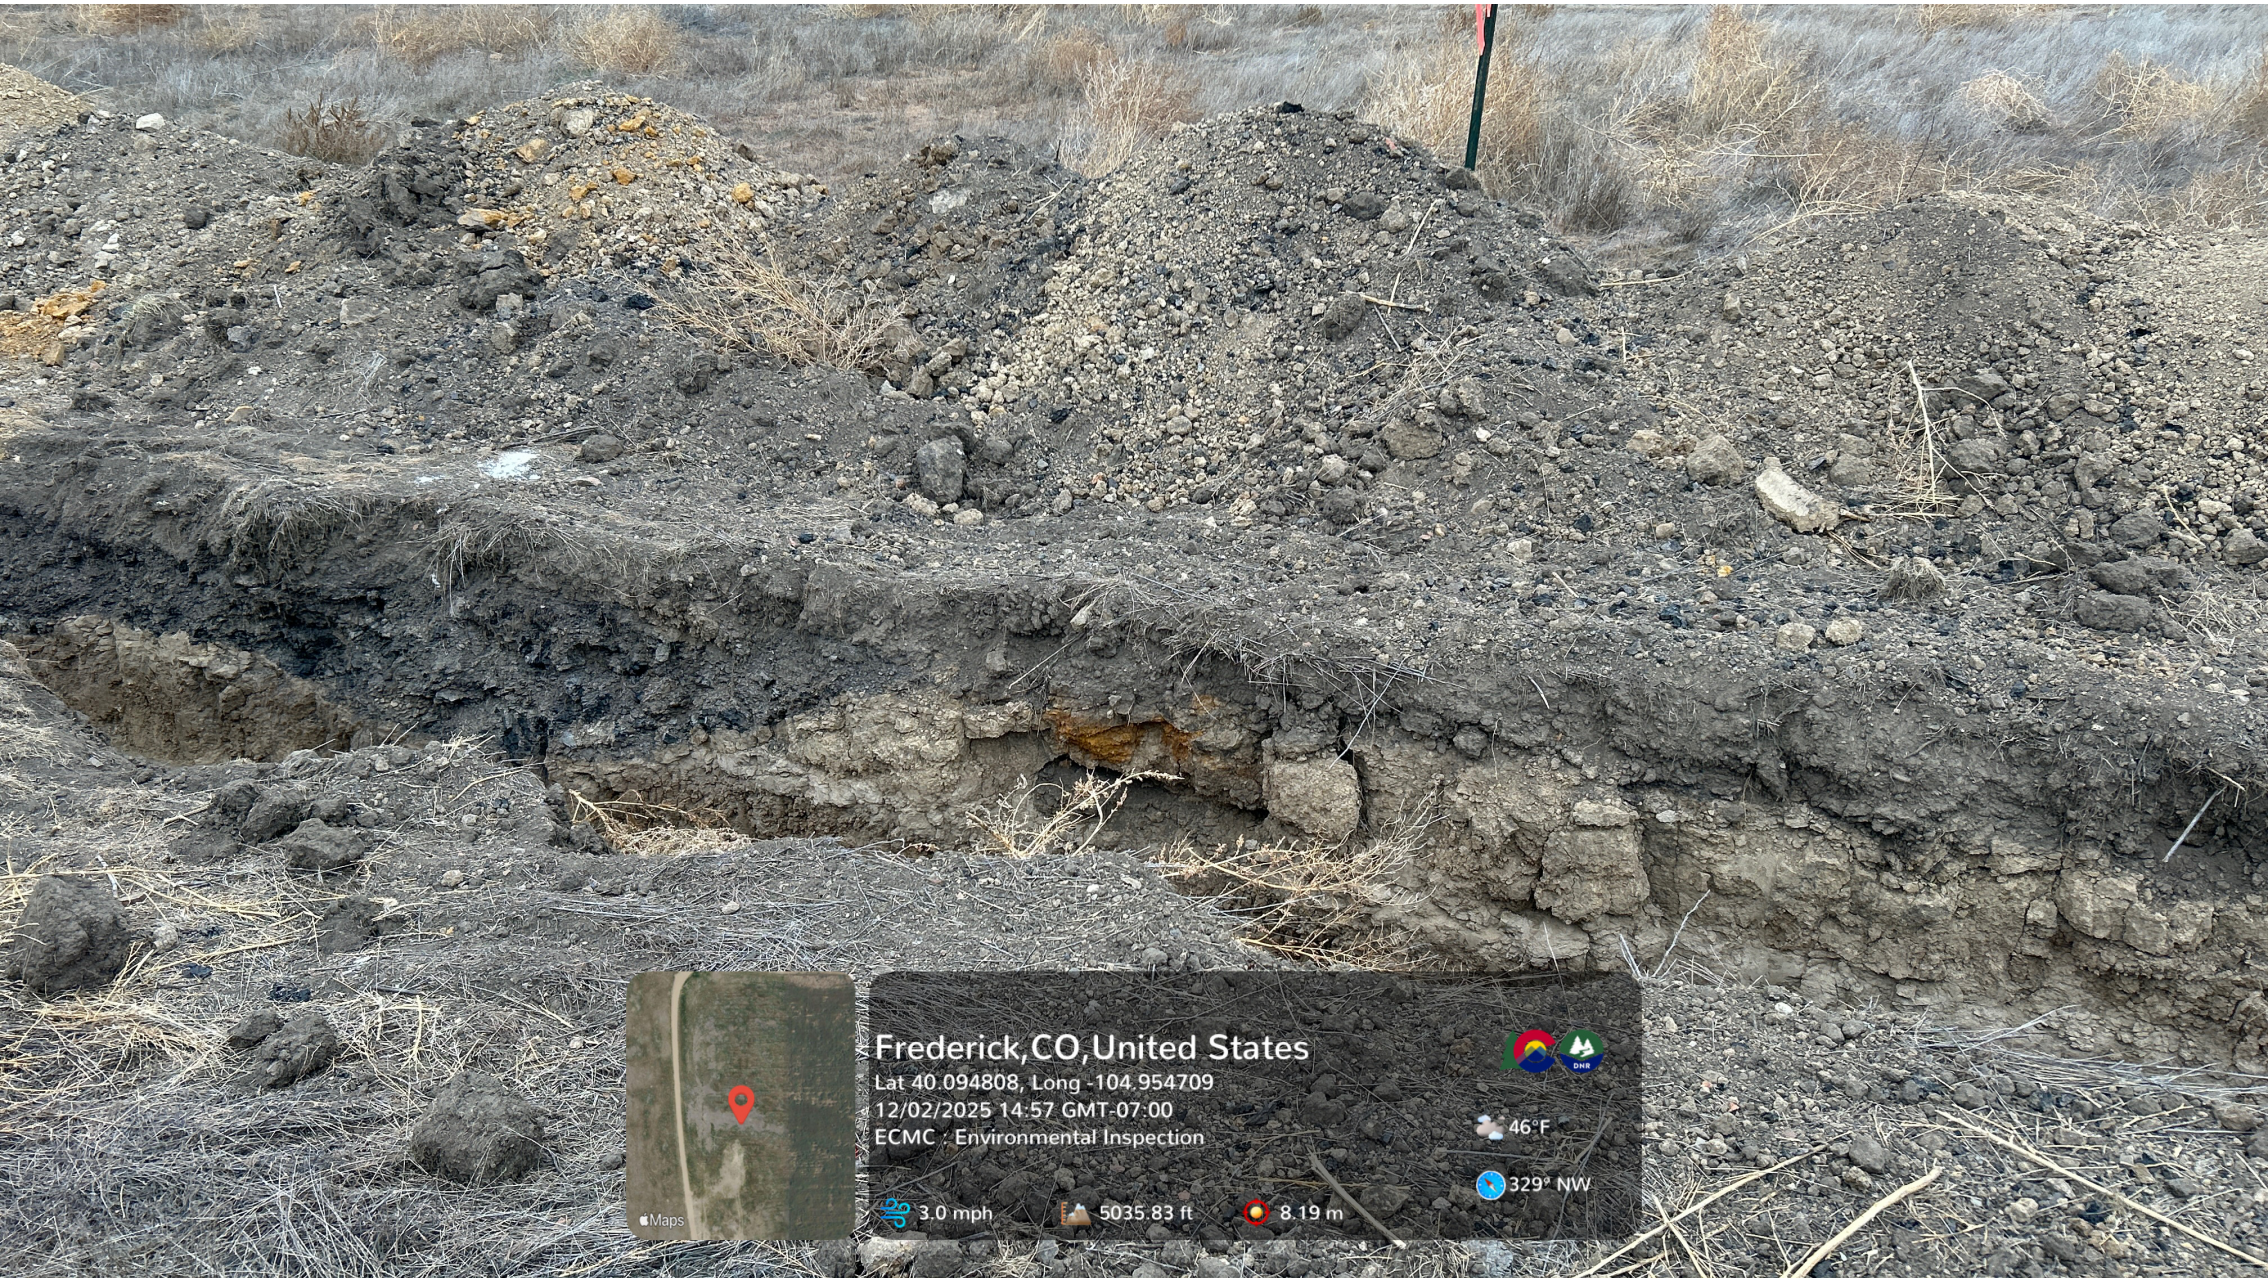
Looking at the soil profile in the areas with black soil.

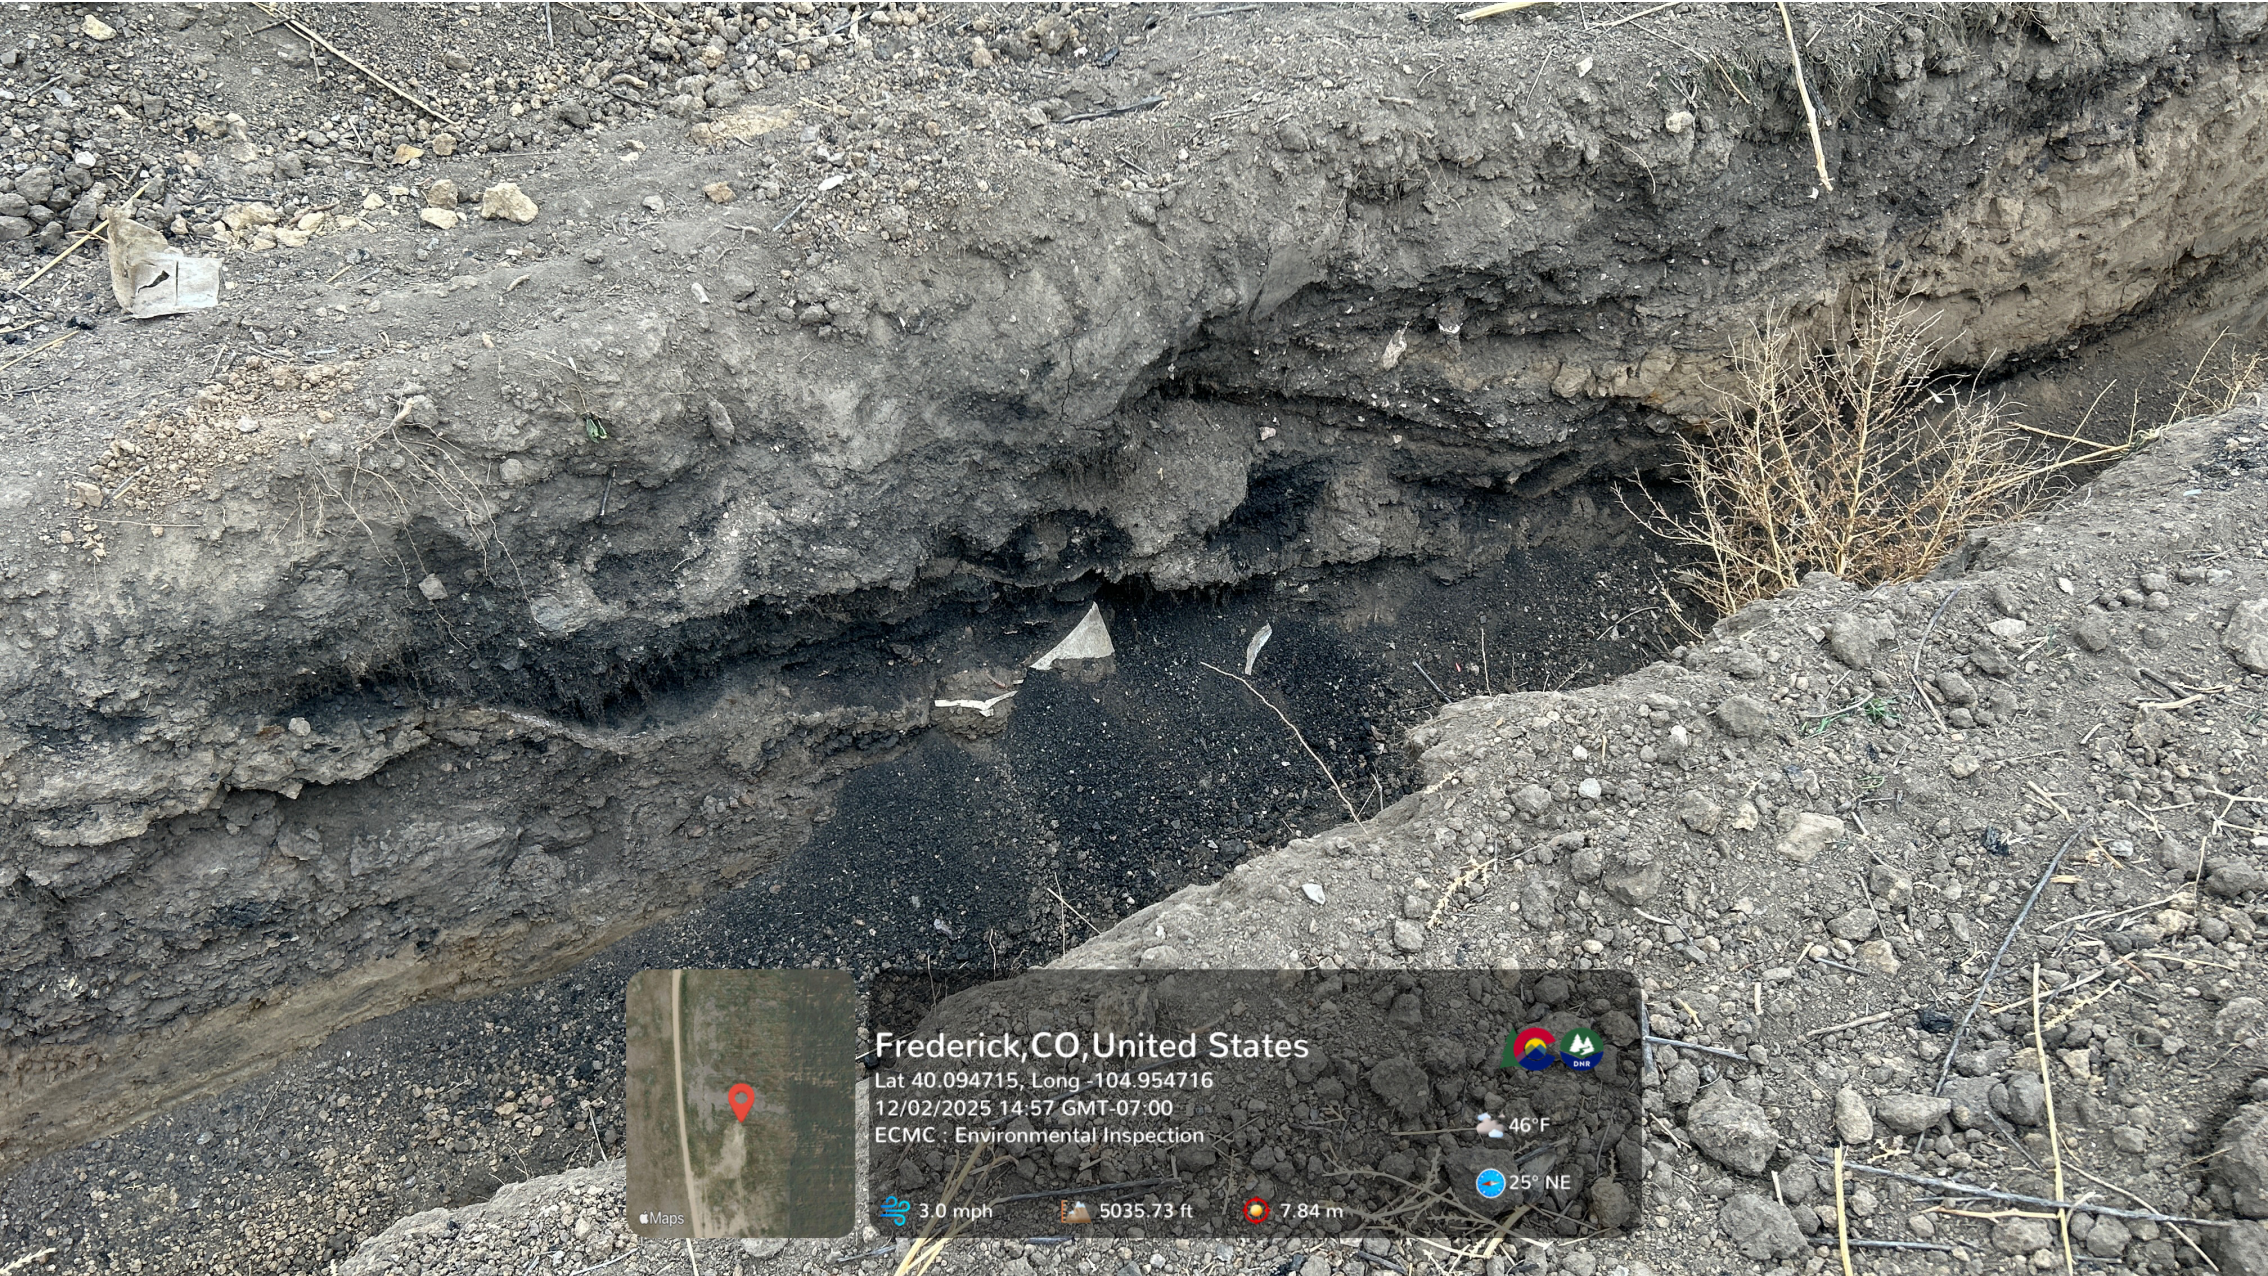
Looking at the soil profile in the areas with black soil.
