Looking south along the Flowline Facility ID 478291 from the State #6 well. Orange construction fencing has been installed along an area of the trench adjacent to the well, but does not continue. A rope with orange ribbons has been installed on both sides of the remaining length of the trench.

ECMC : Environmental Inspection

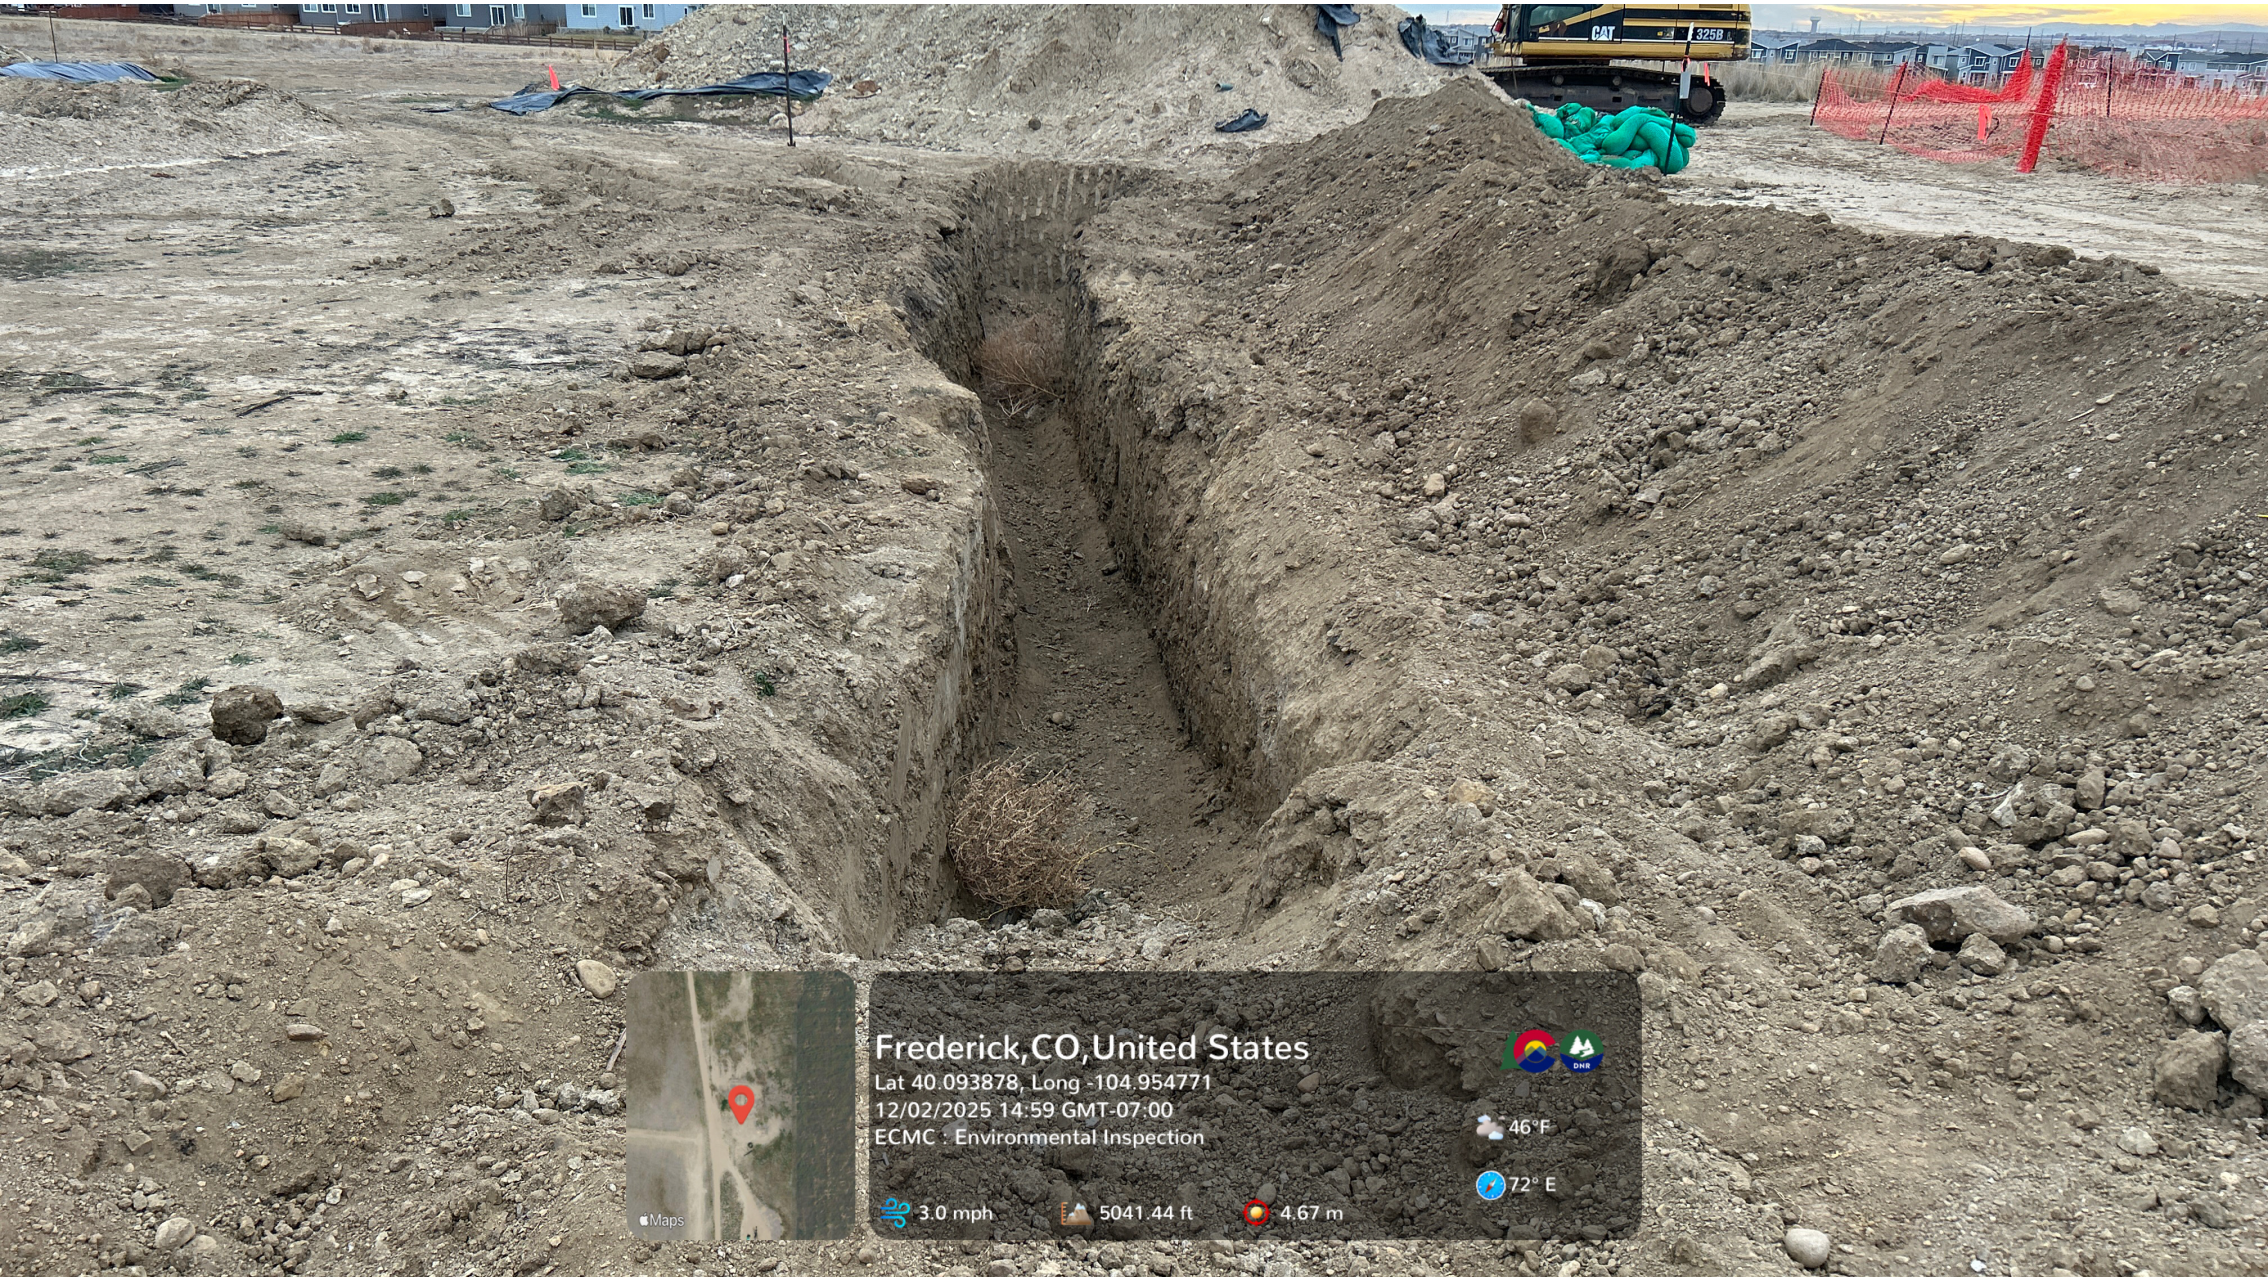
Looking near the southern terminus of the flowline. Equipment, soil stockpiles, and an excavation which appear to be associated with Spill/Release Point ID 490840 are visible and will be addressed in a separate Field Inspection Report.
