Looking at the spill response area. Above ground flowline manifolds and a sign which reads "Amoco Production Company" are visible in the foreground. Two stockpiles, an excavator, and an excavation with orange construction fencing are visible in the midground. Residential building units are visible in the background.

Frederick, CO, United States
Lat 40.093834, Long -104.954639
12/02/2025 14:59 GMT-07:00
ECMC : Environmental Inspection

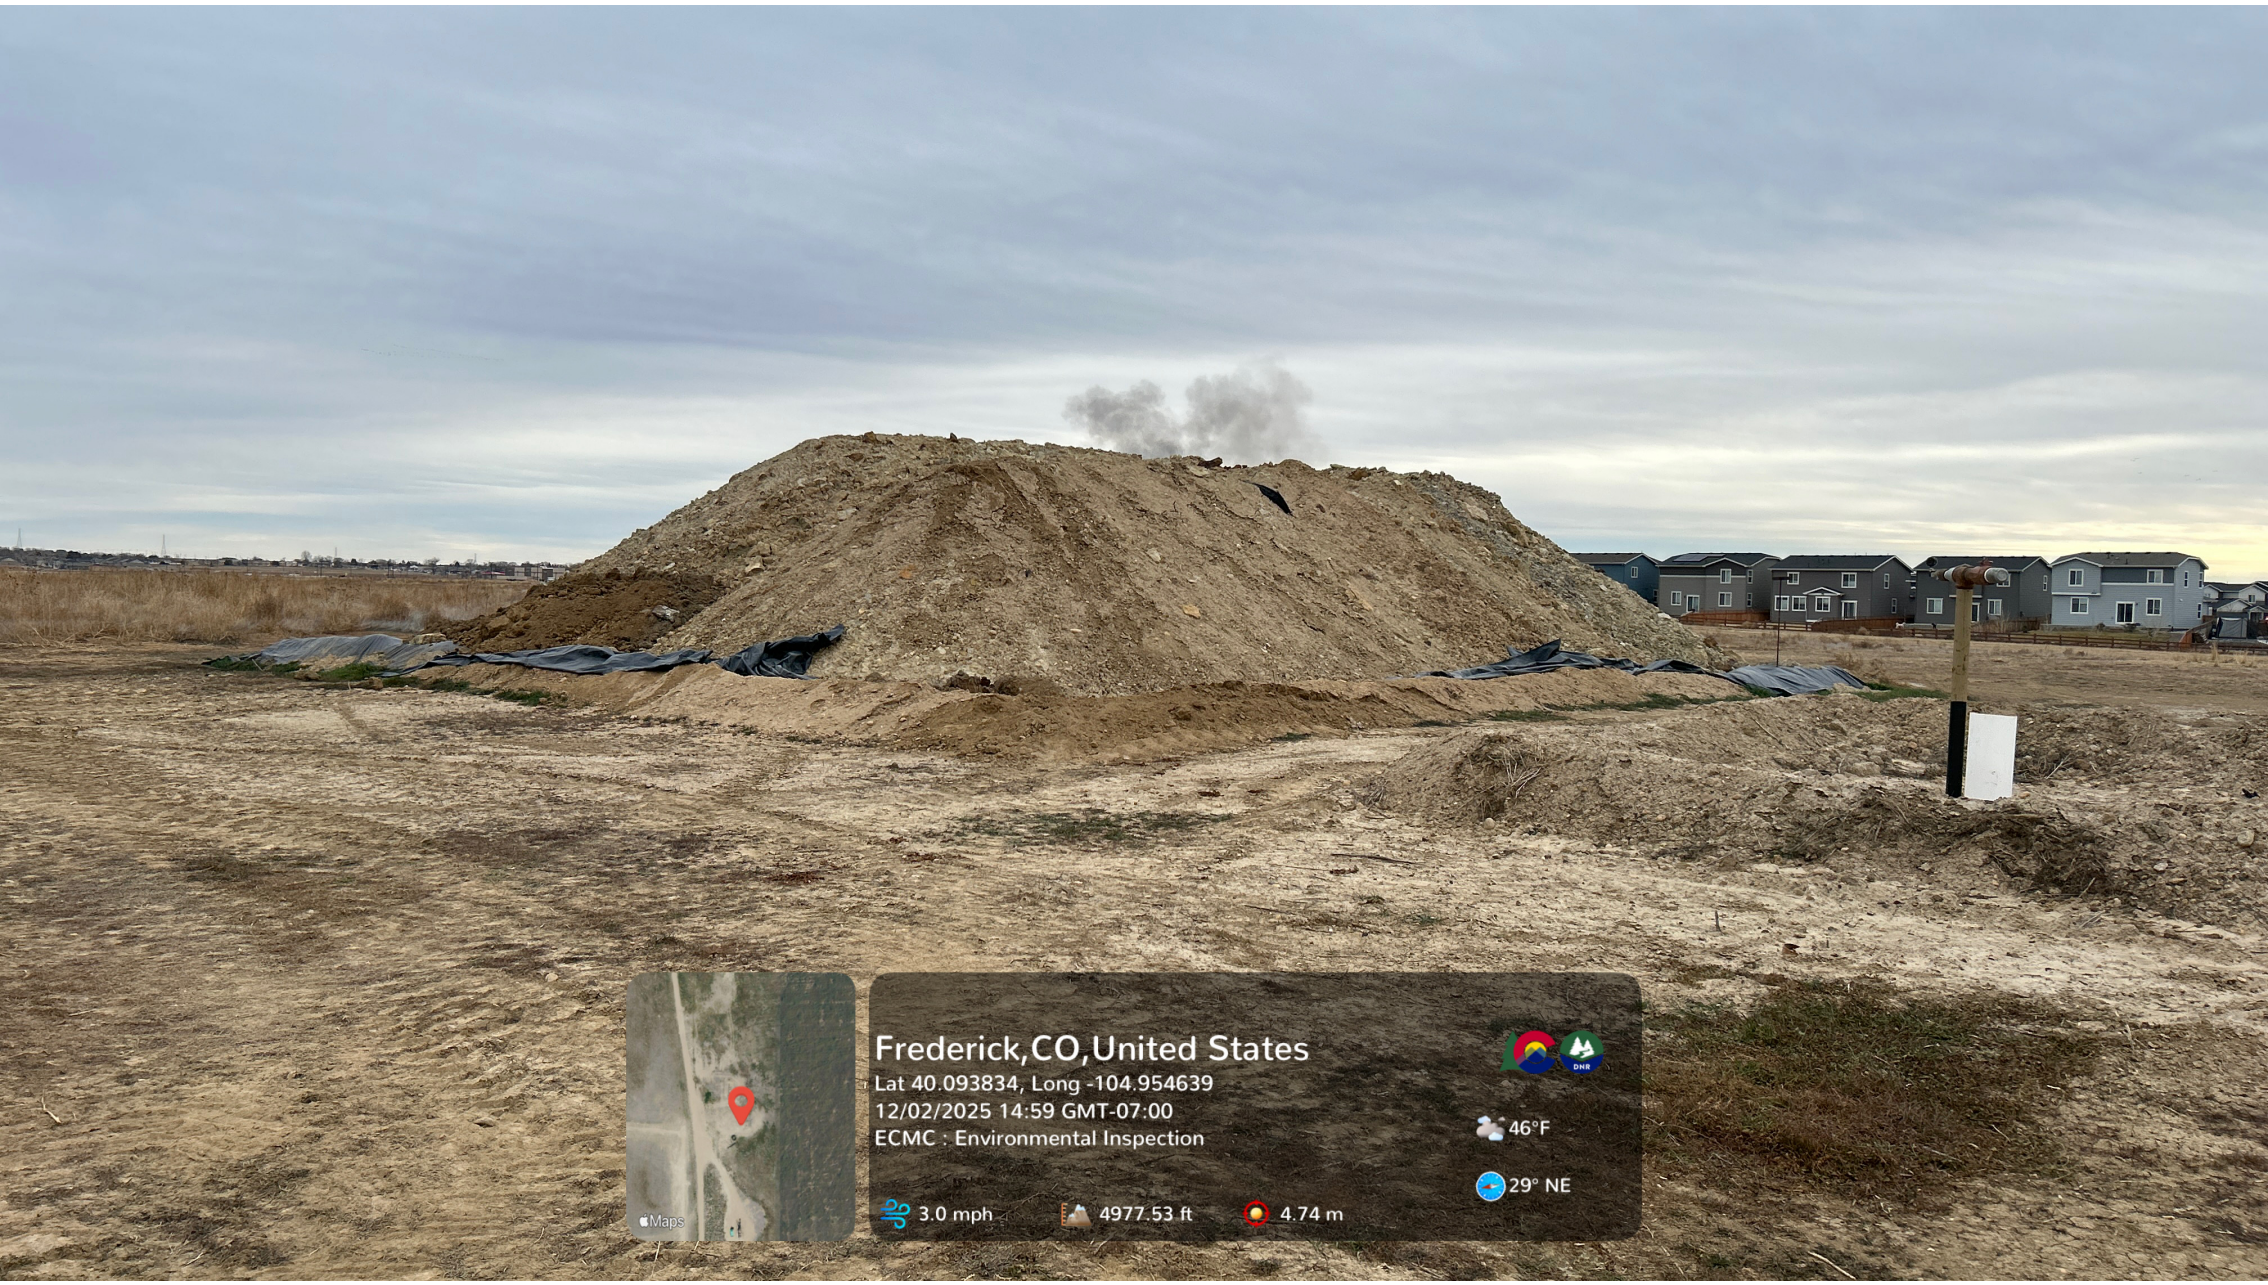
Looking at the east stockpile. A liner is visible; however, the liner is torn, discontinuous, and overtopped by soil.

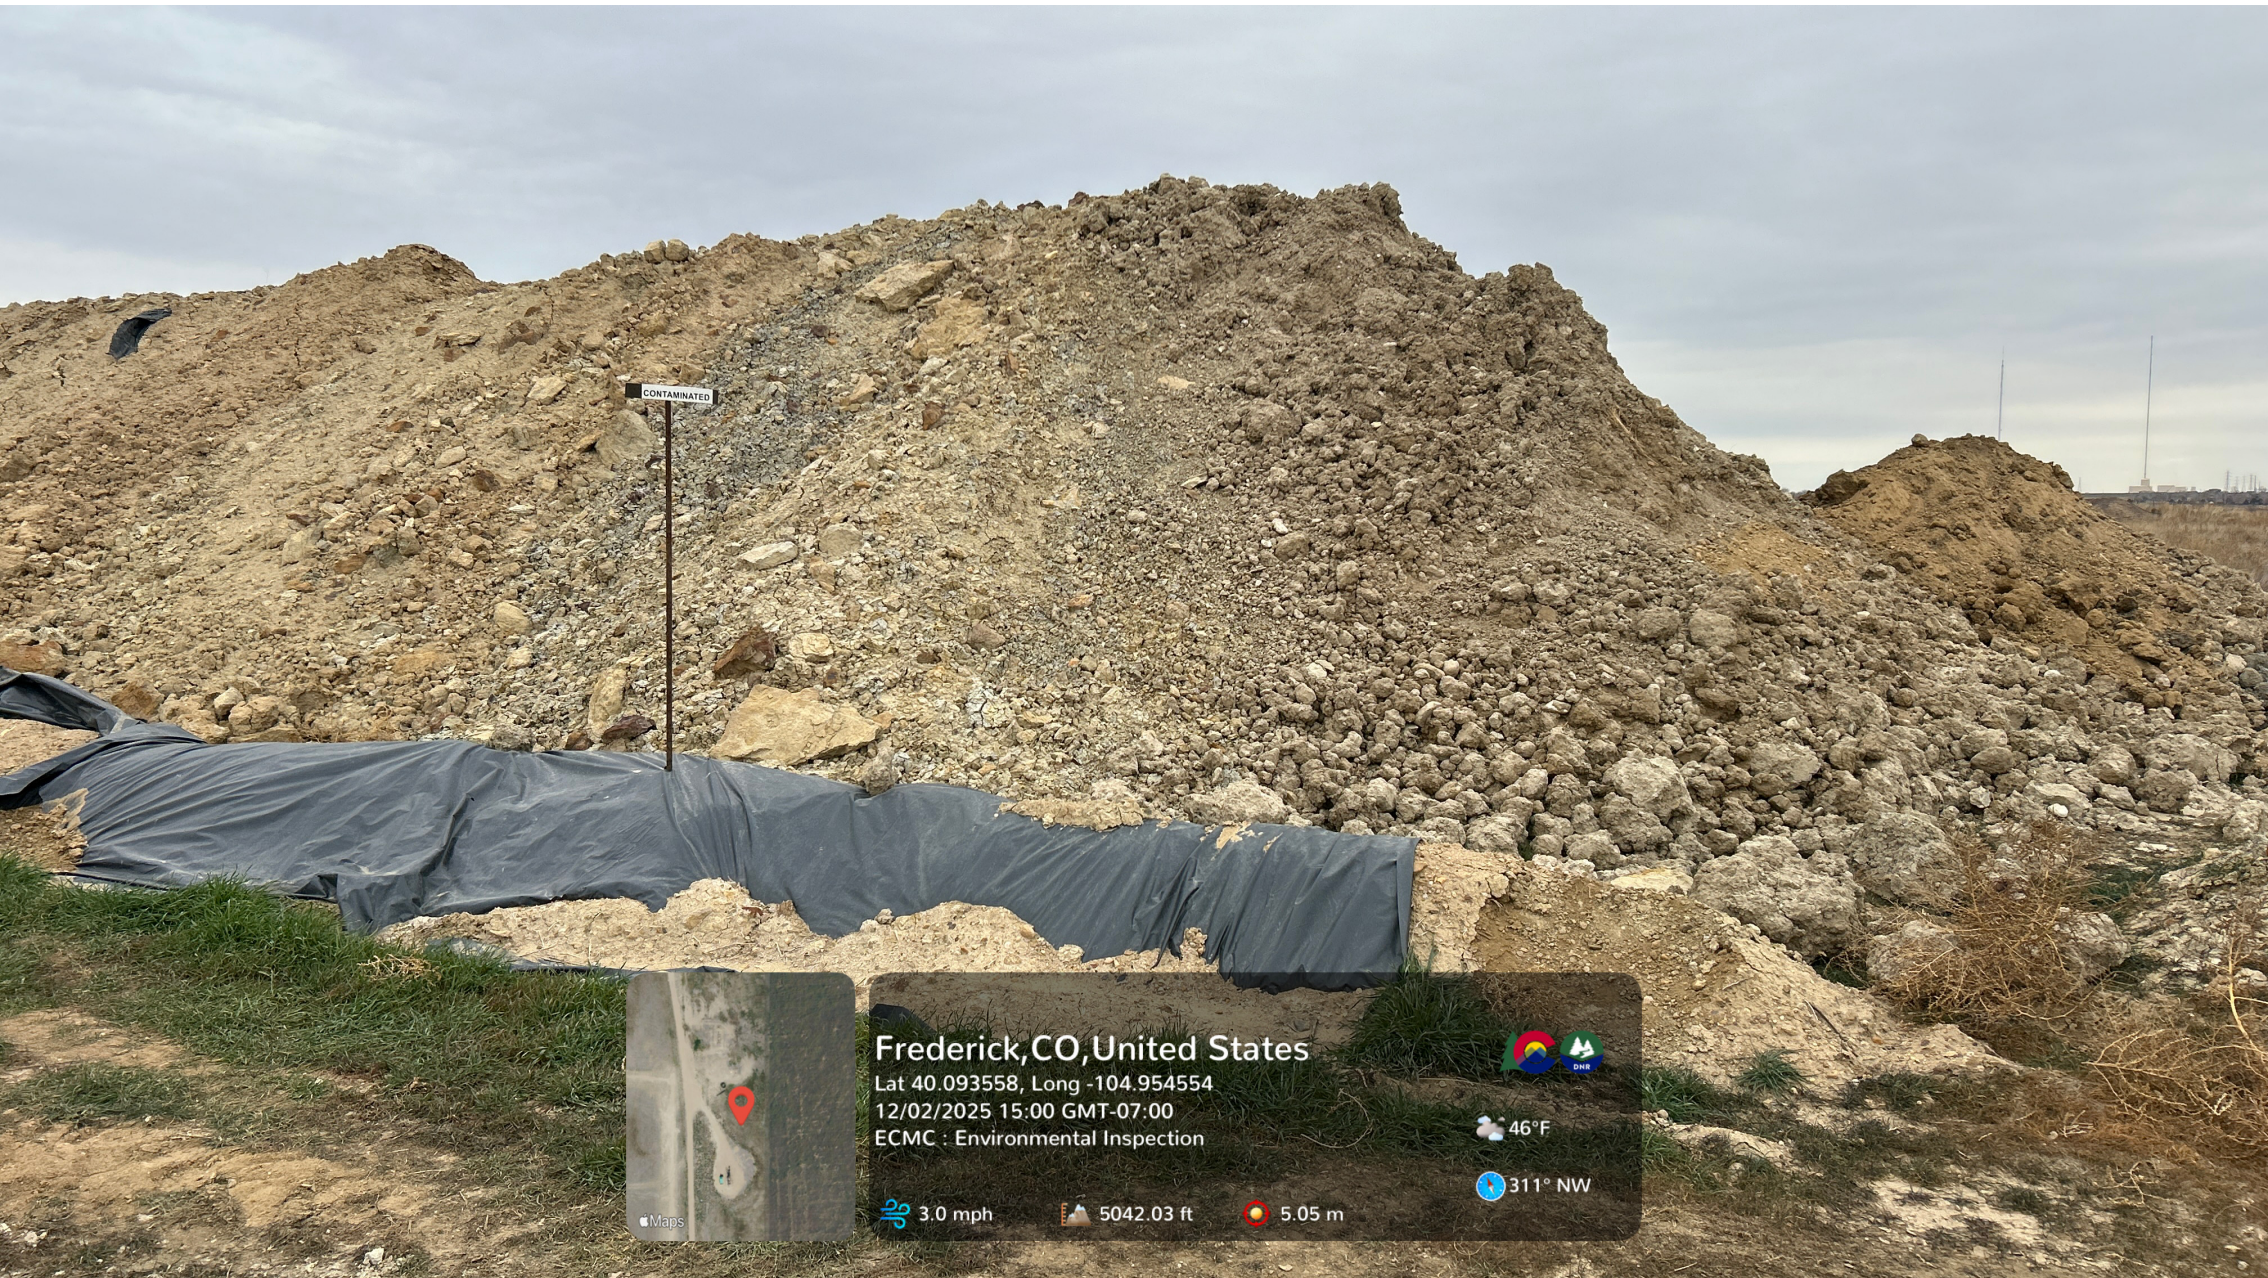
The east soil stockpile is marked "contaminated".

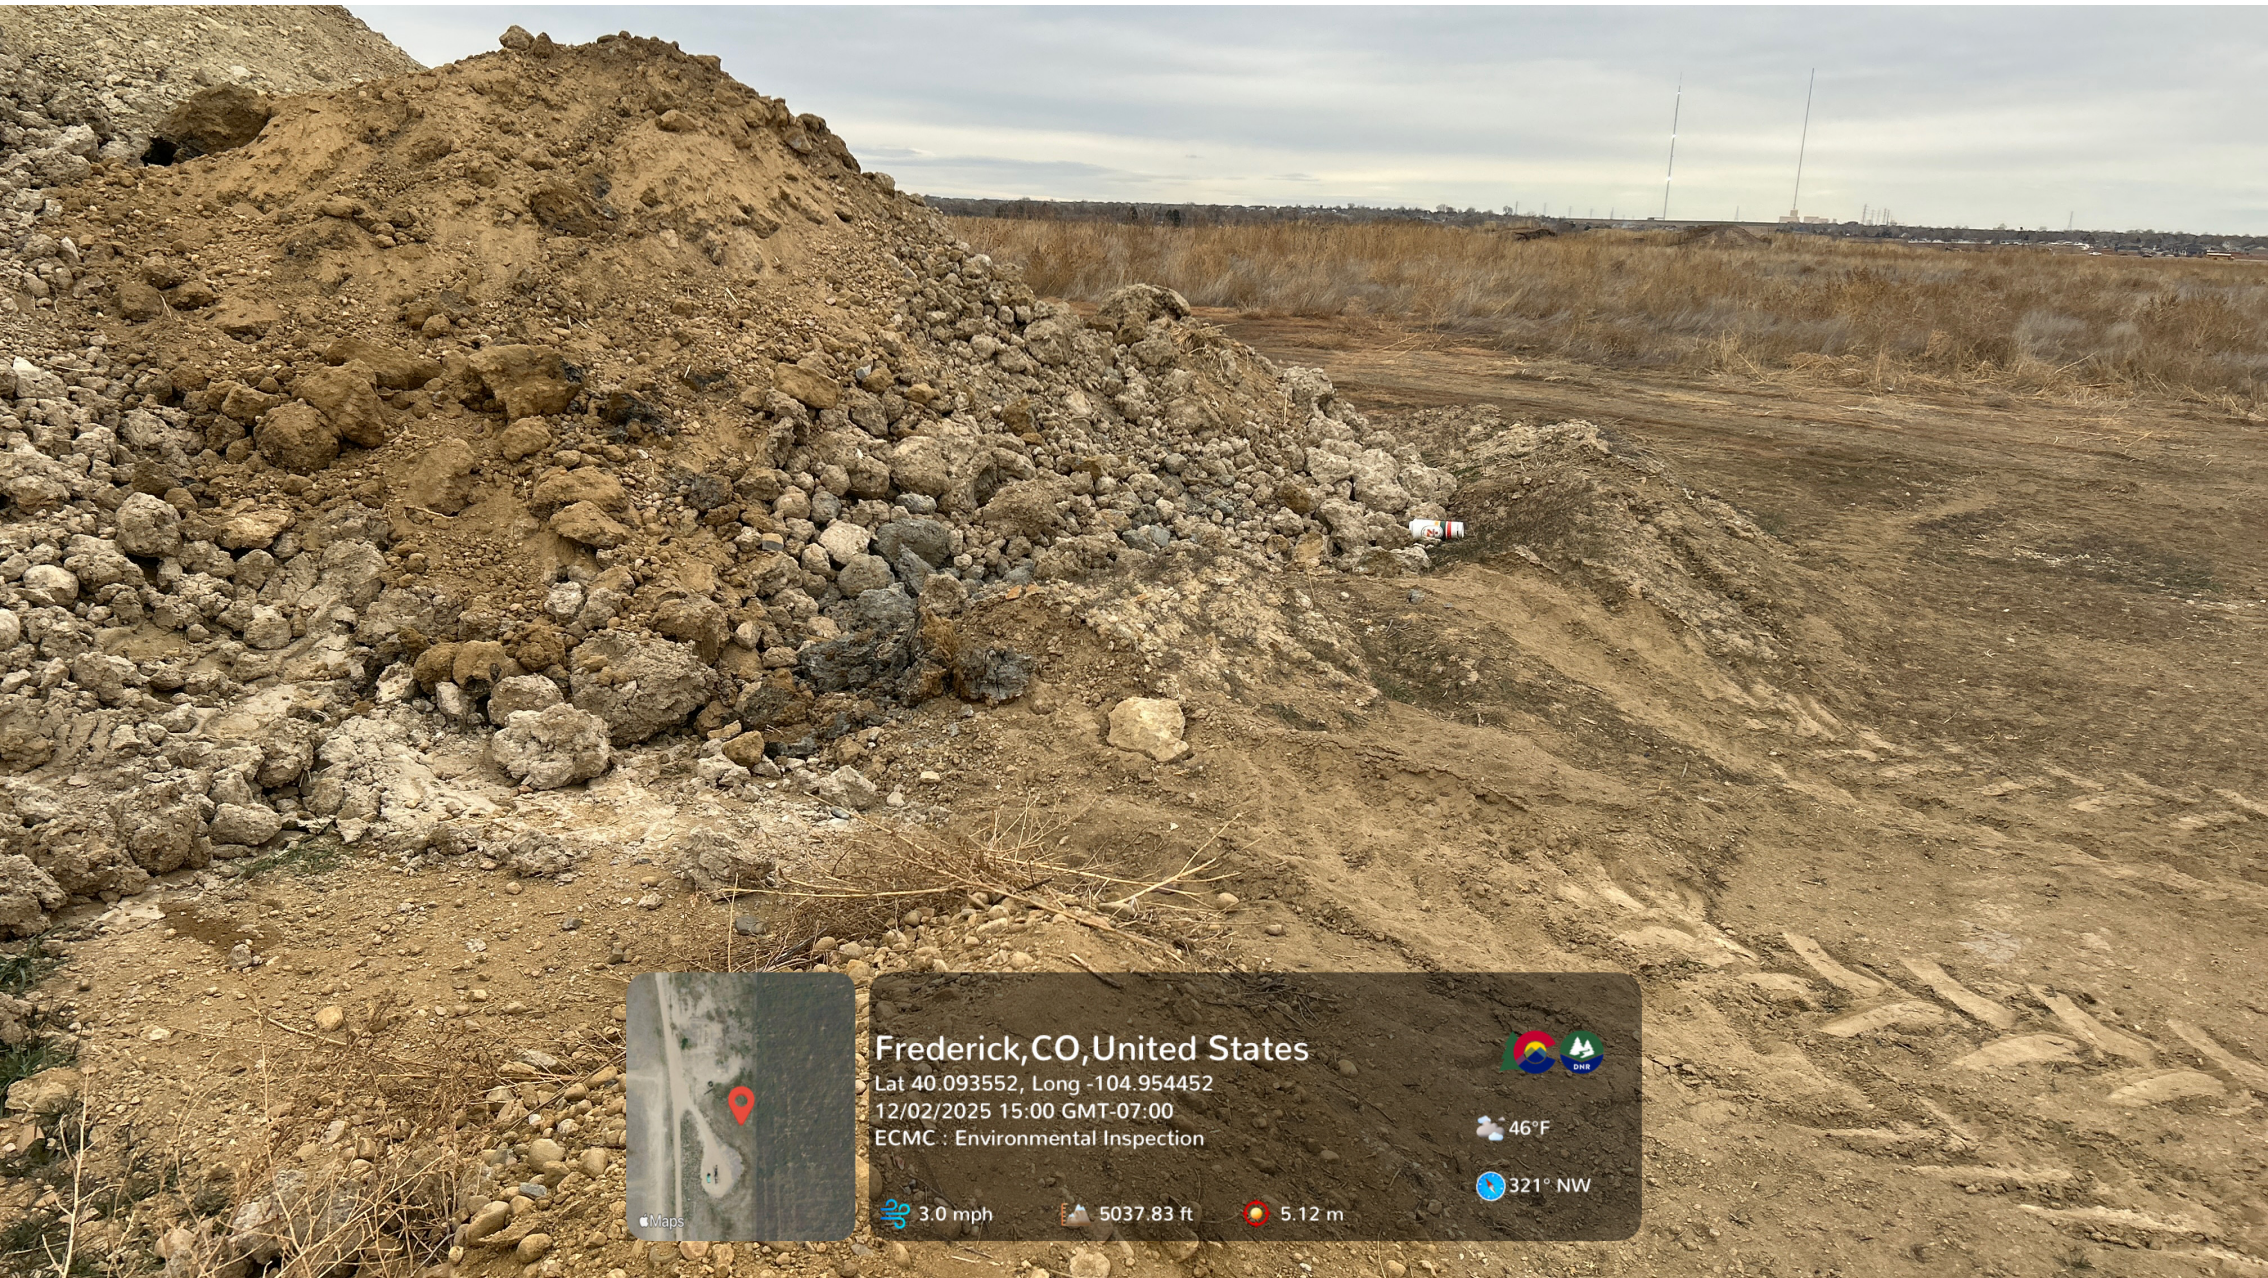
Areas of gray soil are visible outside of the stockpile liner.

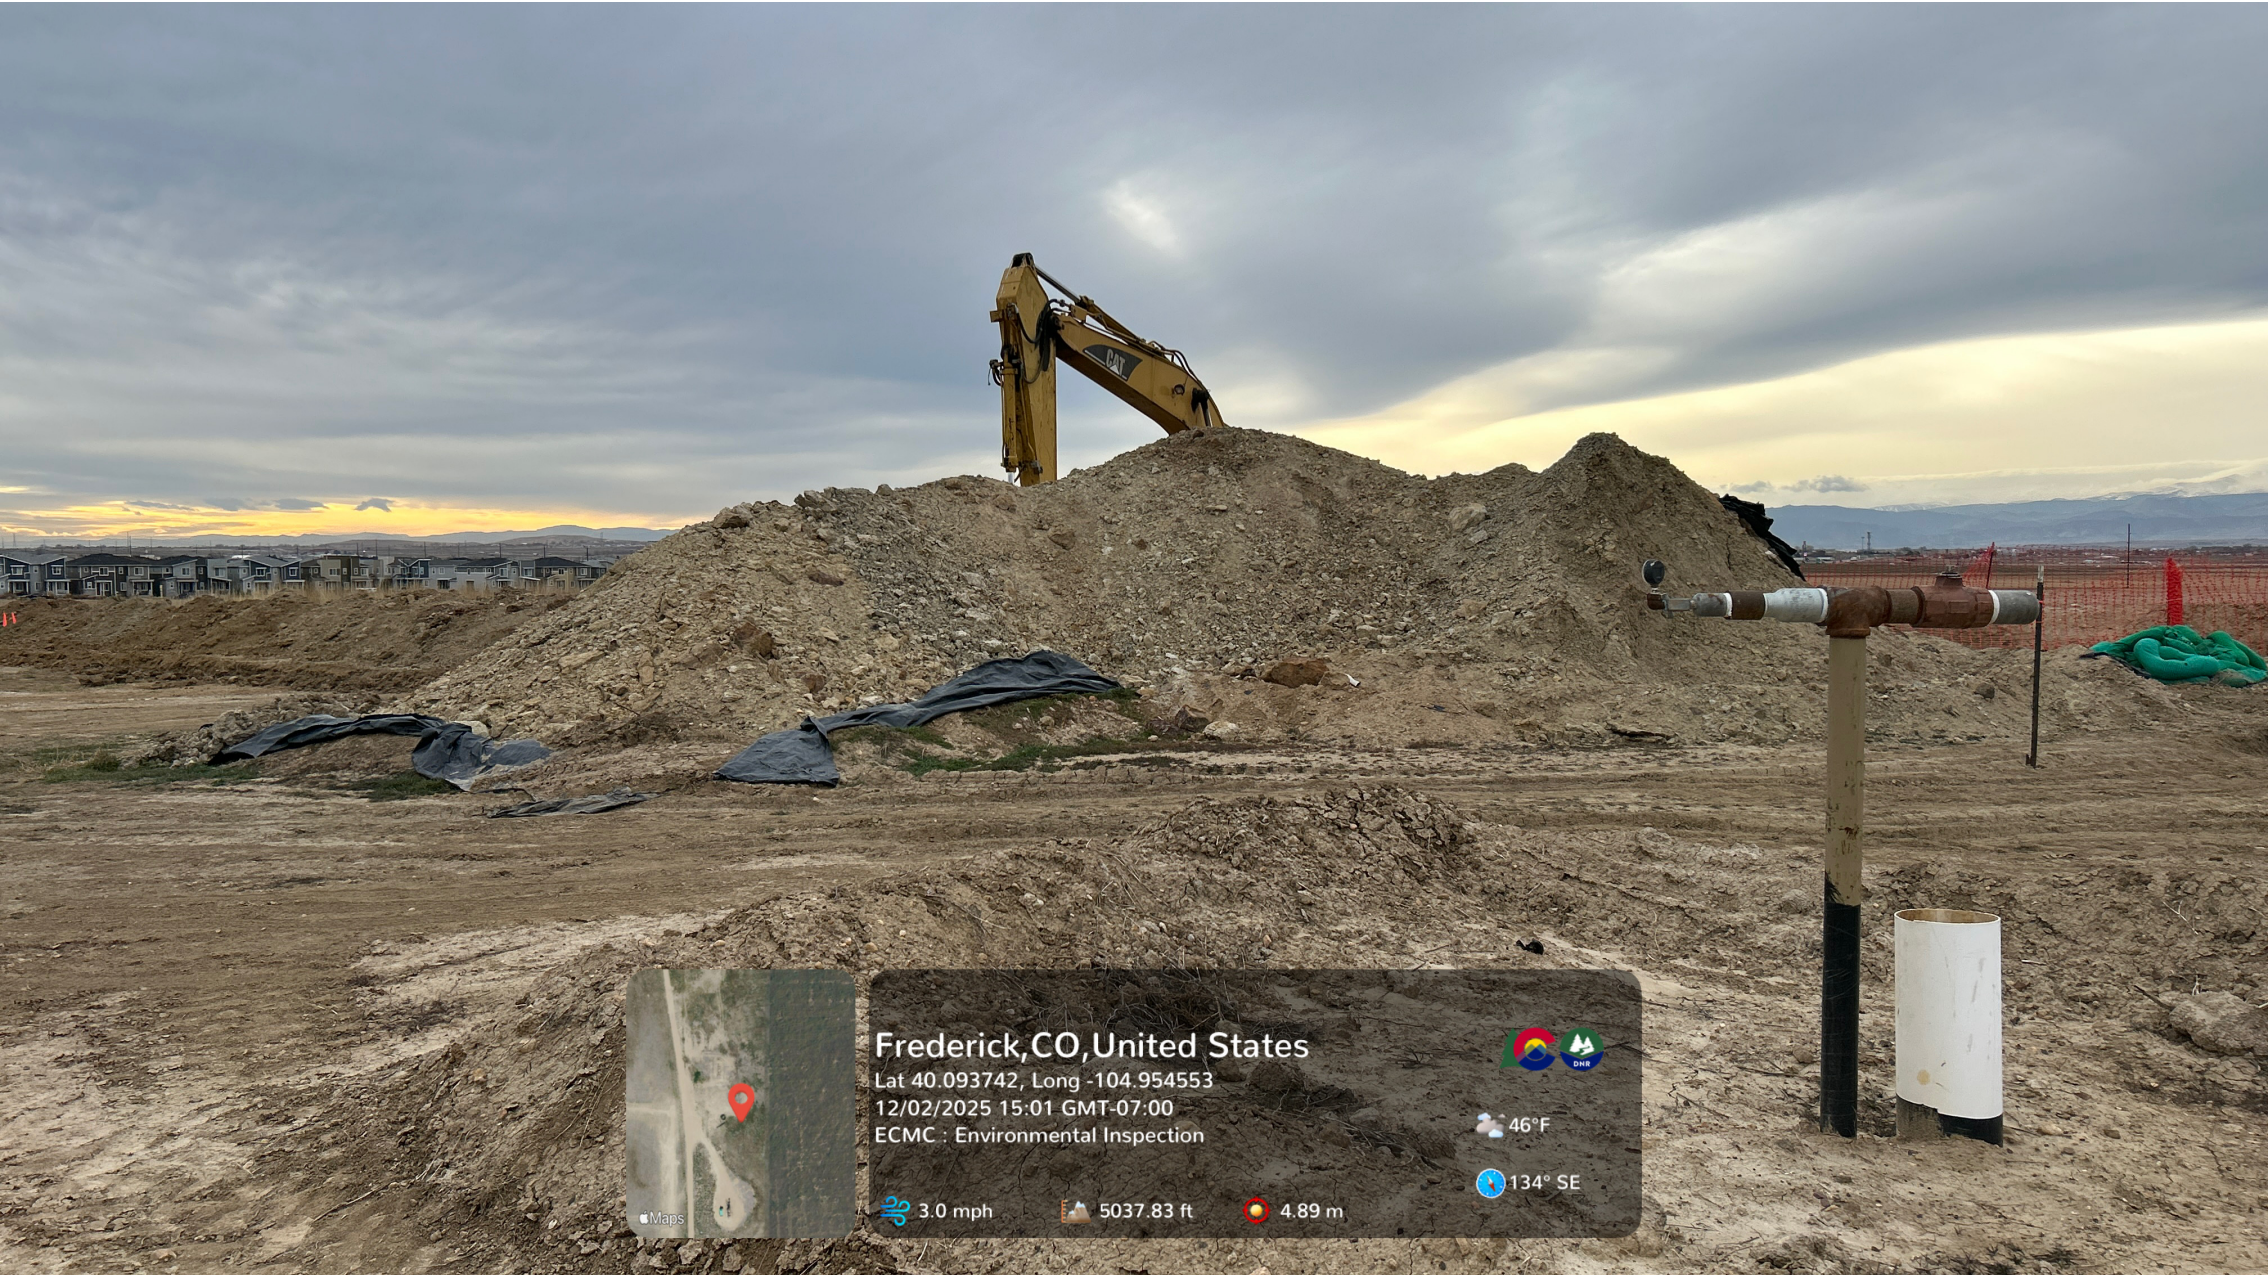
Looking at the west stockpile. A liner is visible; however, the liner is torn, discontinuous, and overtopped by soil.

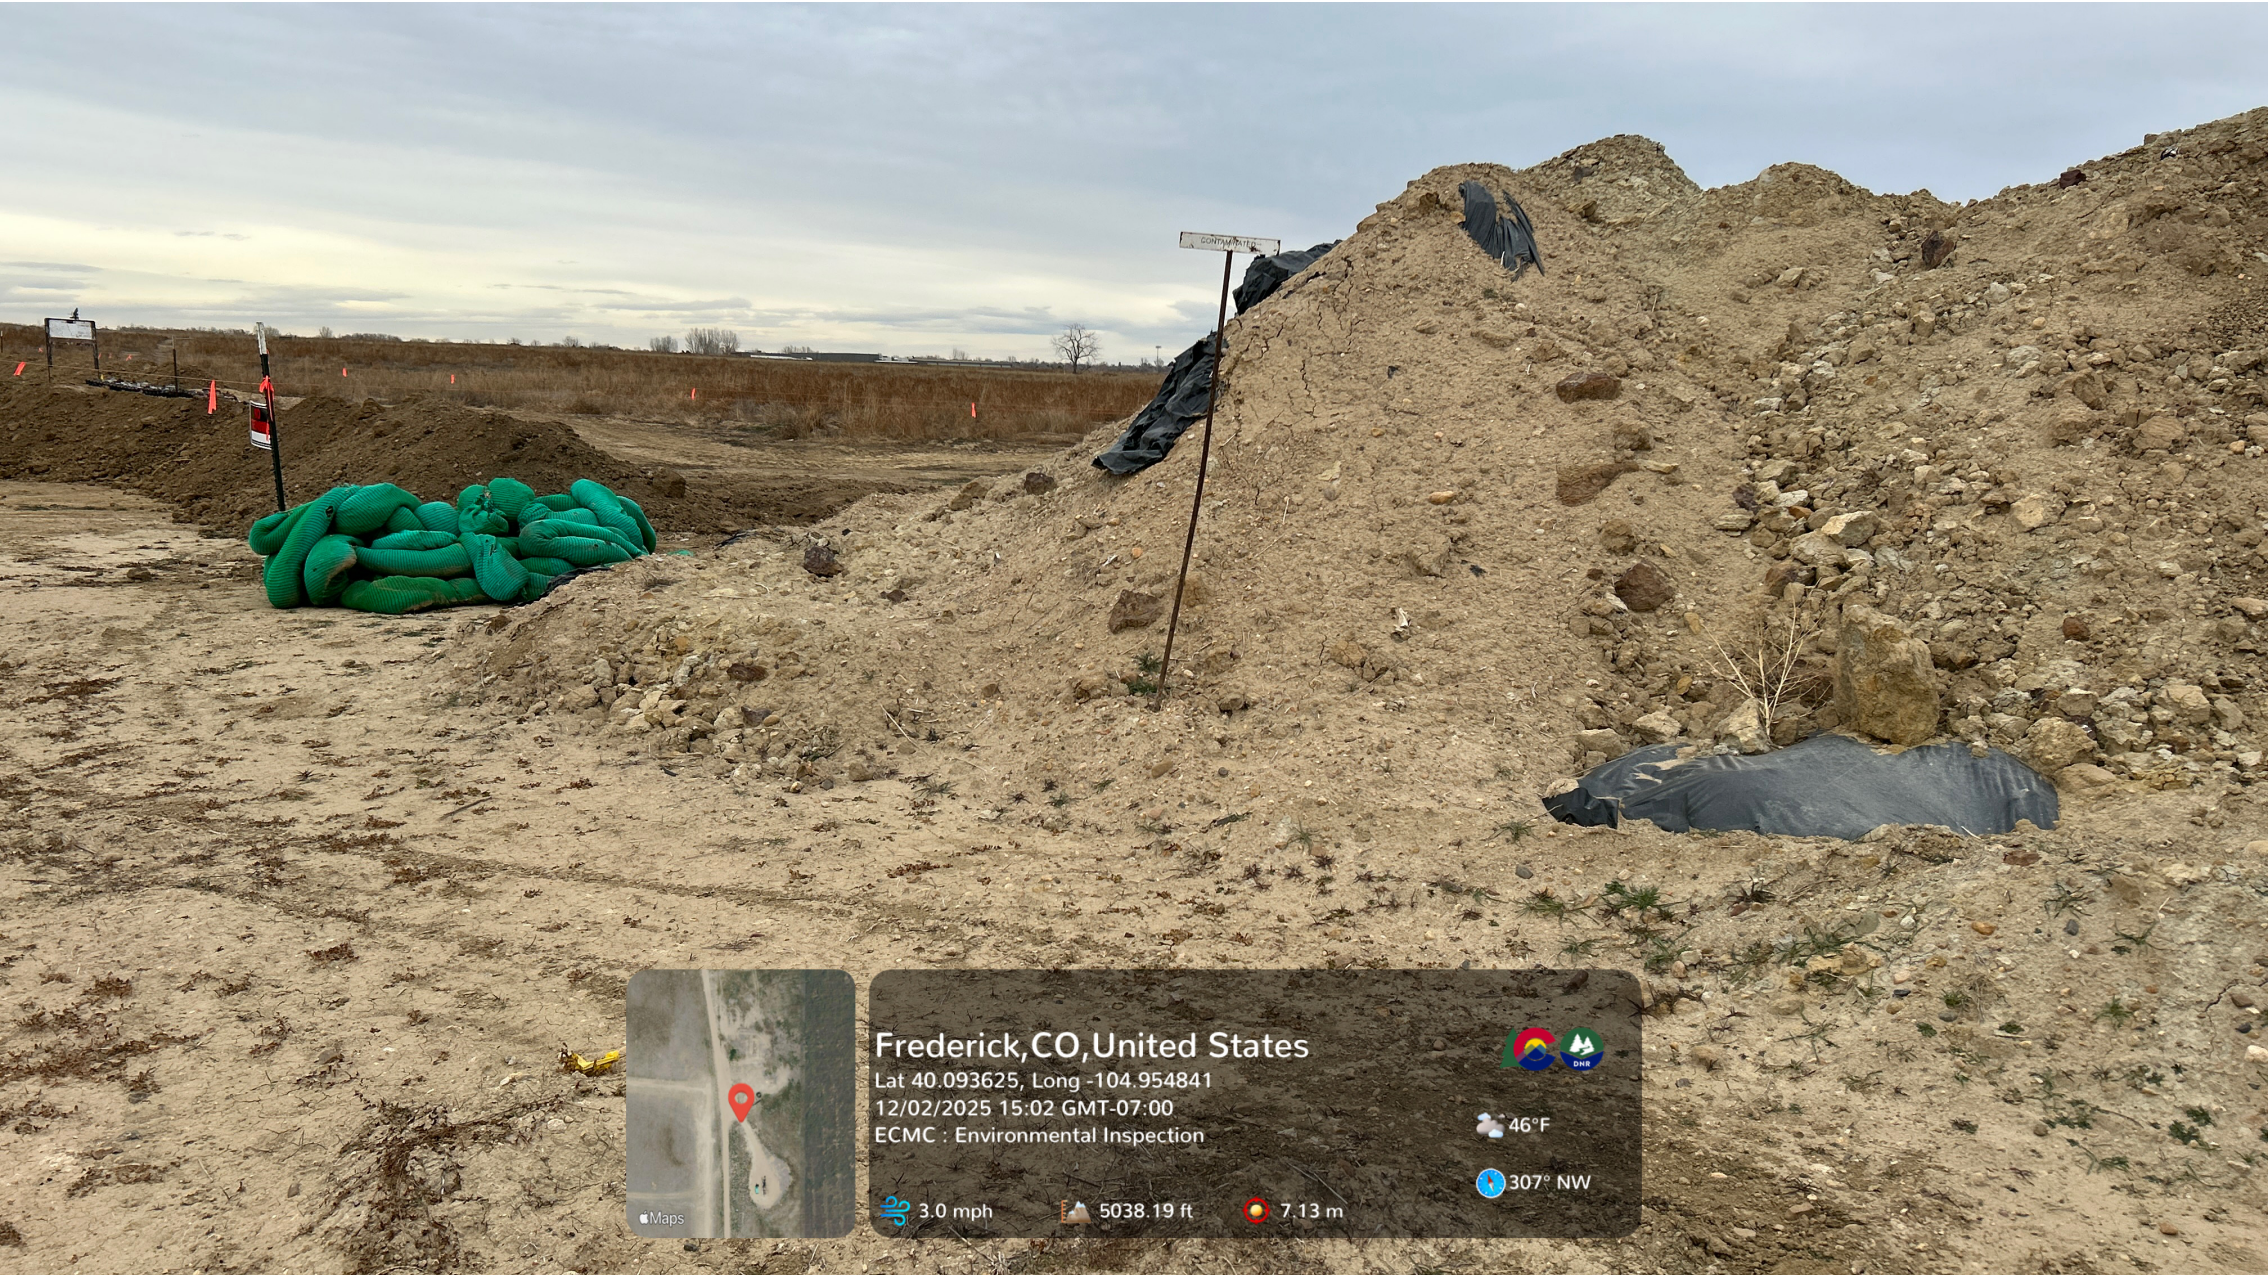
The west soil stockpile is marked "contaminated". Green wattles are visible adjacent to the soil stockpile. A trench that appears to be associated with Flowline Facility ID 476033 is visible in the background and will be addressed in a separate Field Inspection Report.

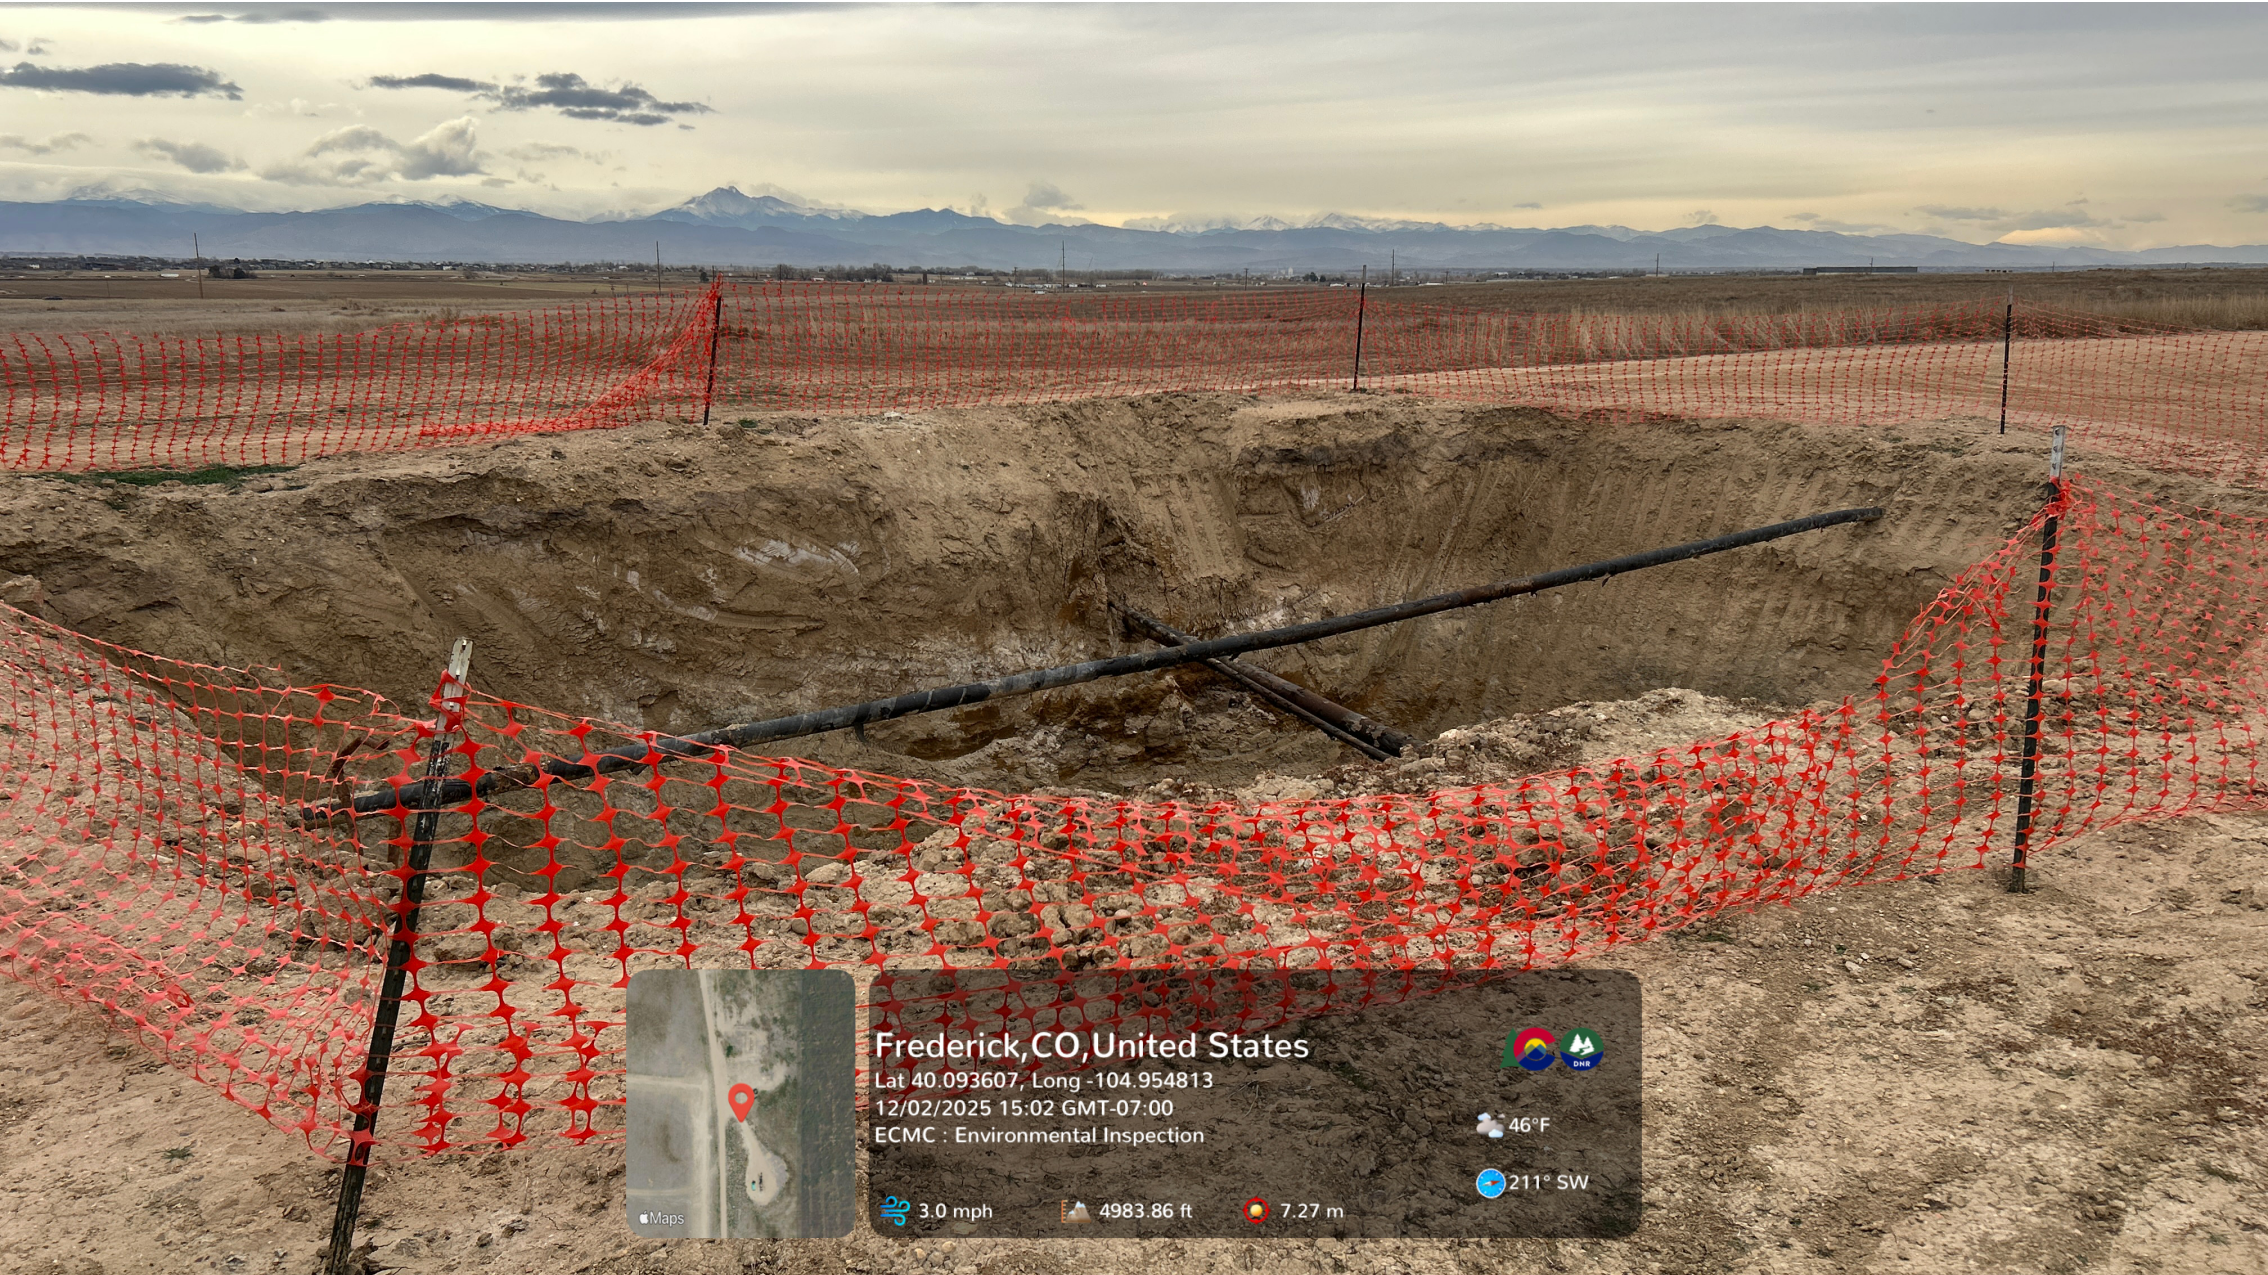
Looking at the open excavation at the spill location. Multiple flowlines are exposed within the excavation. Stained soil is visible within the excavation. A petroleum hydrocarbon odor was observed in the area of the excavation and soil stockpiles.

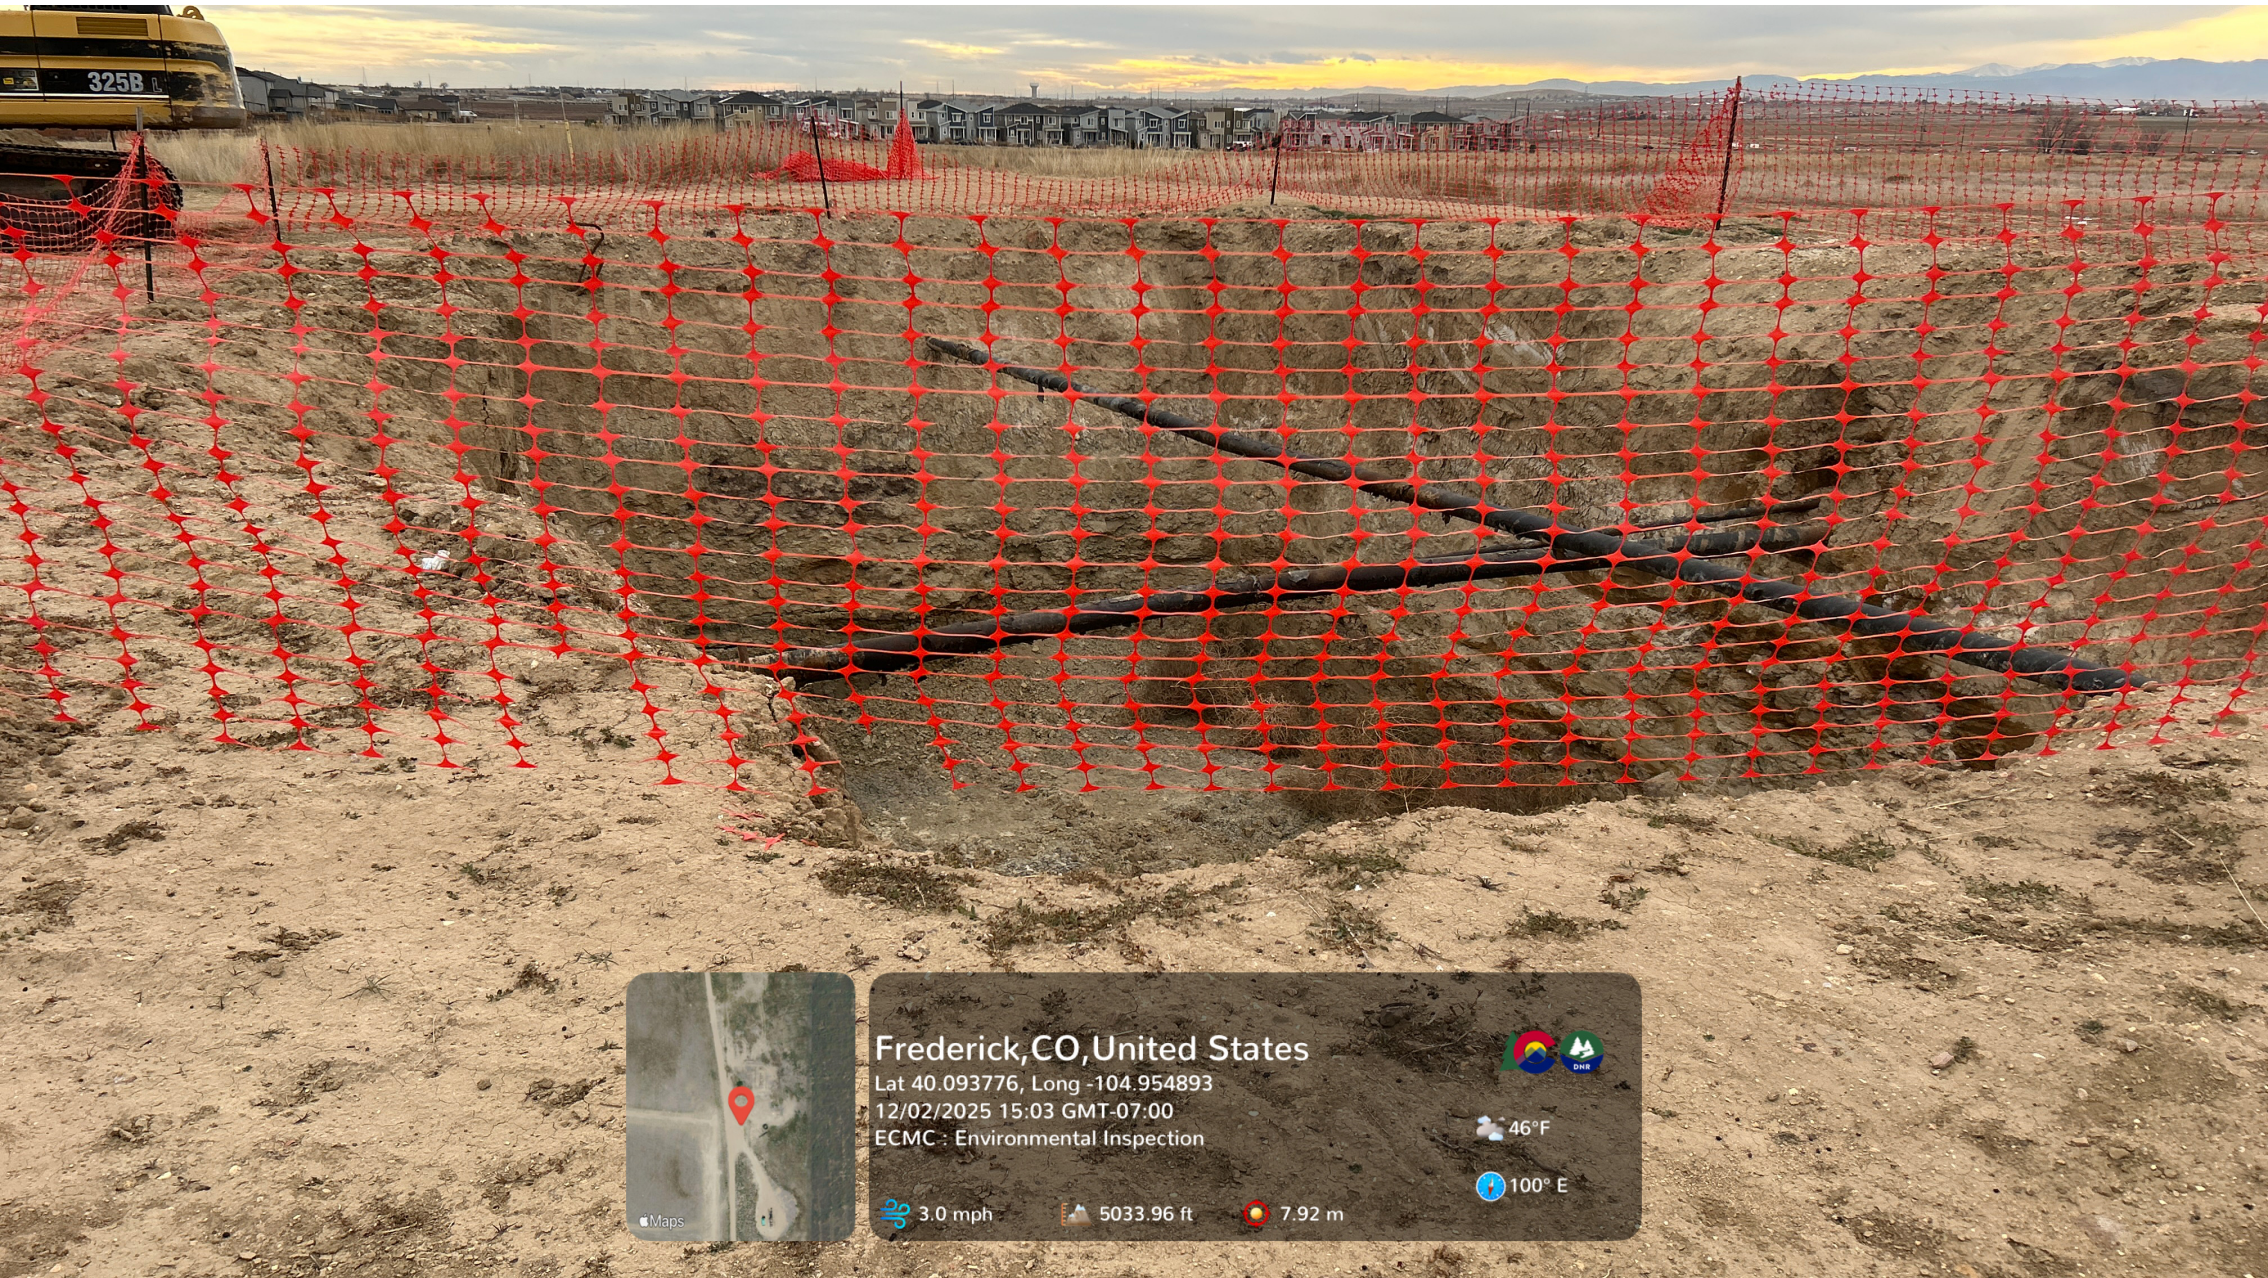
Orange construction fencing surrounds the excavation, but does not encompass the entire perimeter.
