Looking at the spill response area. Above ground flowline manifolds and a sign which reads "Amoco Production Company" are visible in the foreground. Two stockpiles, an excavator, and an excavation with orange construction fencing are visible in the midground. Residential building units are visible in the background.

Frederick, CO, United States
Lat 40.093834, Long -104.954639
12/02/2025 14:59 GMT-07:00
ECMC : Environmental Inspection

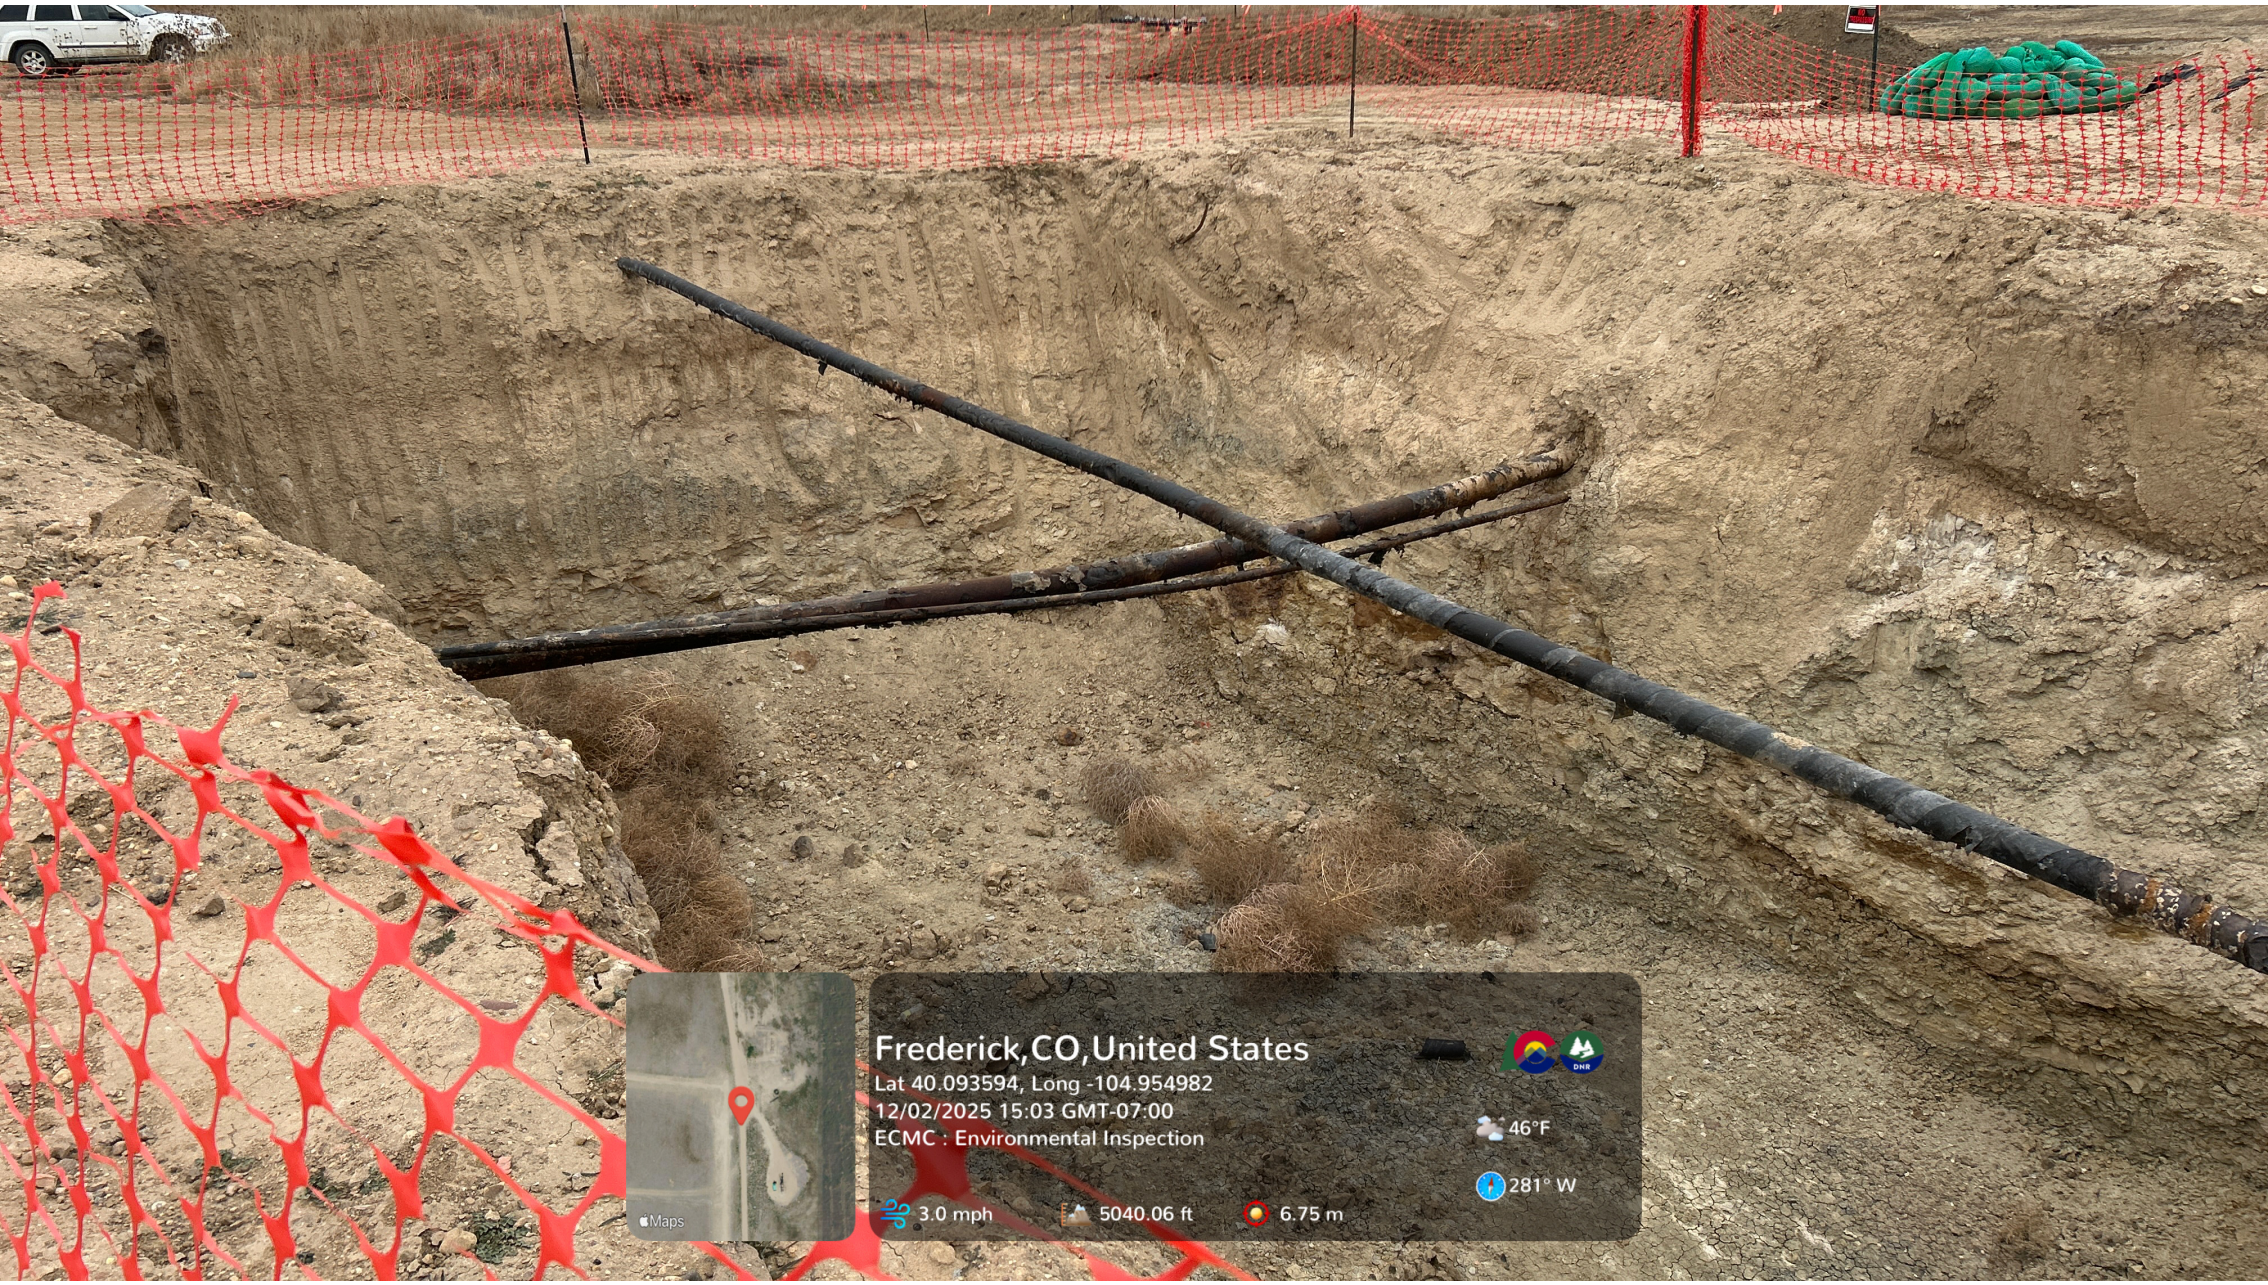
Debris is visible within the open excavation.
