Looking at the former STATE #7 well. An open excavation is visible. The pumping unit has been removed. Unmarked soil stockpiles are visible adjacent to the excavation. No liners or stormwater BMPs are visible. A trench associated with Flowline Facility ID 476252 is visible running south from the former well and will be addressed in a separate Field Inspection Report.

ECMC : Environmental Inspection

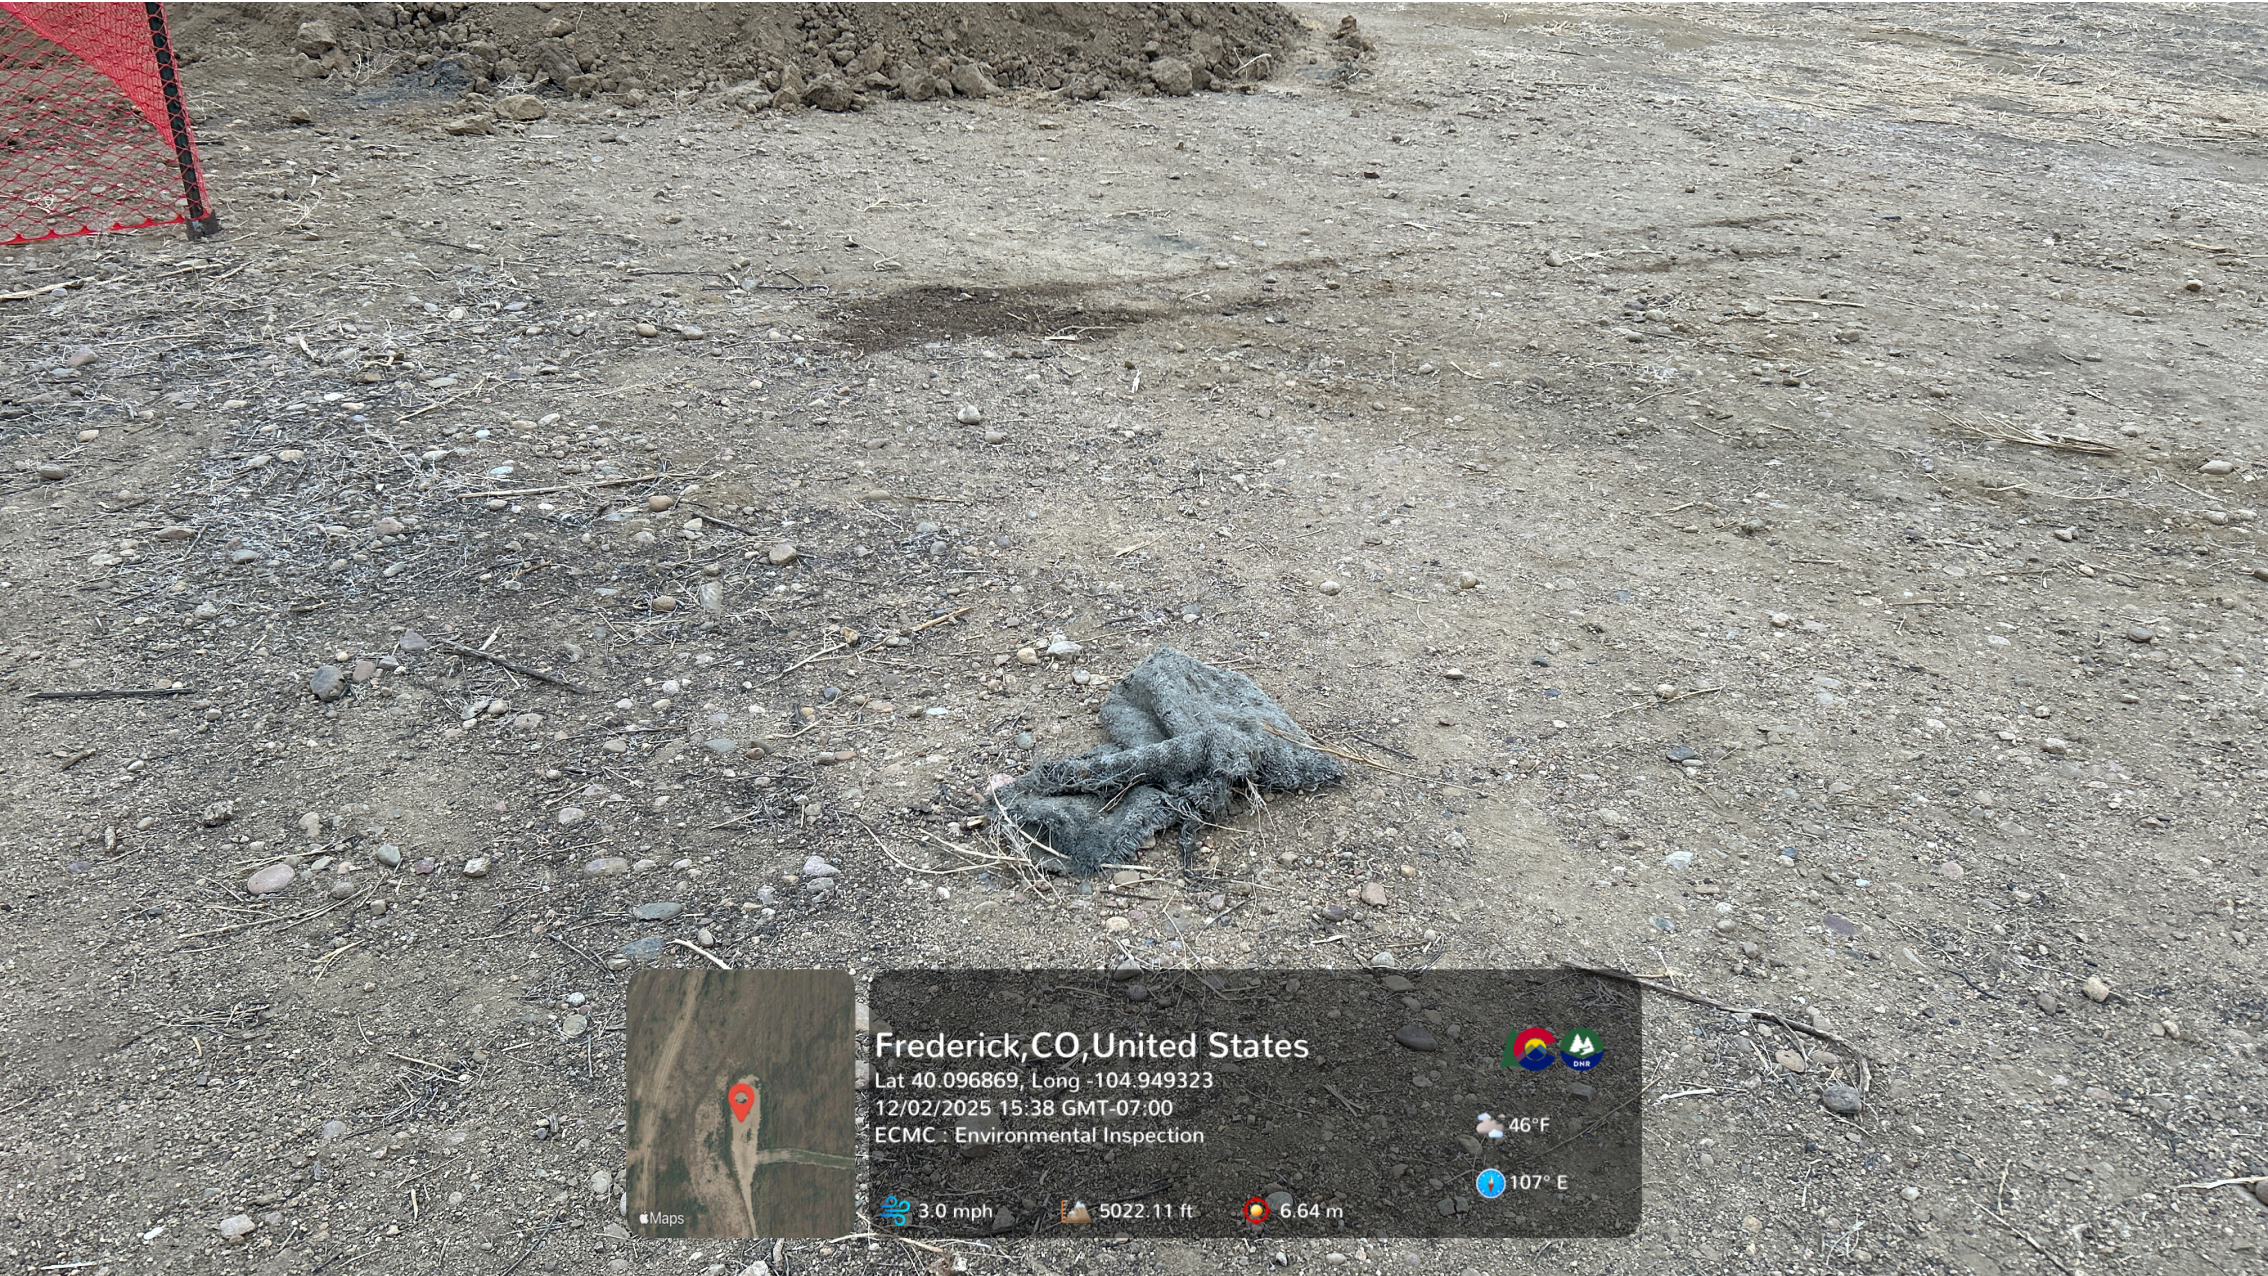
Trash is visible on location.

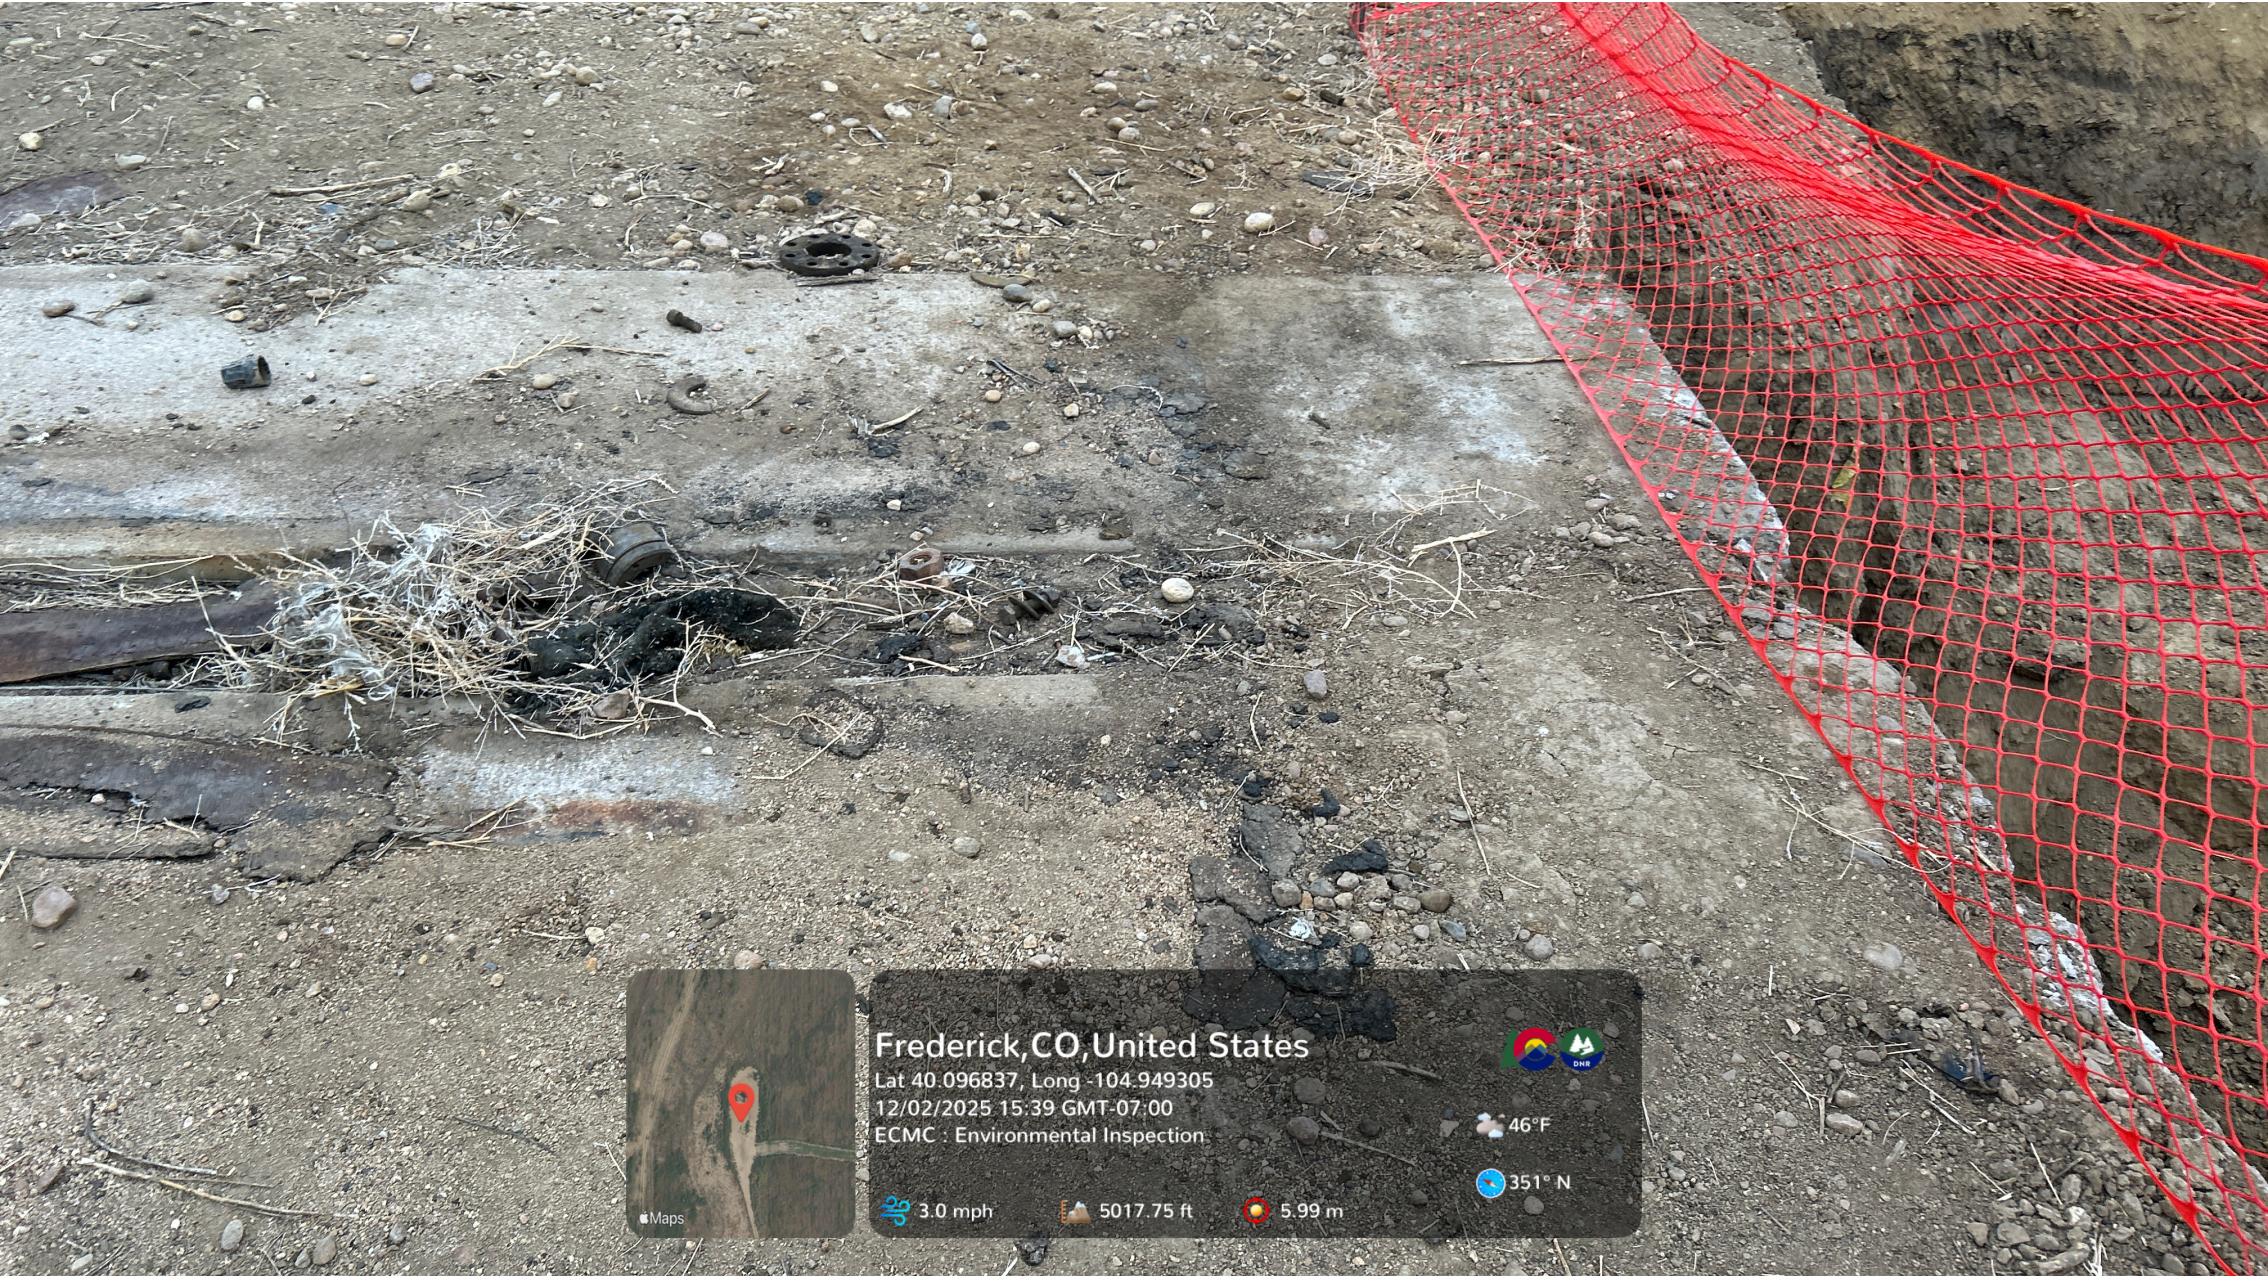
Trash is visible on location.

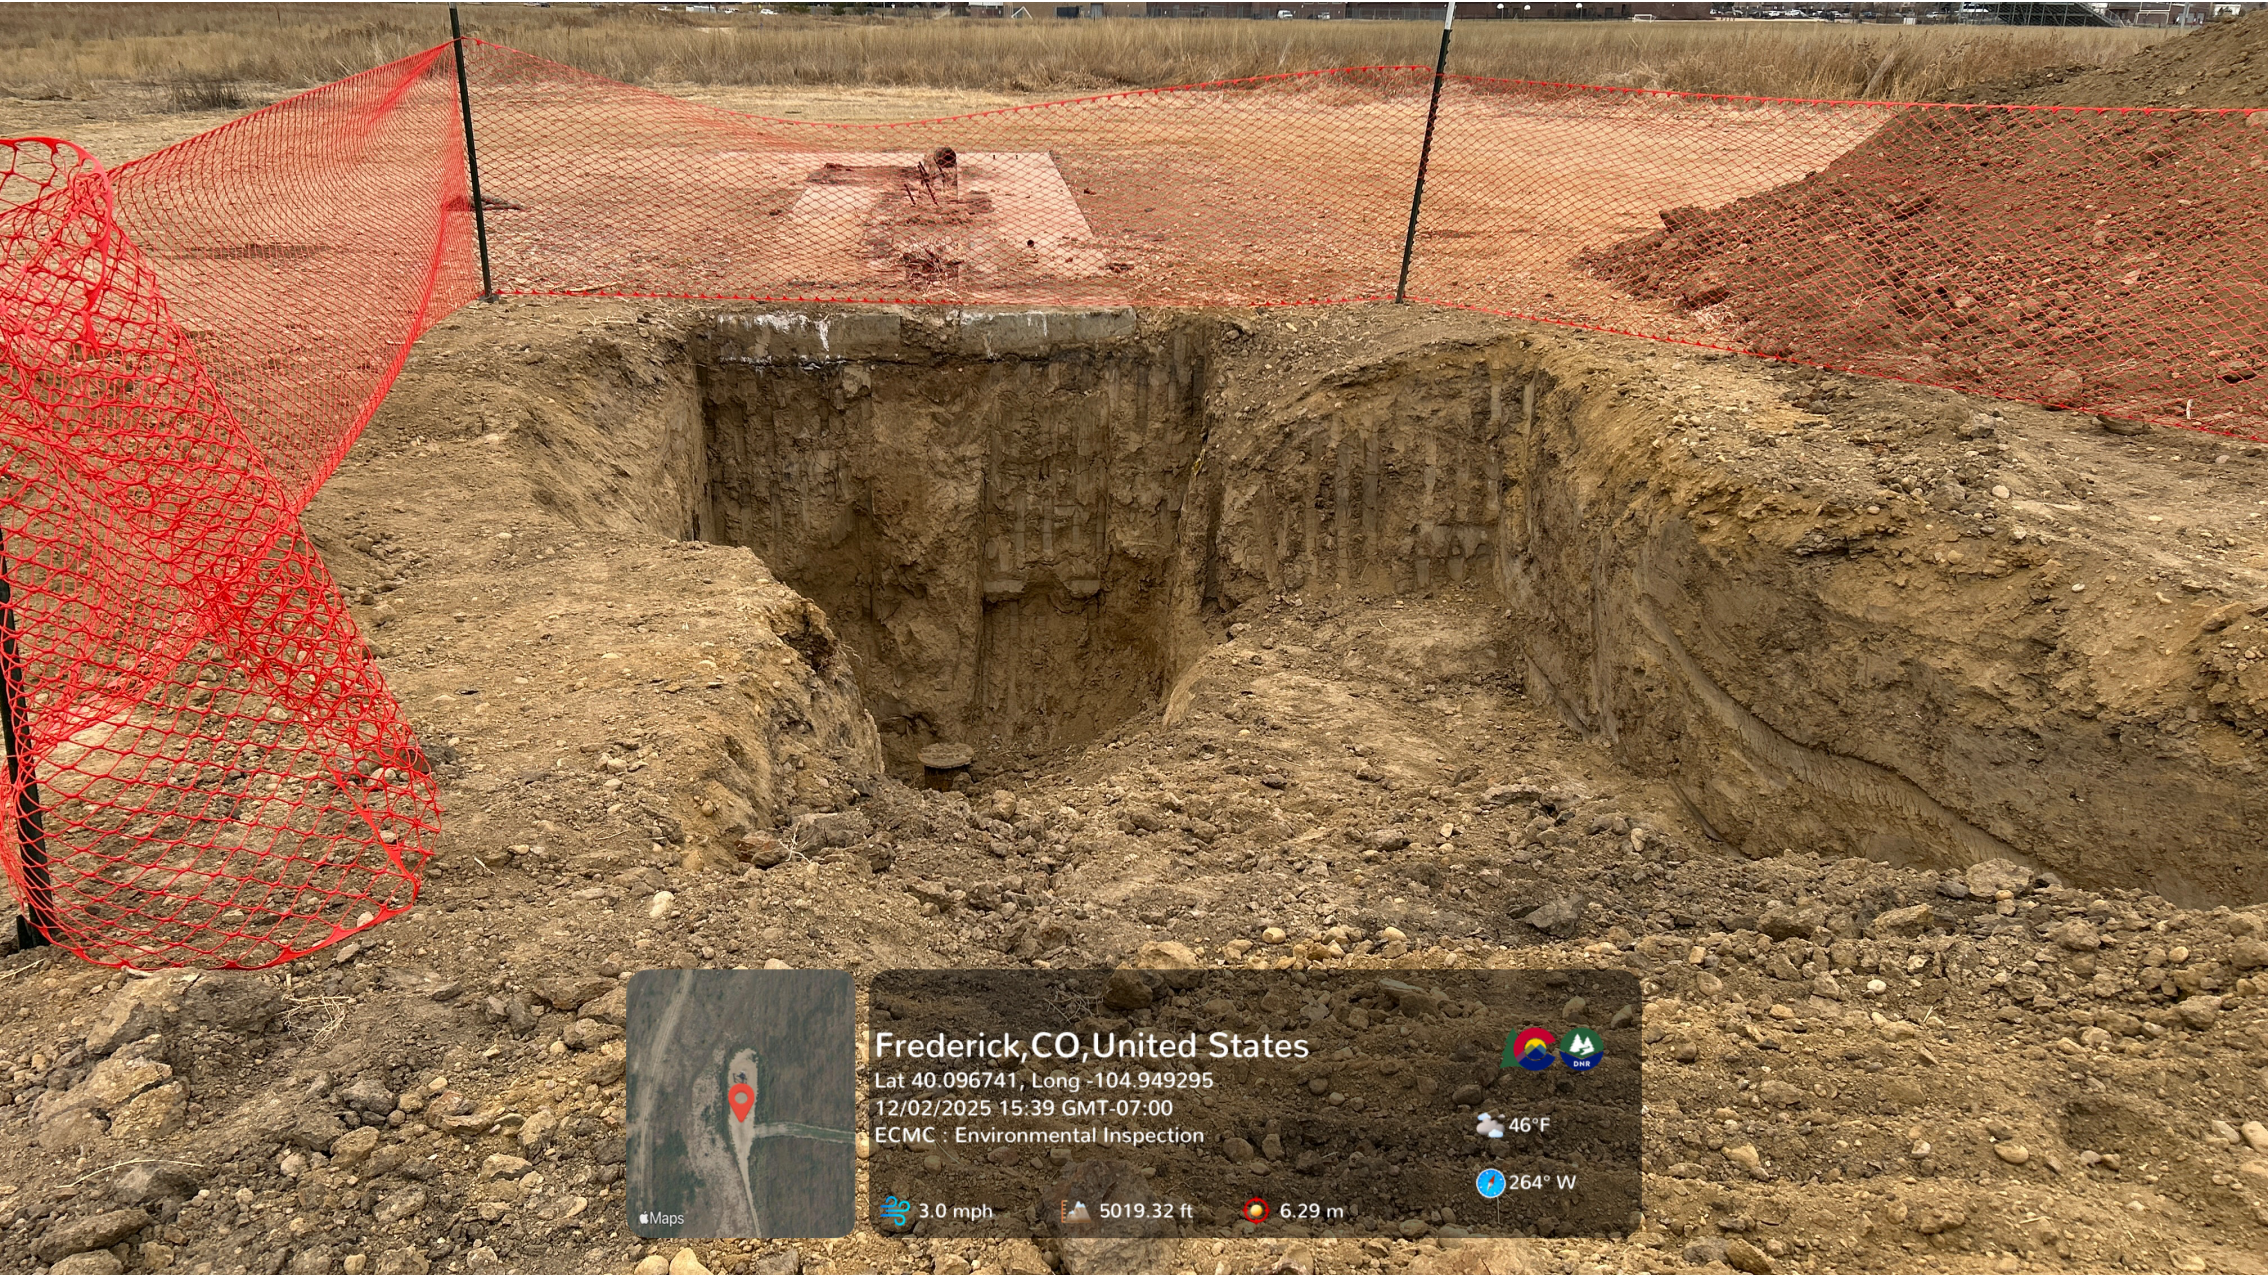
Looking at the open excavation. Orange construction fencing partially surrounds the excavation.
