Looking at the former STATE #13 well. An open excavation is visible. The pumping unit has been partially dismantled.

ECMC : Environmental Inspection

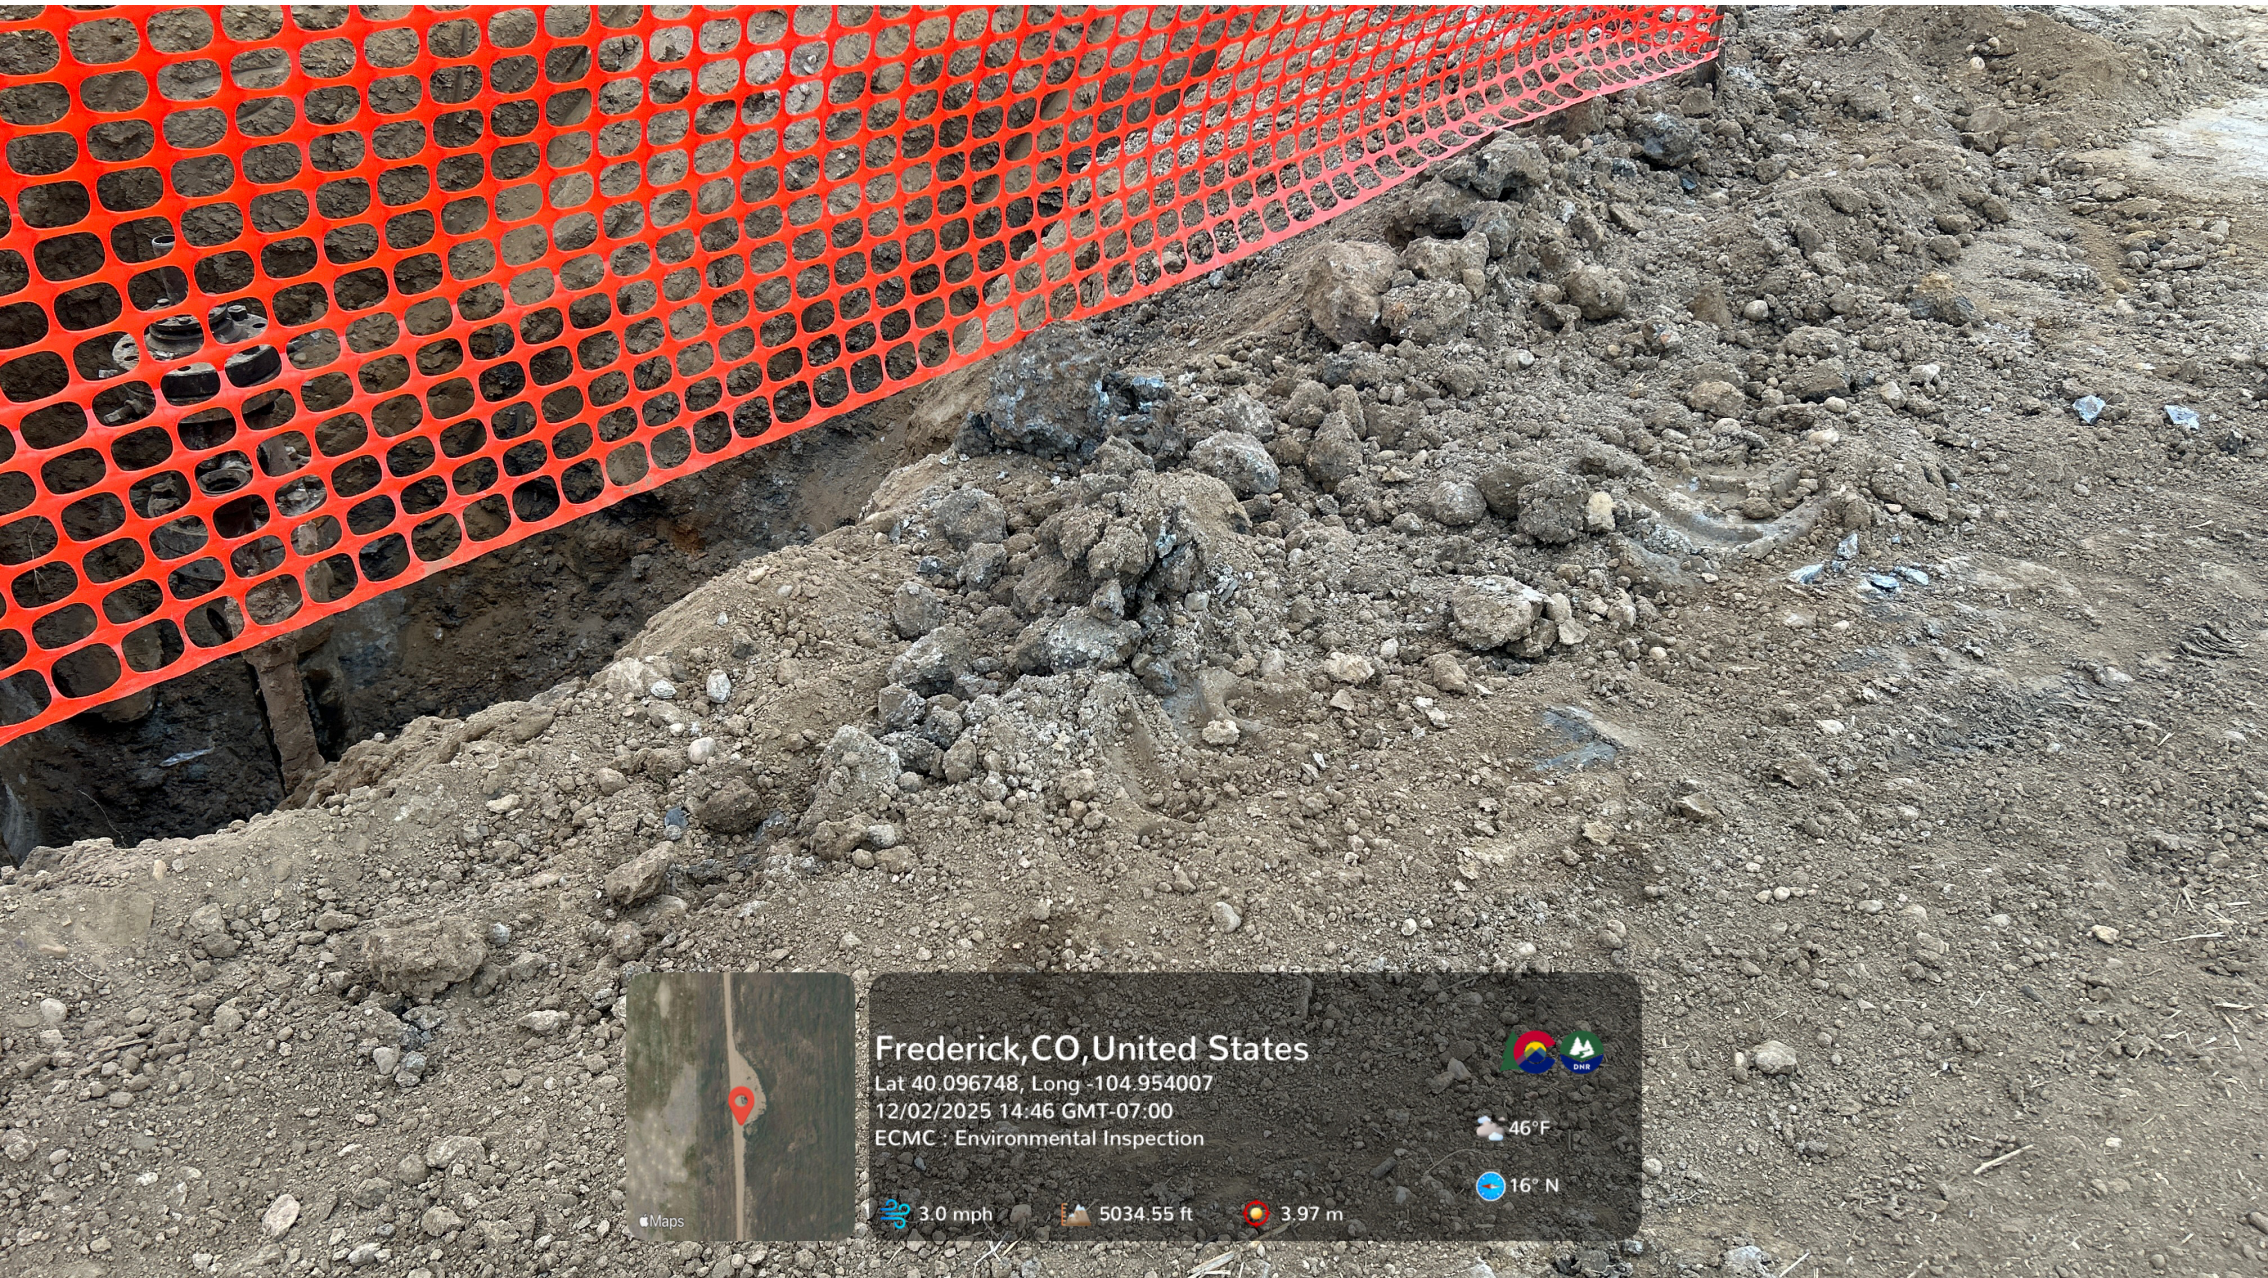
Gray stained soil is visible adjacent to the excavation.

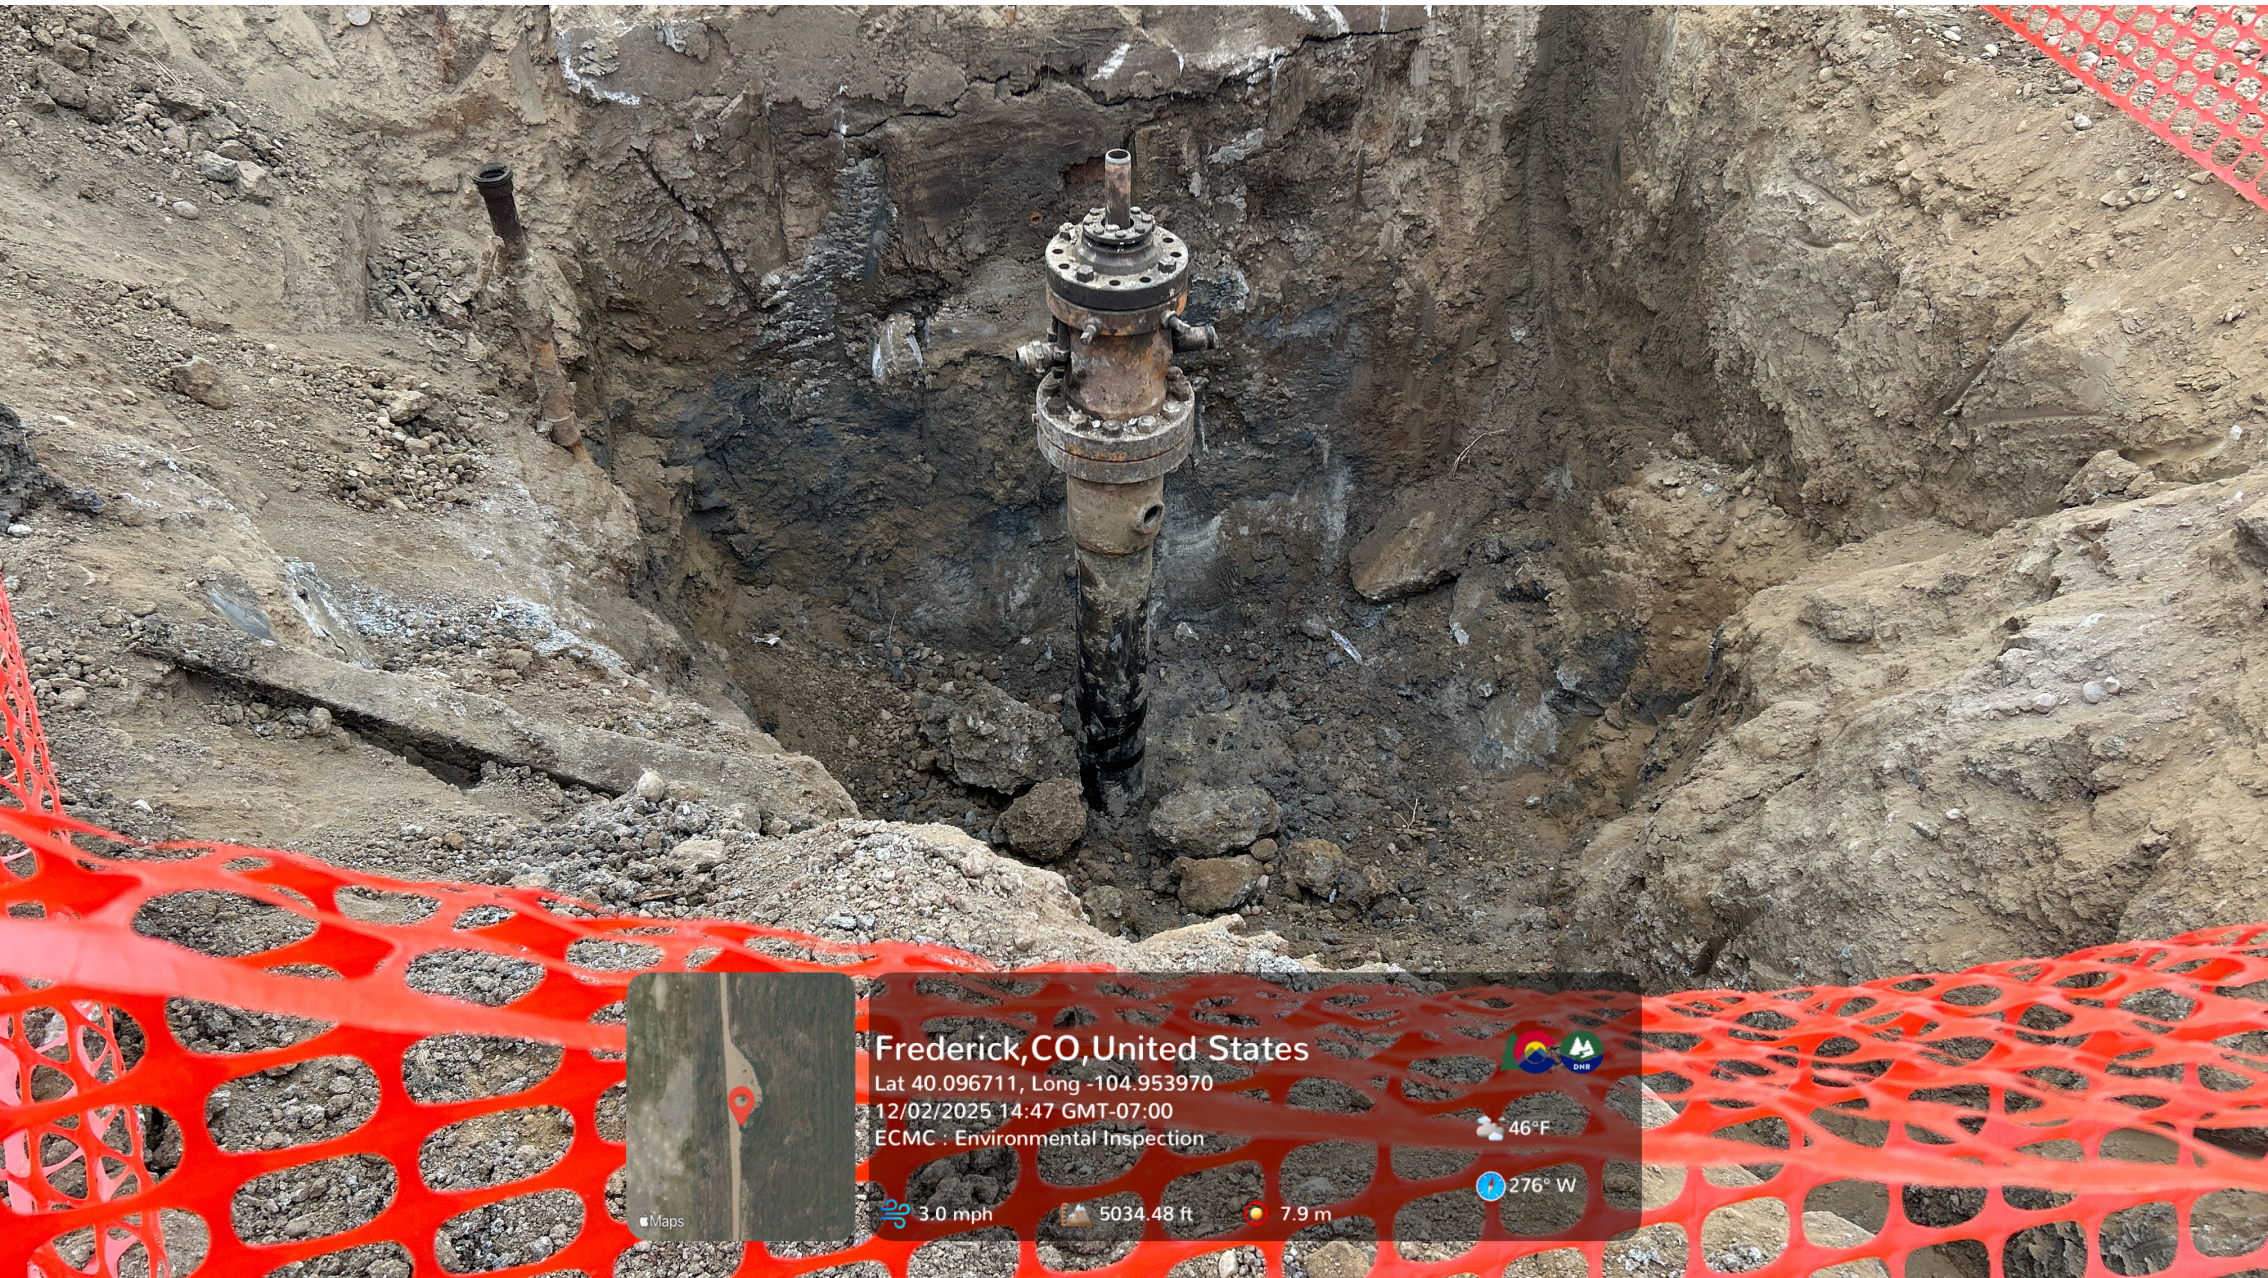
Gray staining is visible throughout the excavation. The well is exposed but has not been cut and capped.

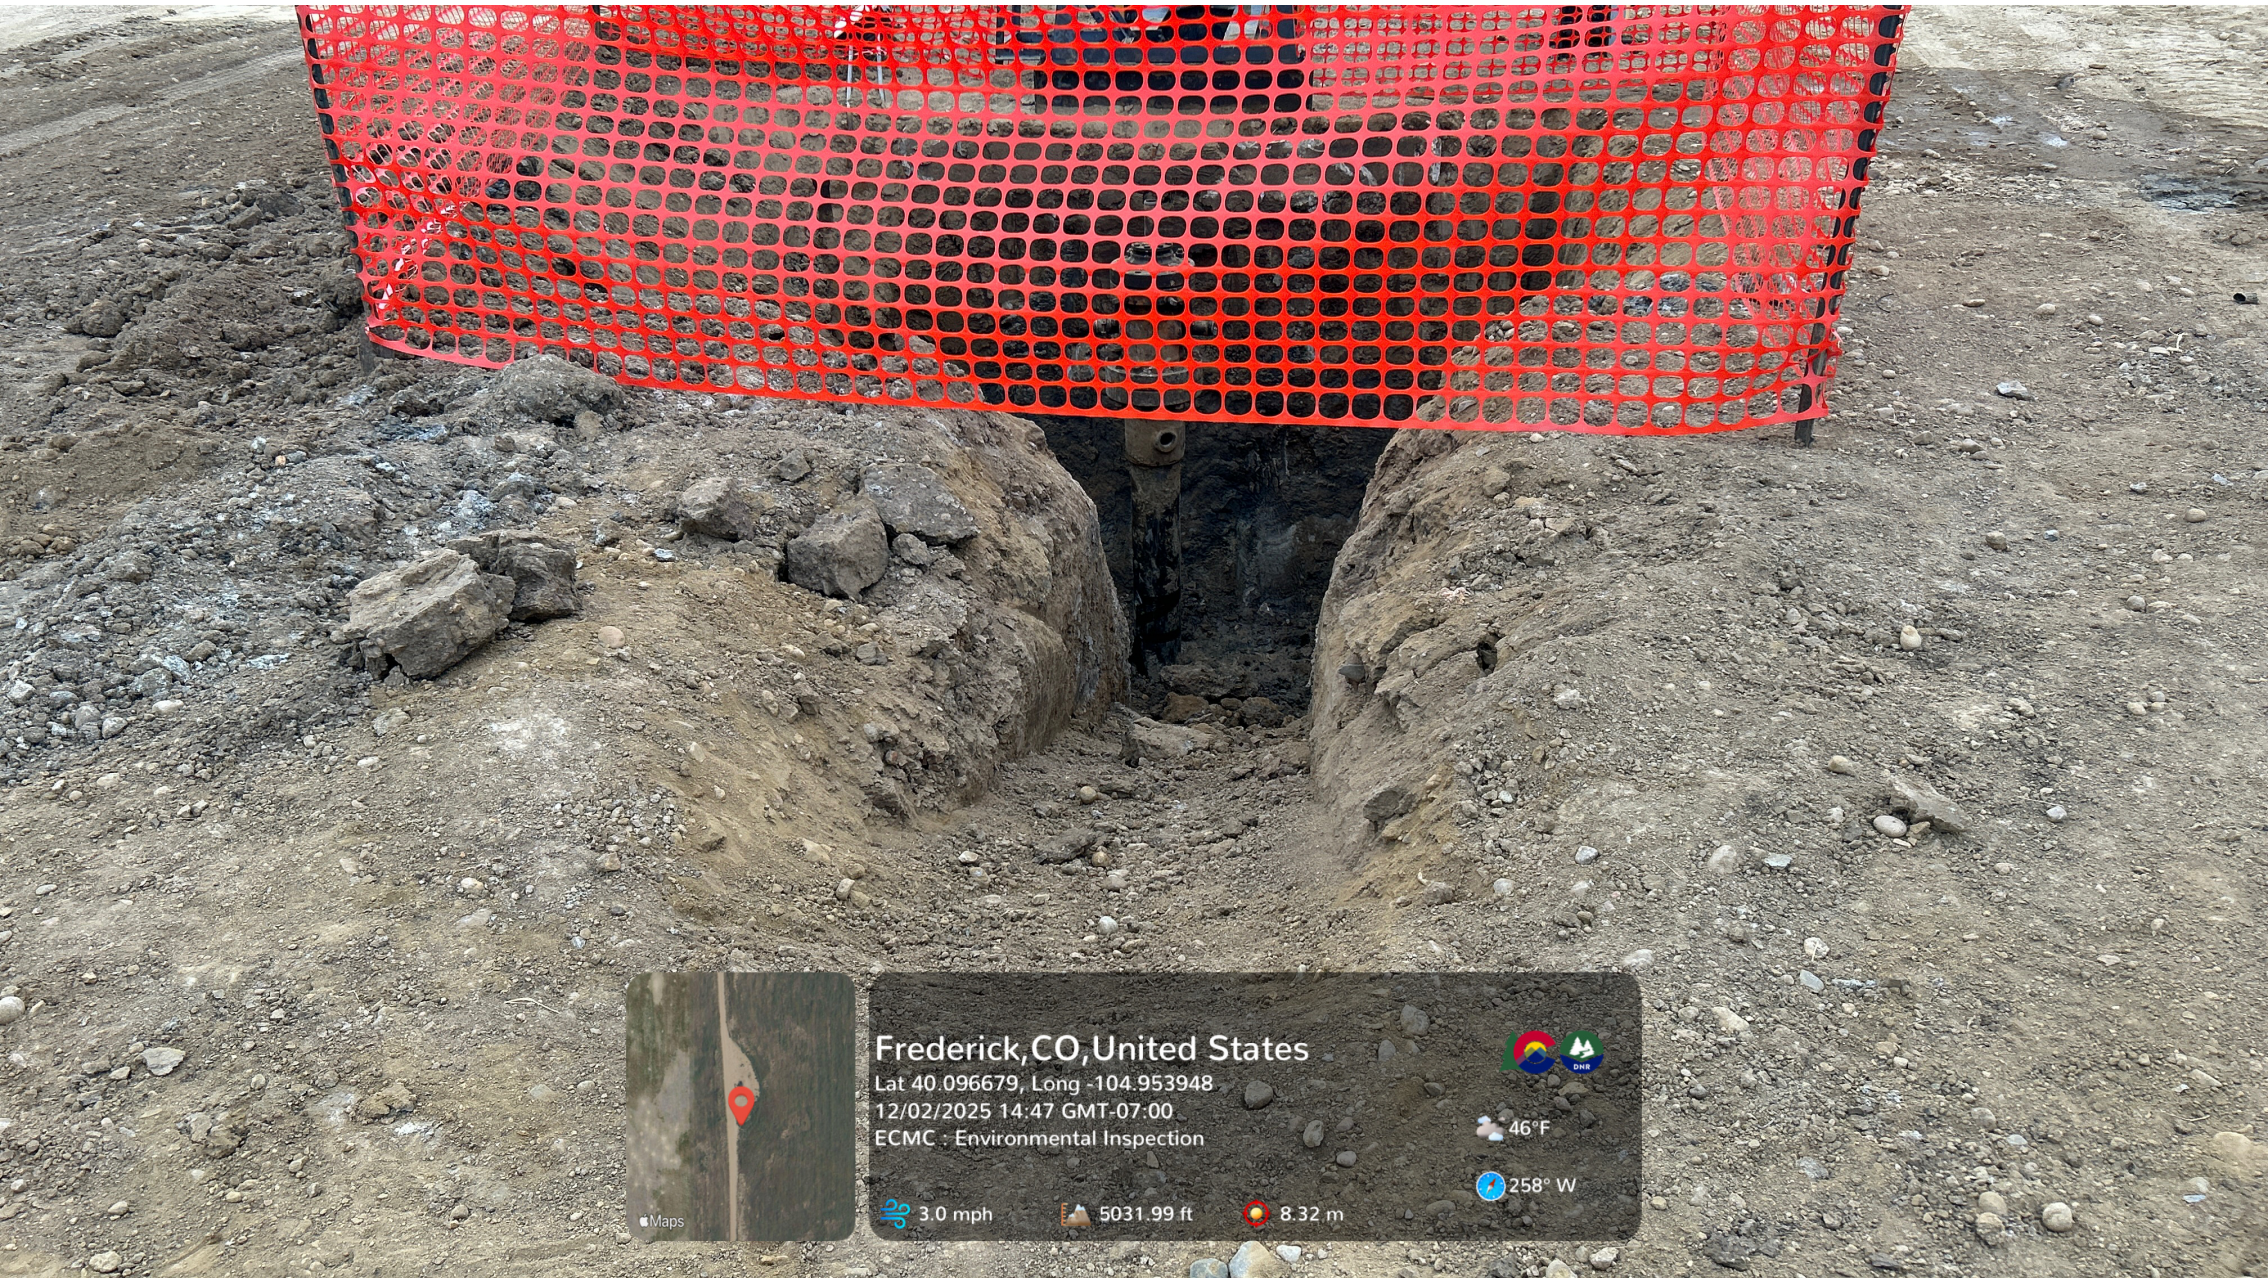
Orange construction fencing has been installed but does not fully encompass the perimeter of the excavation.

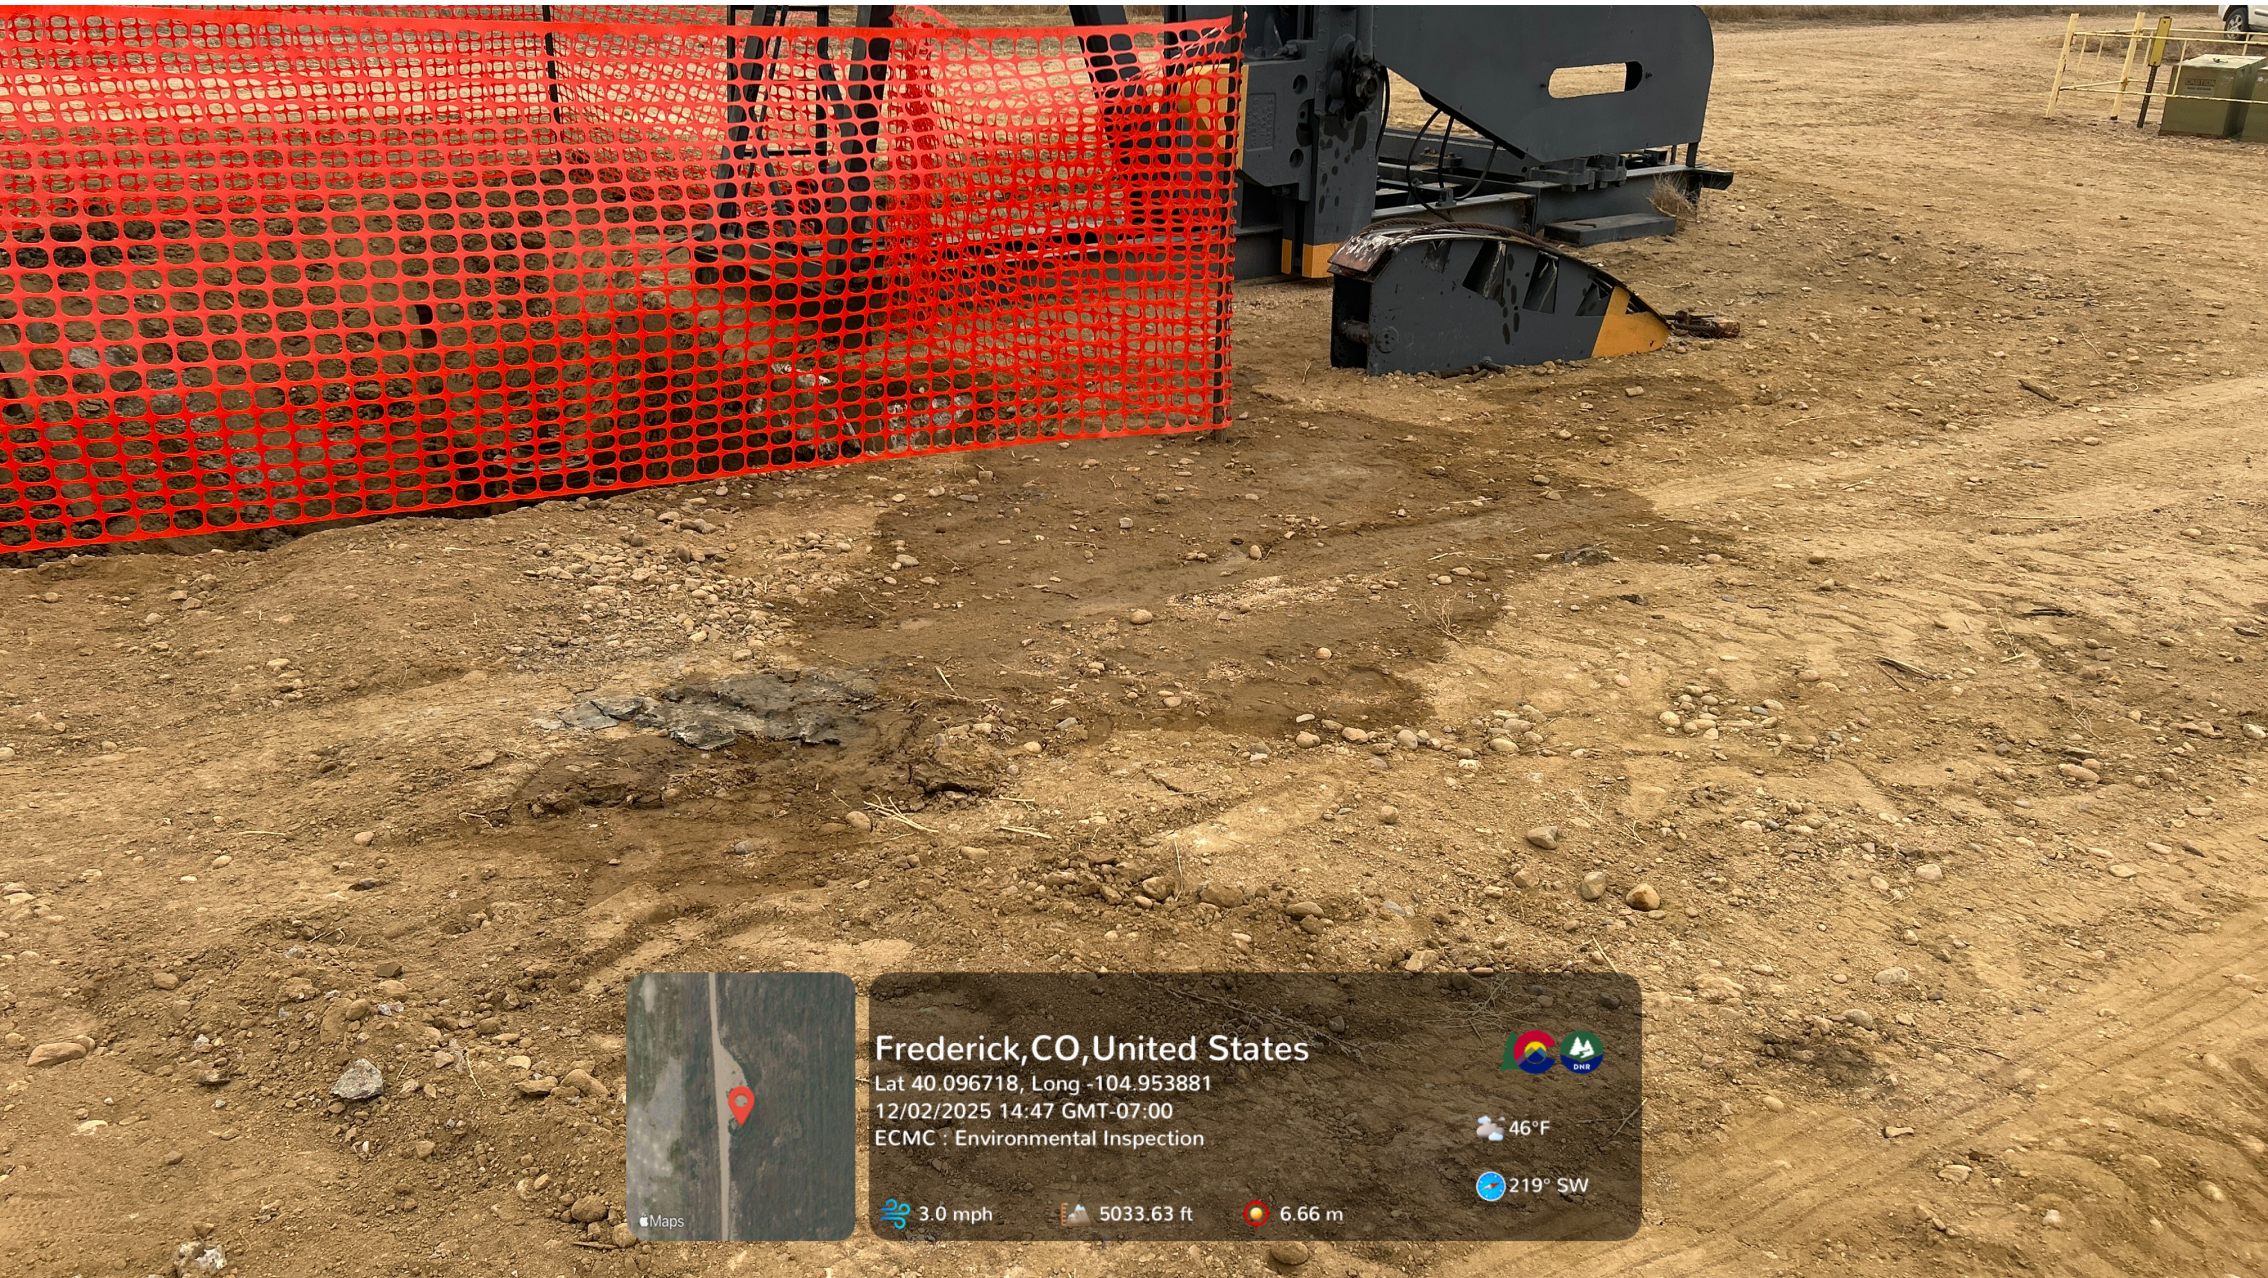
Wet/stained soil is visible adjacent to the well.

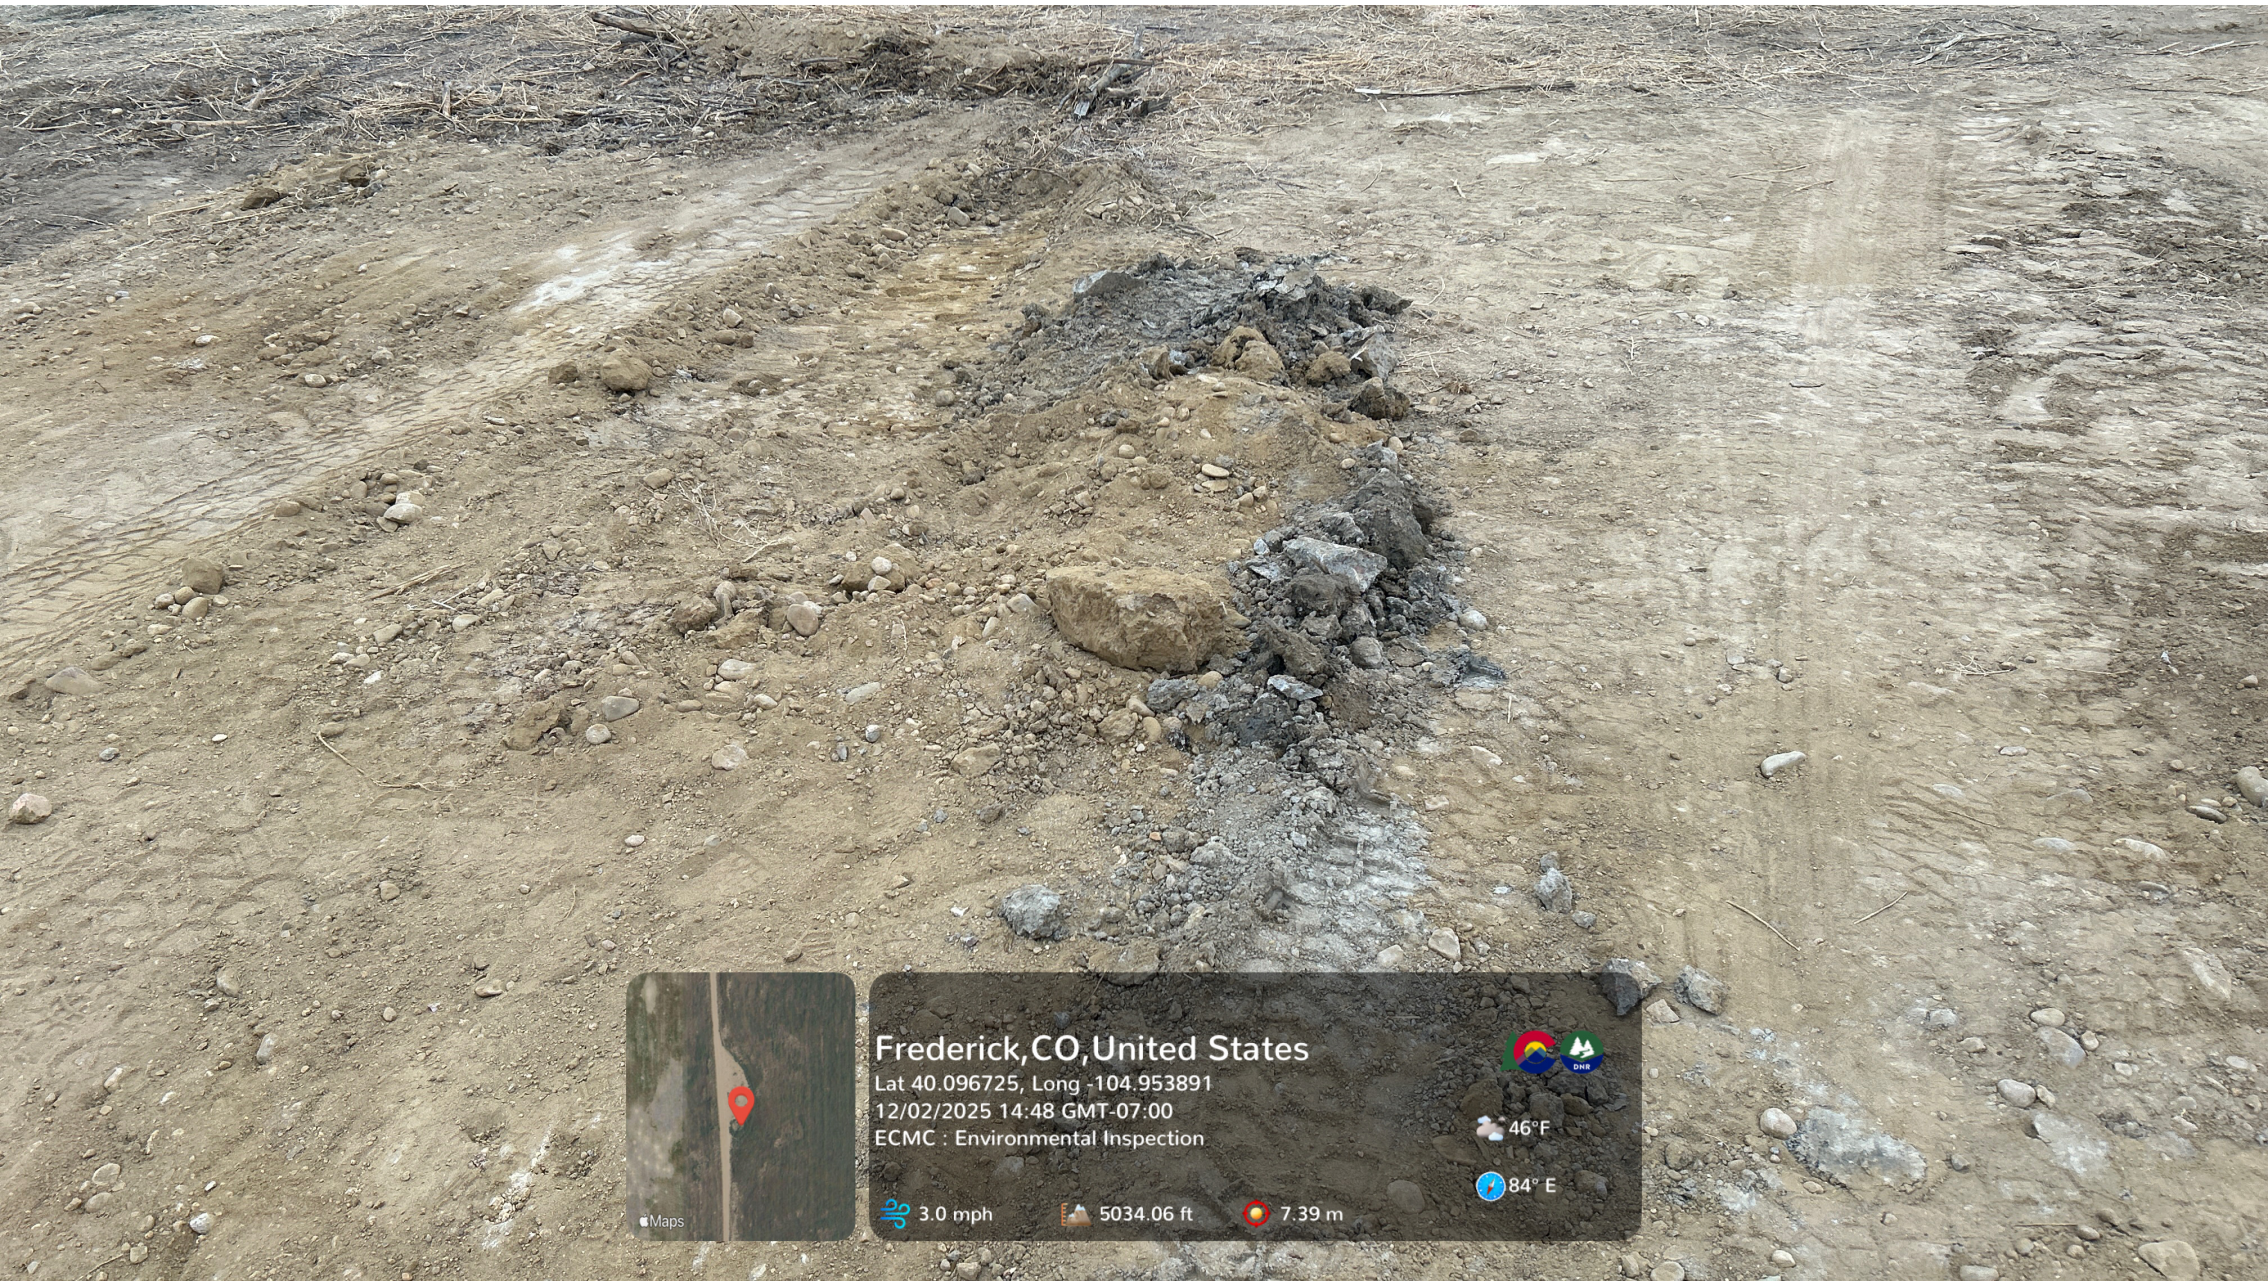
Gray staining is visible on location. A petroleum hydrocarbon odor was observed when the stained soil was disturbed.

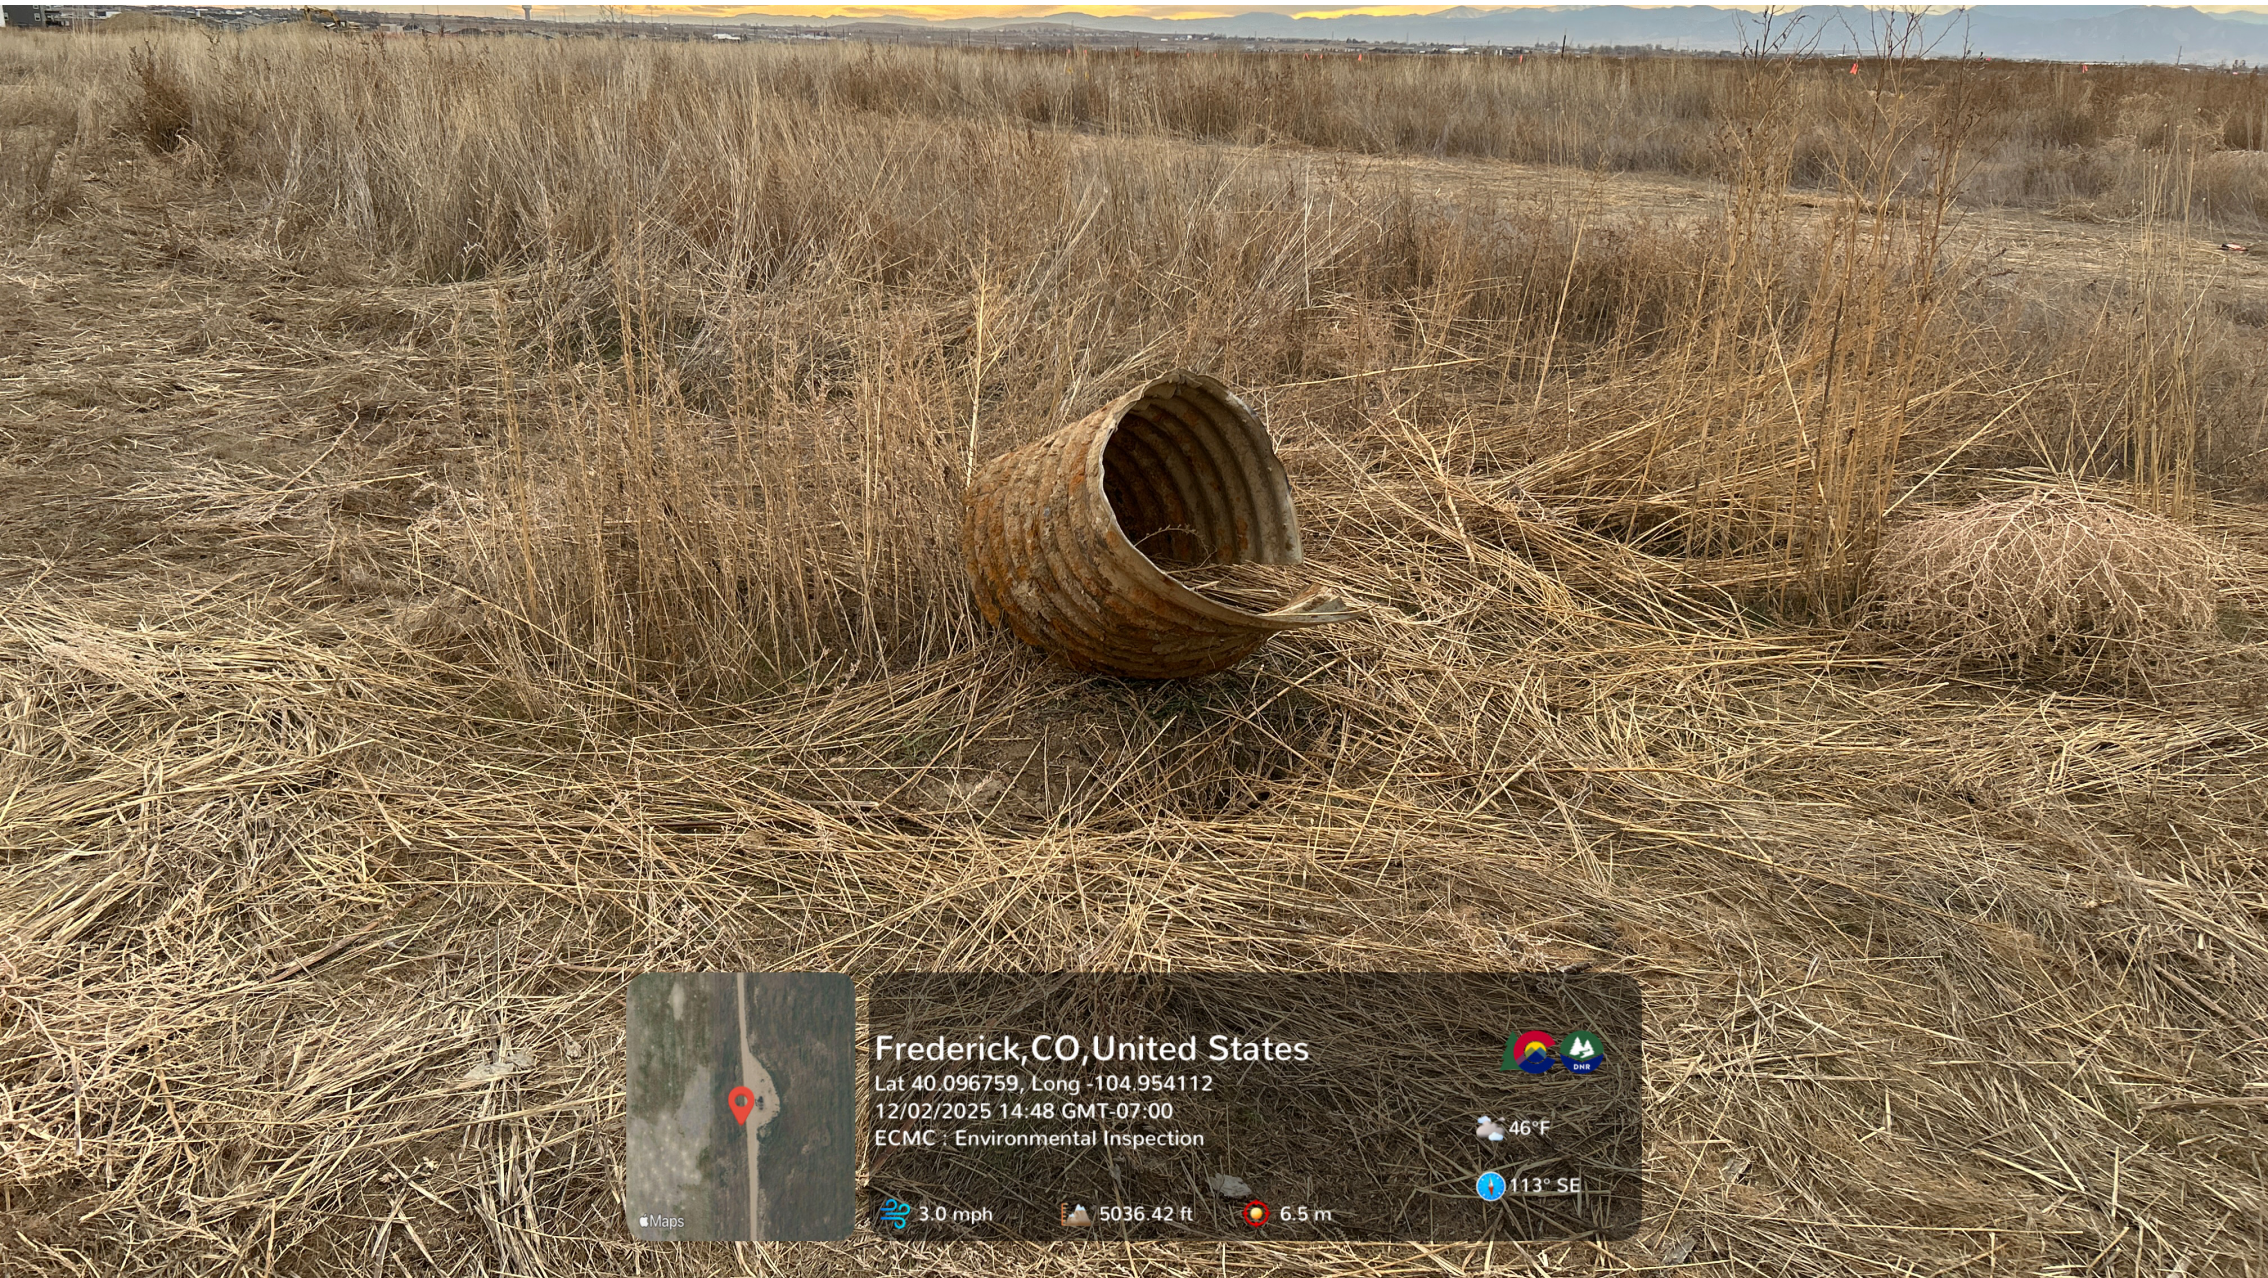
Trash is visible adjacent to the location.
