Inspection Photos  
Location Name: C. Korf 2-19  
API Number: 125-06977

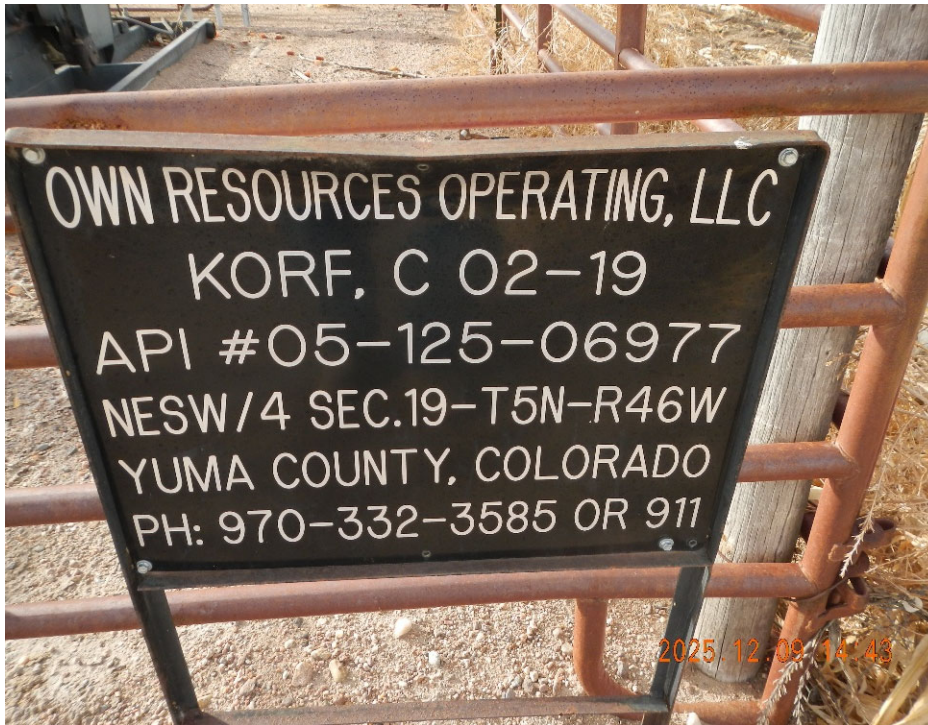
1. Lease sign at well location.

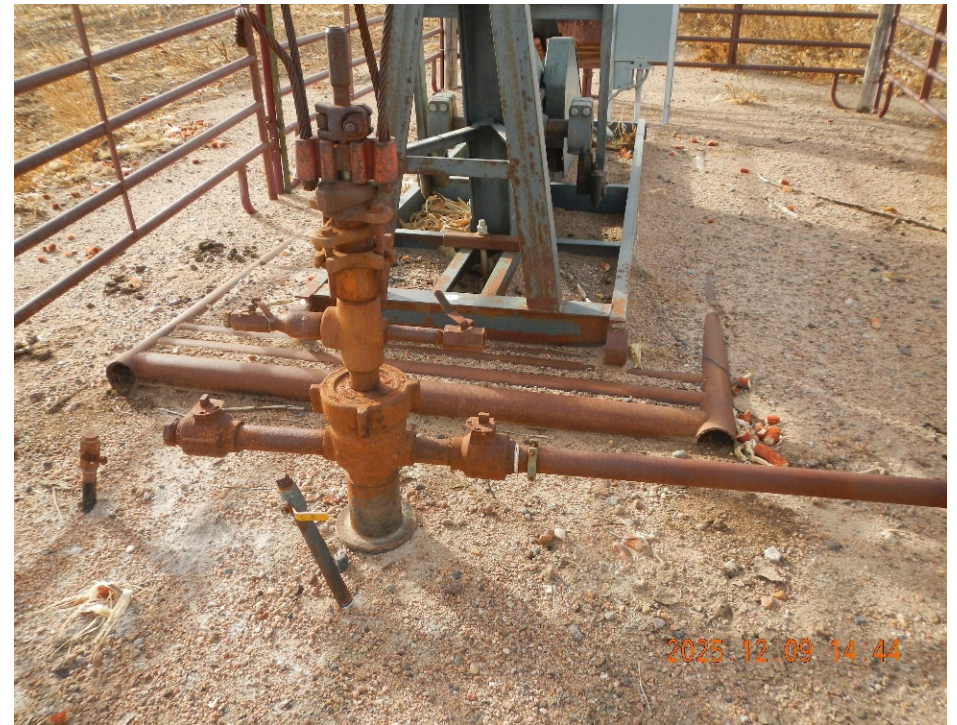
2. View of wellhead. Note open-ended line on tubing water leg.

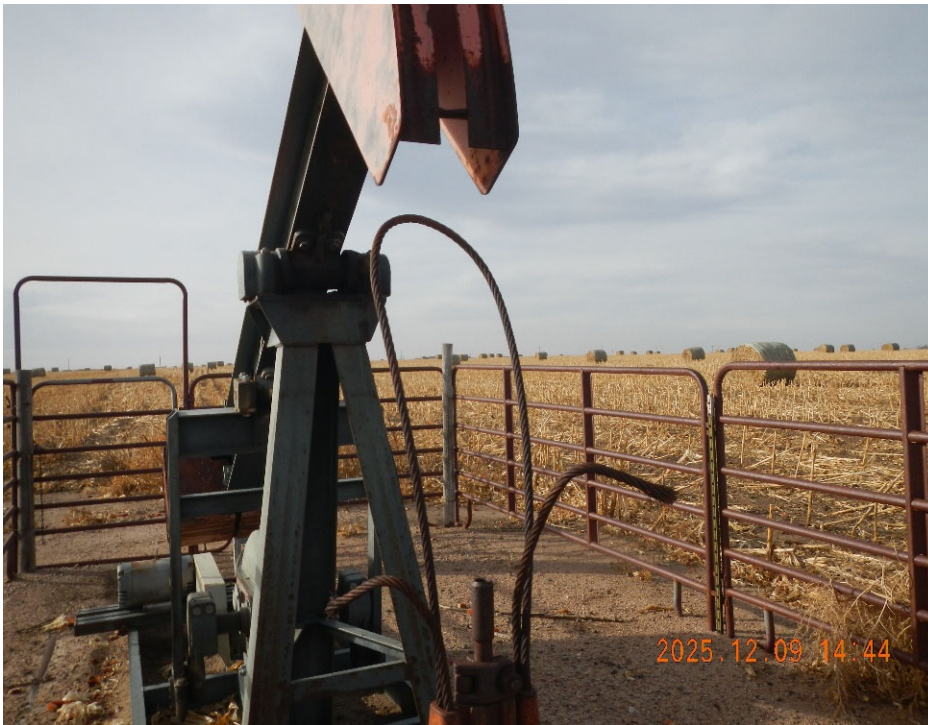
**3. Bridle disconnected from Horsehead.**

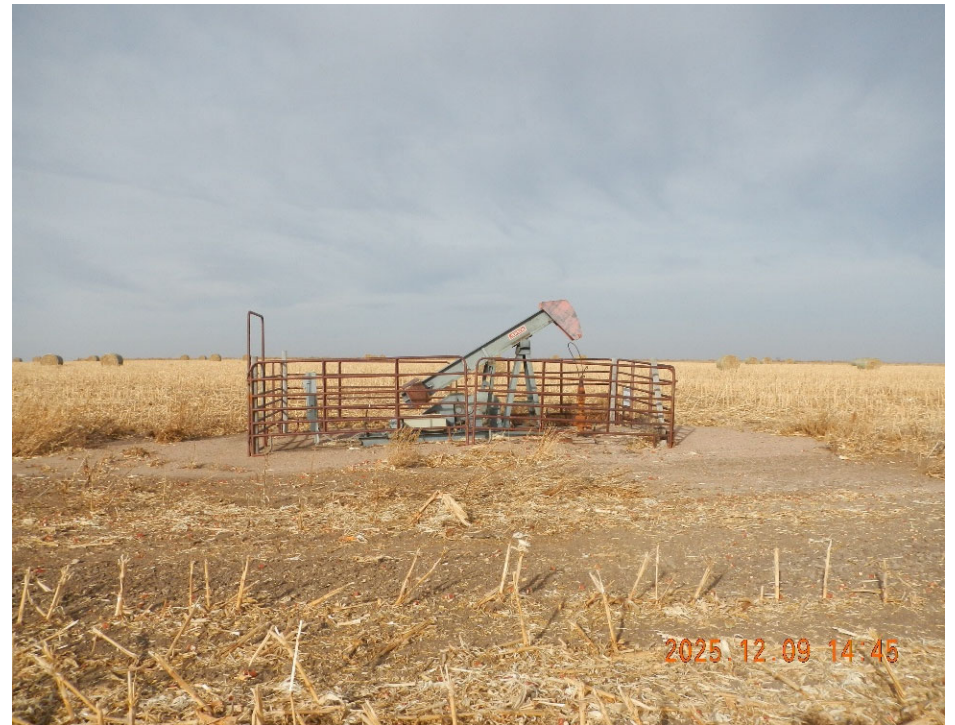
**4. Well location overview.**

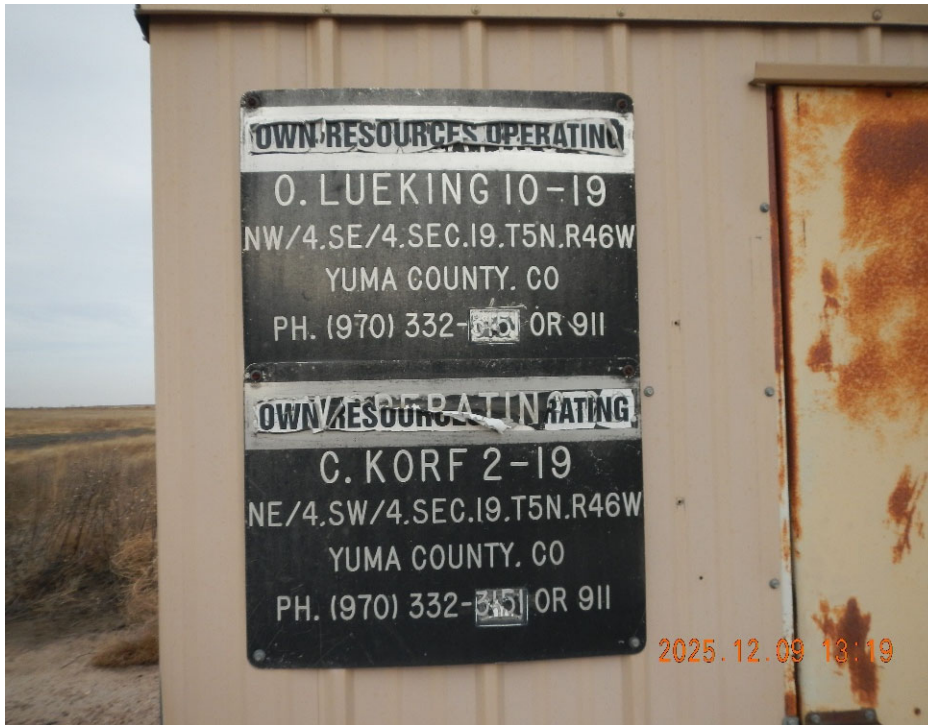
5. Lease sign at gathering location.

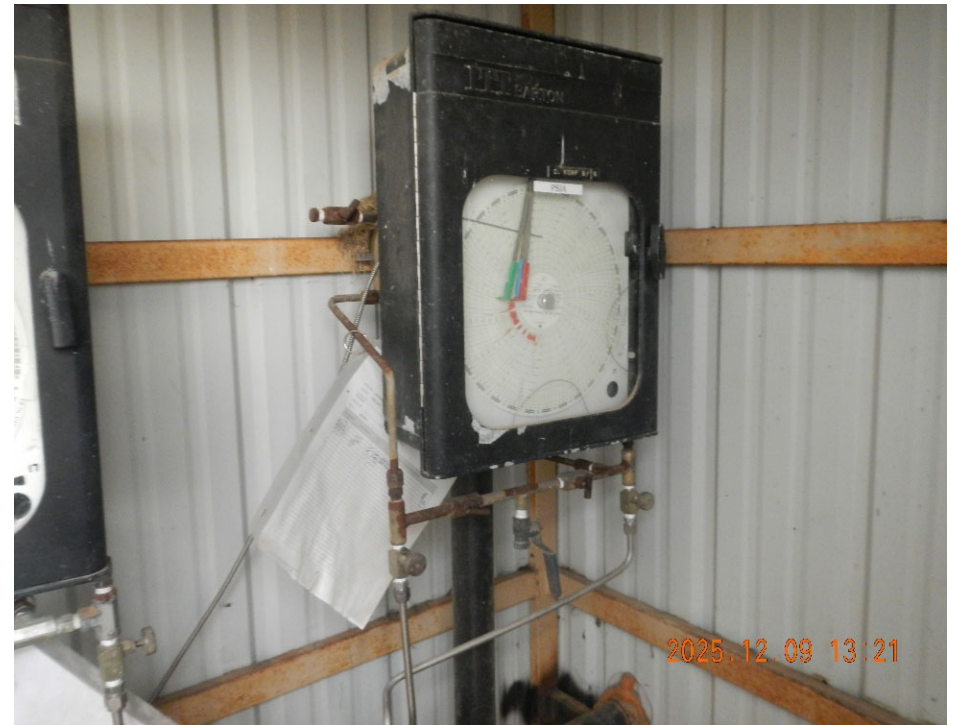
6. Gas meter inside meter shed.

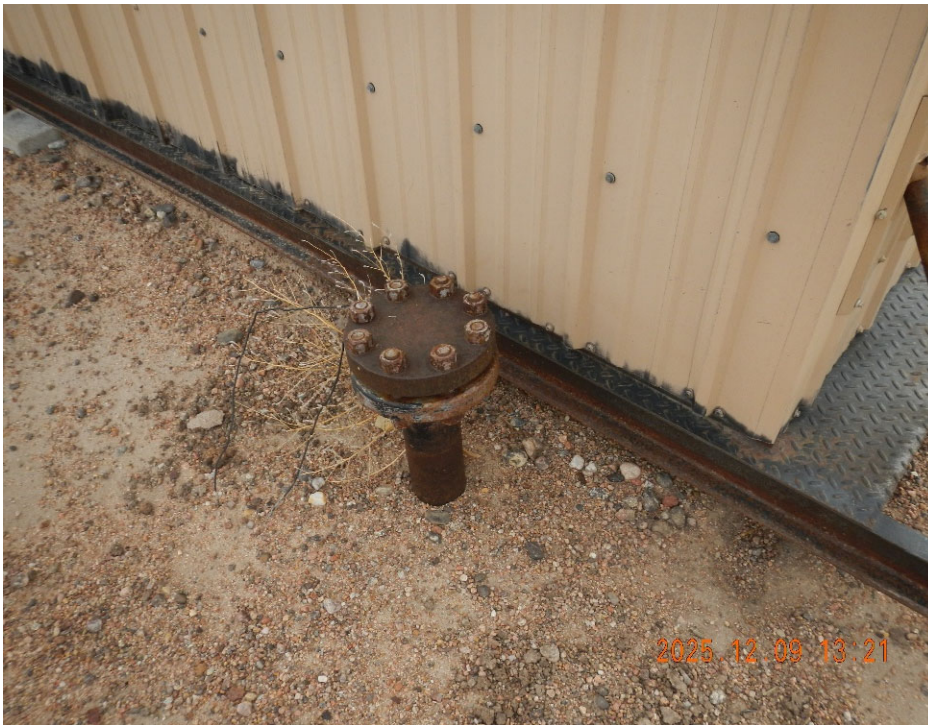
**7. Flowline riser at gathering location with bolted cap.**

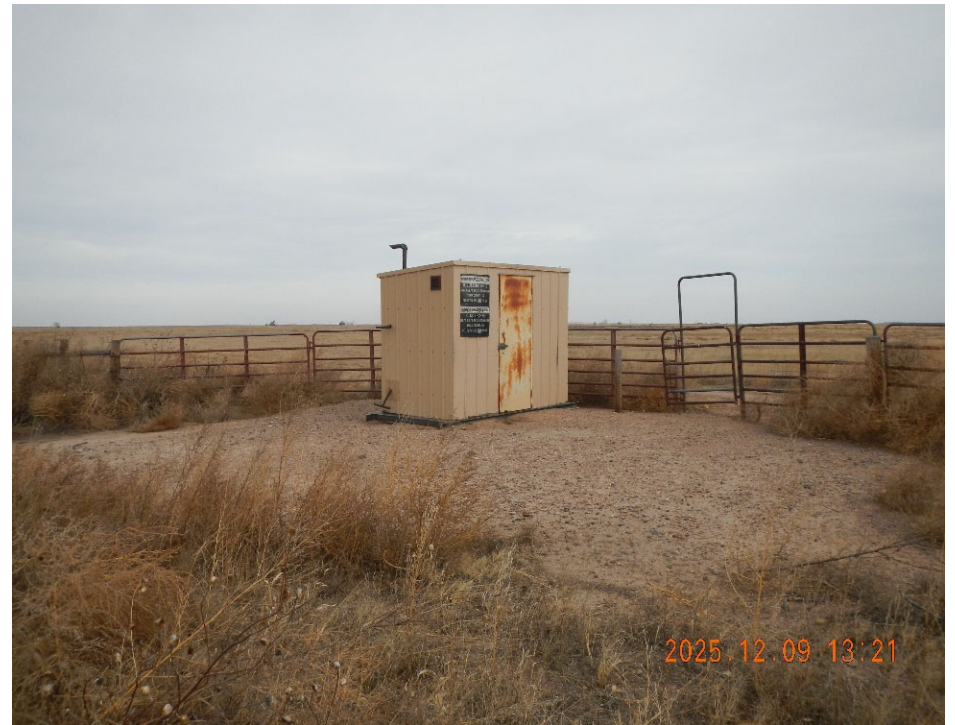
**8. Gathering location overview.**
