Inspection/Audit Photos

Location: QB ENERGY OPERATING LLC FEDERAL #2S-95-15-22 PAD

Location ID: 335858

Date: 11/24/2025

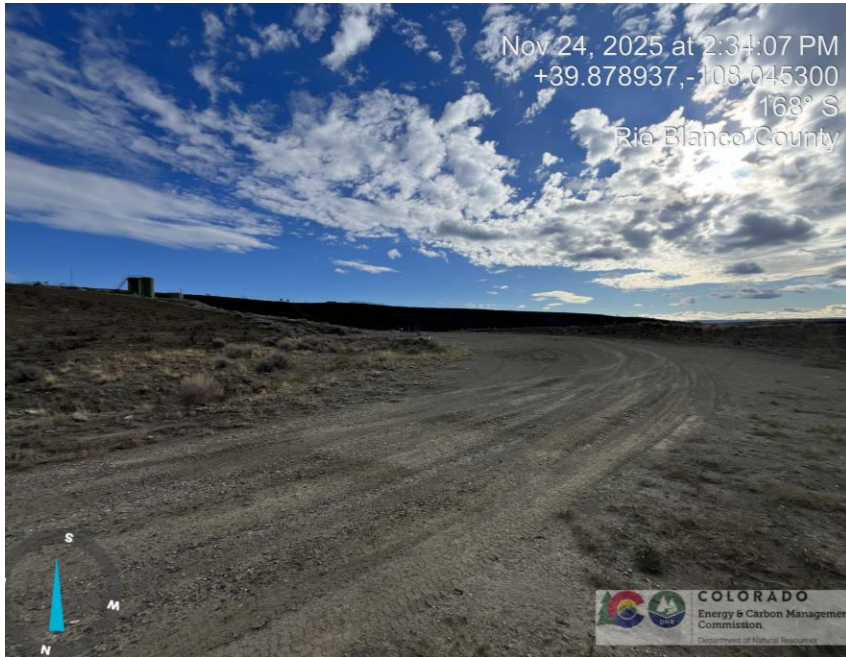
Photo # 4457 Entrance to location

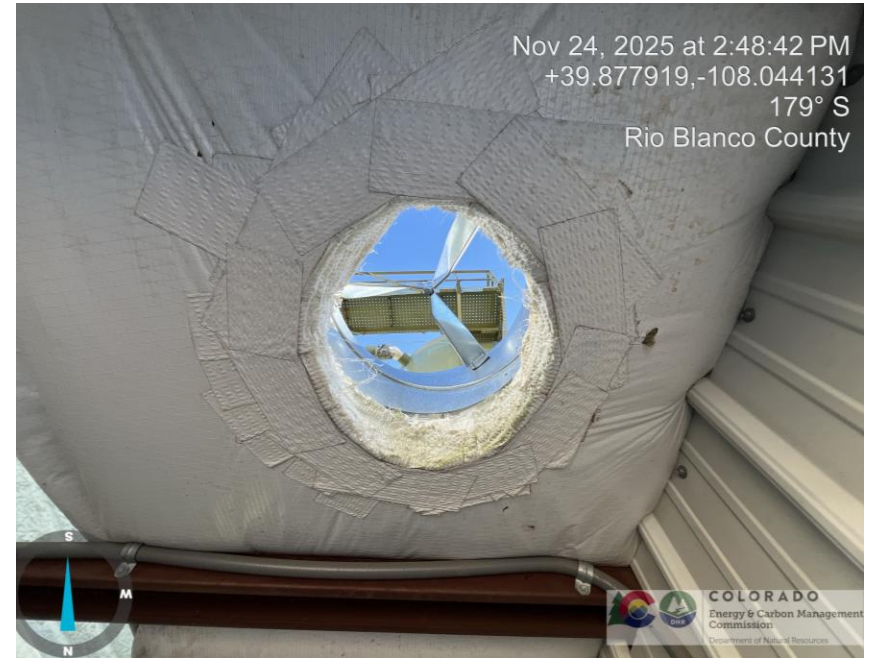
Photo # 4471 Vent in pump house open to wildlife/available for entry by wildlife

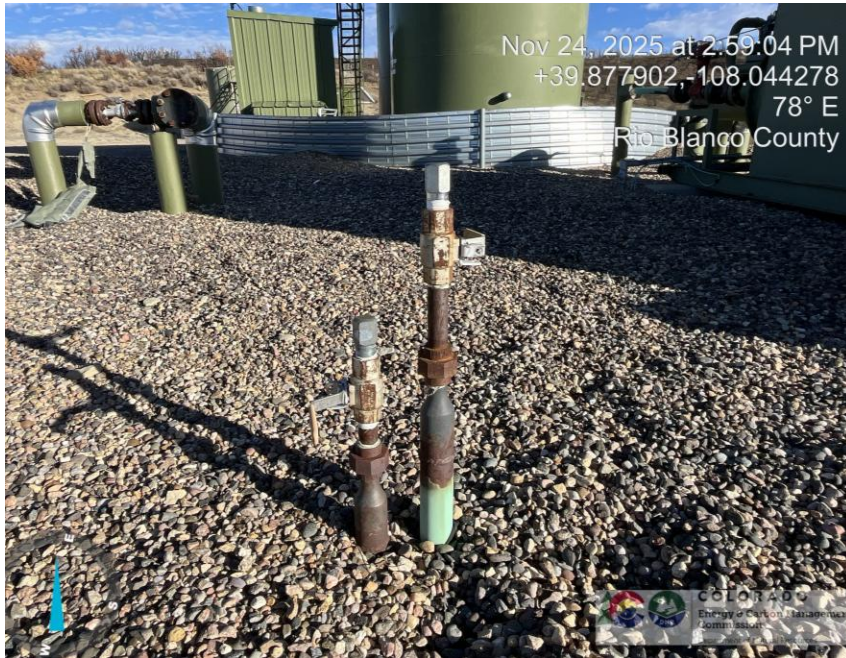
Photo # 4487 Unused flowlines lack lockout tagout (OOSLAT)

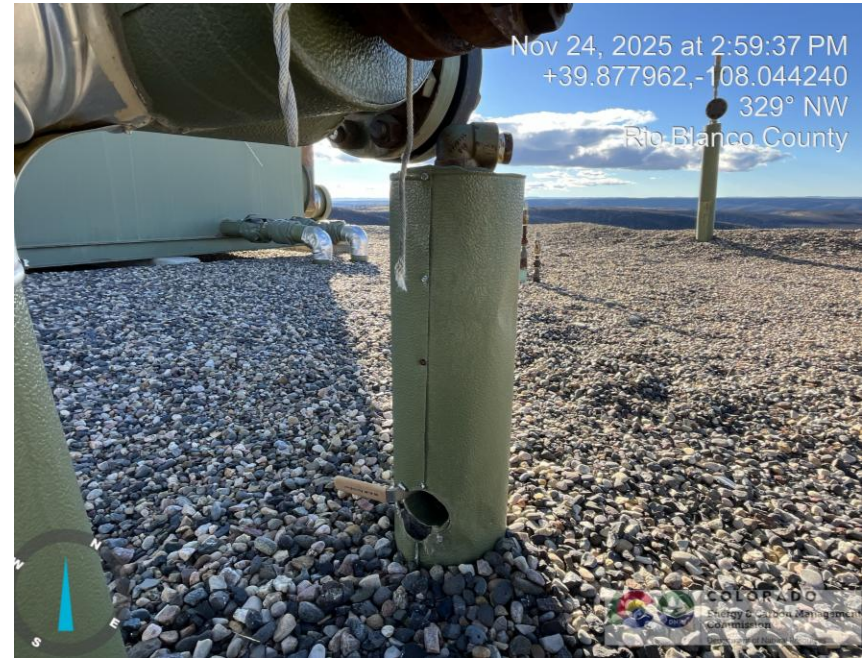
Photo # 4488 Unused flowline lack lockout tagout (OOSLAT)

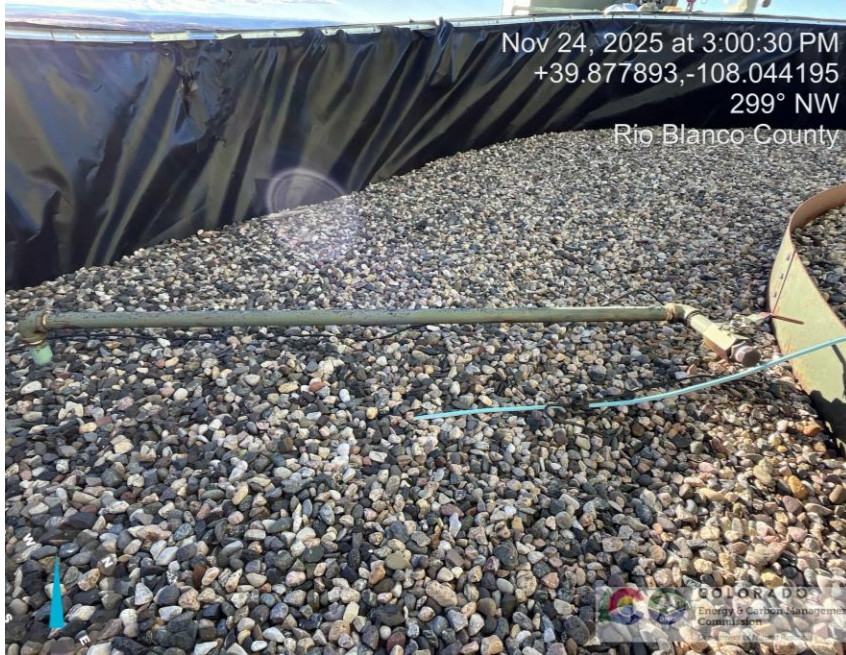
Photo # 4489 Unused flowline lack lockout tagout (OOSLAT

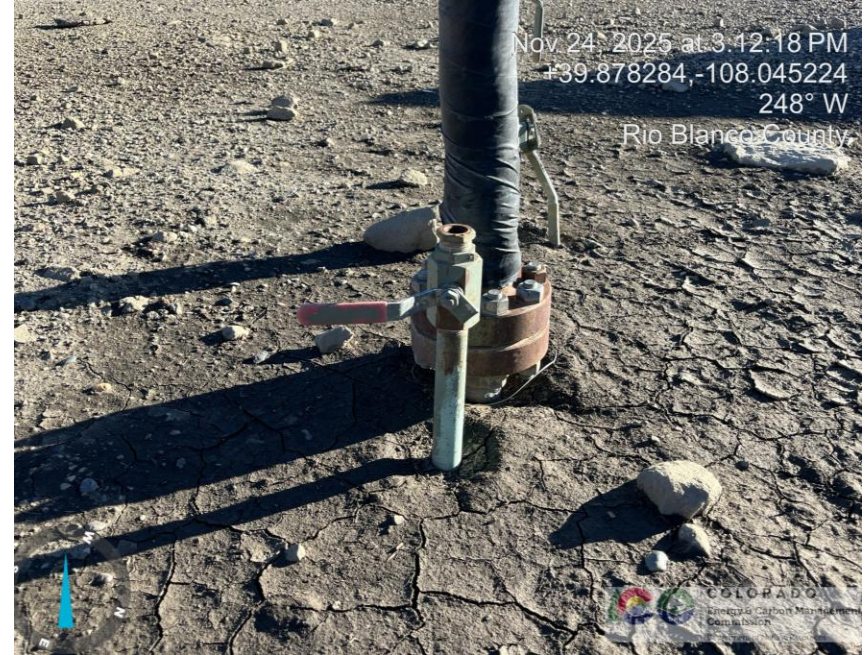
Photo # 4493 Unused flowline lack lockout tagout (OOSLAT

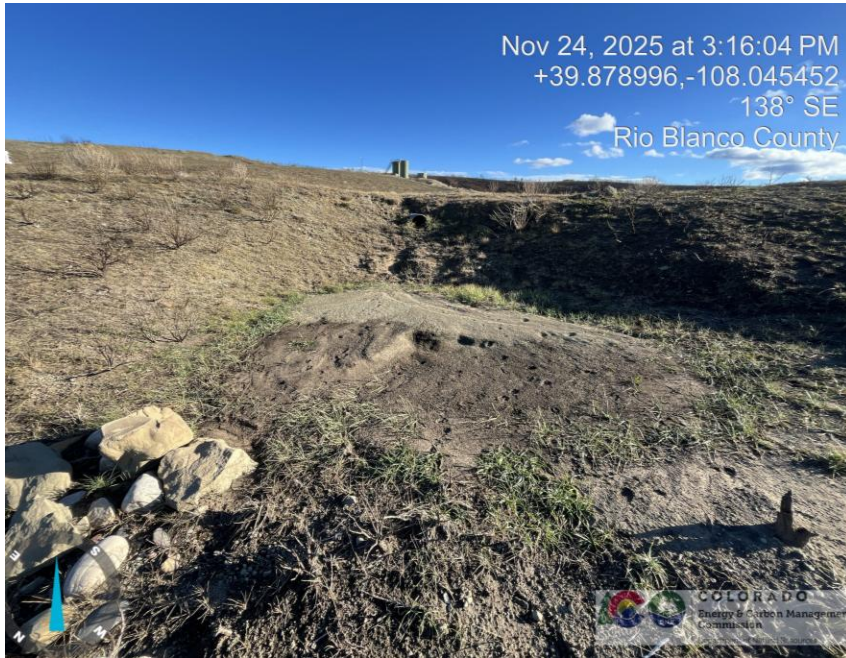
Photo # 4497 Sediment migrating off location and choking off vegetation/insufficient BMP's

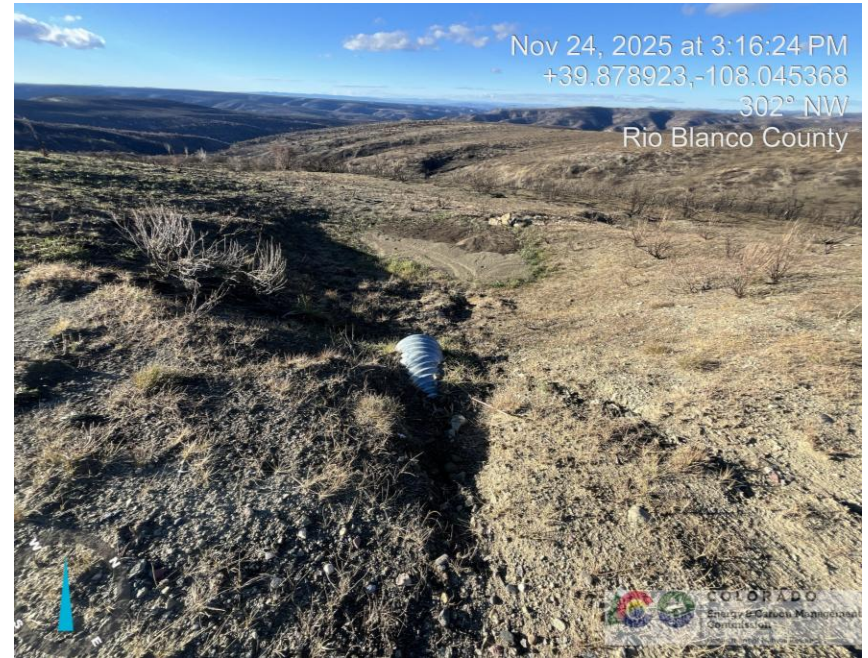
Photo # 4498 Sediment migrating off location and choking off vegetation/insufficient BMP's

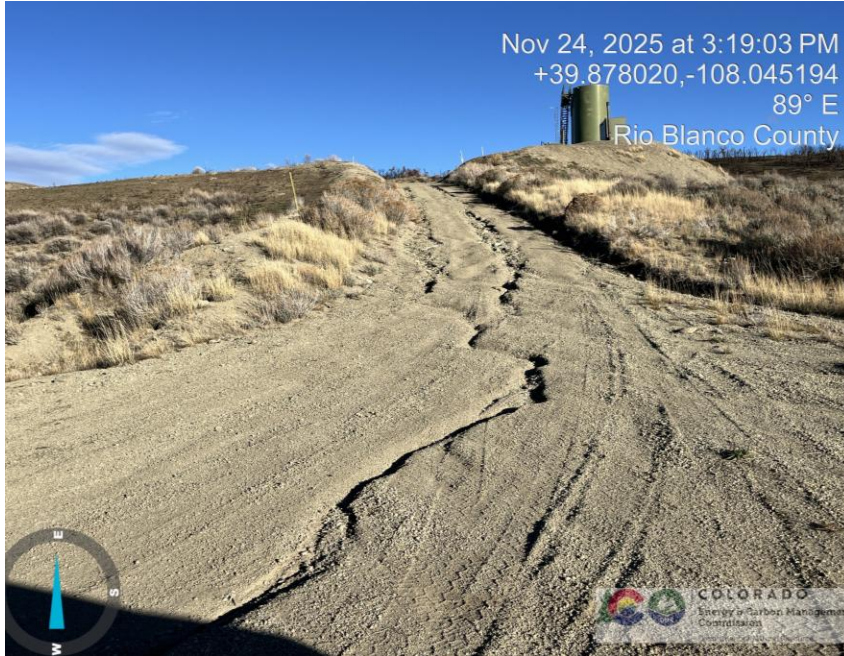
Photo # 4501 Insufficient erosion control on lease road; rill erosion cutting down lease road/insufficient BMP's

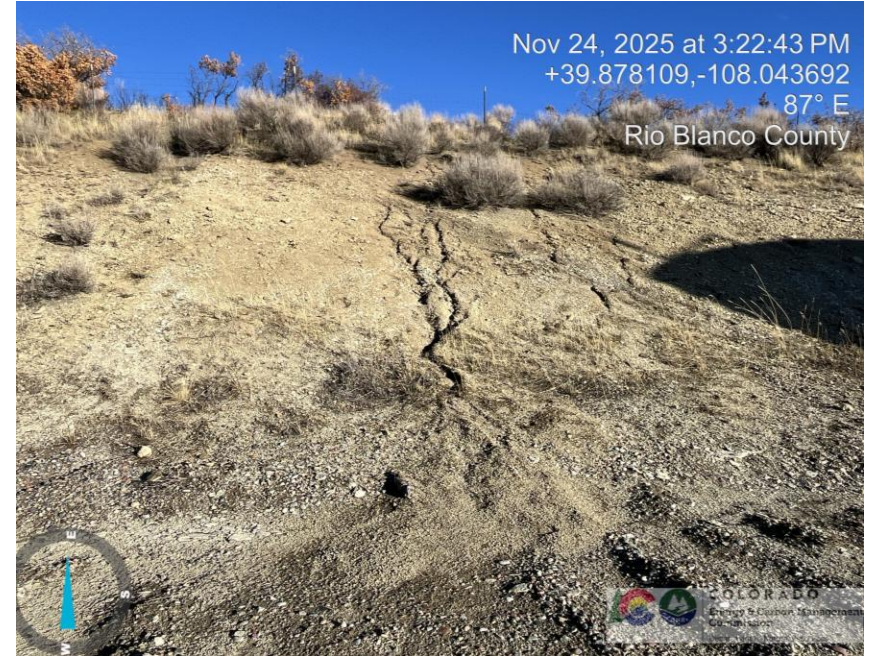
Photo # 4503 Rill erosion & transport of sediment on cut slope/sediment migrating onto location/insufficient BMP's

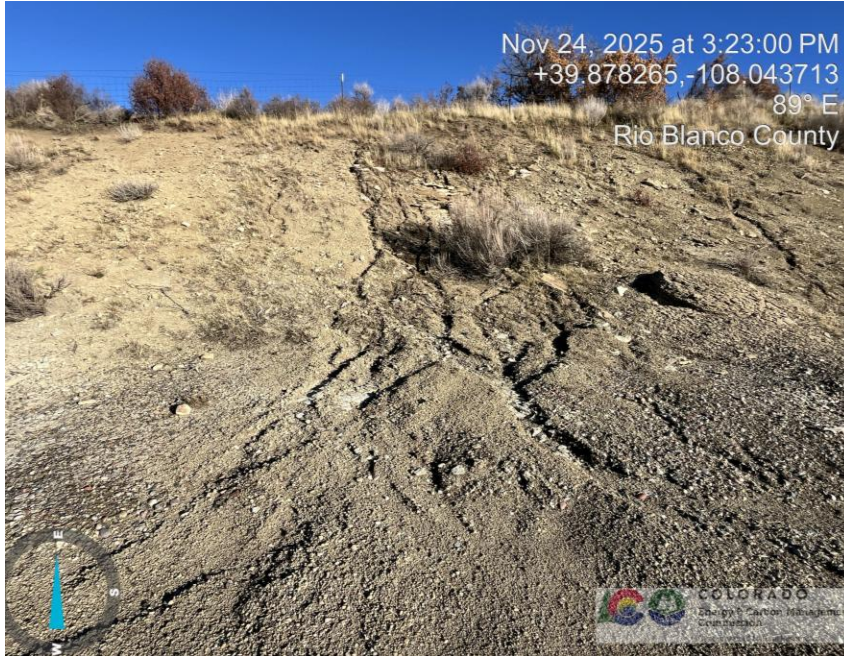
Photo # 4504 Rill erosion & transport of sediment on cut slope/sediment migrating onto location/insufficient BMP's

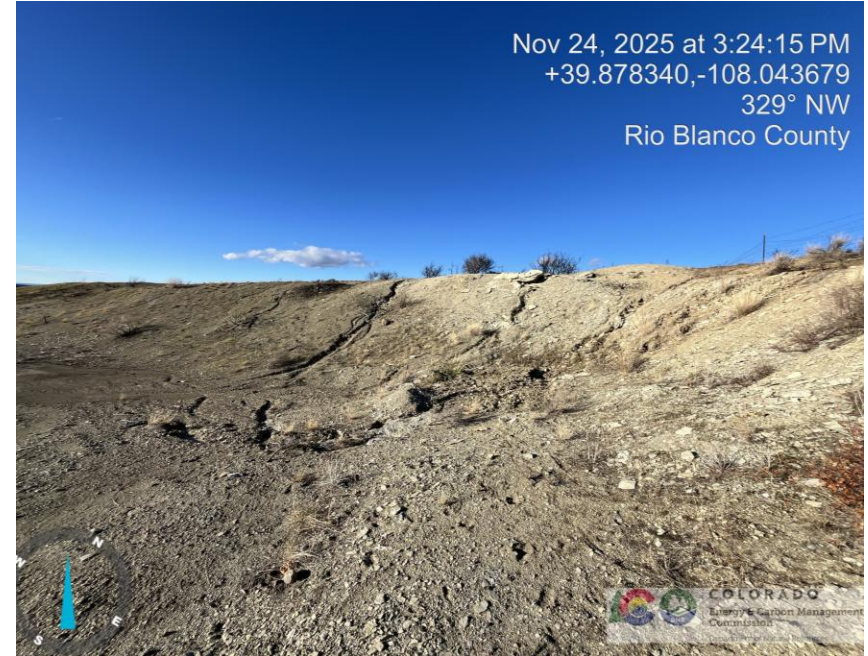
Photo # 4505 Rill erosion & transport of sediment on cut slope/sediment migrating onto location/insufficient BMP's

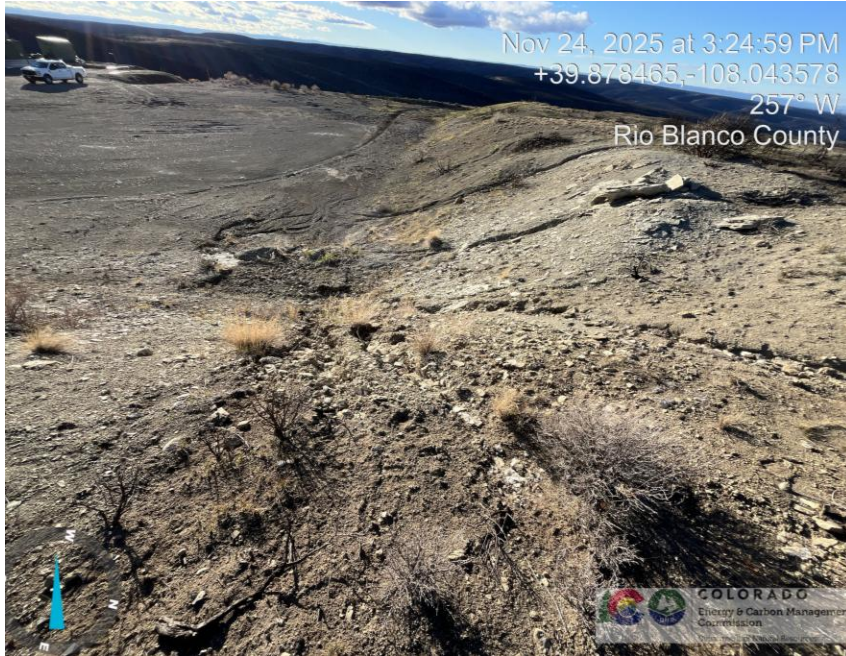
Photo # 4506 Rill erosion & transport of sediment on cut slope/sediment migrating onto location/insufficient BMP's

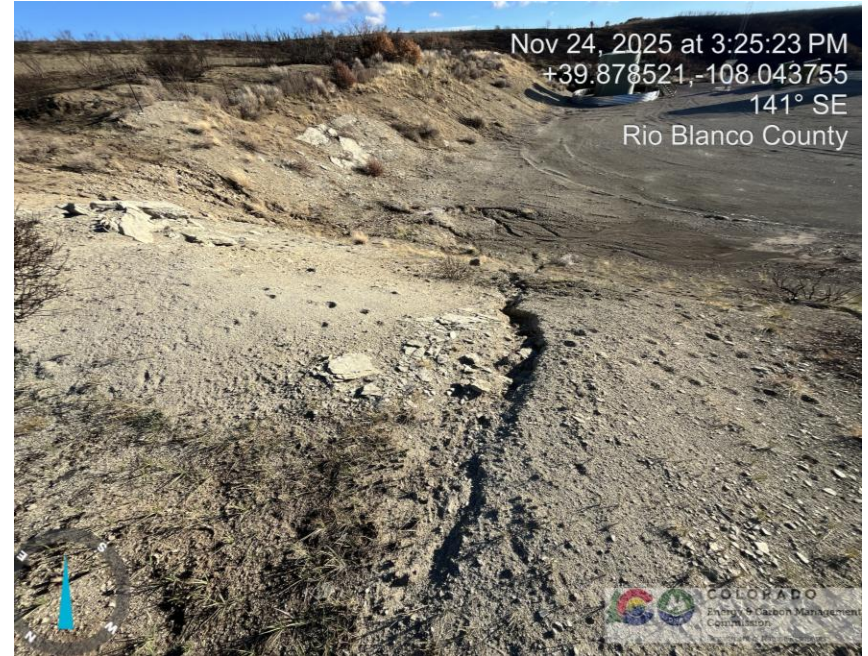
Photo # 4507 Rill erosion & transport of sediment on cut slope/sediment migrating onto location/insufficient BMP's

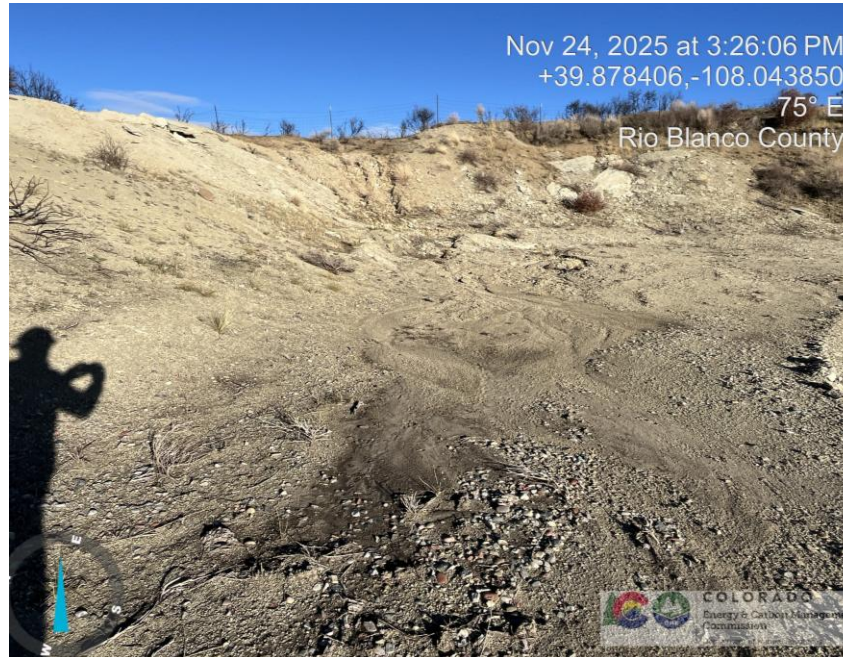
Photo # 4508 Rill erosion & transport of sediment on cut slope/sediment migrating onto location/insufficient BMP's
