WELL NAME: WILLYS 32-8 TR, API #: 071-08688, INSP. # 716301887

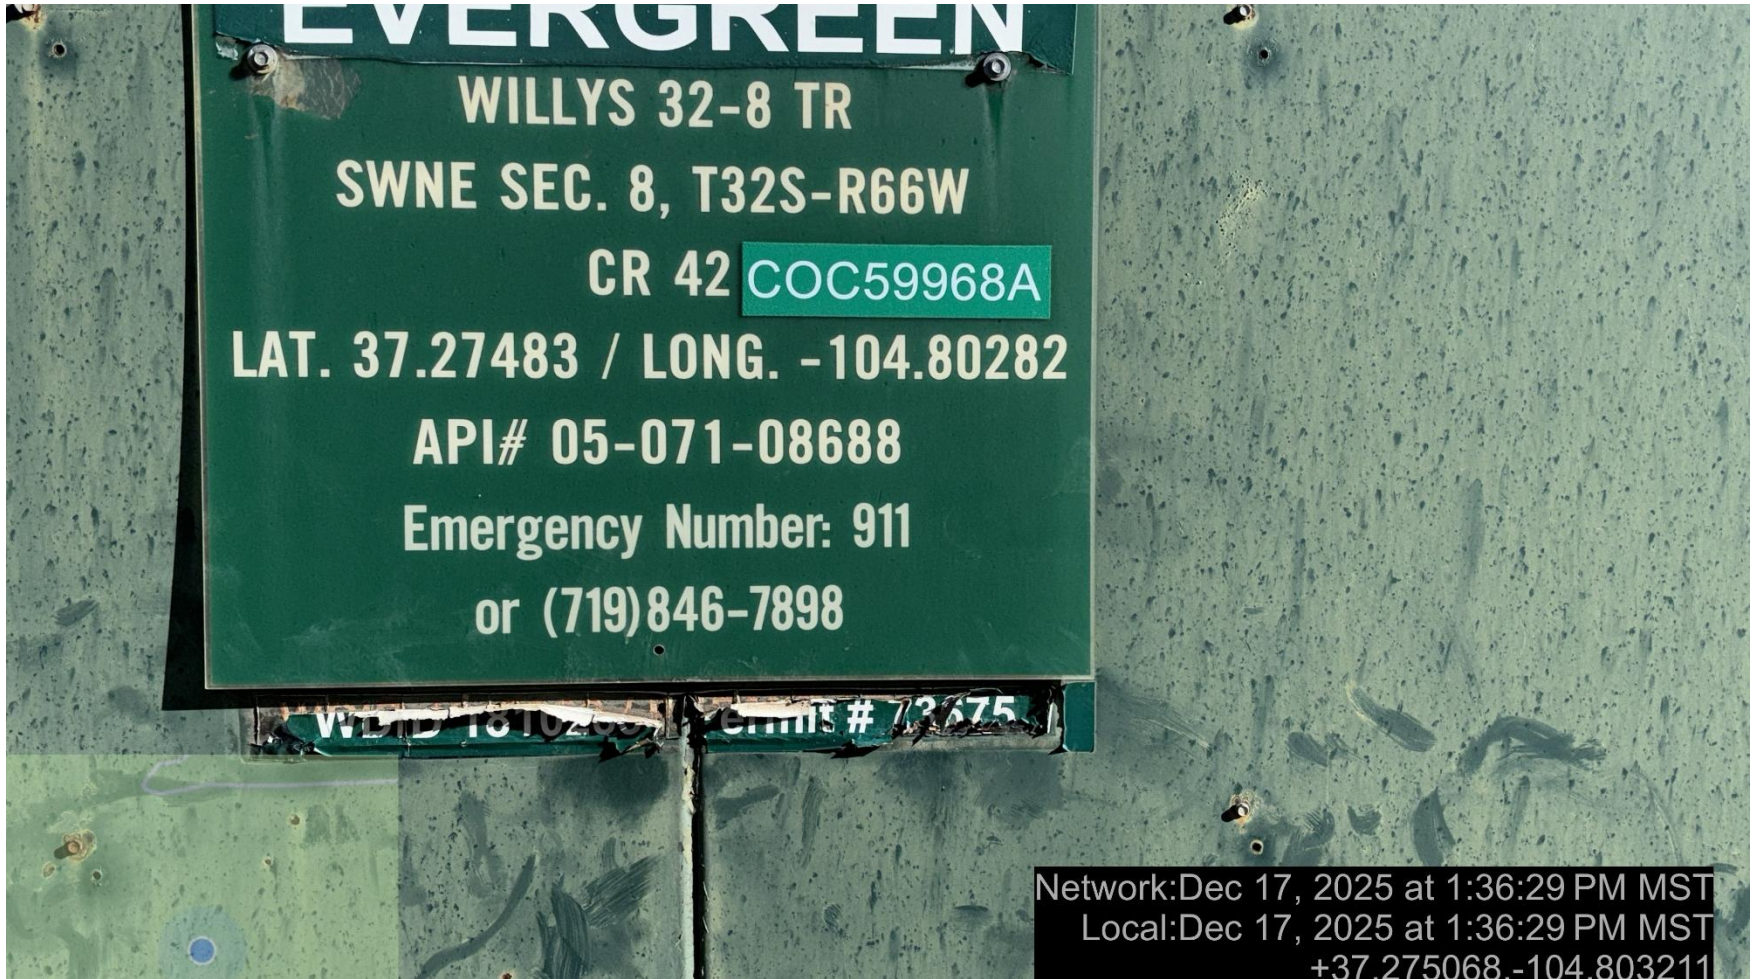
PHOTO 1: WELL SIGN

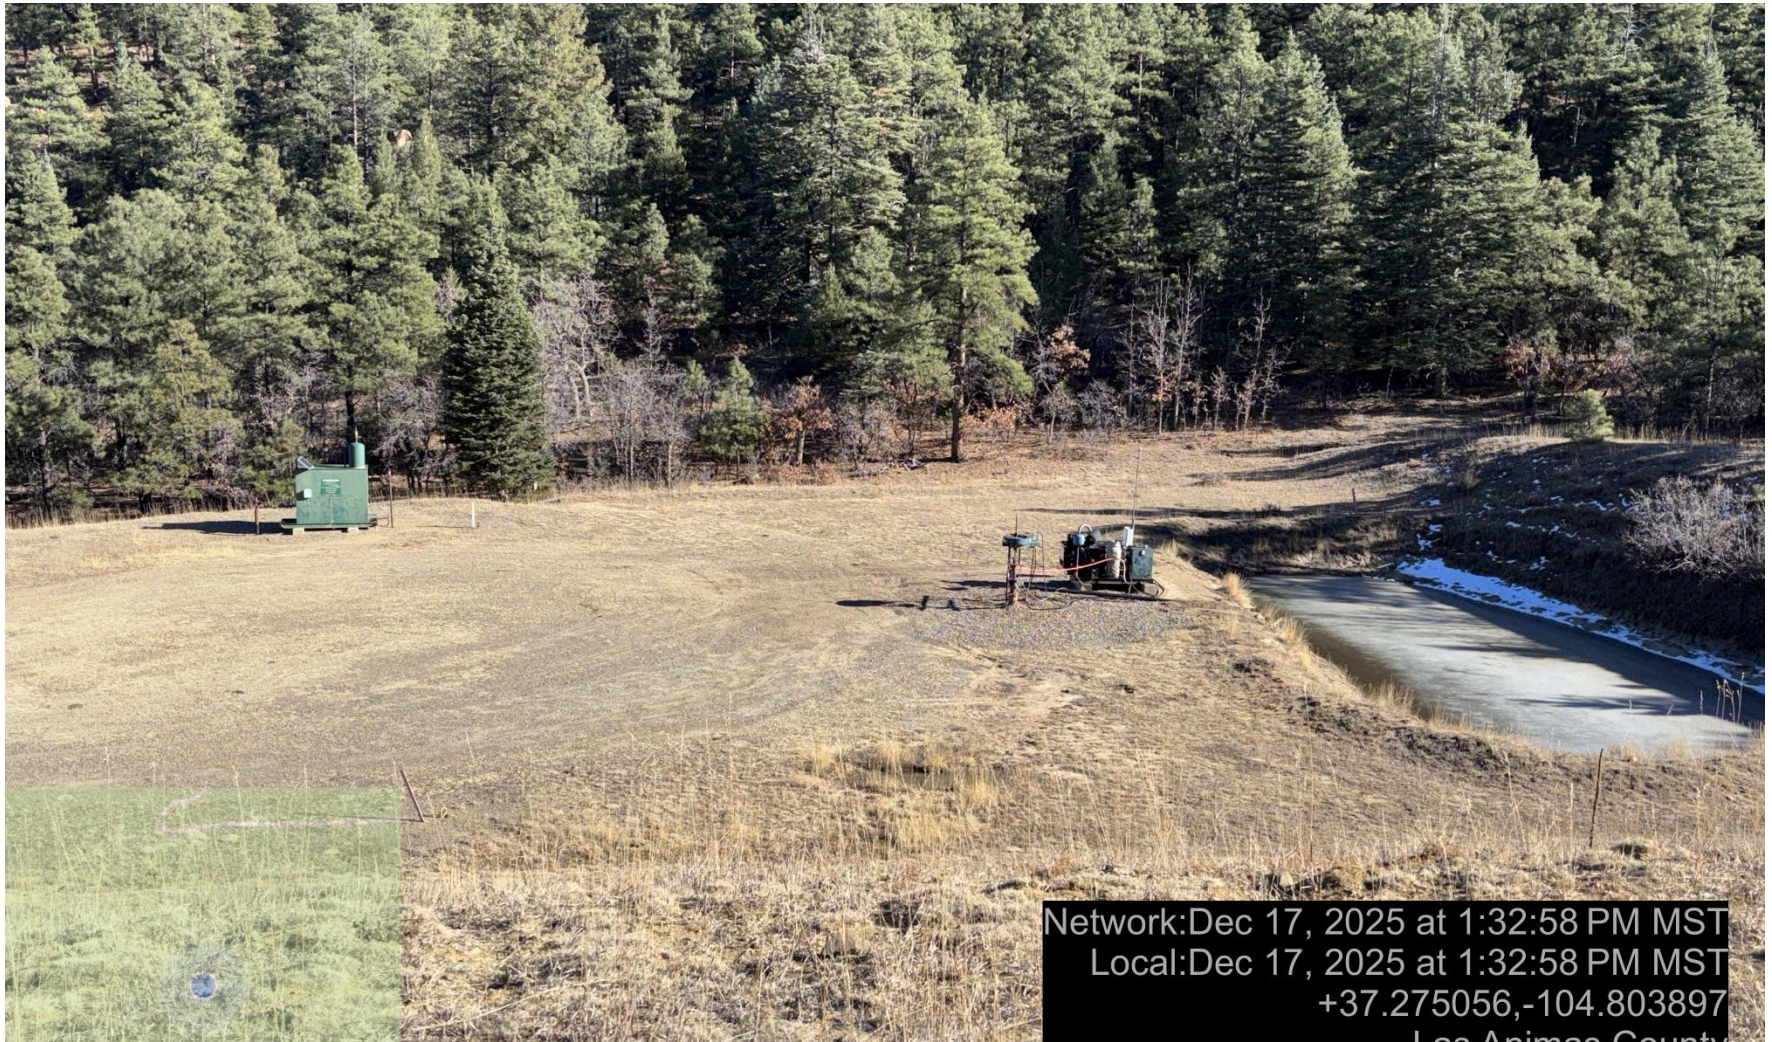
PHOTO 2: LOCATION.

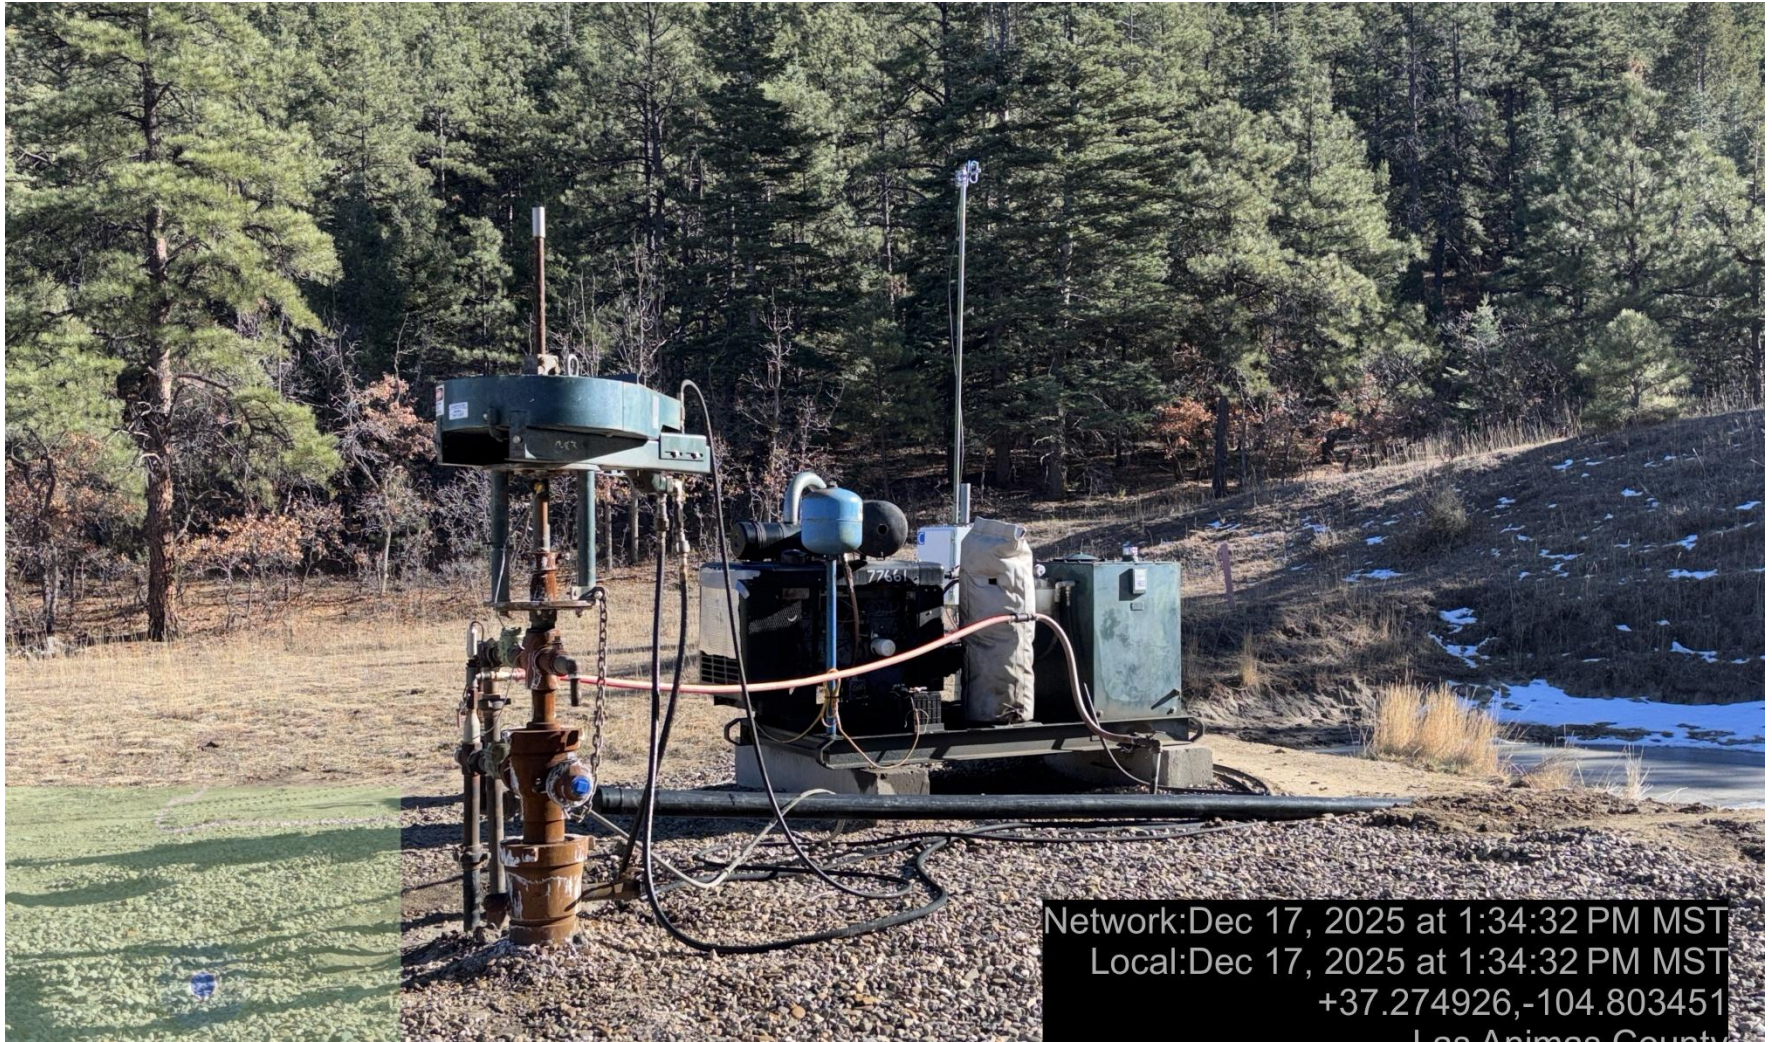
PHOTO 3: WELLHEAD AND EQUIPMENT.

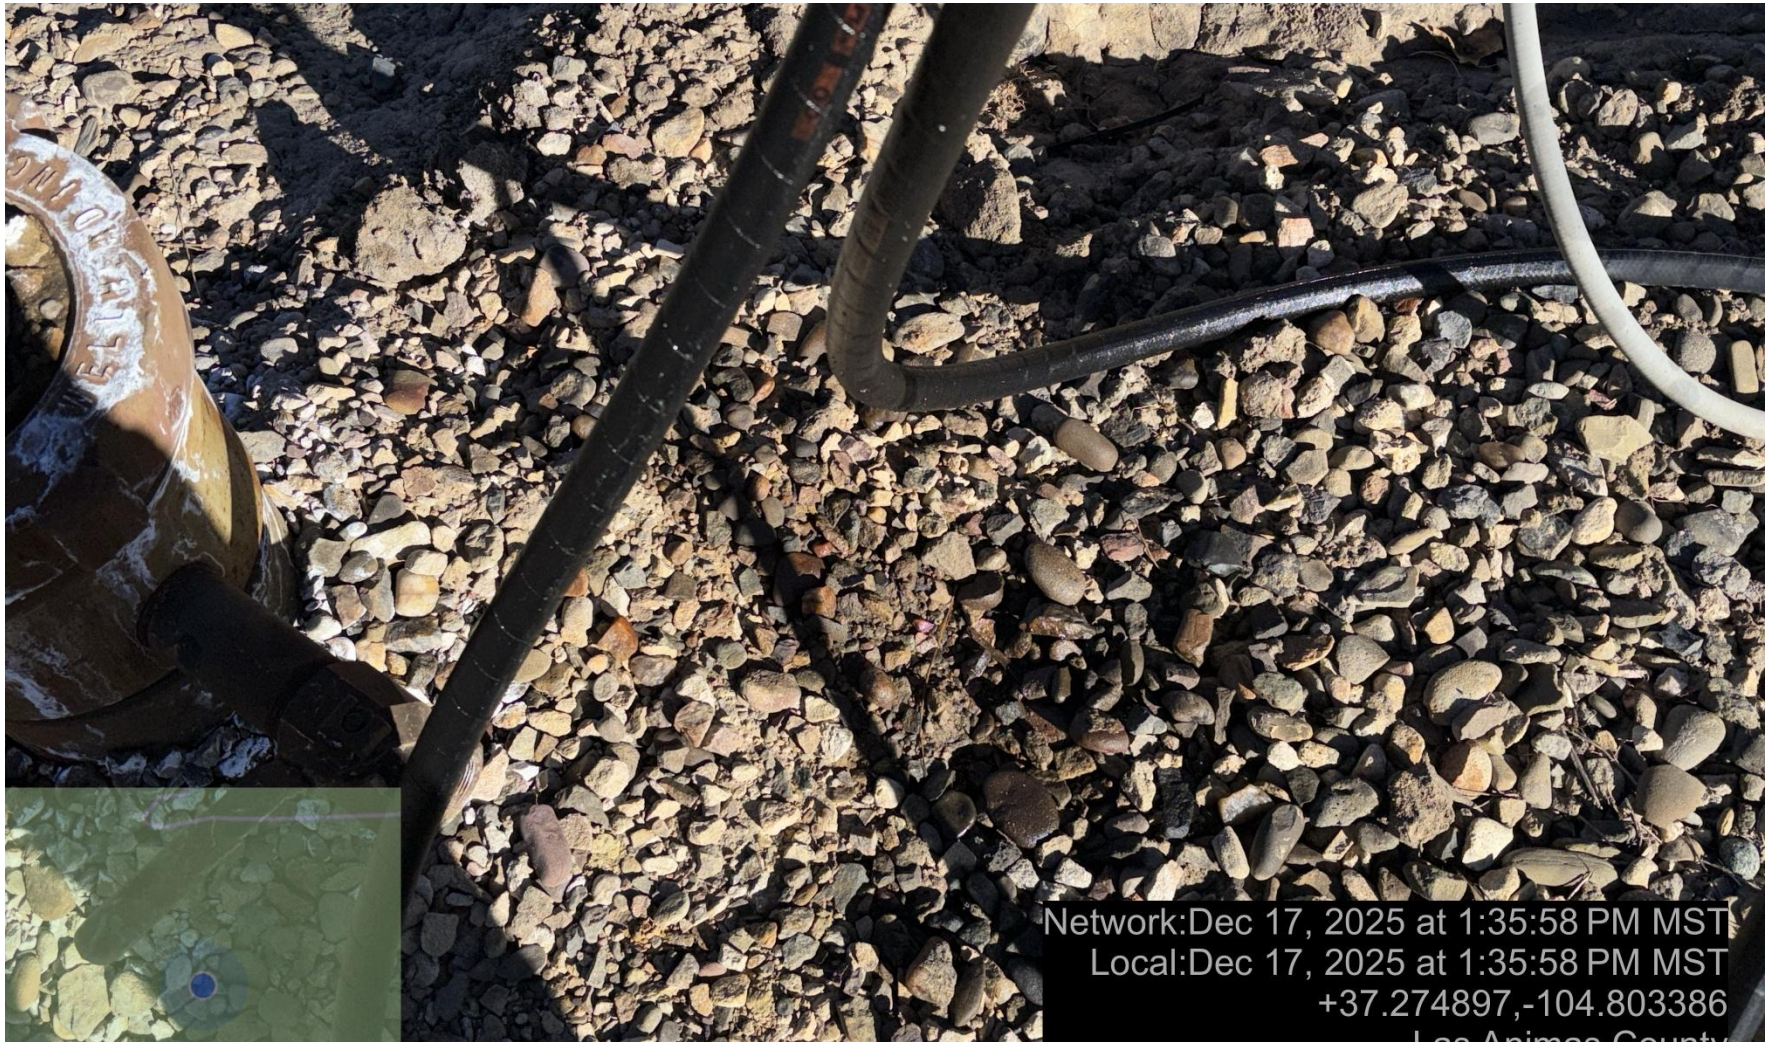
PHOTO 4: AREA OF IMPACTED SOIL UNDER A LEAK ON DRIVEHEAD. Conduct maintenance on equipment, cleanup stained material and review self inspection processes. COMPLY WITH RULE 1002,.(2).D. 1-1-2026. CA DATE 1-1-2026.

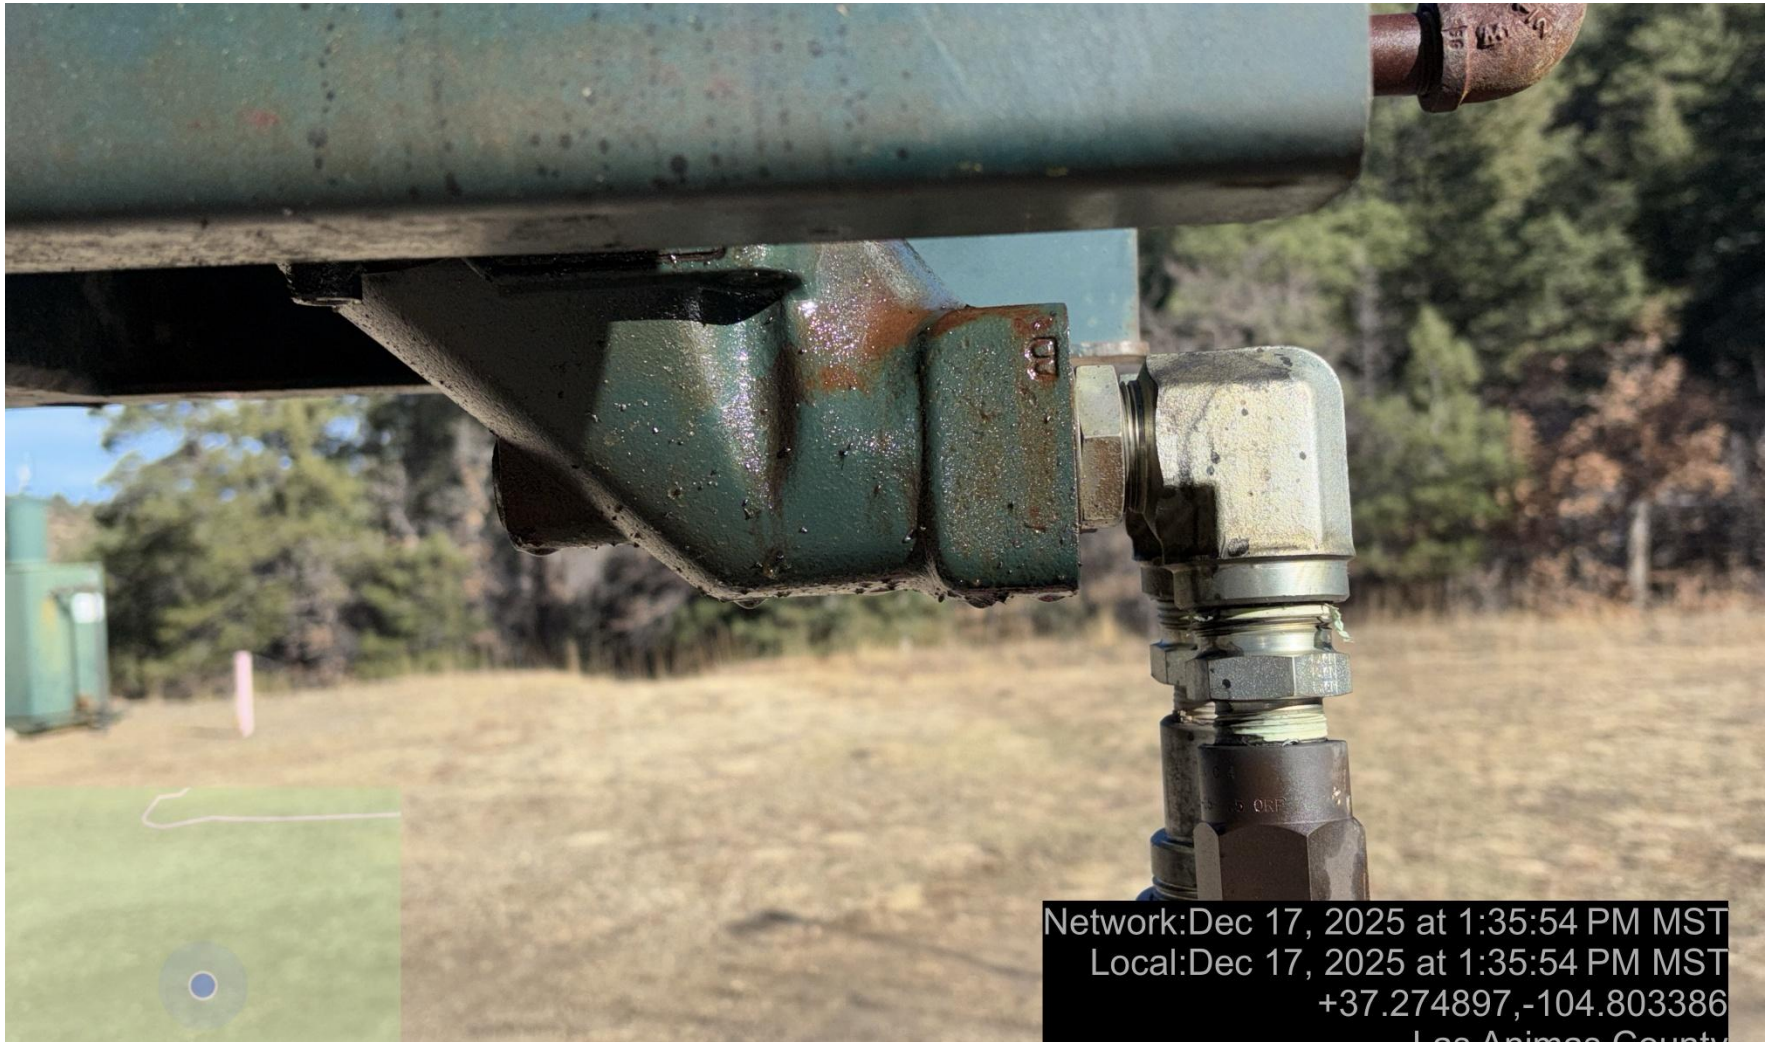
PHOTO 6: DRIVEHEAD IS LEAKING HYDRAULIC FLUID. Securely fasten all valves, pipes, fittings, and Production Facilities to ensure good mechanical condition, inspect at regular intervals and maintain in good mechanical condition. Engineer, operate, and maintain equipment within the manufacturer's recommended specifications per Rule 608.e. CA DATE 1/1/2026.
