WELL NAME: APACHE CANYON 10-16V, API #: 071-07560, INSP. # 716301890

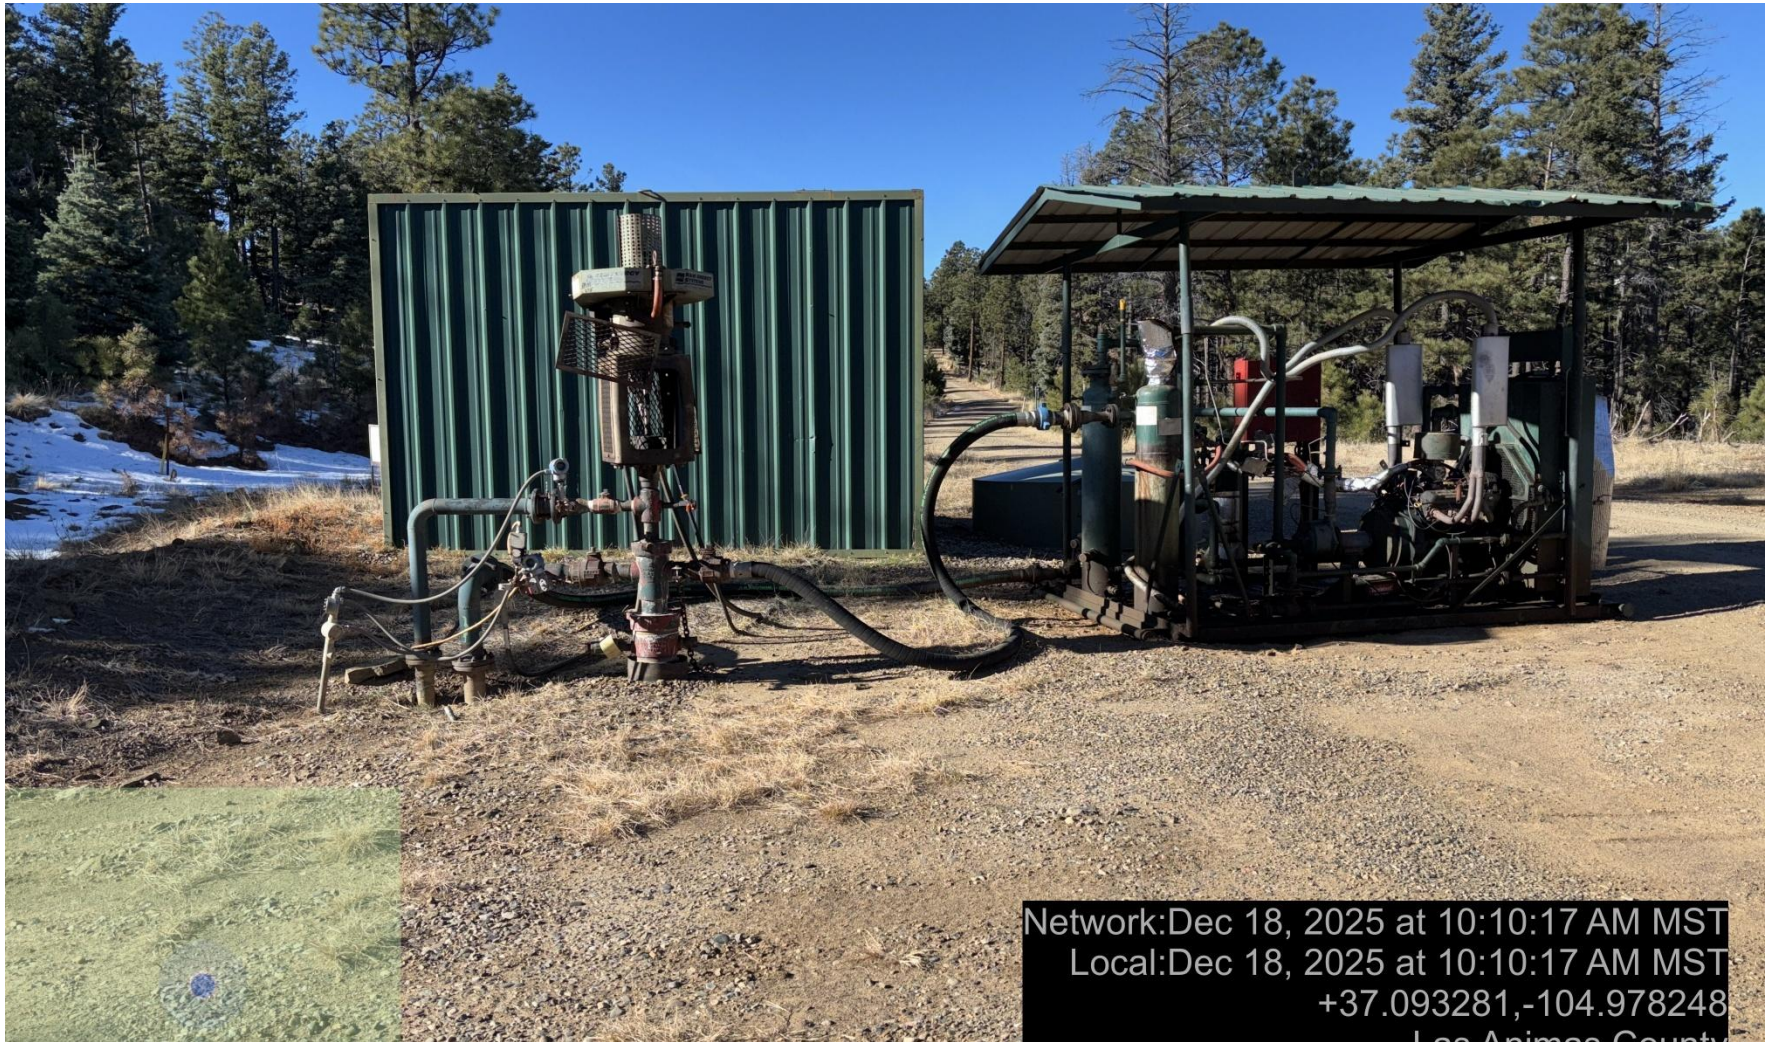
PHOTO 3: WELLHEAD AND EQUIPMENT.

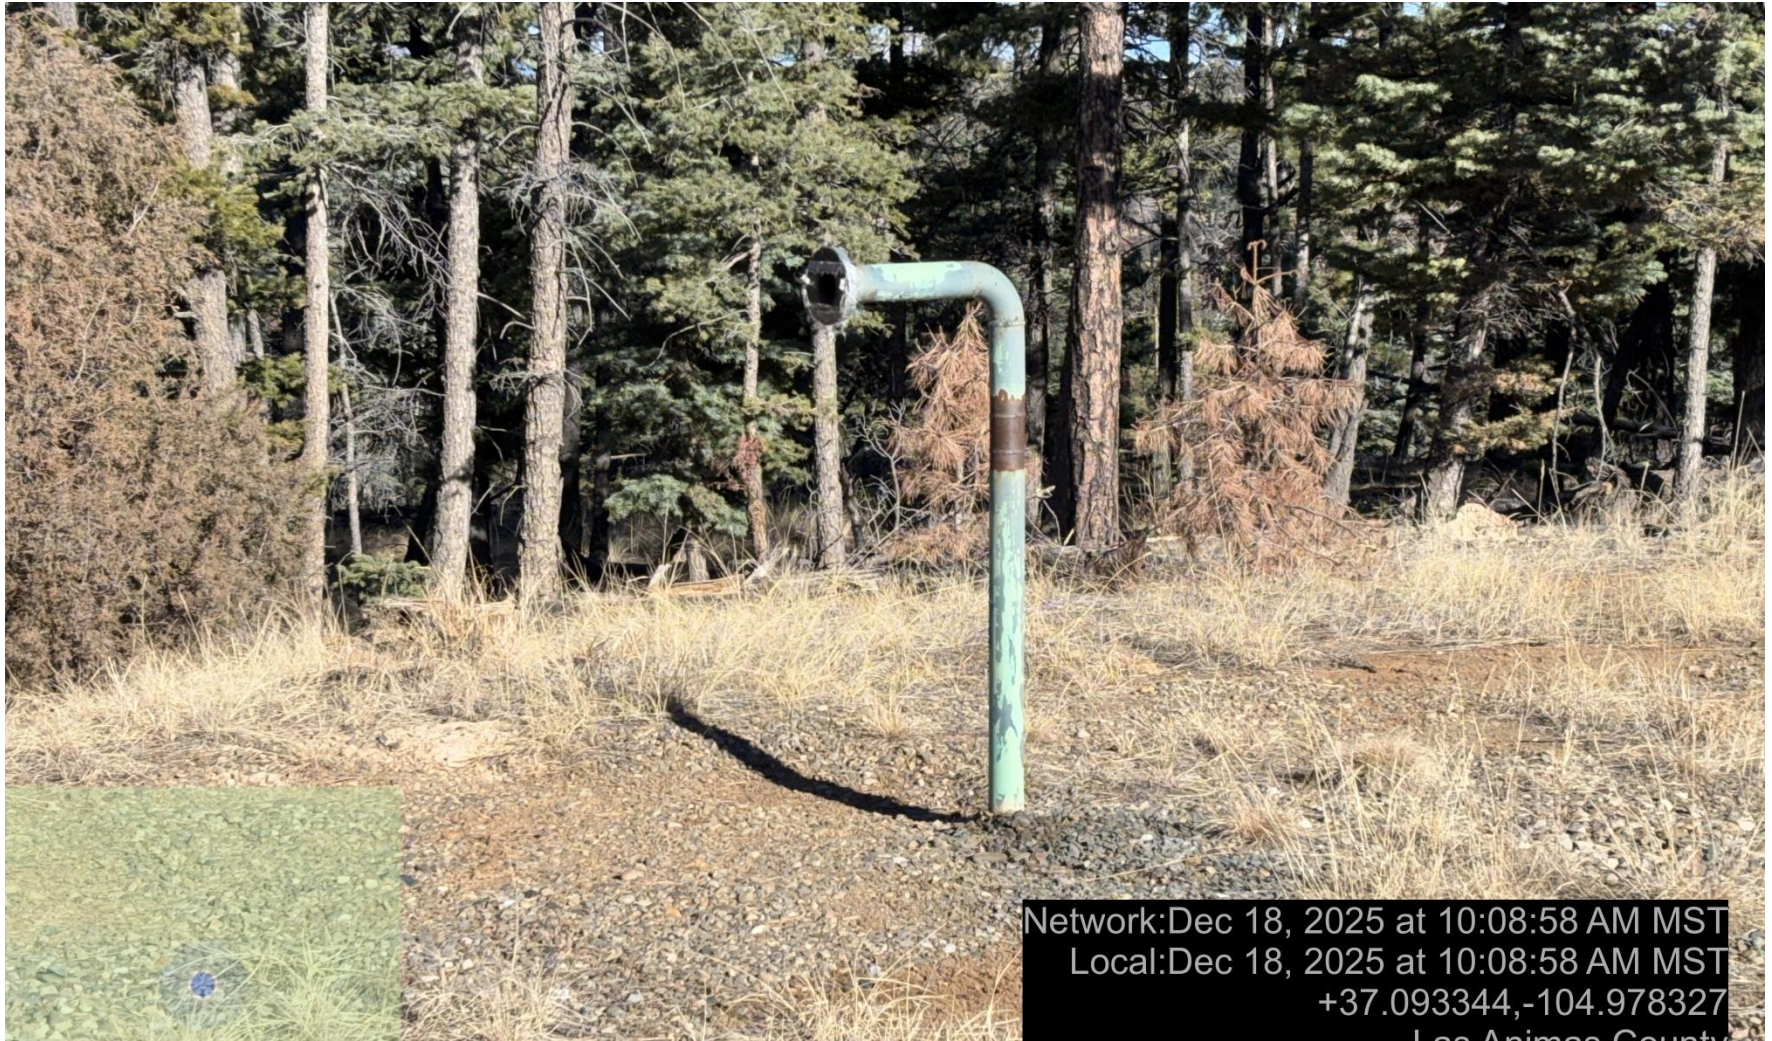
**PHOTO 4: UNUSED OR UNUSEFUL EQUIPMENT (3" RISER OPEN TO ATMOSPHERE ON NORTH SIDE OF LOCATION). REMOVE
UNUSED OR UNUSEFUL EQUIPMENT PER RULE 606. CA DATE 1-18-2025.**

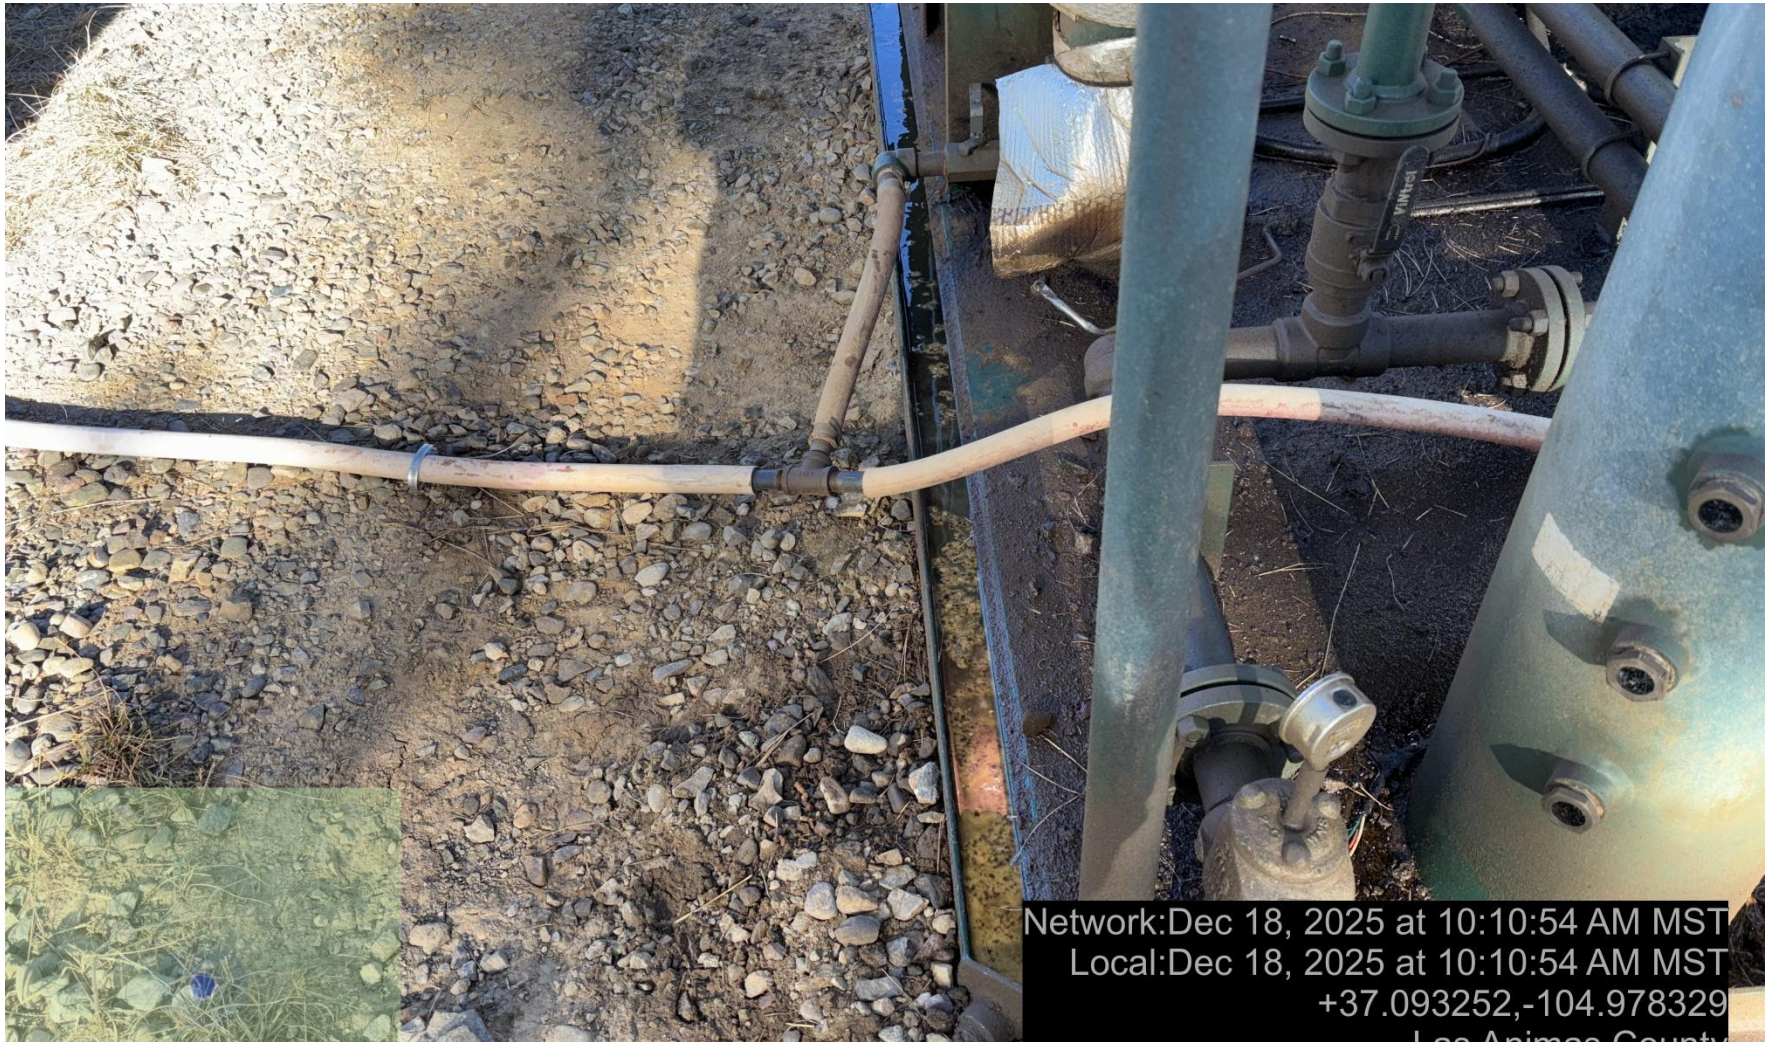
PHOTO 5: AREA OF IMPACTED SOIL NEAR COMPRESSOR. Conduct maintenance on equipment, cleanup stained material and review self inspection processes. COMPLY WITH RULE 1002,,(2).D. CA DATE 1-18-2025.

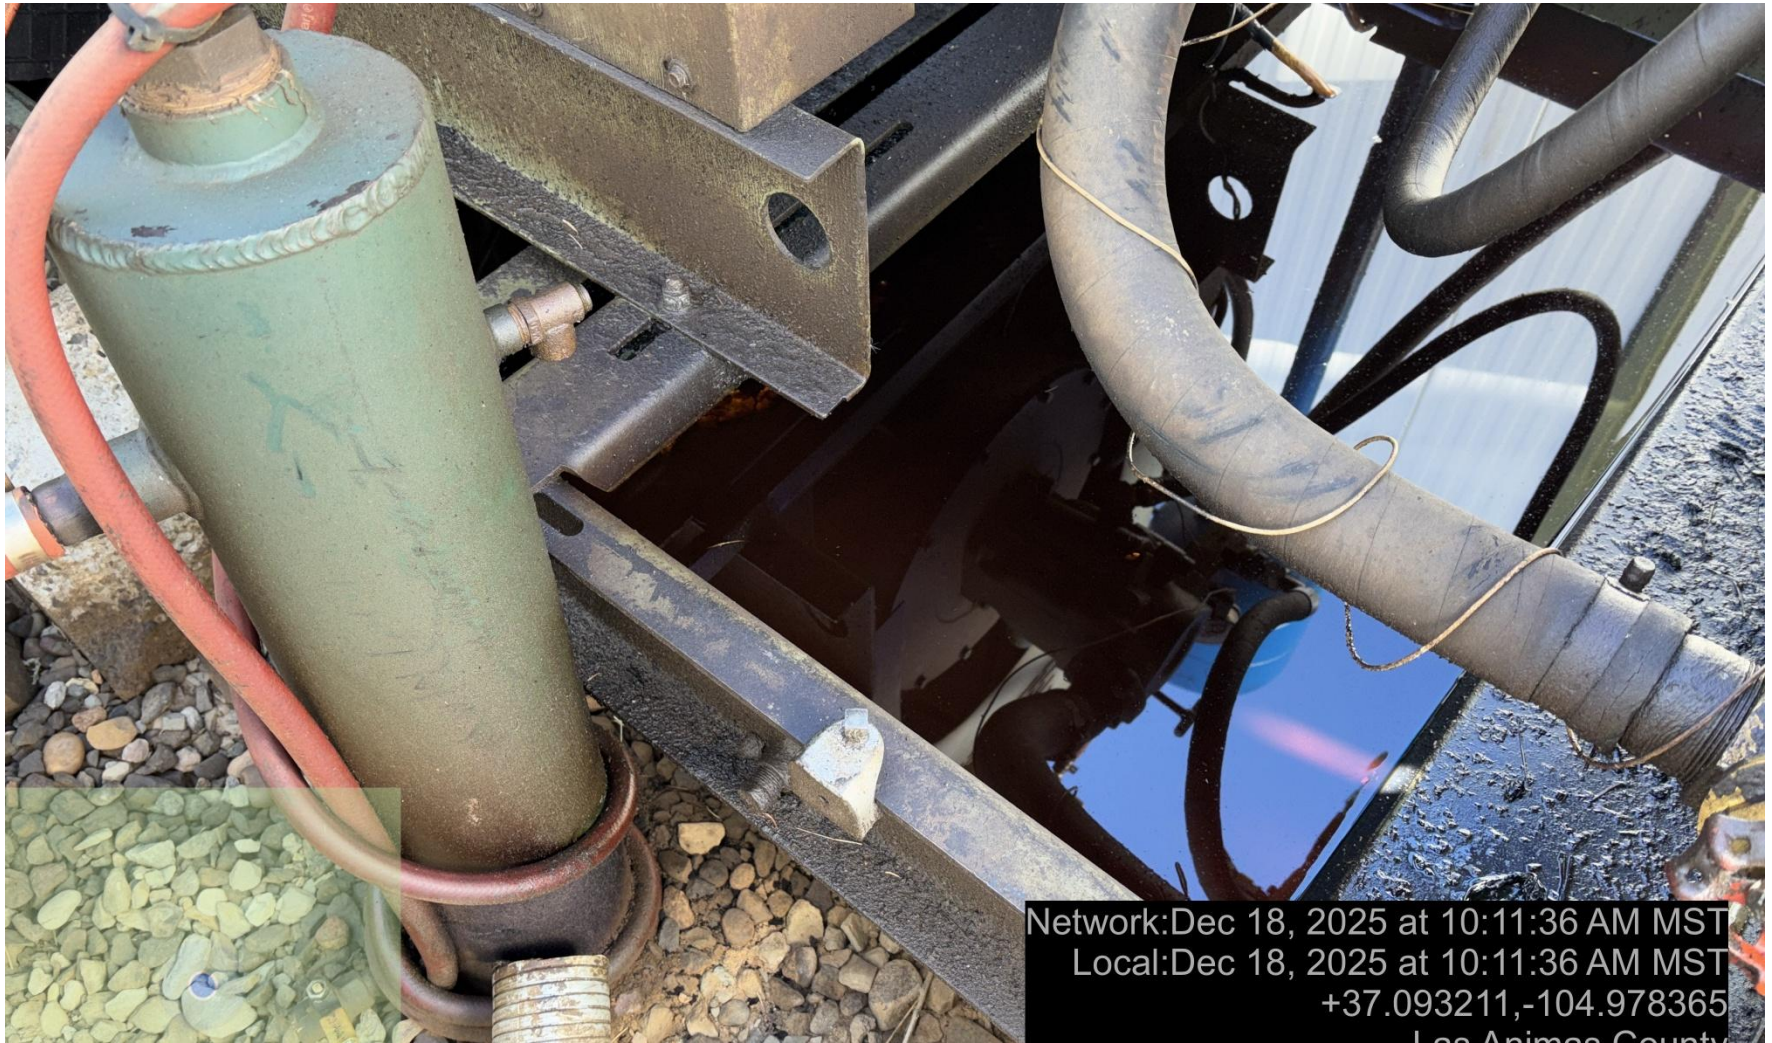
PHOTO 6: OIL IN PRIME MOVER ENGINE SKID WITHOUT WILDLIFE PROTECTION NET OR SCREEN (IT APPEARS THE ENGINE OIL HAS BEEN DRAINED DIRECTLY INTO ENGINE SKID AND LEFT, THIS PRACTICE SHOULD STOP IMMEDIATELY). DRAIN OILY WASTE REPAIR ALL LEAKS AND REMOVE IMPACTED SOIL PER RULE 1002..(2).D & 1002.f.(2)B, Comply with general provisions of the oil and gas act for wildlife protection AND SB-181. CA DATE 12-19-2025.

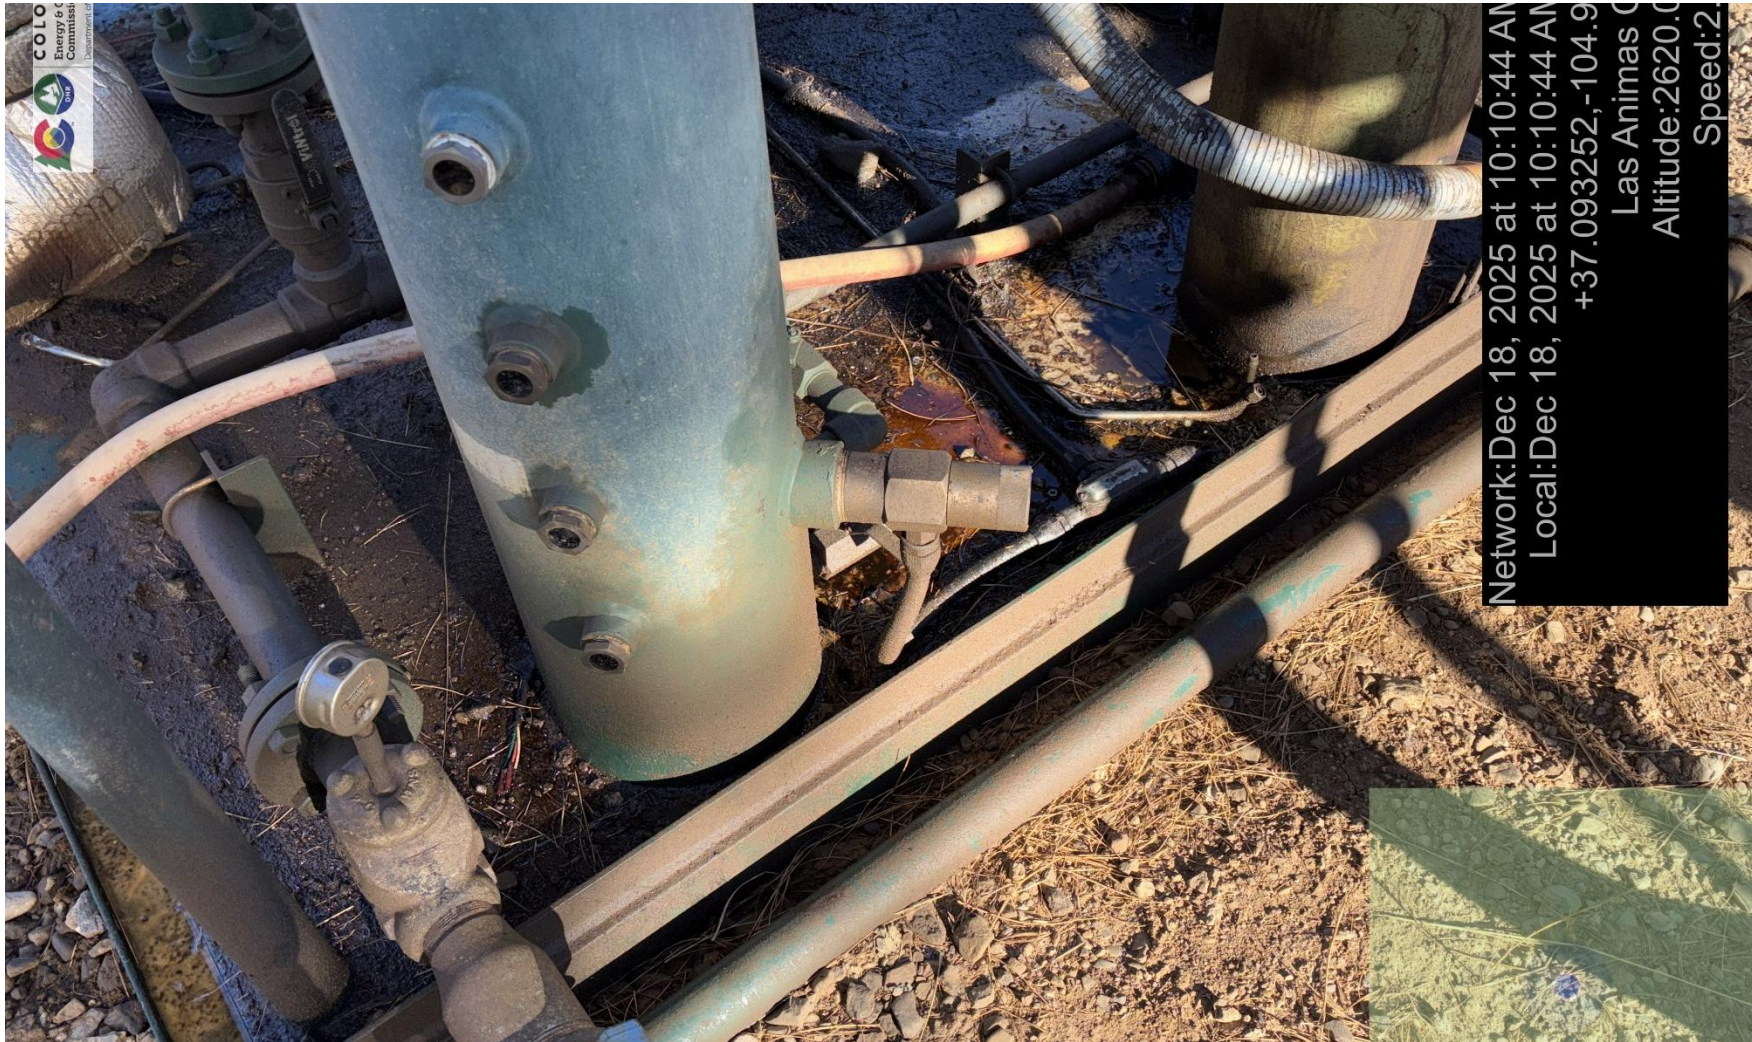
PHOTO 7: OILY WASTE IN COMPRESSOR SKID WITHOUT WILDLIKE PROTECTION NET OR SCREEN. DRAIN OILY WASTE REPAIR ALL LEAKS AND REMOVE IMPACTED SOIL PER RULE 1002..(2).D & 1002.f.(2)B, Comply with general provisions of the oil and gas act for wildlife protection AND SB-181. CA DATE 12-19-2025.
