Interim Reclamation and Stormwater Inspection

December 16, 2025

Location Name: HSR-PARKER #15-16A

Inspection Document #: 718601254

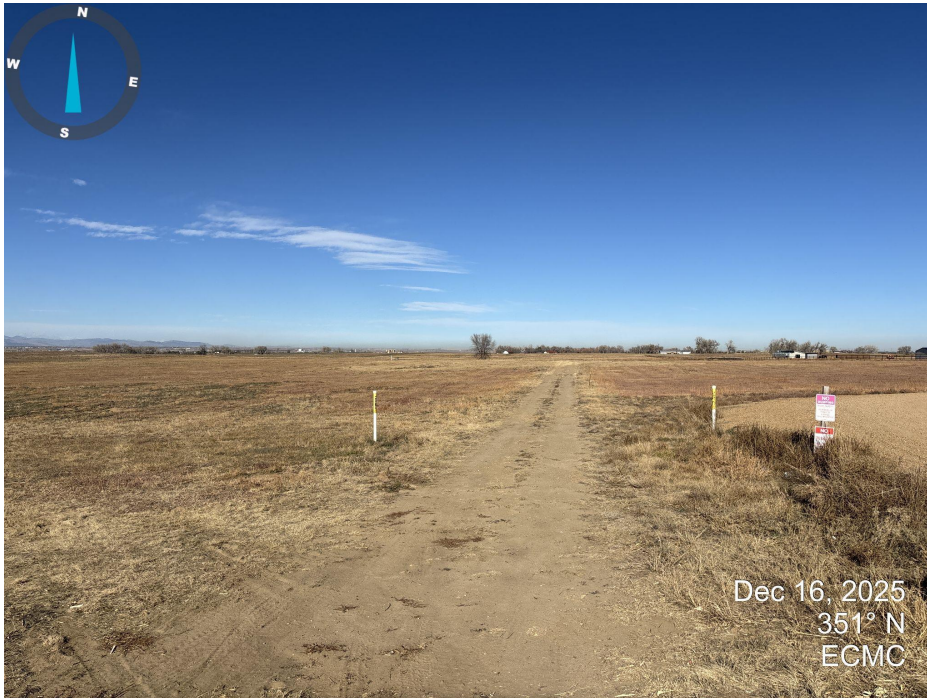
Photo 1. Looking north down the access road. It appears that a portion of the access road has been disturbed by construction unrelated to oil and gas. See photo 10.

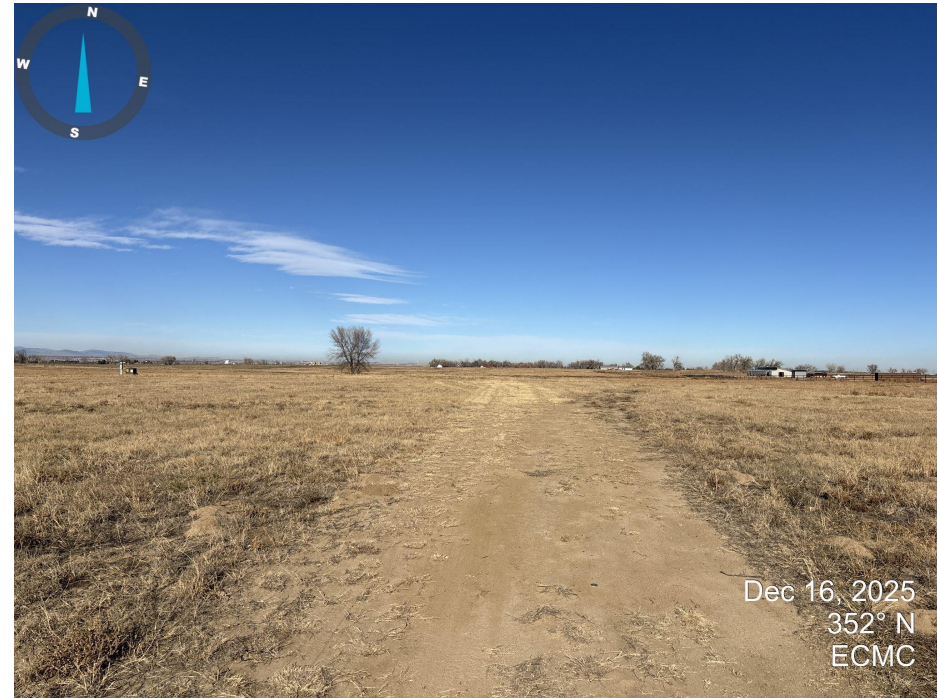
Photo 2. Picture taken at the bend in the access road. It appears that a power box and meter unrelated to oil and gas were recently installed near the location.

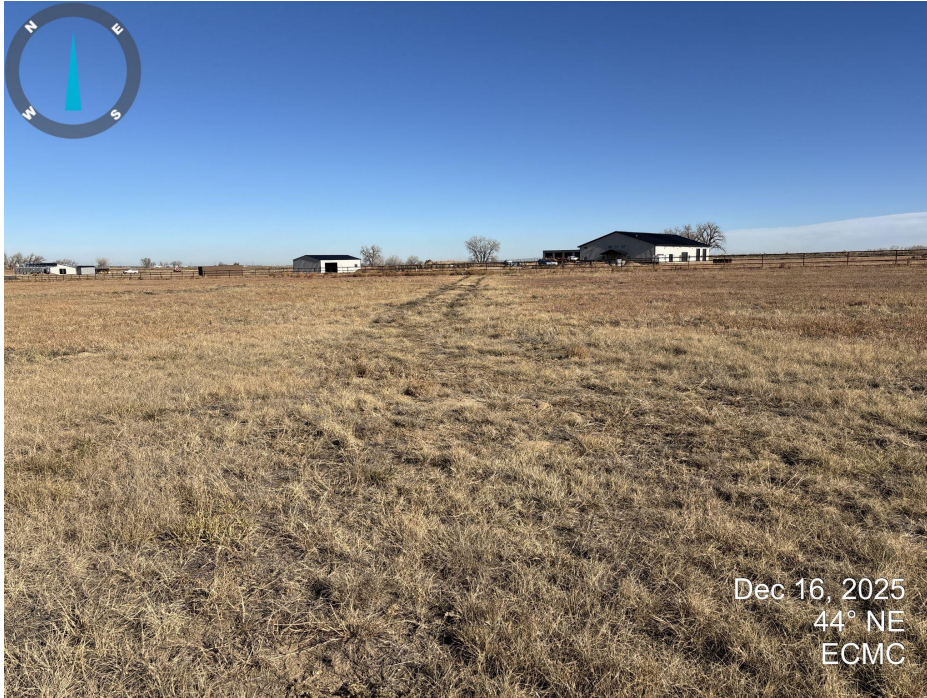
Photo 3. Looking northeast down the access road. It appears that desirable vegetation has established on the former access road. The access road appears to be reflective of the surrounding area.

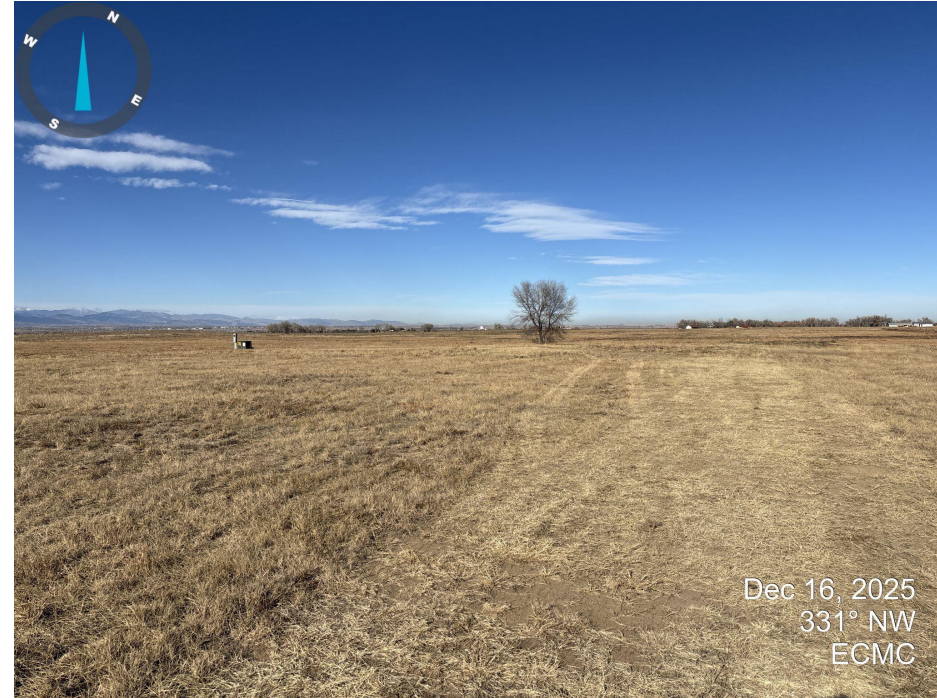
Photo 4. Looking north across the north side of the location. Non oil and gas electric box is visible.

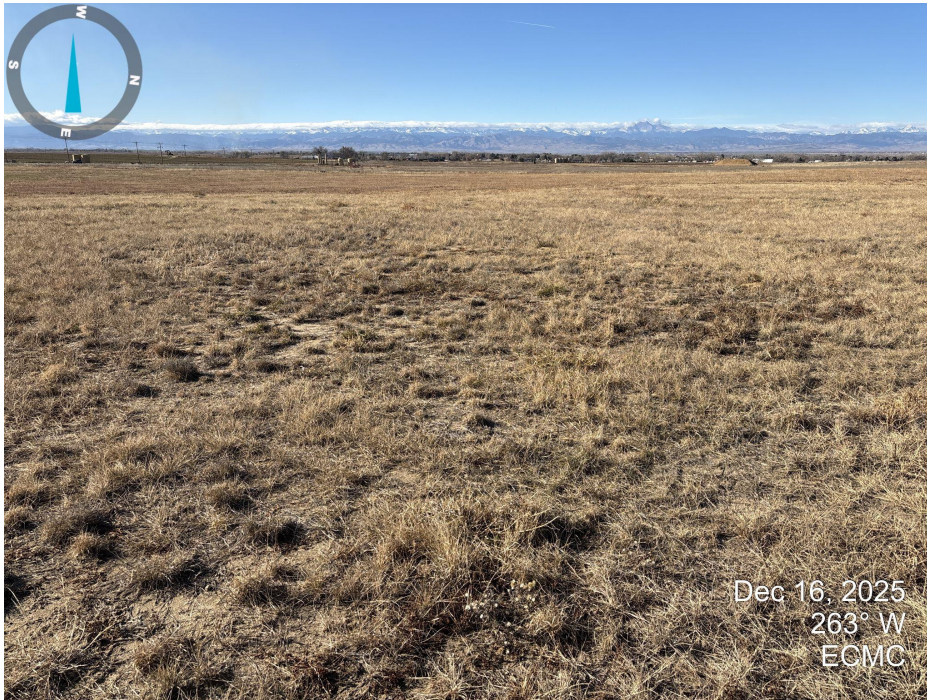
Photo 5. Looking west across the well location. No oil and gas equipment remains on location. Desirable perennial vegetation is present on the location and appears to have reached 80% coverage of the reference area.

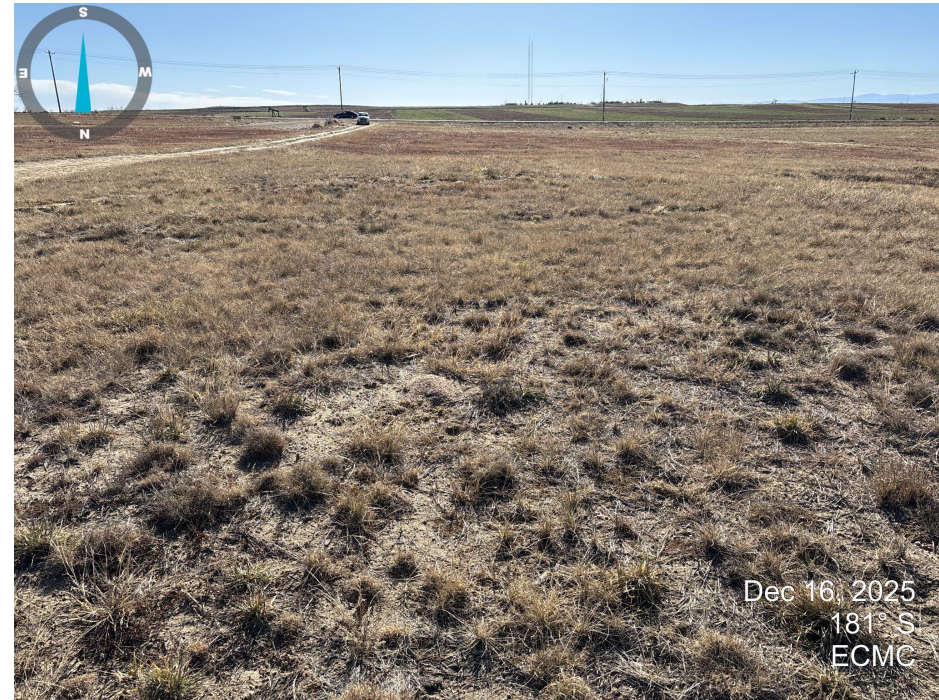
Photo 6. Looking south from the wellbore area. See photo 5 comments.

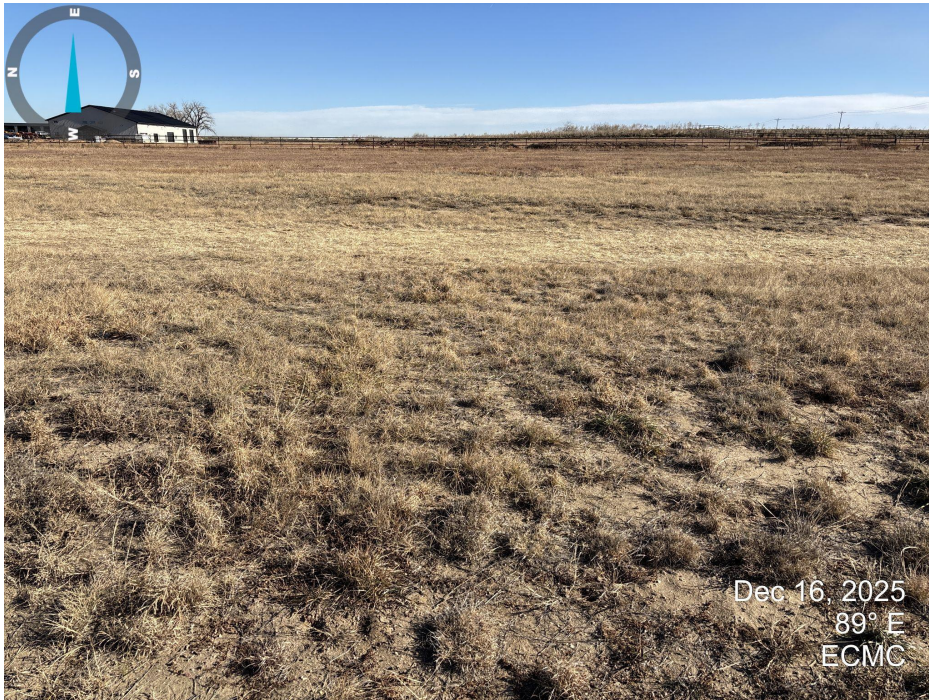
Photo 7. Looking east from the wellbore area. See photo 5 comments.

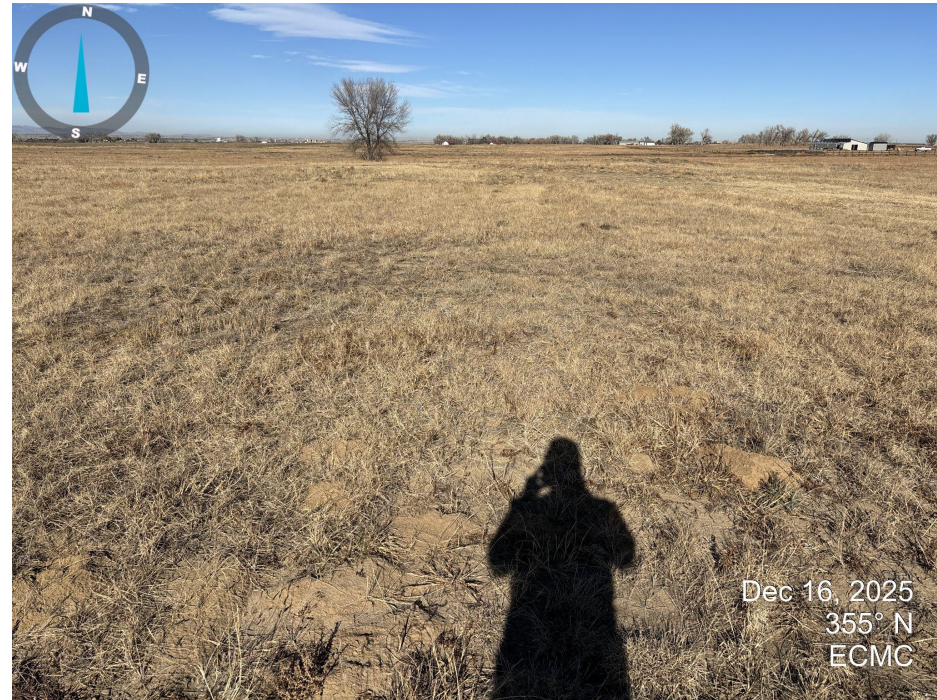
Photo 8. Looking north from the wellbore area. See photo 5 comments.

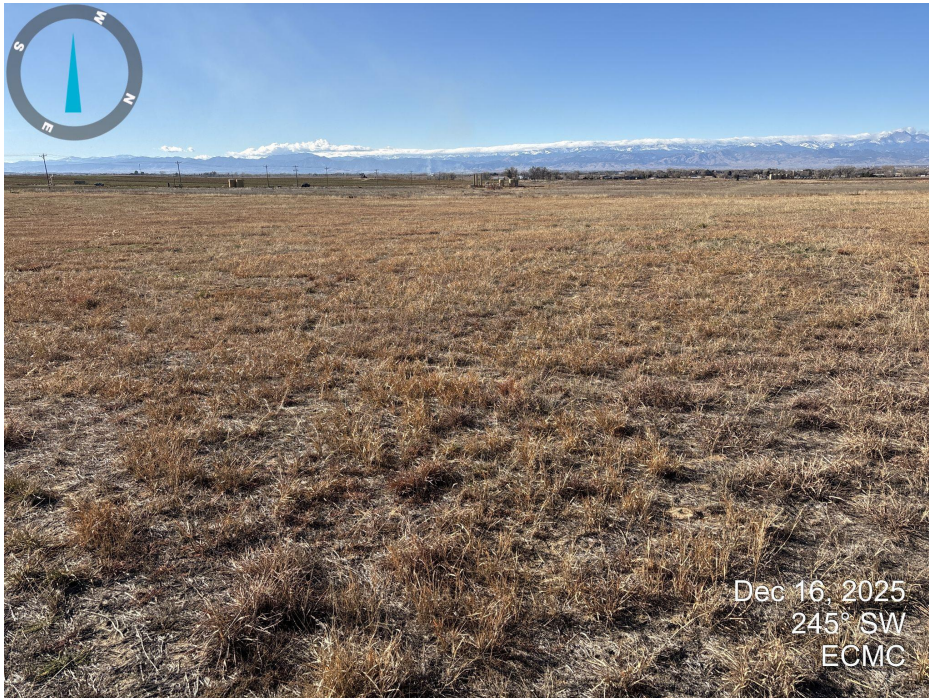
Photo 9. Reference vegetation to the west of the location.

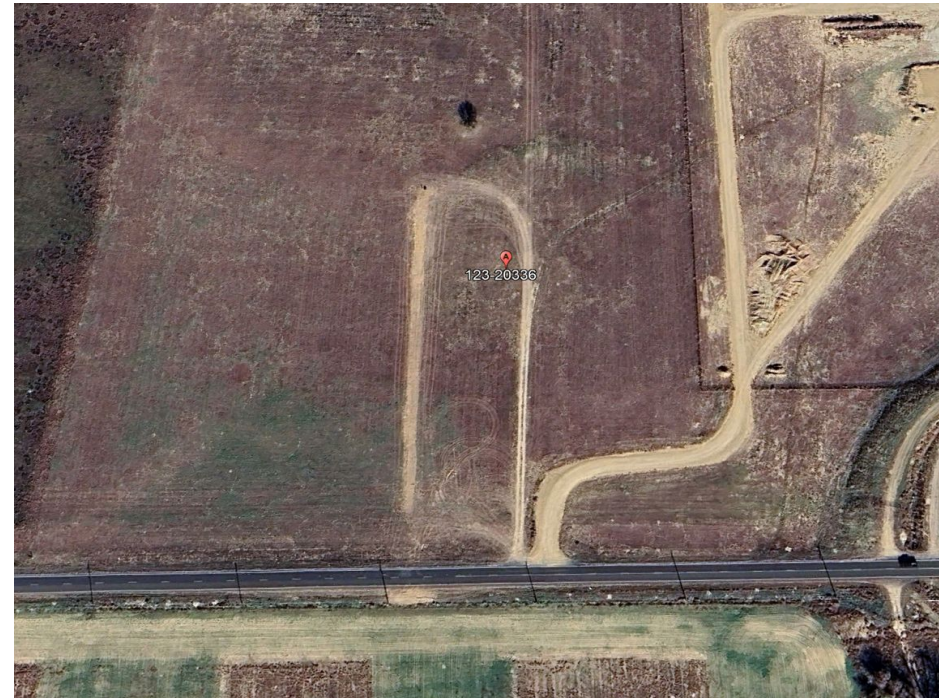
Photo 10. Google earth aerial imagery taken 11/2025. Construction that appears unrelated to oil and gas has disturbed a portion of the former access road and location.
