Inspection Photos

Operator: Nuevida Resources

Location ID: 484496

Inspection Document #: 714003037

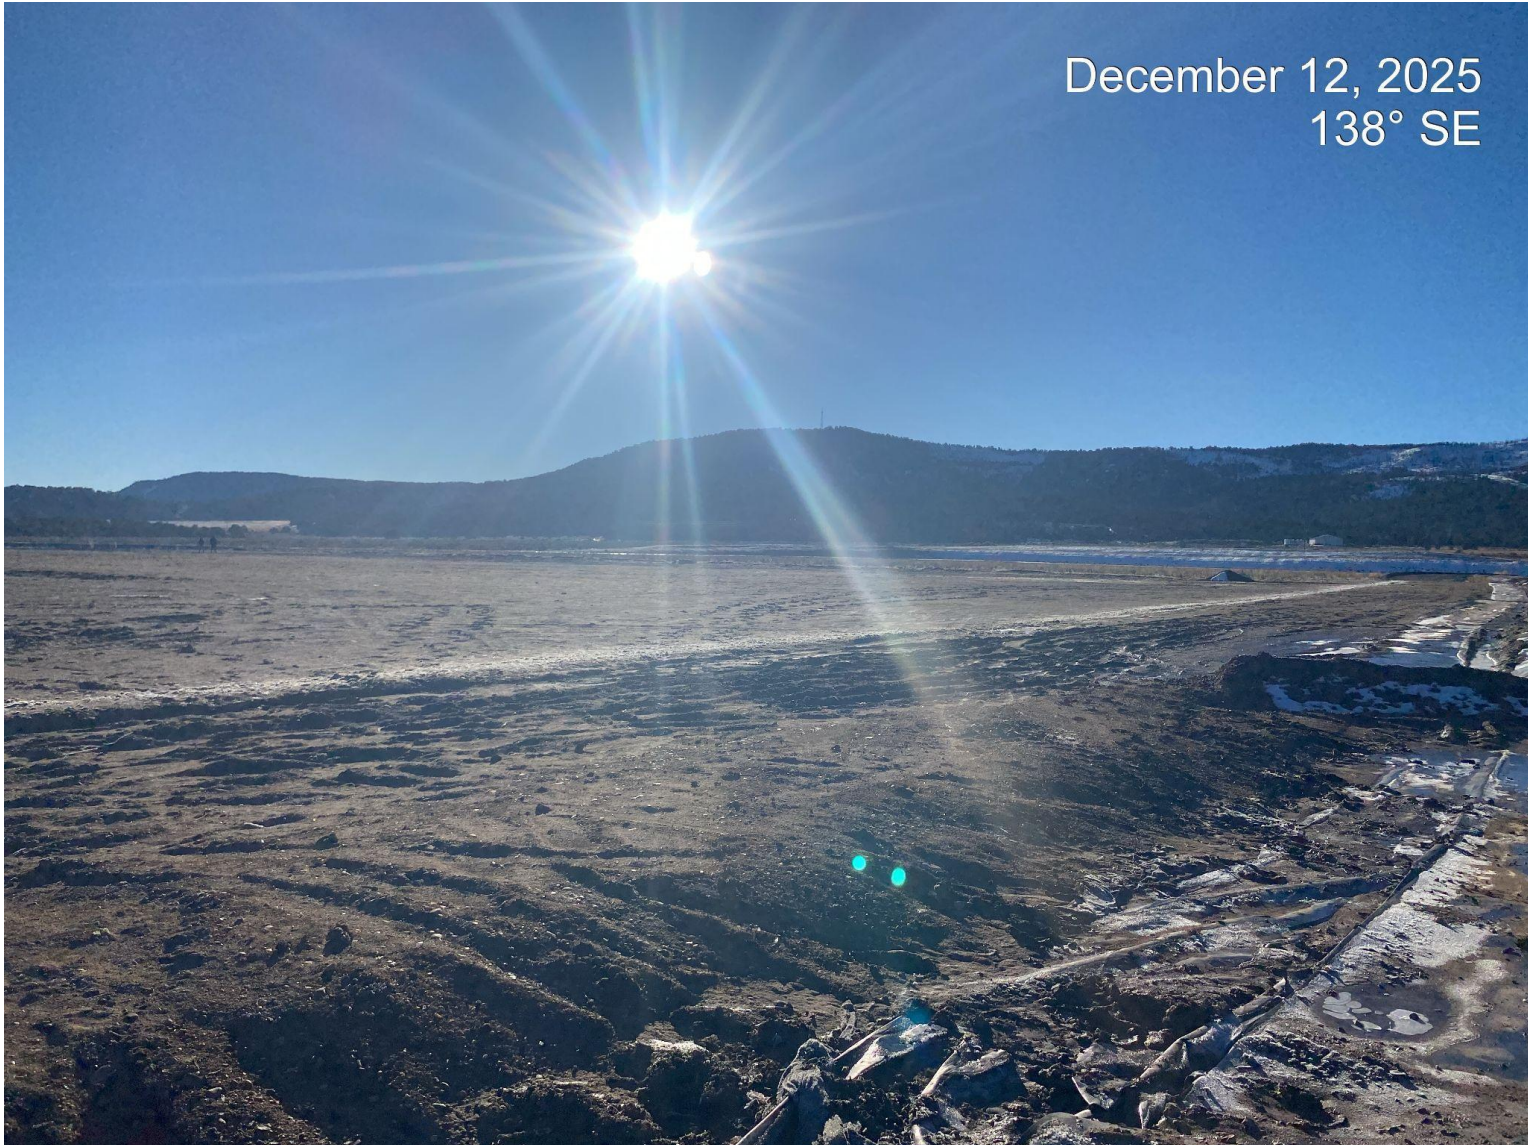
December 12, 2025
138° SE

Photo 1. Ground view of the southern TUA pad taken from the western edge facing center.

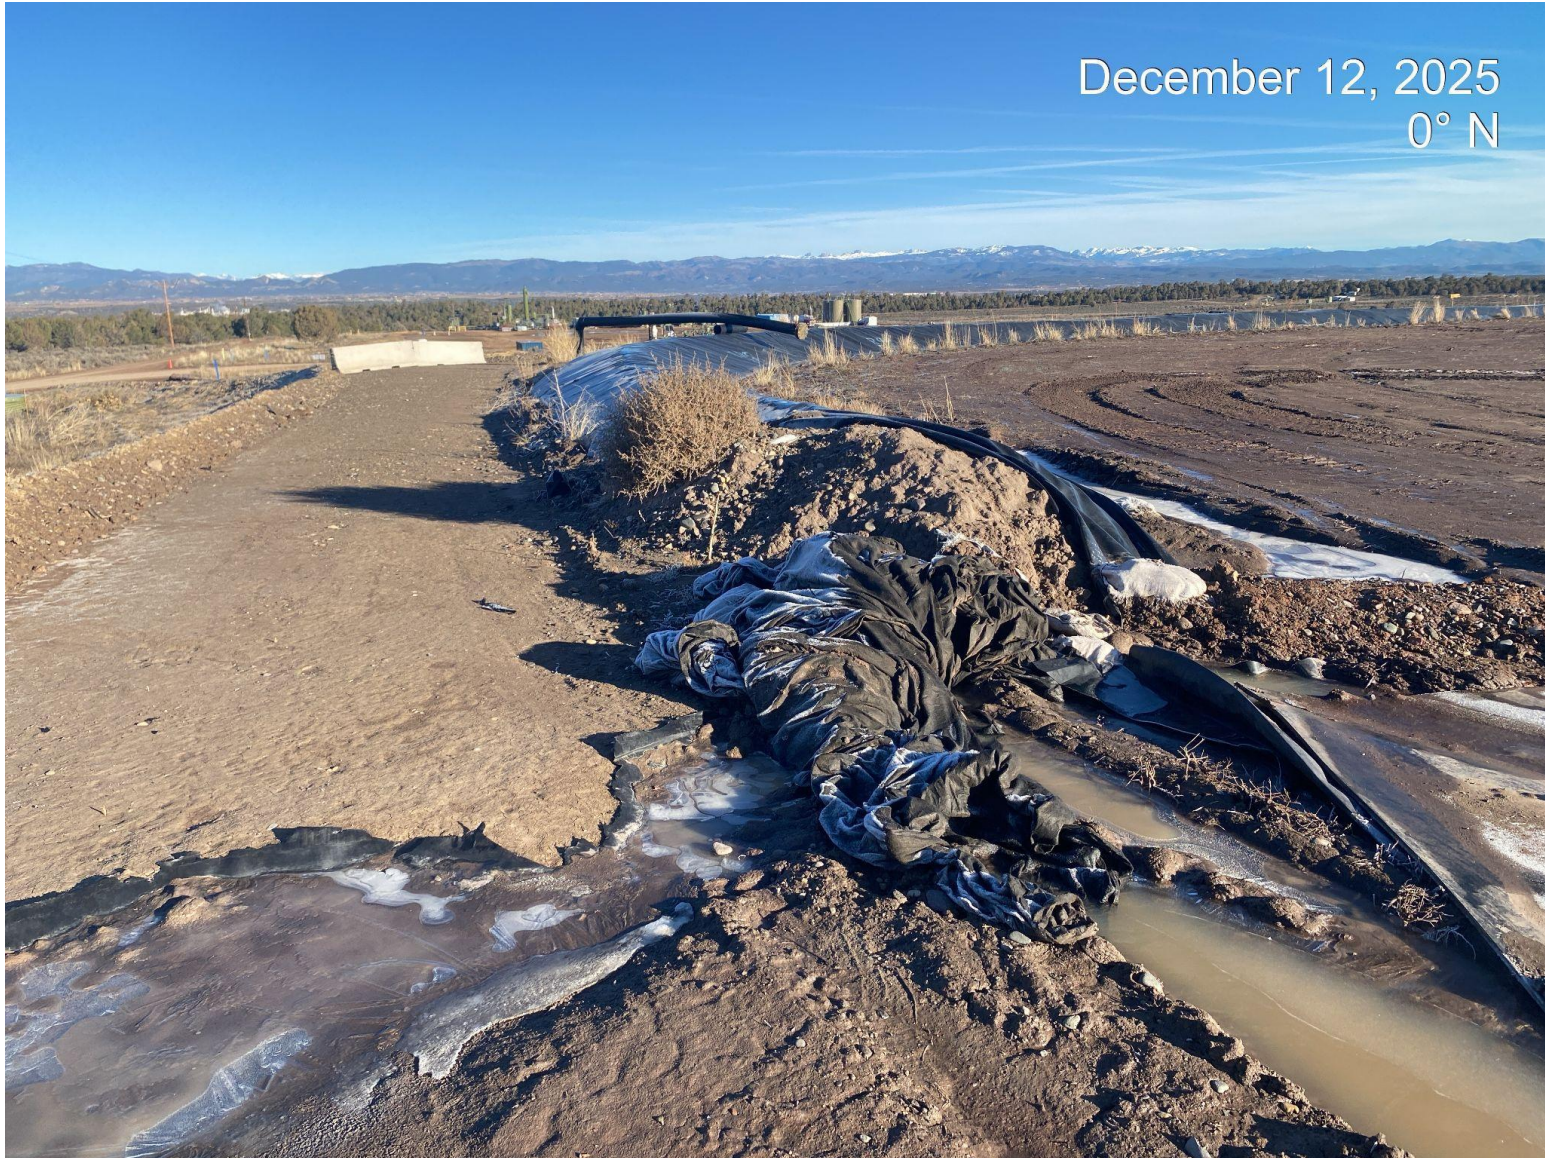
December 12, 2025
0° N

Photo 2. Unused fabric/mats piled on the western edge of the TUA pad.

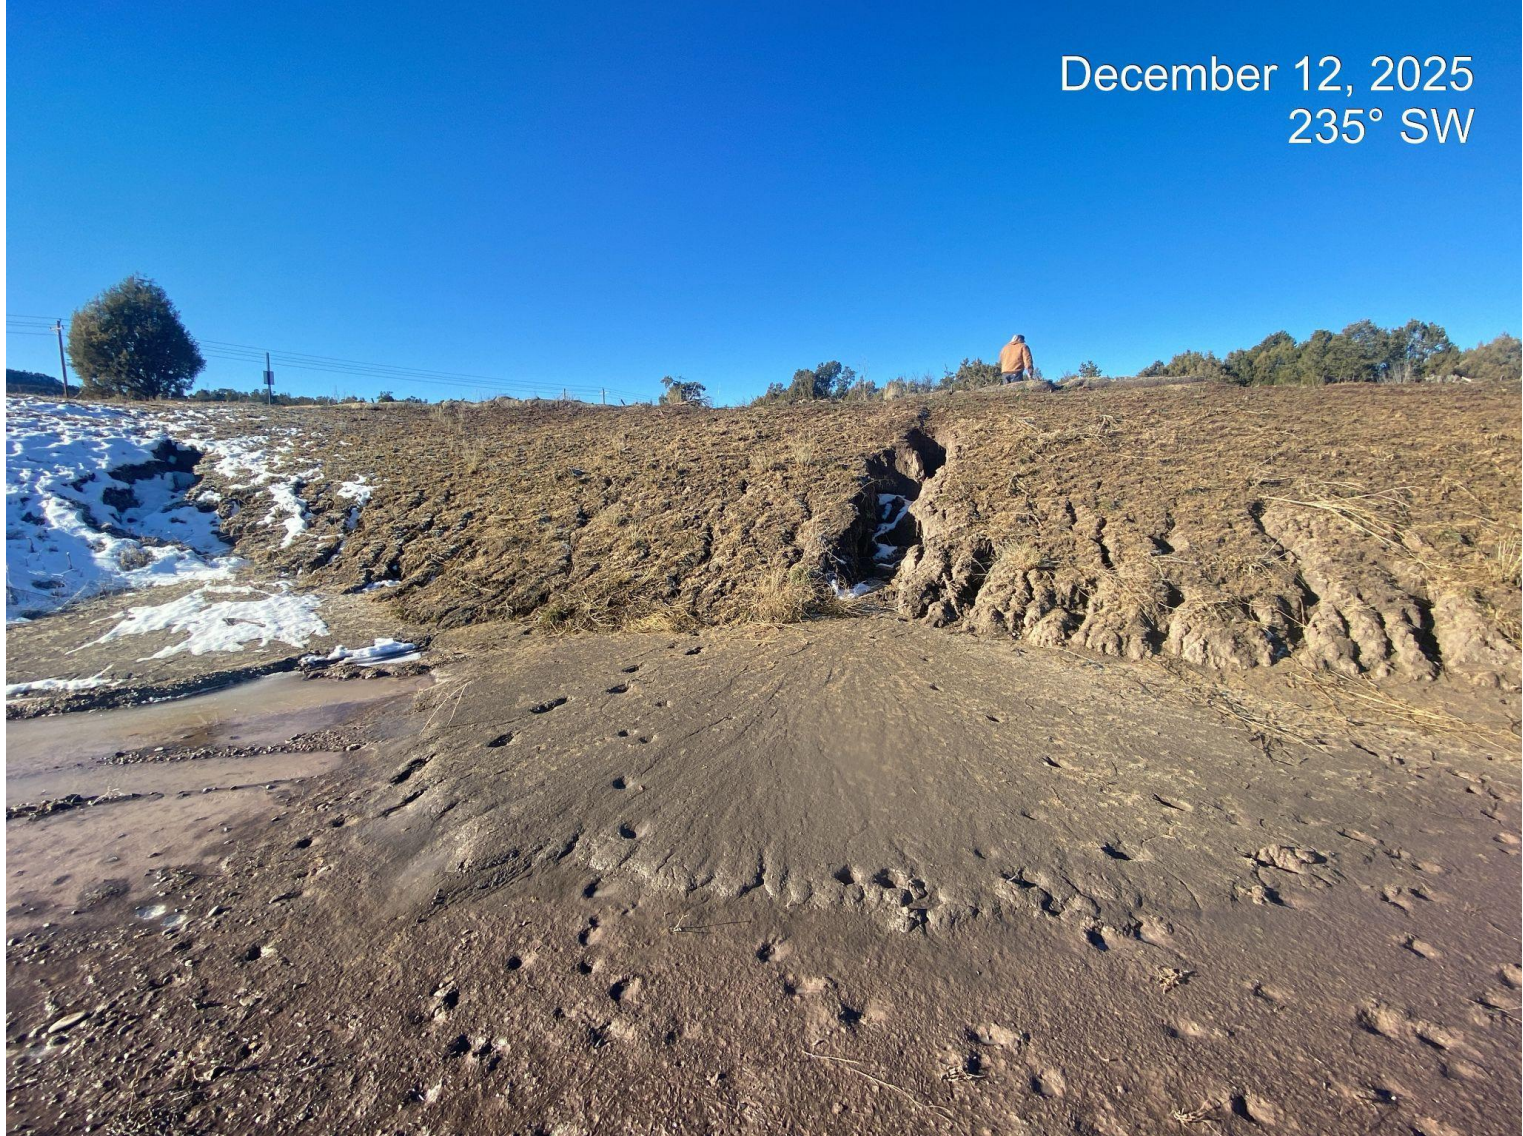
December 12, 2025
235° SW

Photo 3. Gully erosion (and sediment deposition) persisting in the SW corner of the TUA cut slope area.

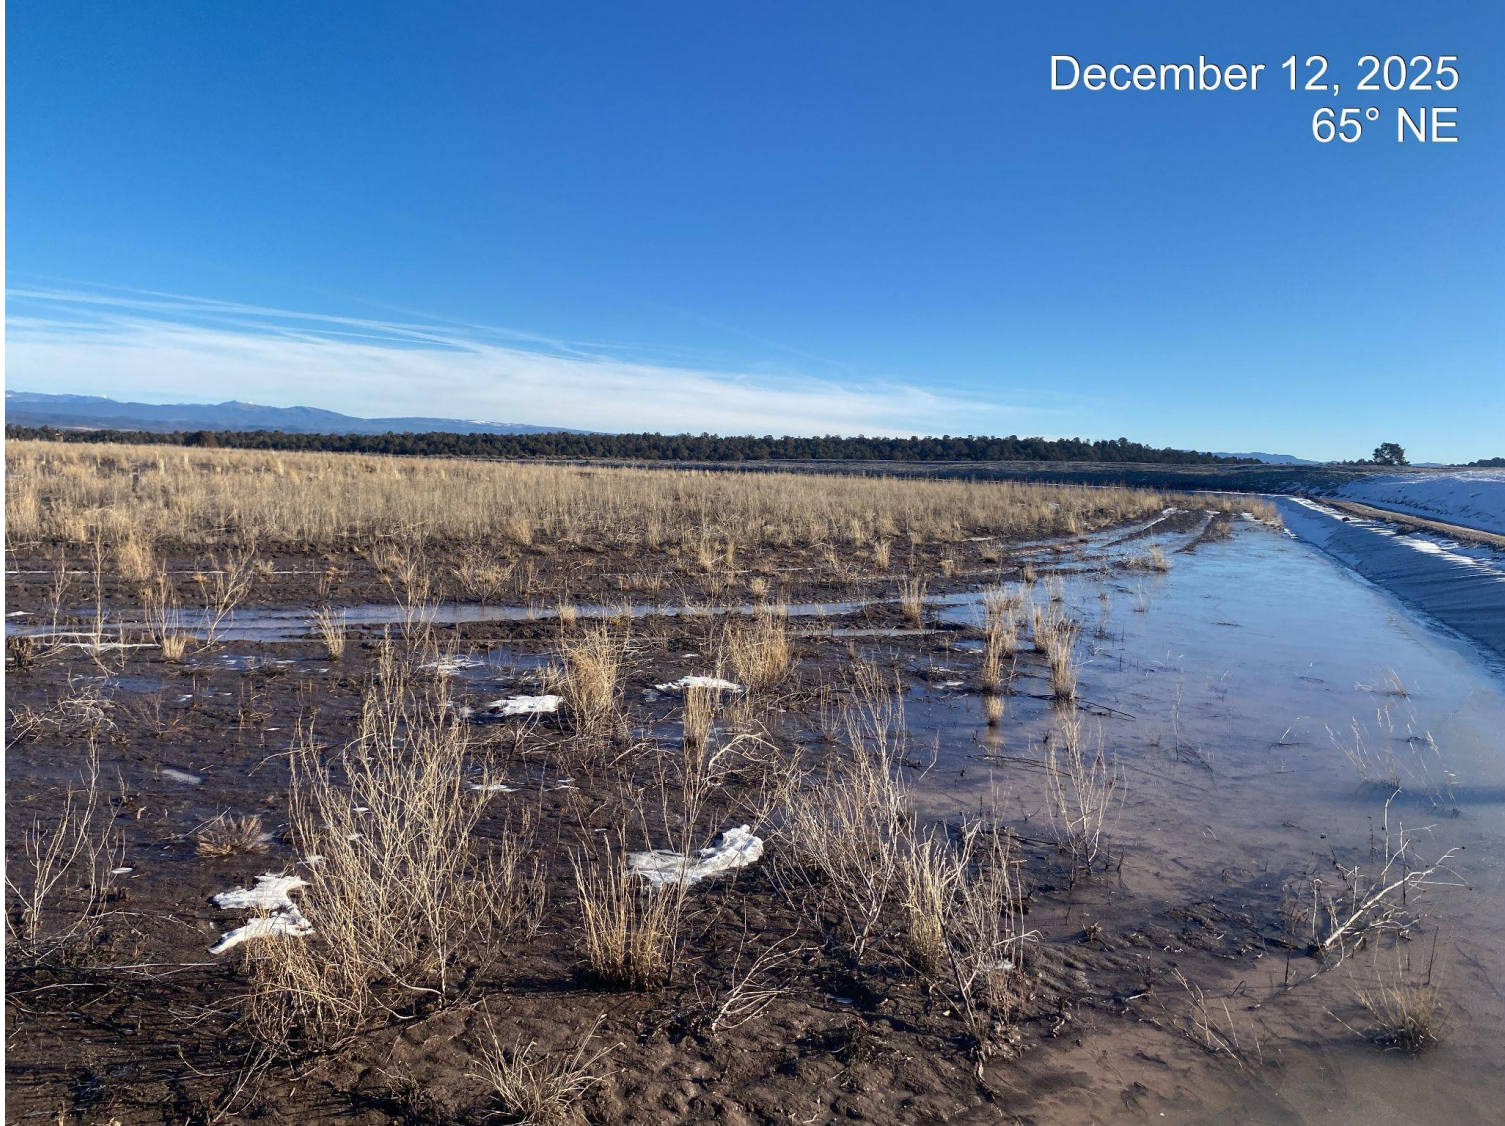
December 12, 2025
65° NE

Photo 4. Pooling water observed on the southern edge of the TUA pad.

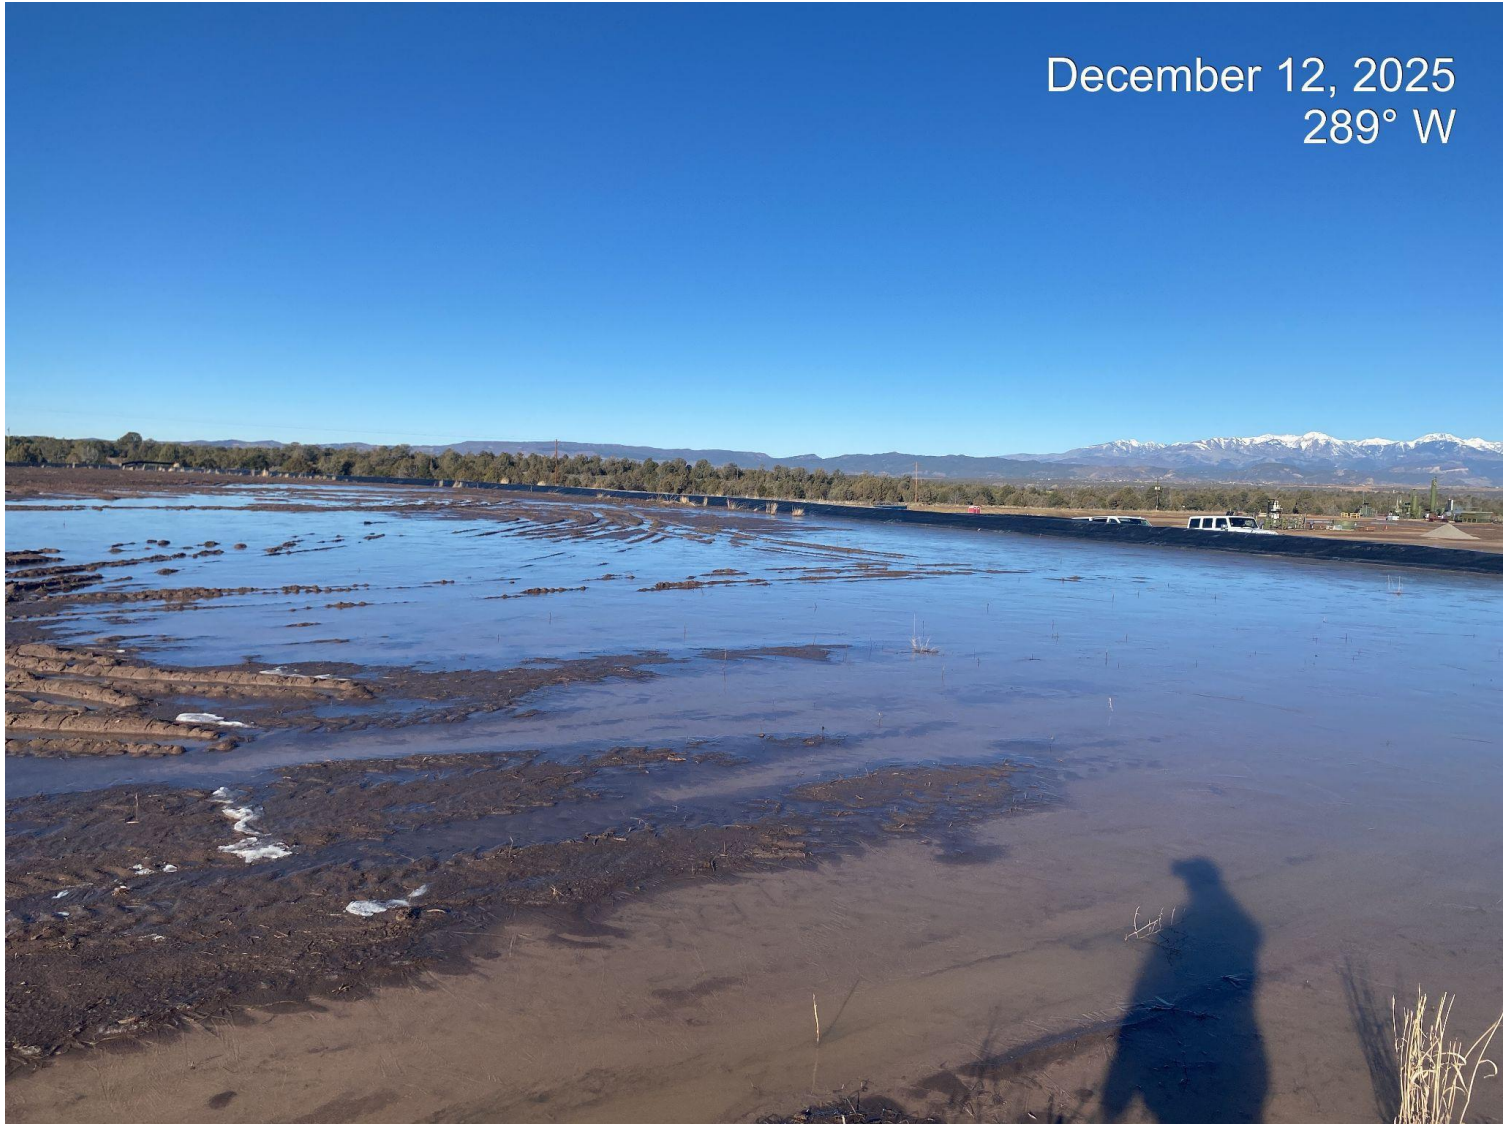
December 12, 2025
289° W

Photo 5. Pooling water occurring in the NE corner and along the northern edge of the TUA pad.

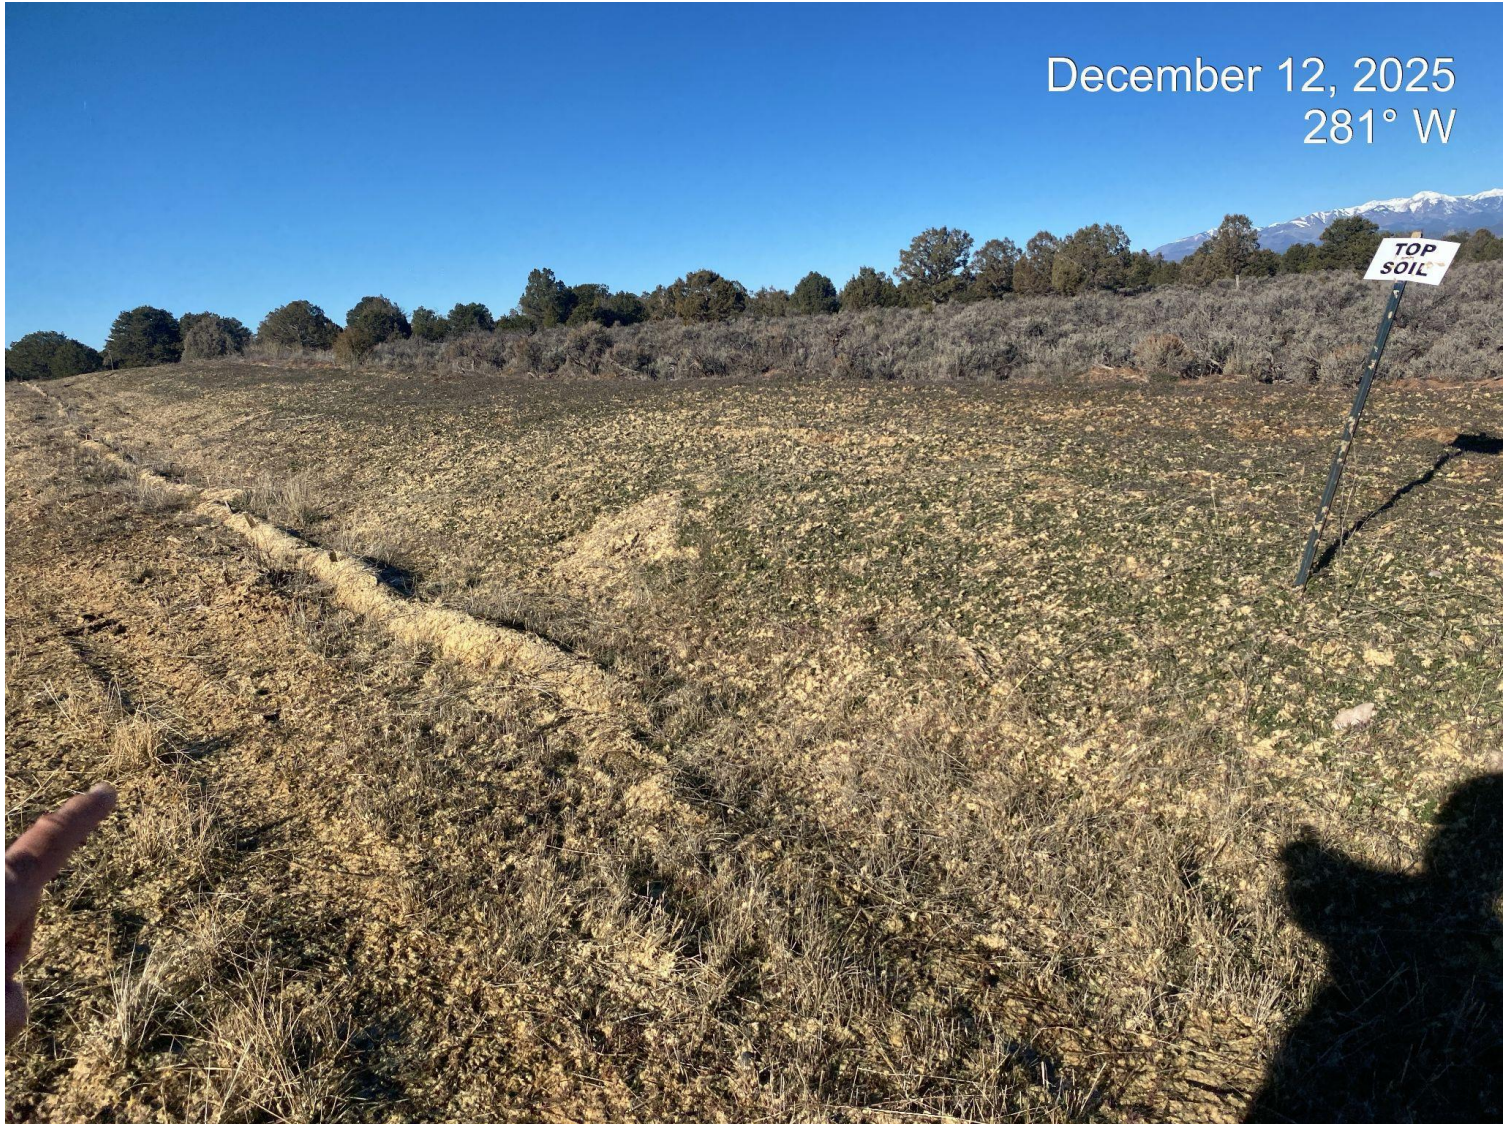
December 12, 2025
281° W

Photo 6. View of topsoil pile covered in annual weeds included but not limited to Kochia, Red Stem Filaree and Cheatgrass. Note: Top soil pile is representative of all other topsoil piles on both the well pad and TUA pad.

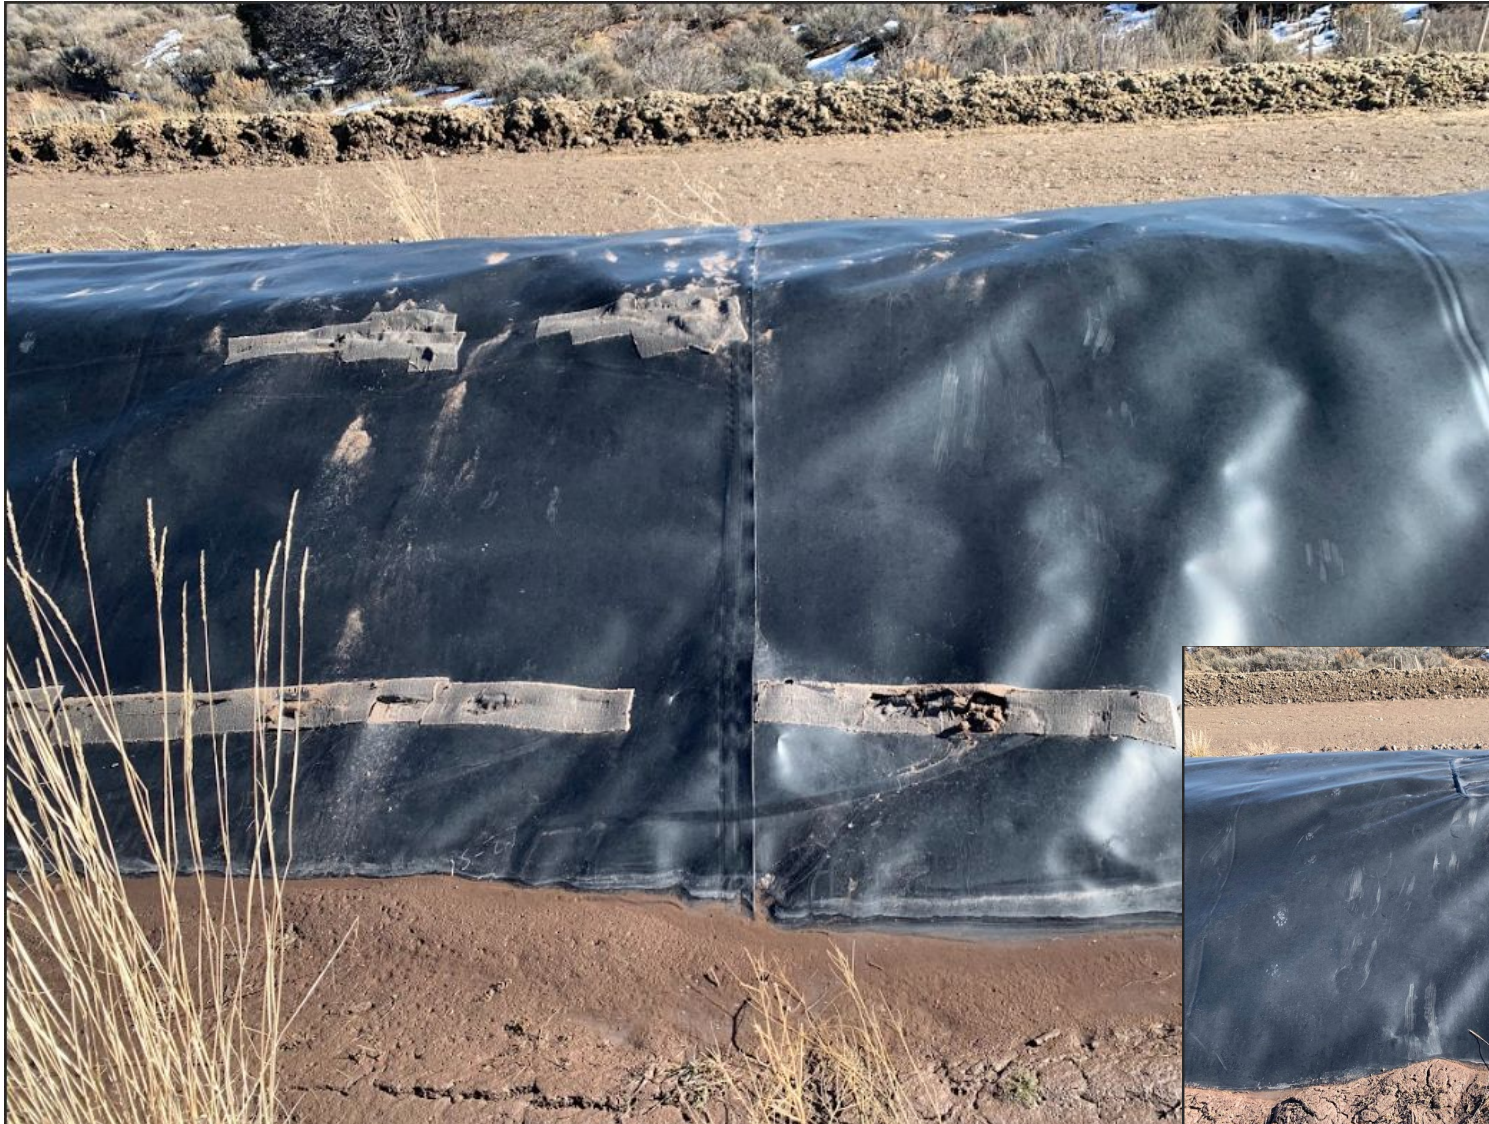
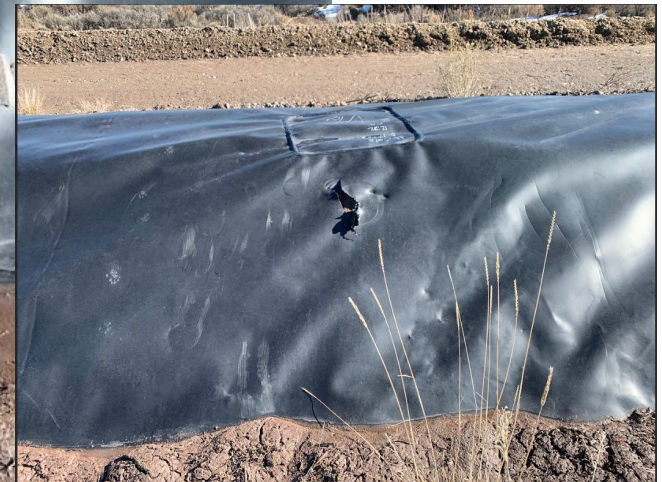
Photo 6. Holes/punctures observed on TUA perimeter berm liner. Existing patch jobs were not successful and holes persist.

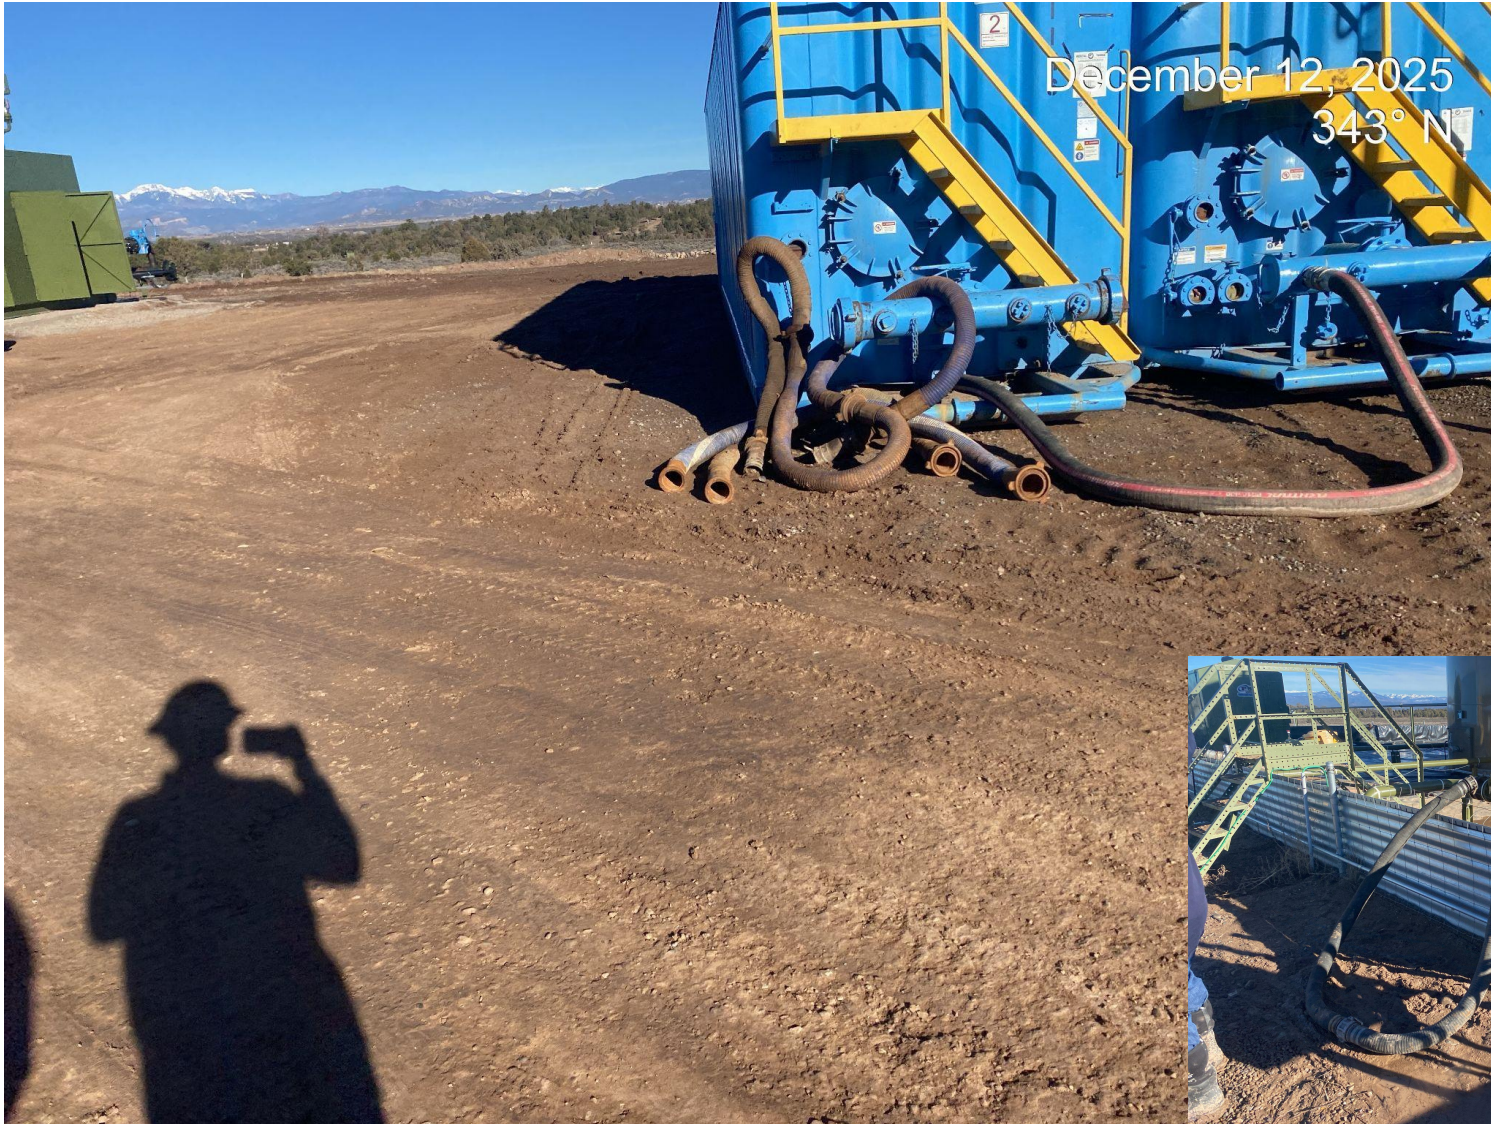
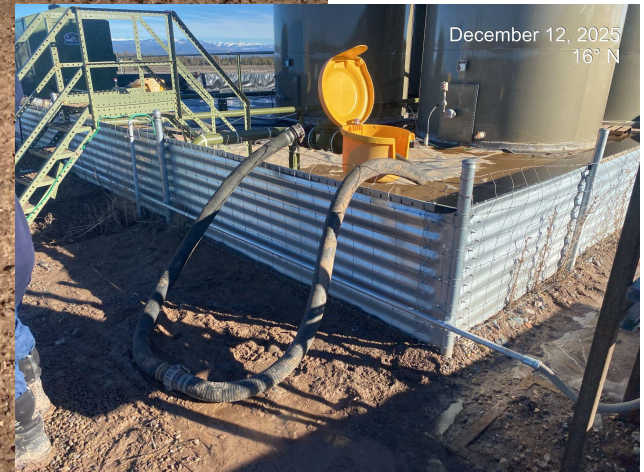
Photo 8. Various unused tubing observed around the location.

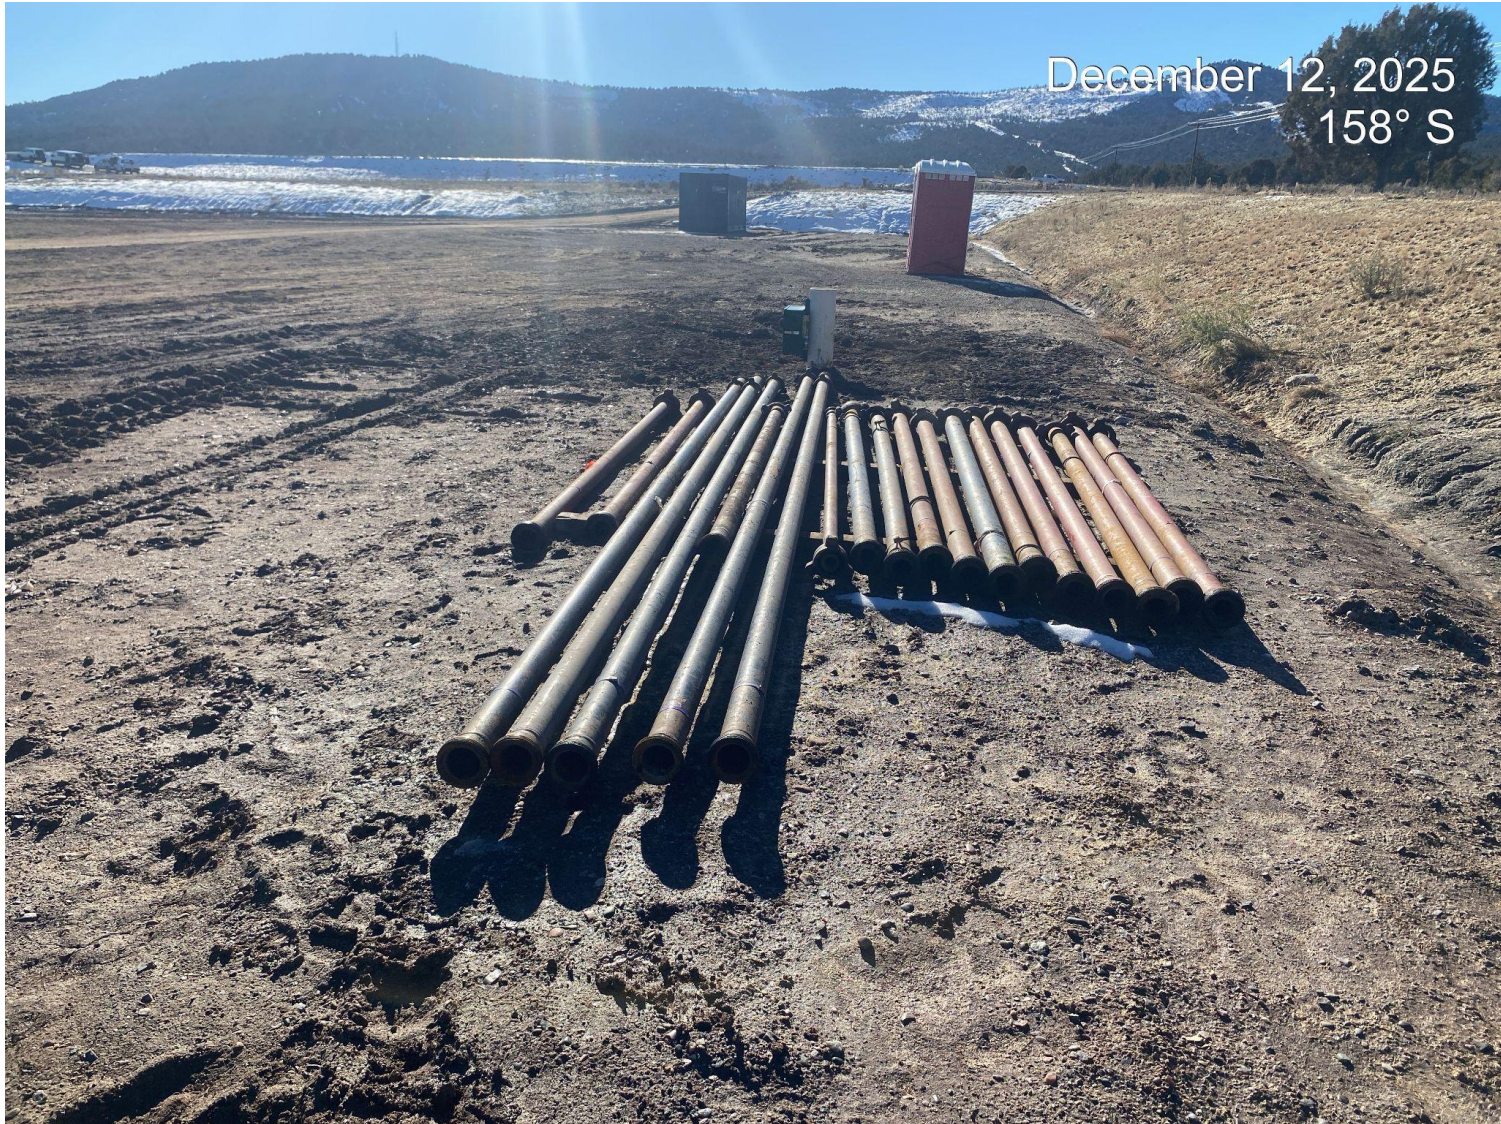
December 12, 2025
158° S

Photo 9. Unused piping stored on the western edge of the well pad.

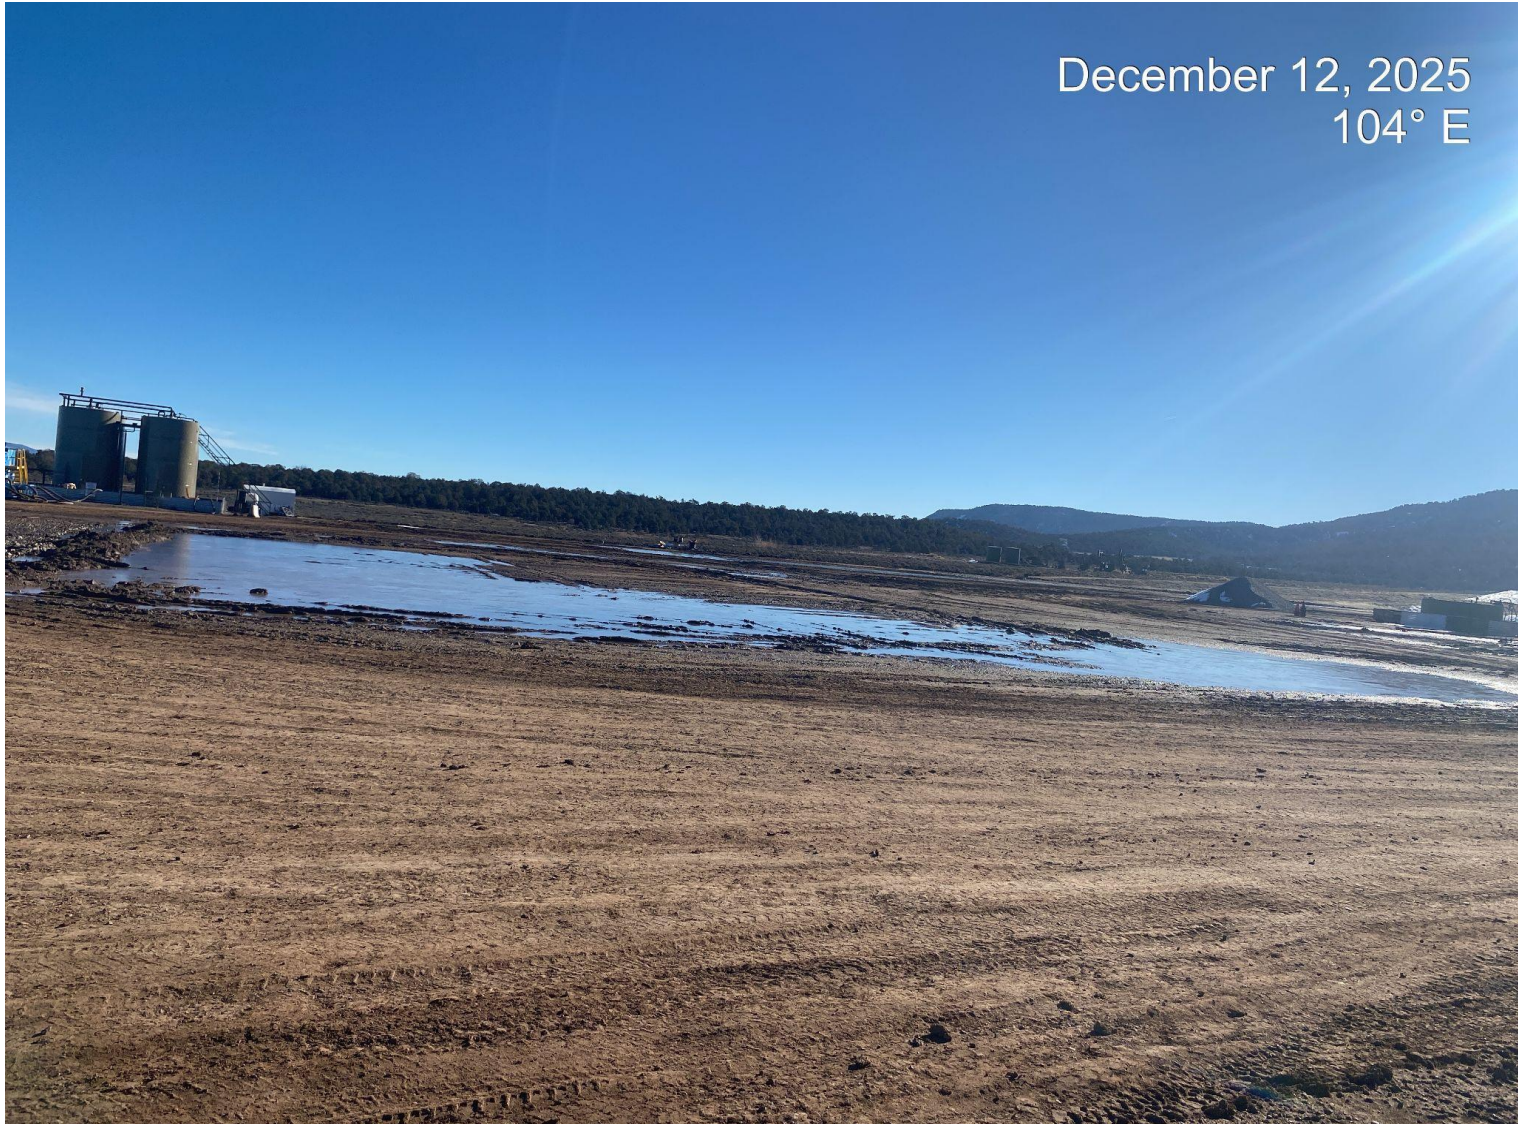
December 12, 2025
104° E

Photo 10. Pooling water observed on the well pad.

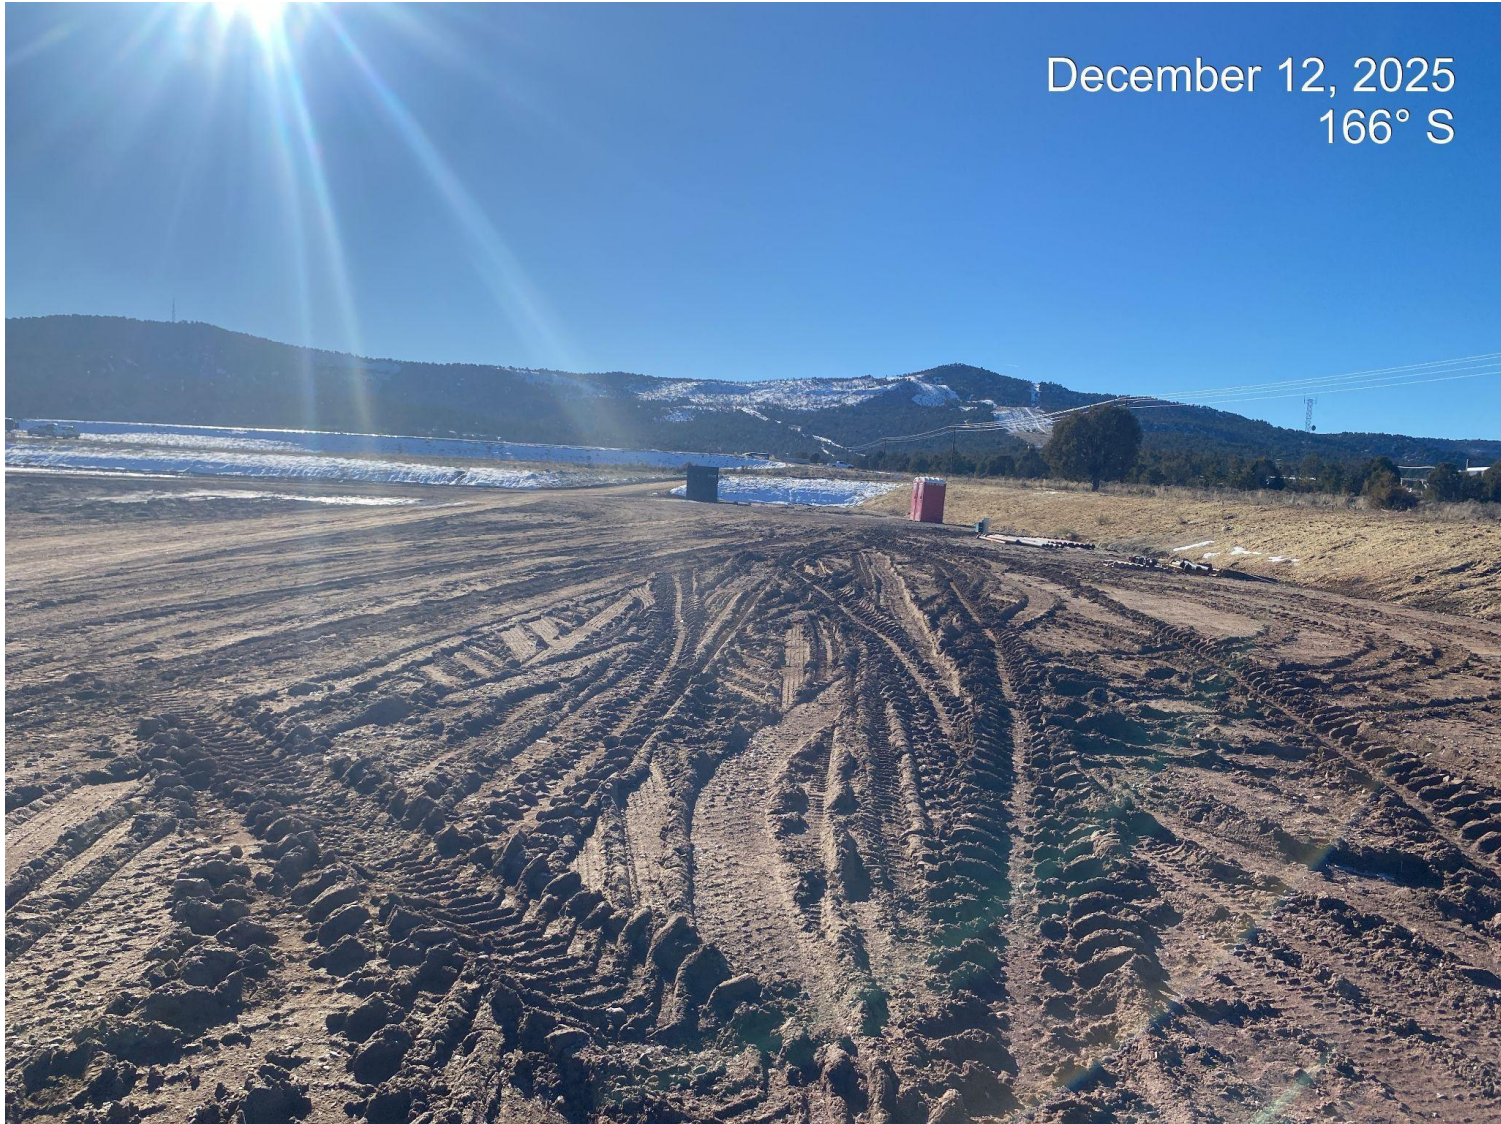
December 12, 2025
166° S

Photo 11. Vehicle tracking observed on the western edge of the well pad. Tracking is consistent with tracking observed throughout the well pad.

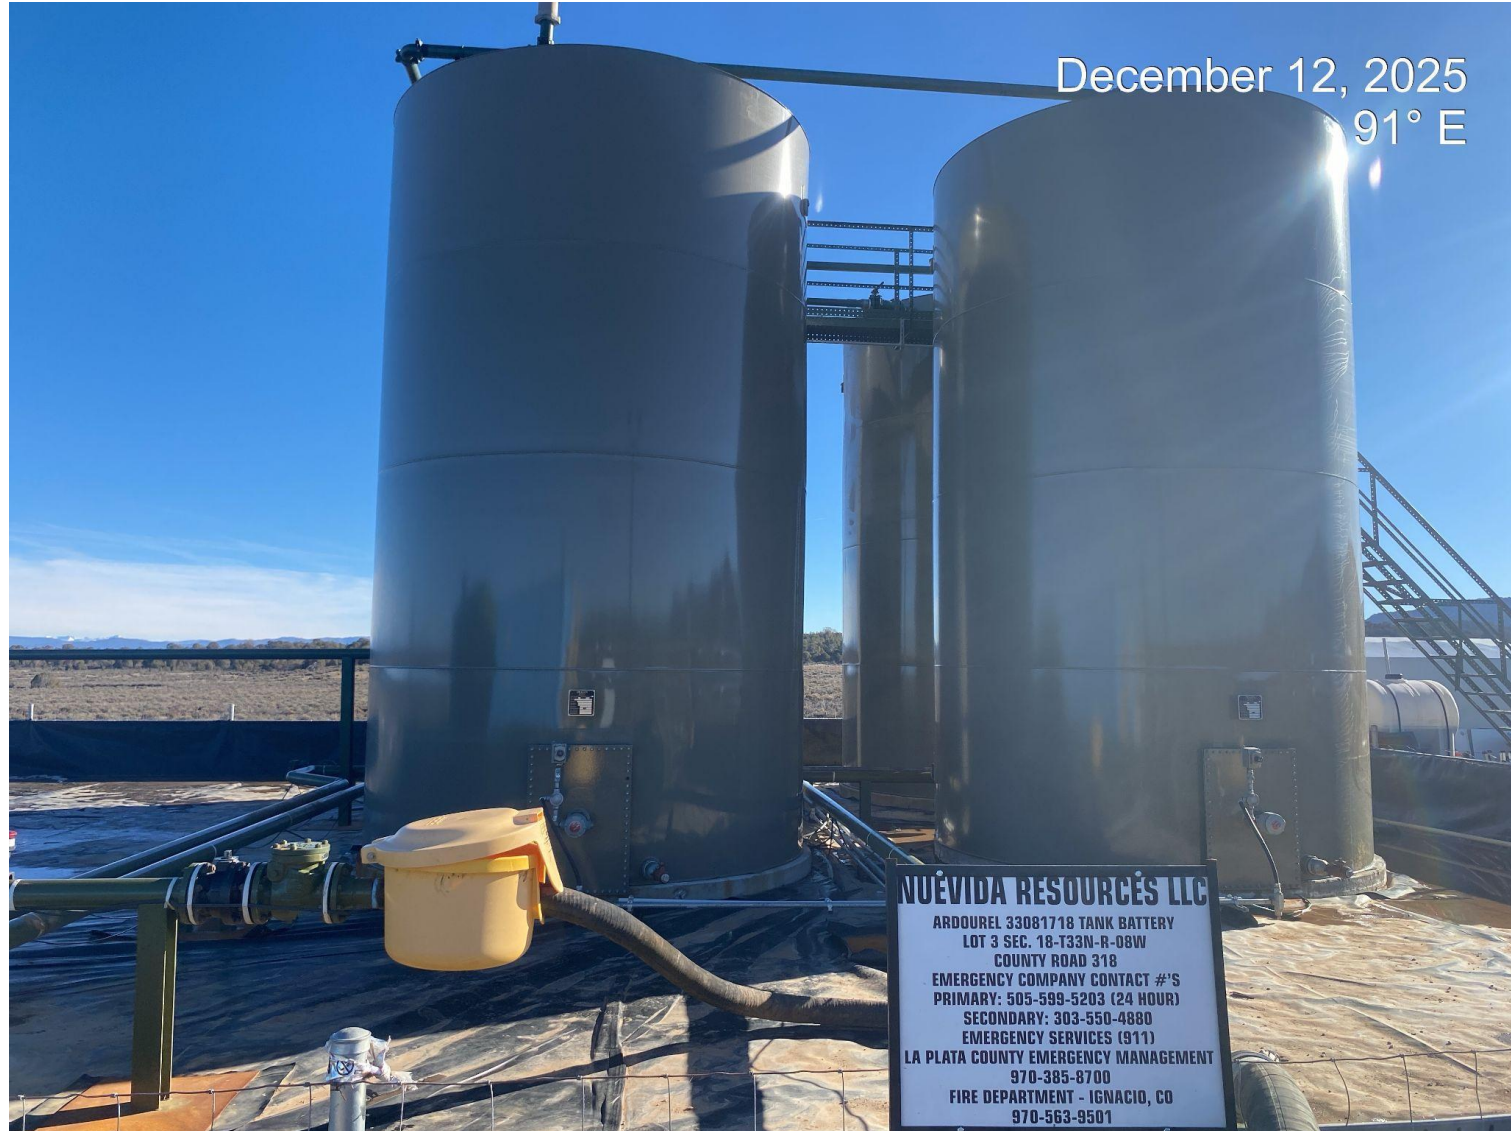
December 12, 2025
91° E

Photo 12. Tanks in the northeast corner of the well pad remain unmarked. Physical markings on each individual tank is required.
