Inspection Photos

Operator: Nuevida Resources

Location ID: 484496

Inspection Document #: 714003037

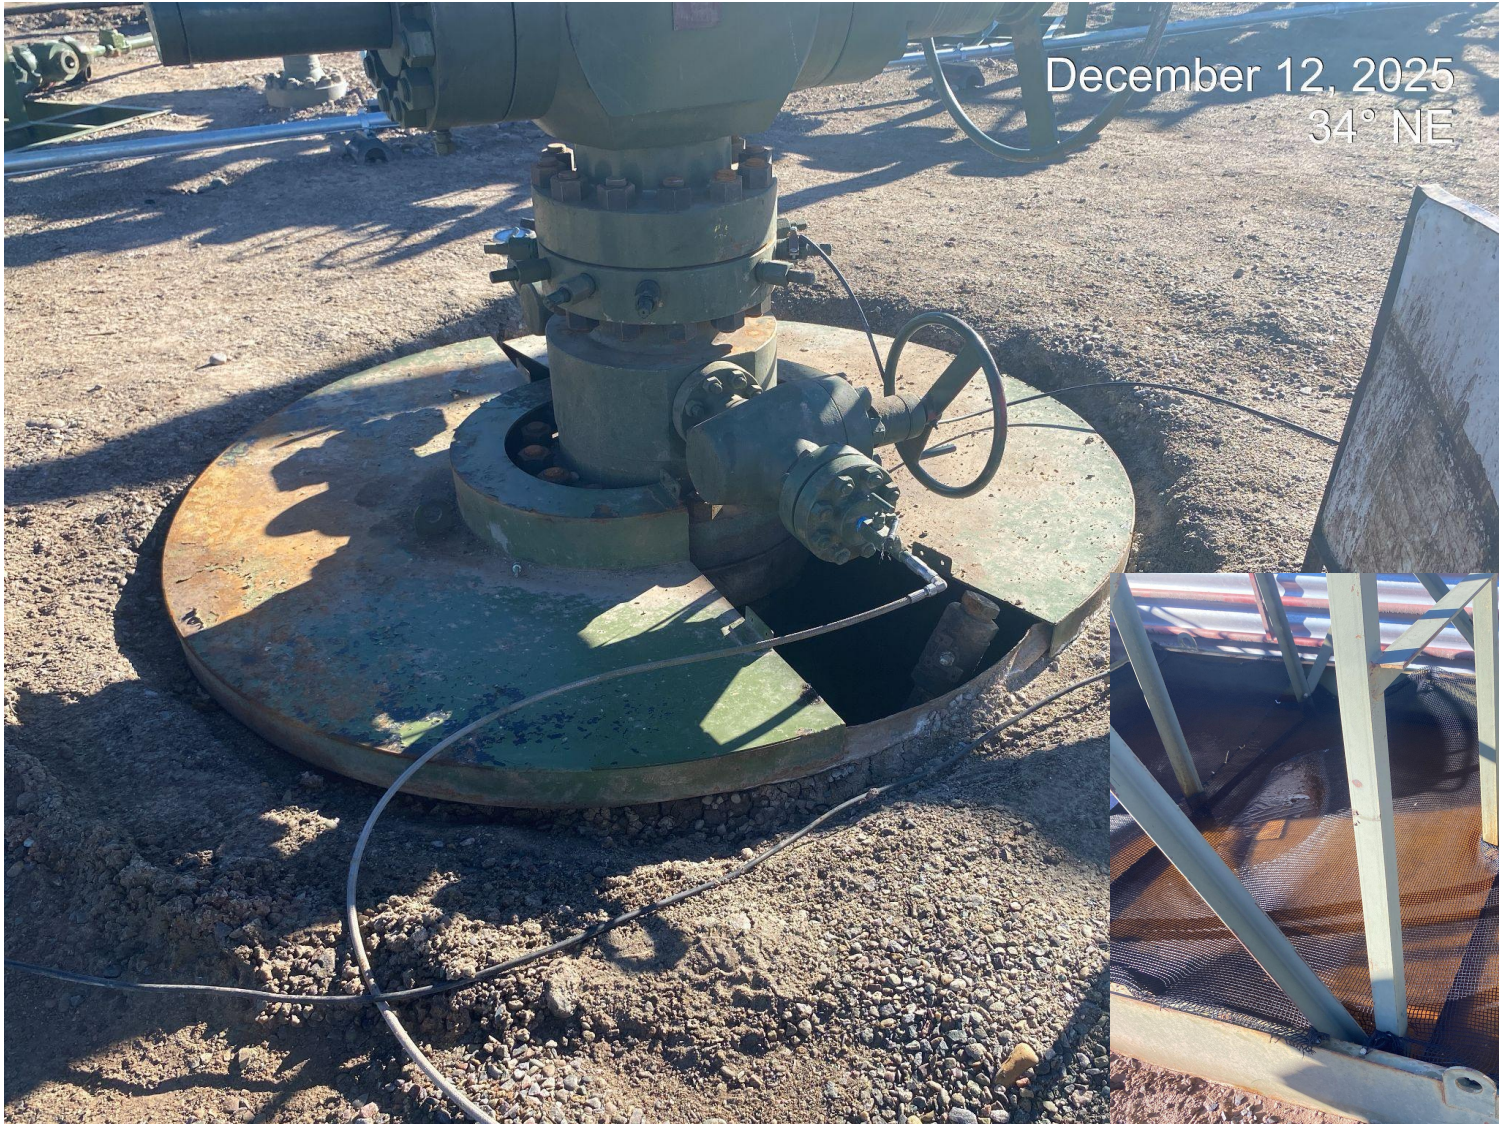
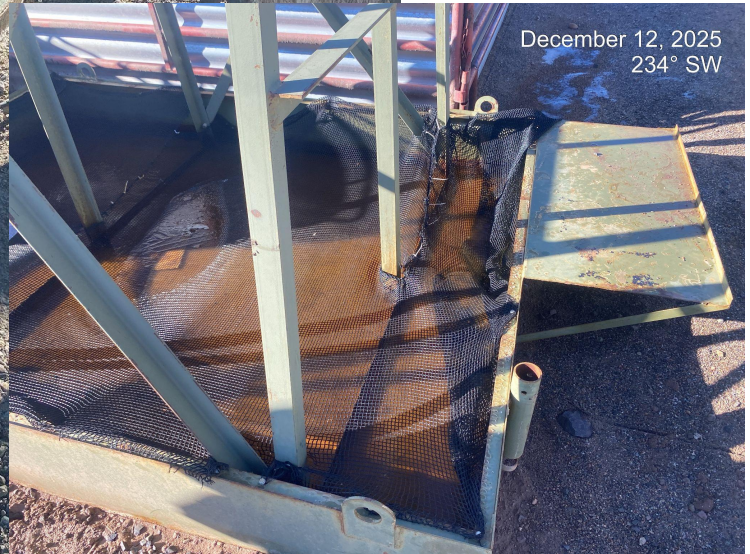
Photo 13. Wildlife protections/coverings at the both the well pads and chem/lube tank secondary containment are insufficient/no longer functioning and need maintenance/replacing.
