Inspection/Audit Photos

Location Name: QB ENERGY OPERATING LLC PUCKETT 21C-25 (MESA 10) Pad

Location #: 335105

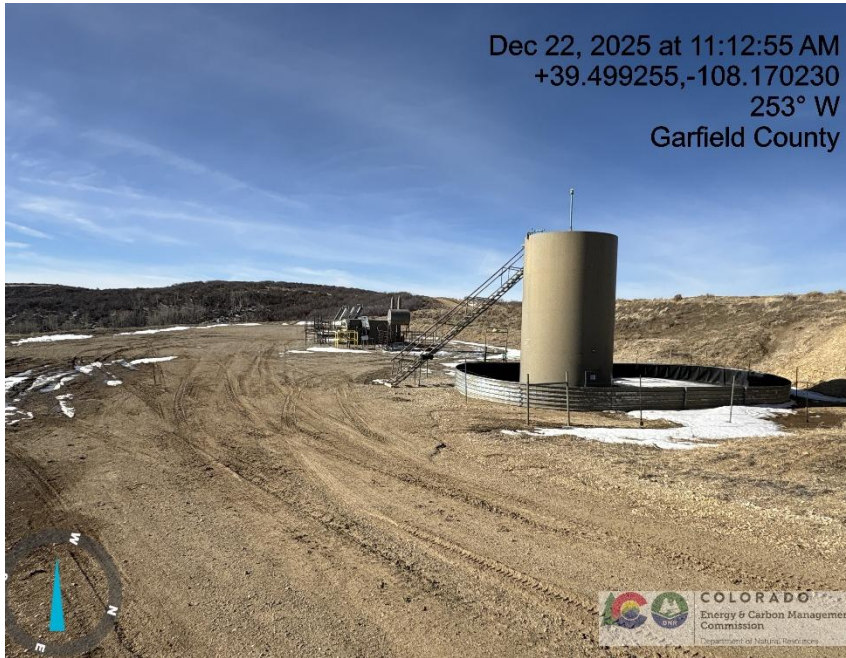
Photo # 4811 From entrance to location

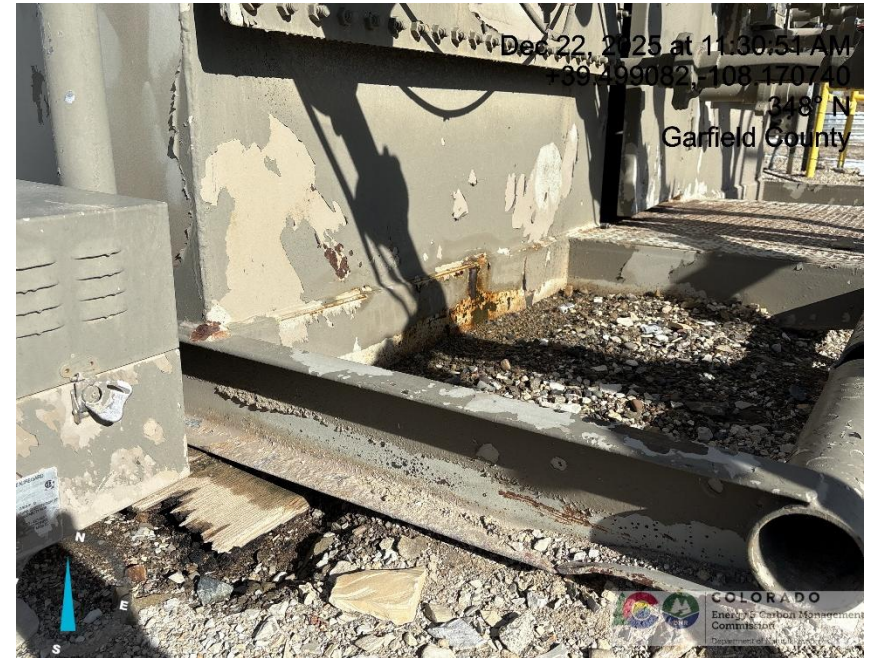
Photo # 4818 Mechanical Condition - Possible separator leak & staining near separator

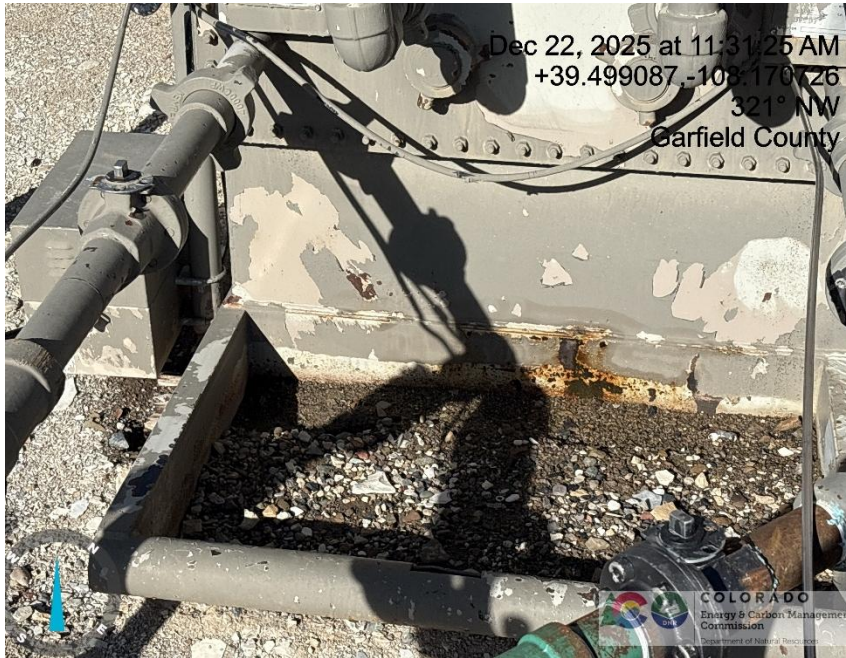
Photo # 4819 Mechanical Condition - Possible separator leak & staining near separator

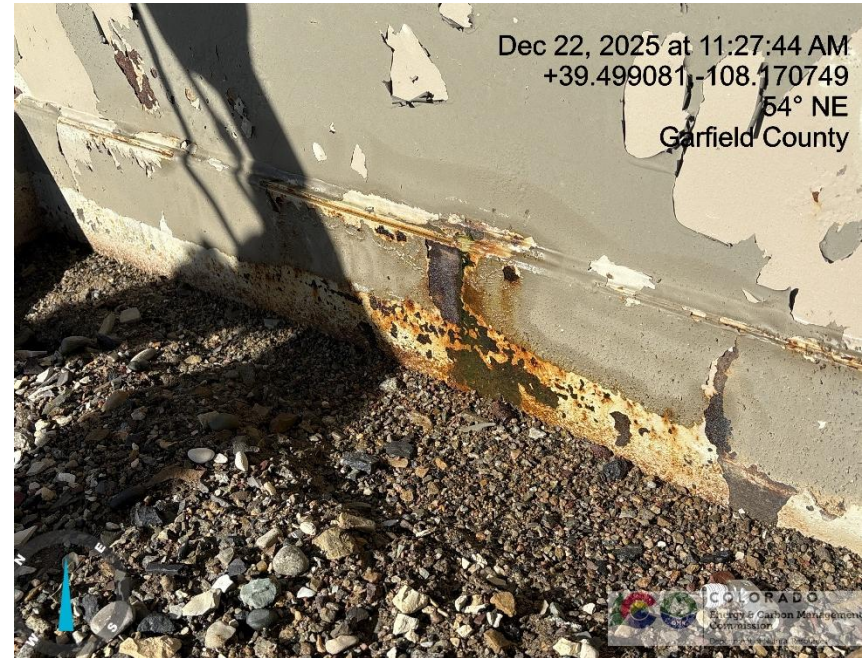
Photo # 4820 Mechanical Condition - Possible separator leak & staining near separator

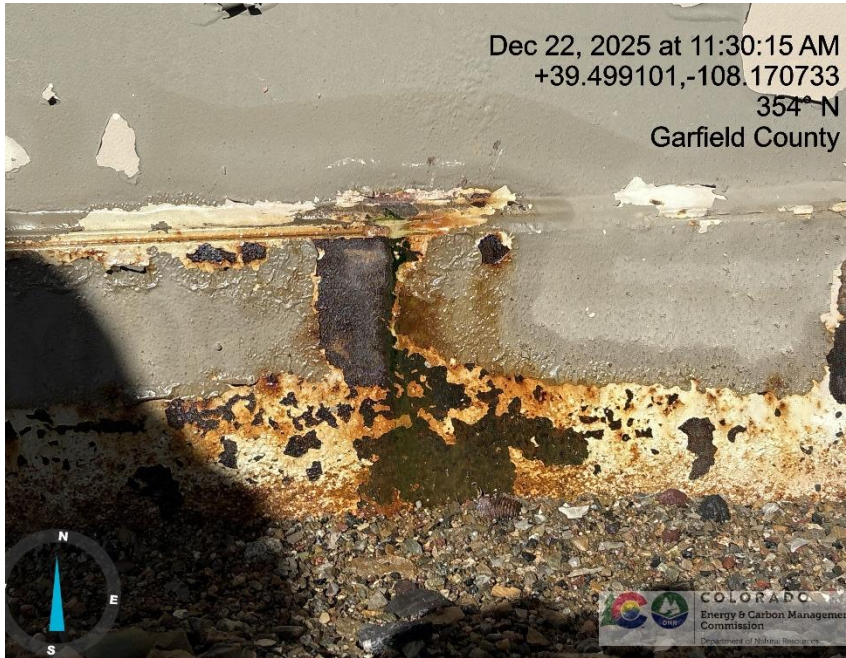
Photo # 4821 Mechanical Condition - Possible separator leak & staining near separator

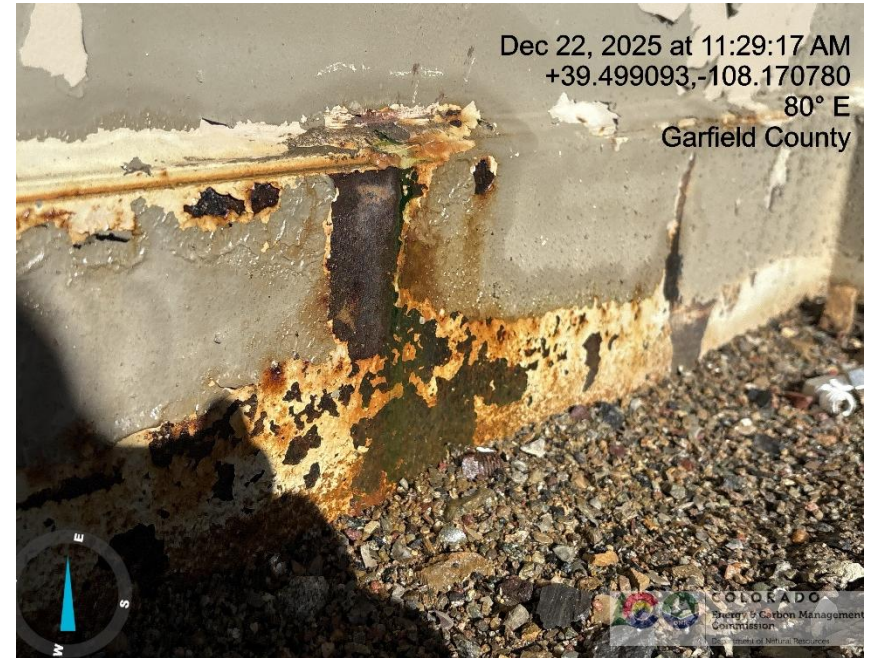
Photo # 4822 Mechanical Condition - Possible separator leak & staining near separator

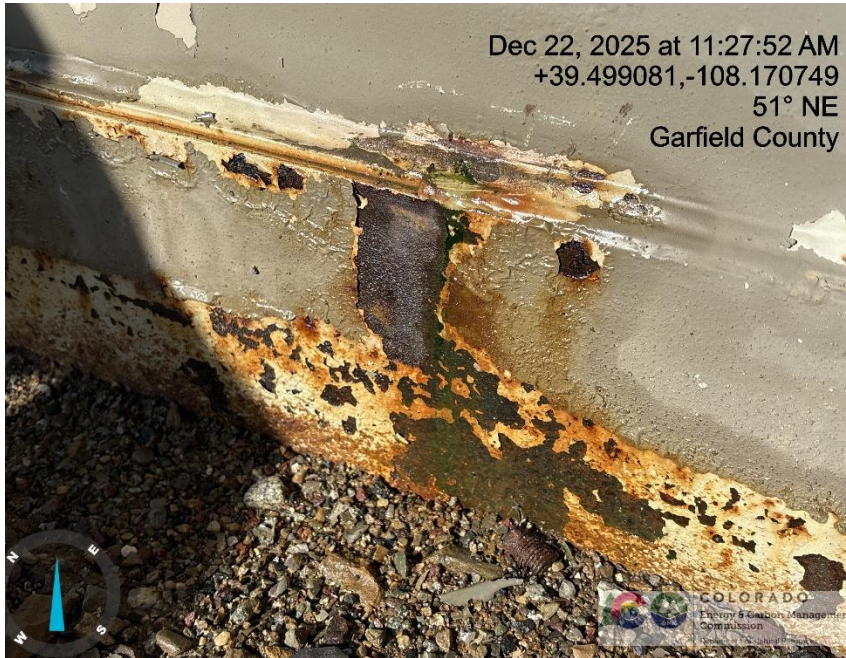
Photo # 4823 Mechanical Condition - Possible separator leak & staining near separator

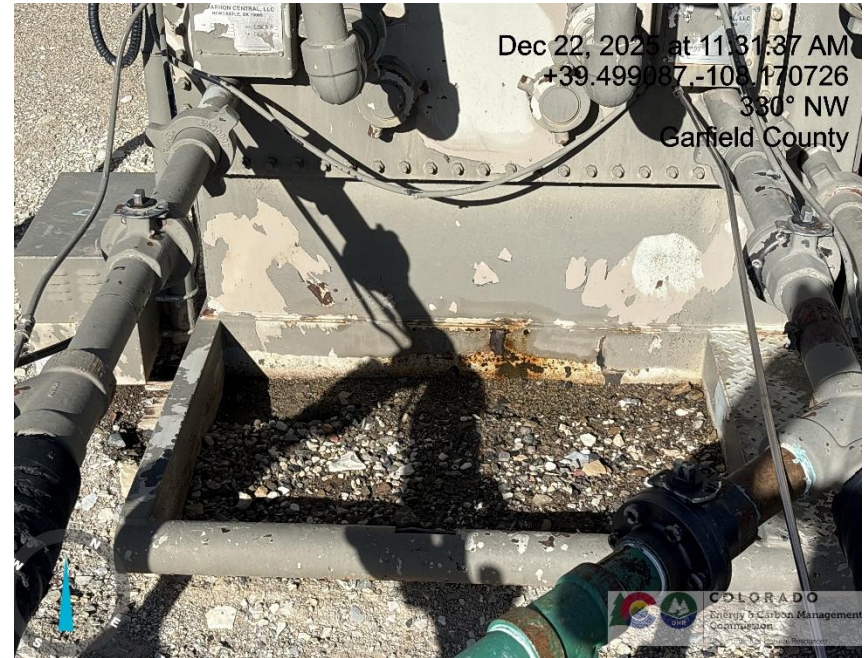
Photo # 4824 Mechanical Condition - Possible separator leak & staining near separator
