Inspection Photos
Location Name: Clark, Francis Doughty 2
Location ID: 318444

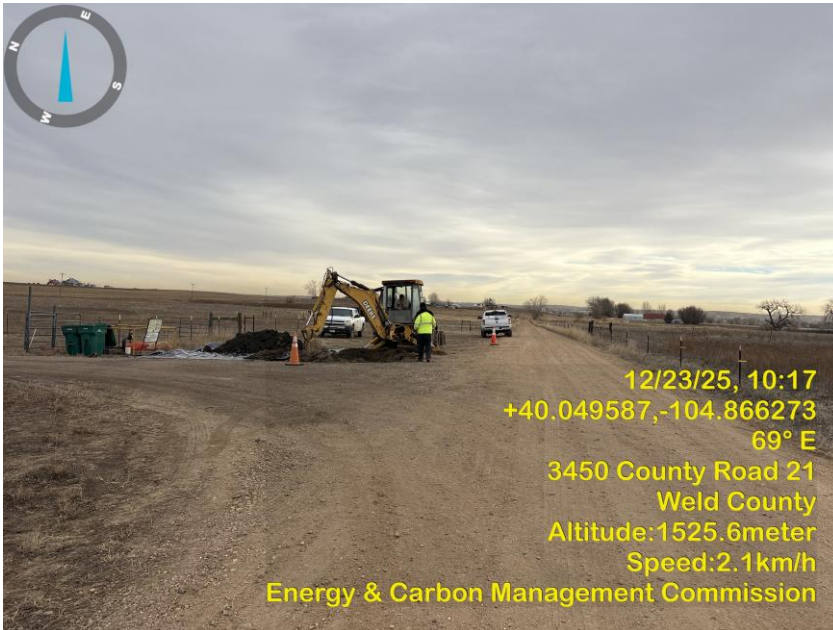
Photo 1 Spill Location.

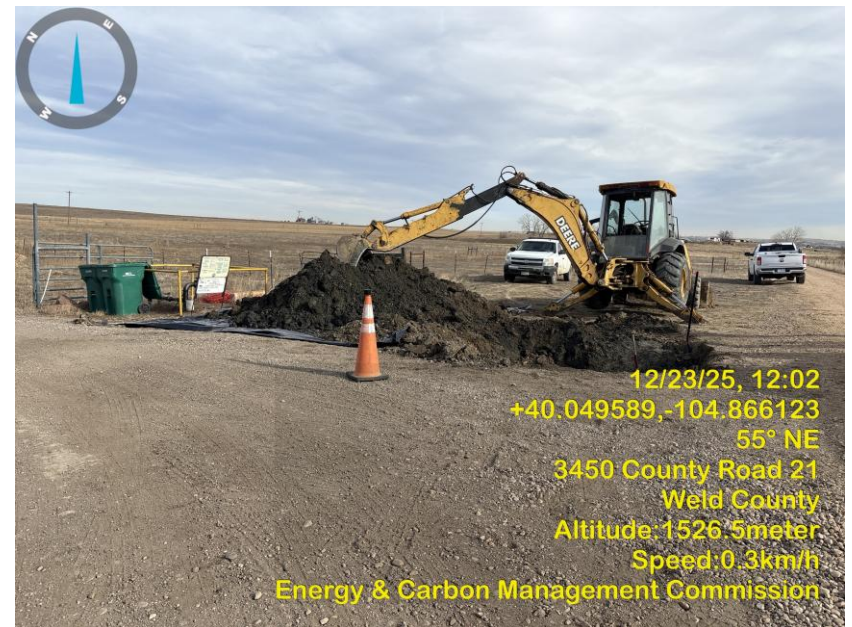
Photo 2 Backhoe & Excavation.

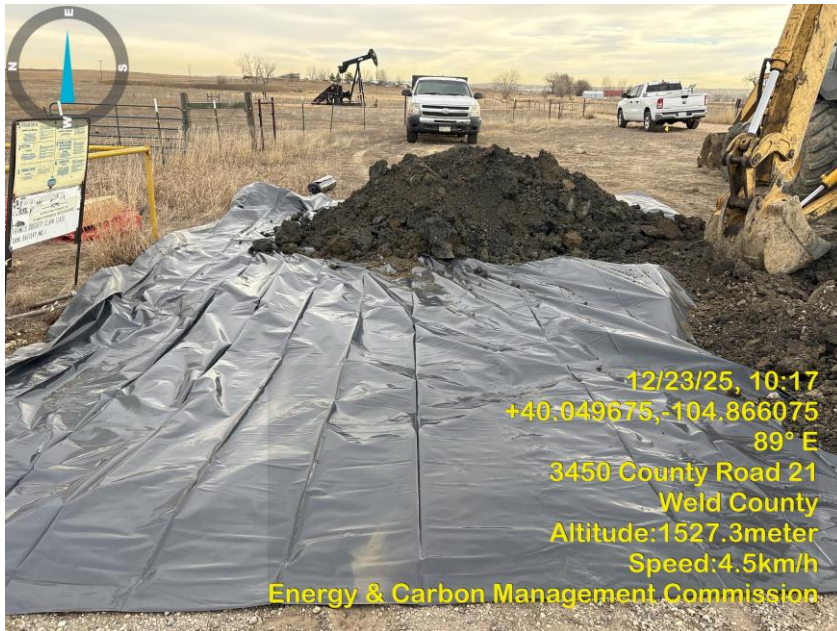
Photo 3 Contaminated soil pile.

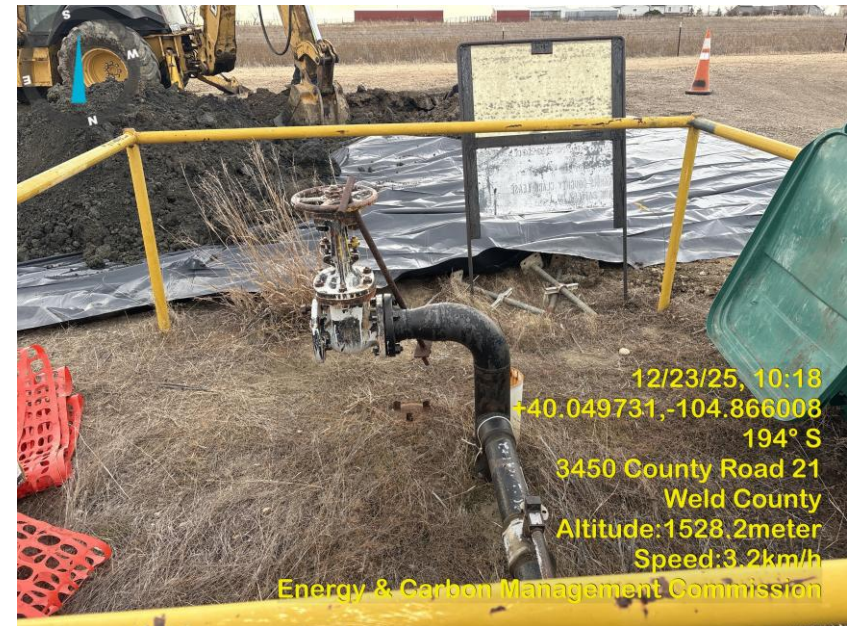
Photo 4 Marked flow line.

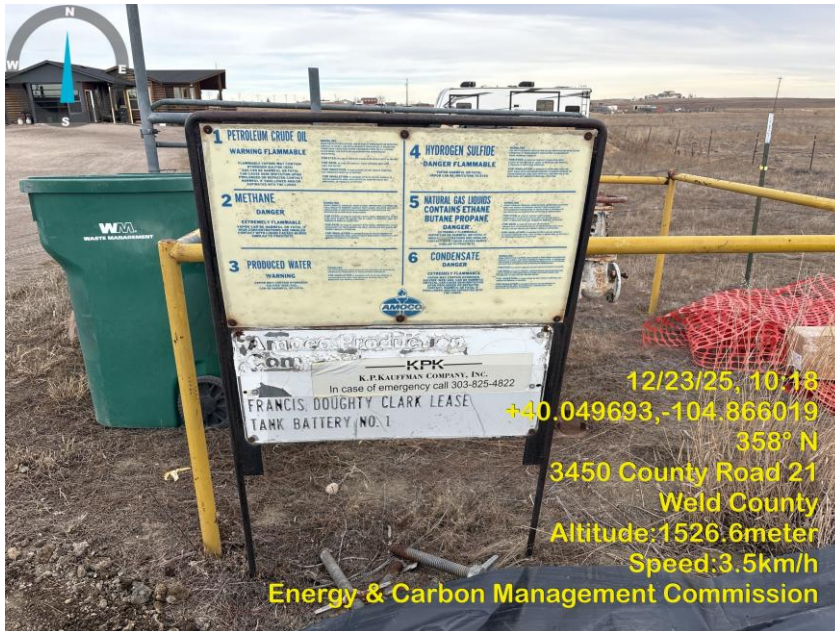
Photo 5 Old KP Kauffman battery sign marking the flow line area.

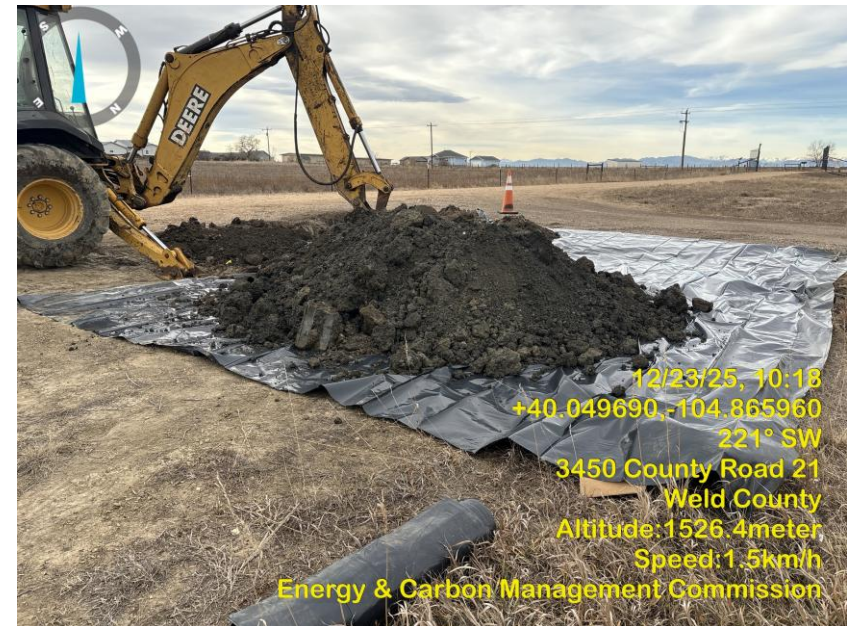
Photo 6 Contaminated soil pile.

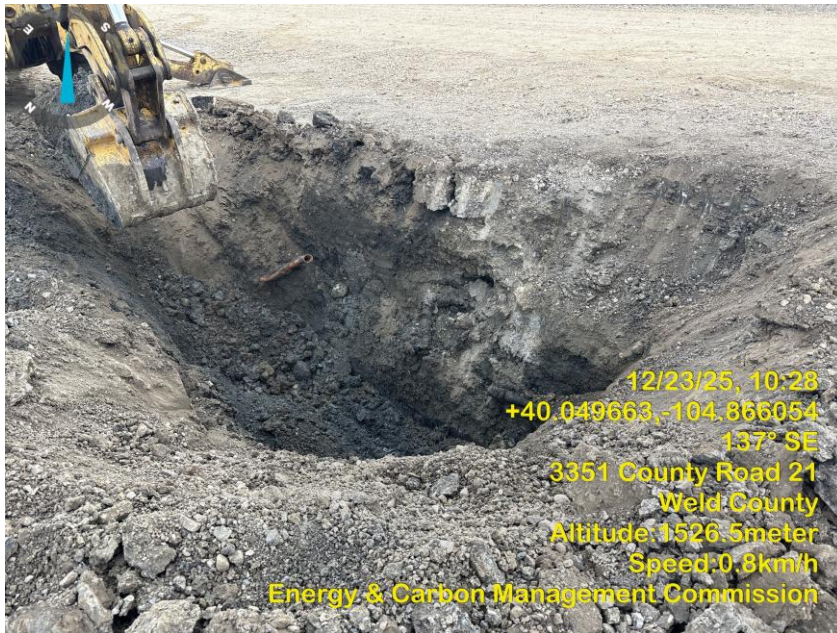
Photo 7 Excavation hole exposing flow lines.

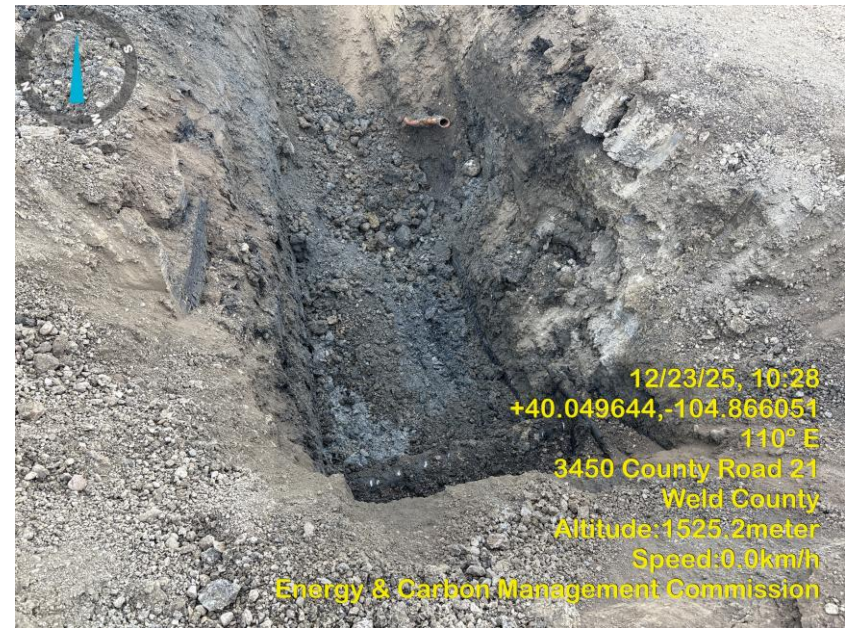
Photo 8 Excavation hole exposing flow lines.

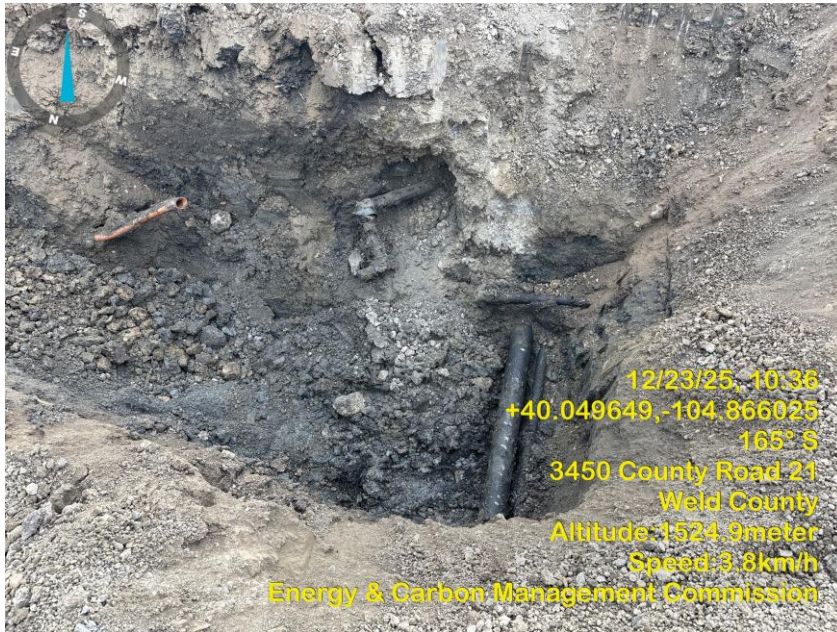
Photo 9 Excavation hole exposing flow lines.

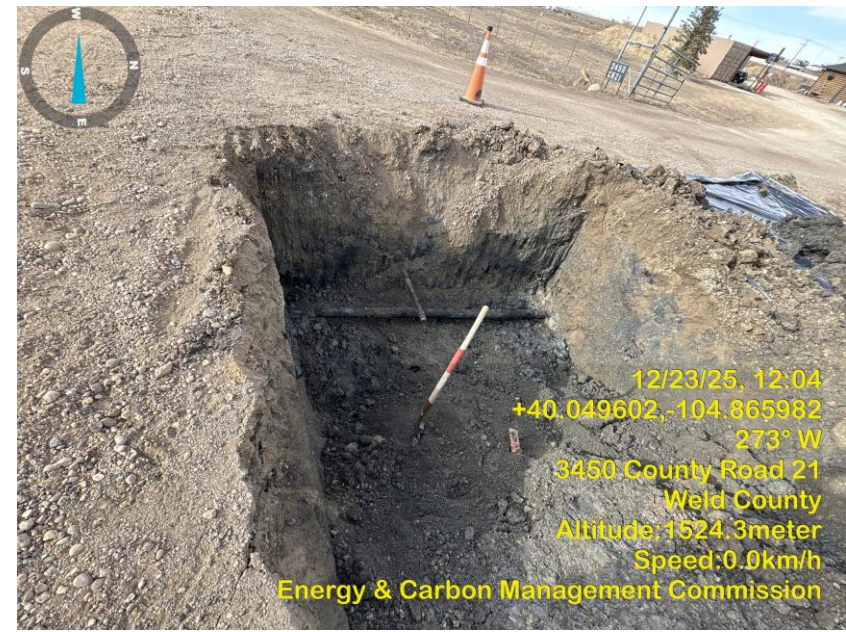
Photo 10 Excavation hole exposing flow lines.

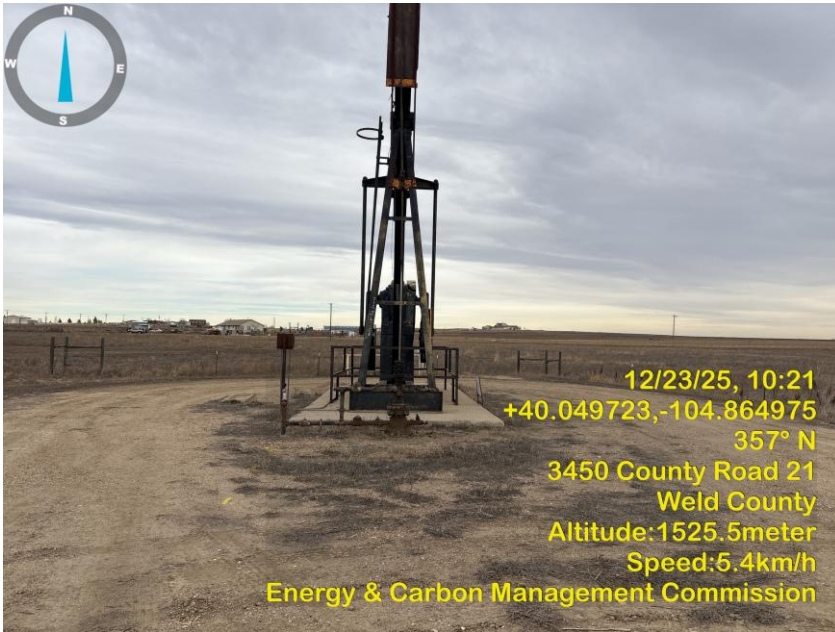
Photo 11 Wellsite.

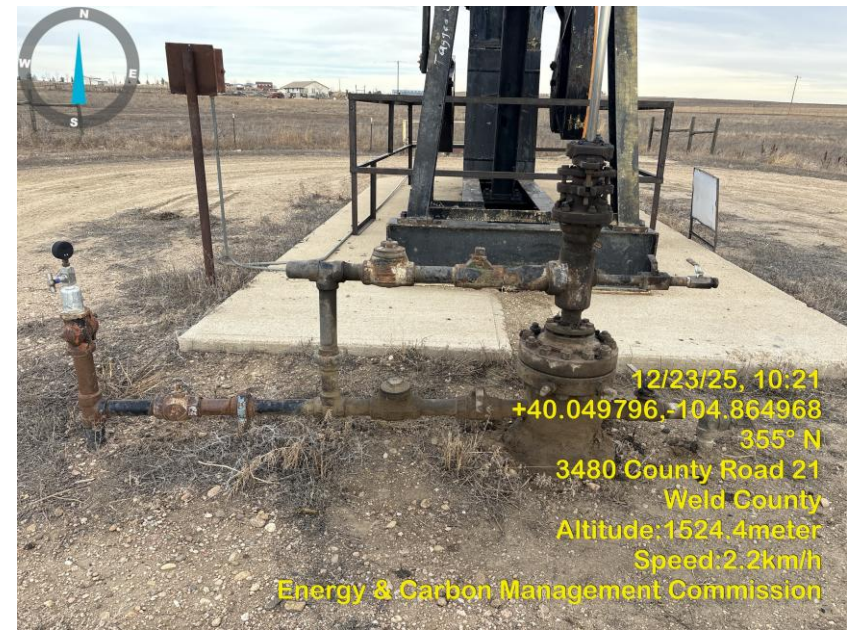
Photo 12 Wellhead.

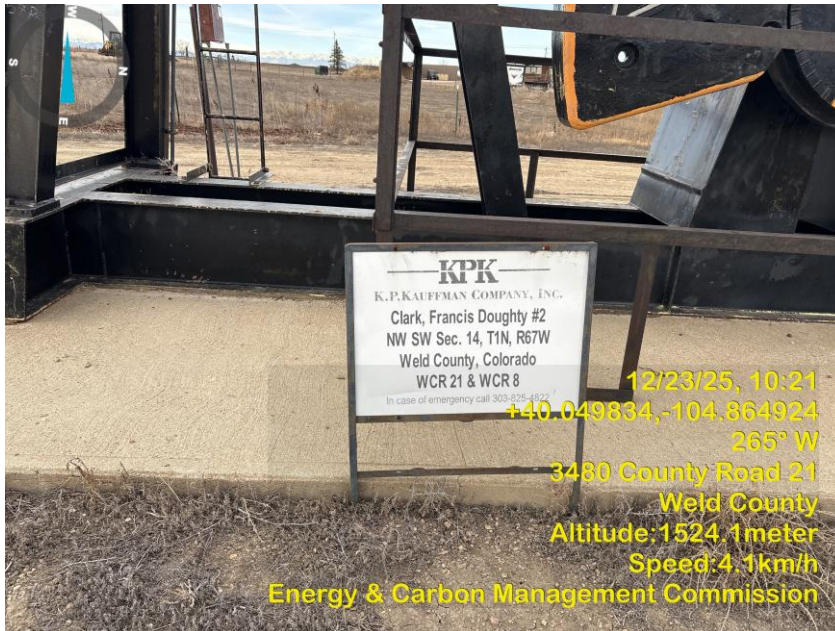
Photo 13 Wellsite sign.

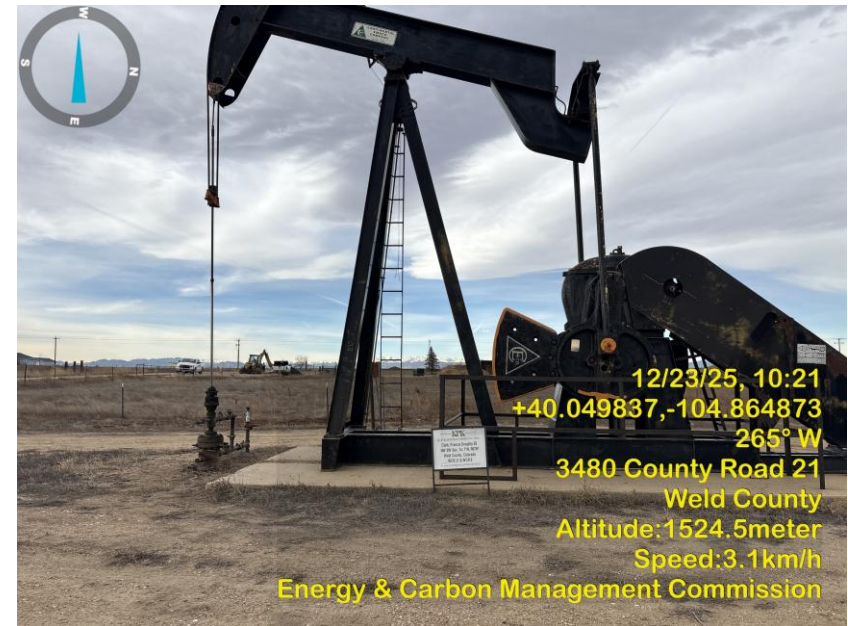
Photo 14 Wellsite with the spill excavation work in the background.

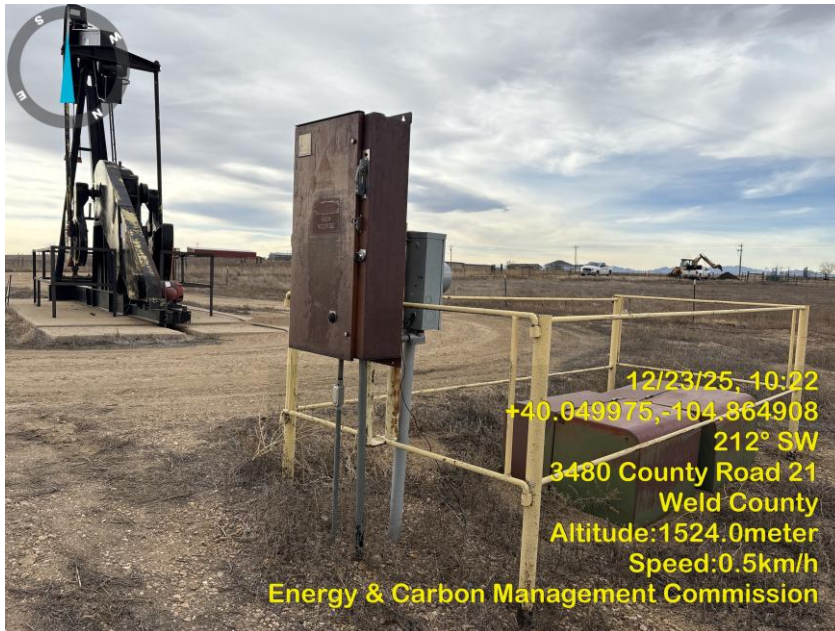
Photo 15 Wellsite ancillary equipment.

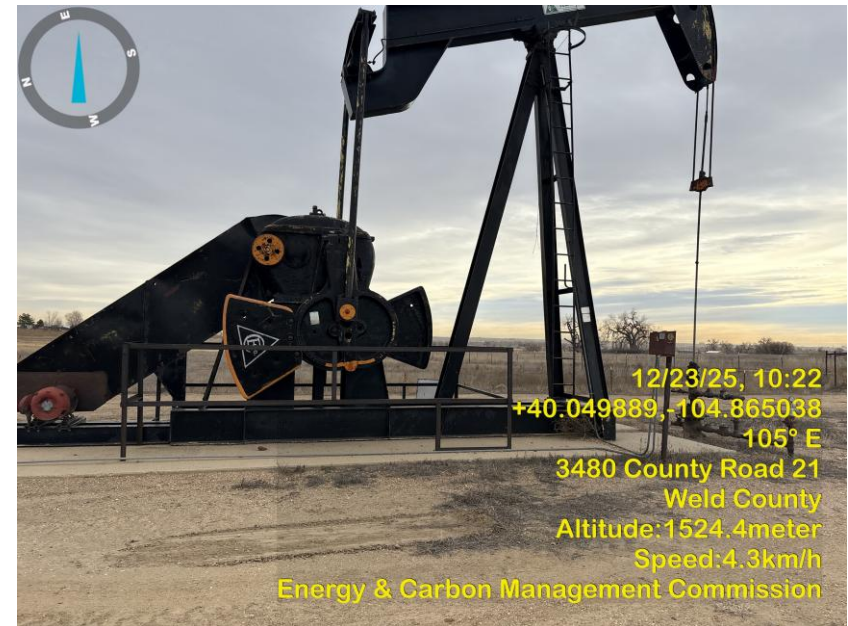
Photo 16 Wellsite.
