Inspection/Audit Photos

Location Name: QB ENERGY OPERATING LLC PUCKETT 22B-1 Pad

Location #: 324253

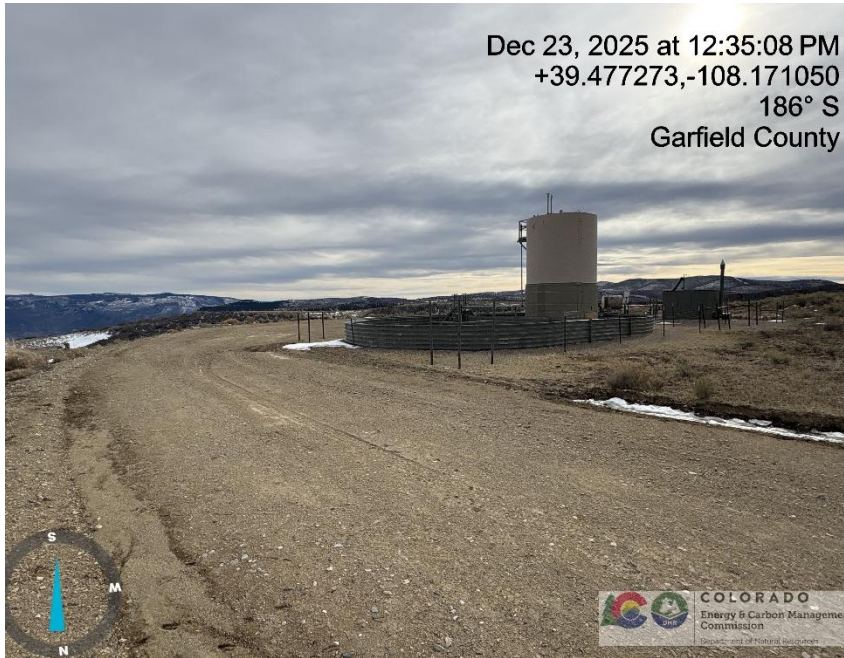
Photo # 5618 From entrance to location

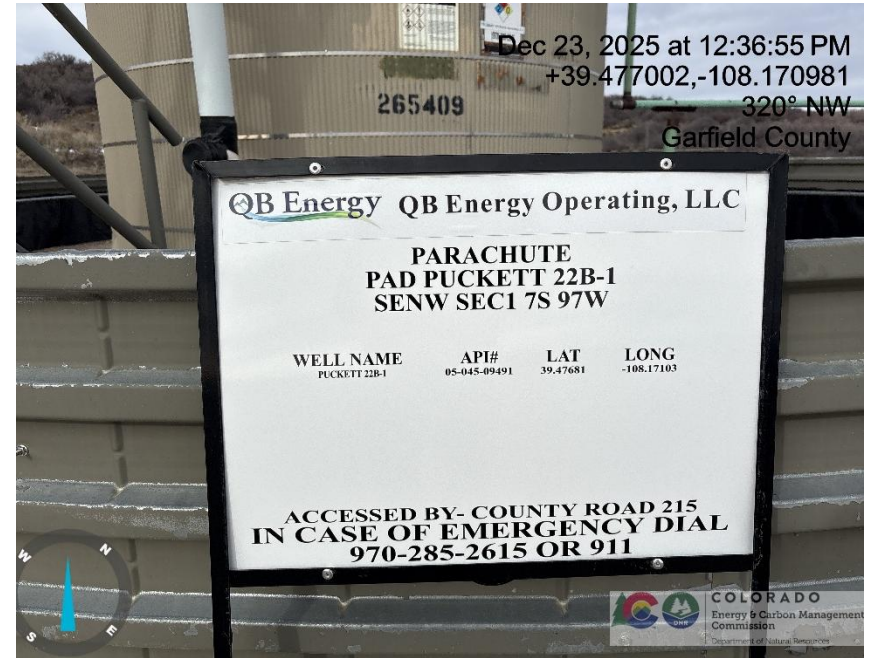
Photo # 5619 Location

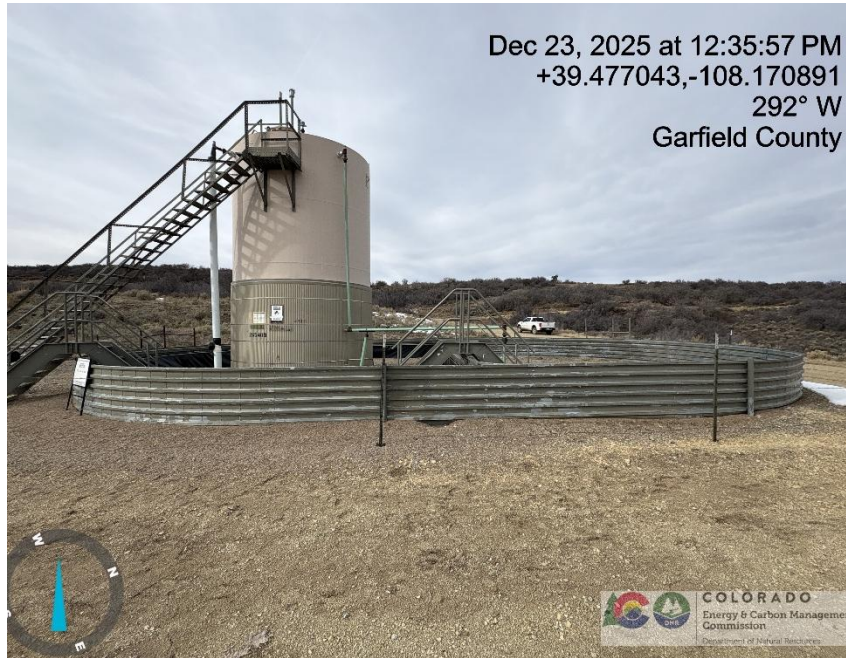
Photo # 5620 Location

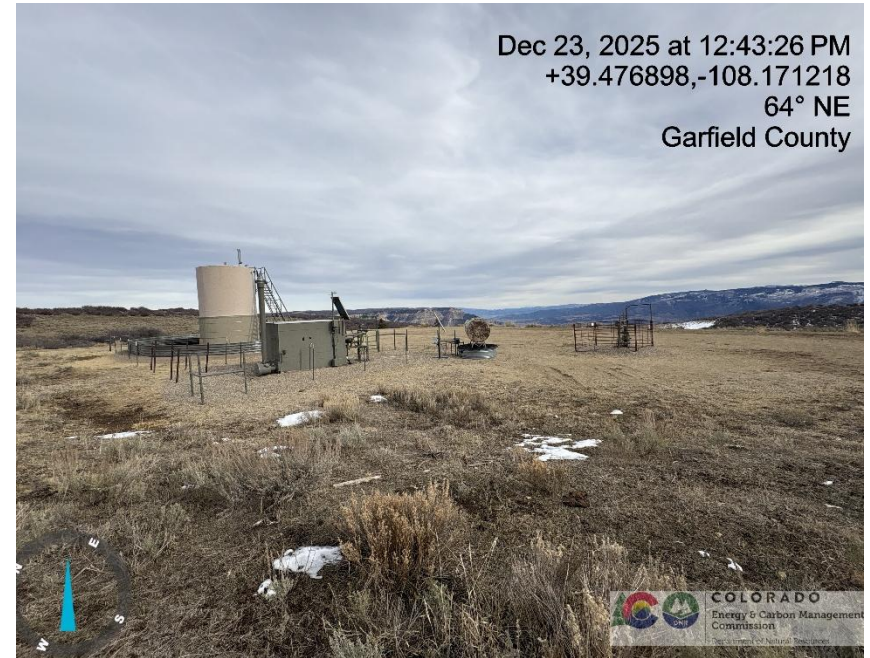
Photo # 5621 Location

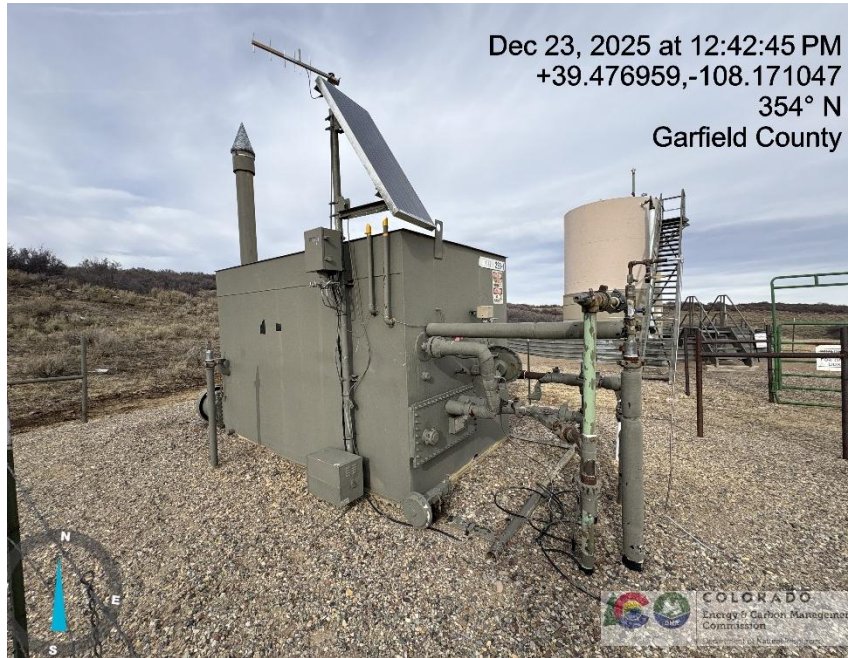
Photo # 5622 Location

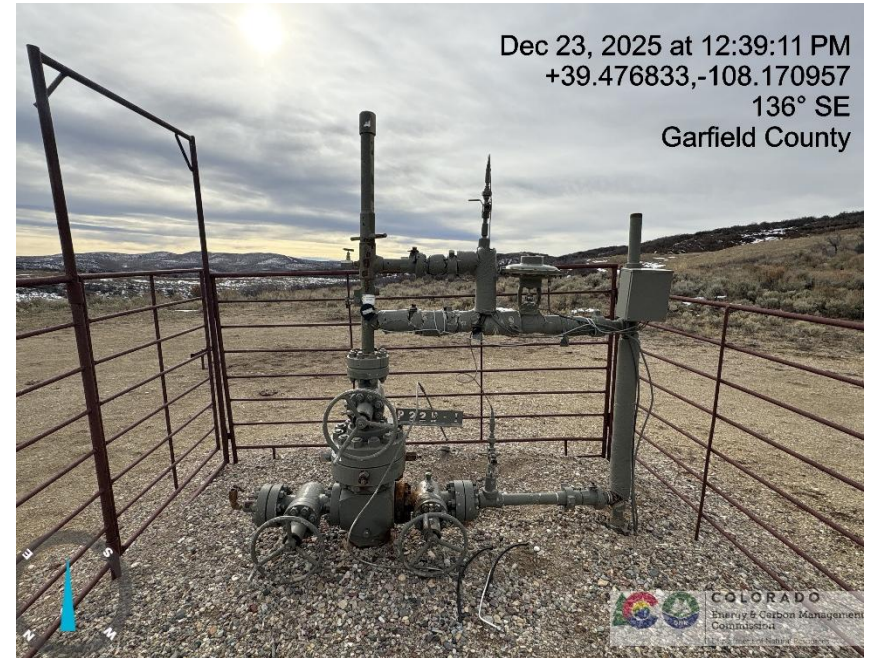
Photo # 5623 Location

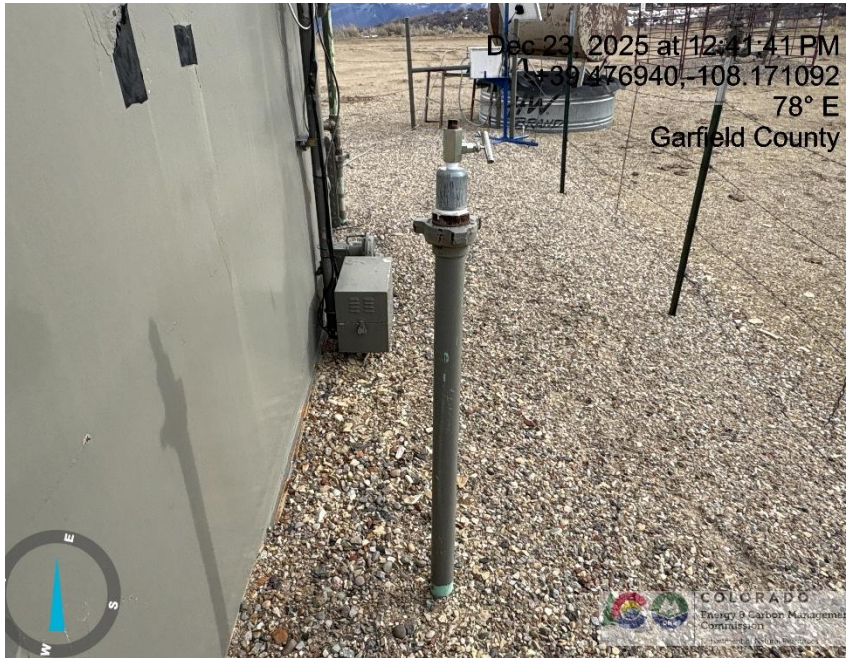
Photo # 5624 Unused flowline lacks lockout tagout (OOSLAT)

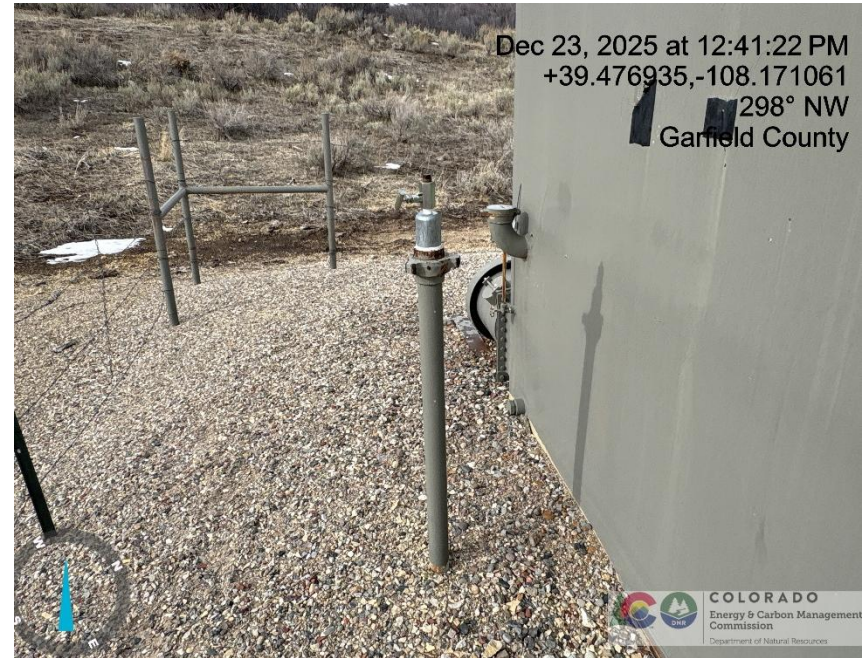
Photo # 5625 Unused flowline lacks lockout tagout (OOSLAT)

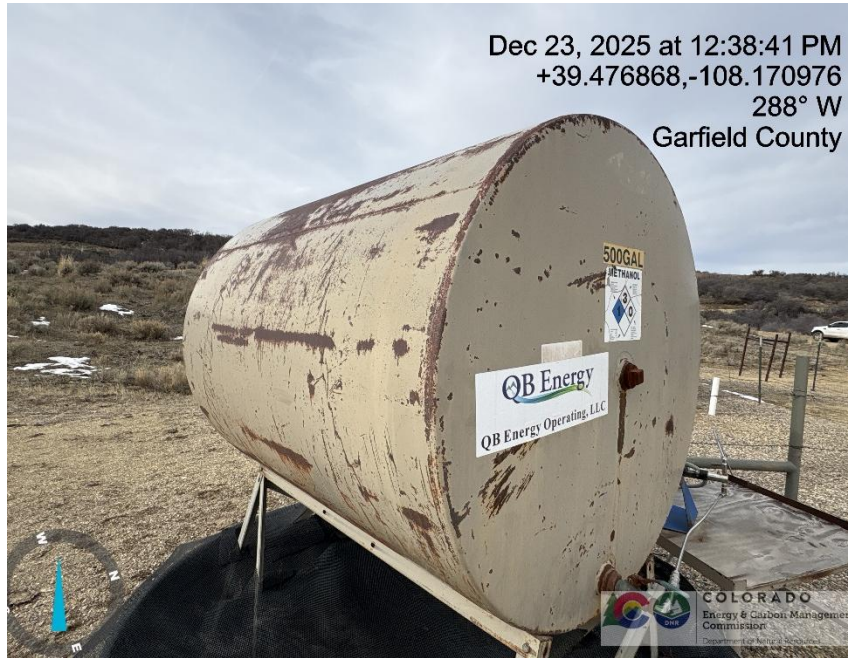
Photo # 5626 Methanol tank lacks required information

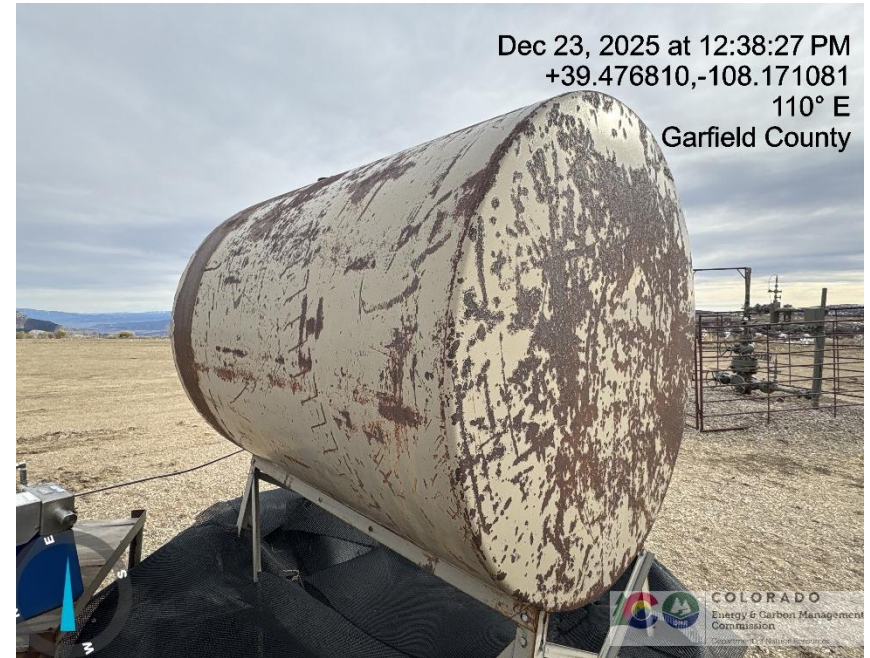
Photo # 5627 Methanol tank lacks required information

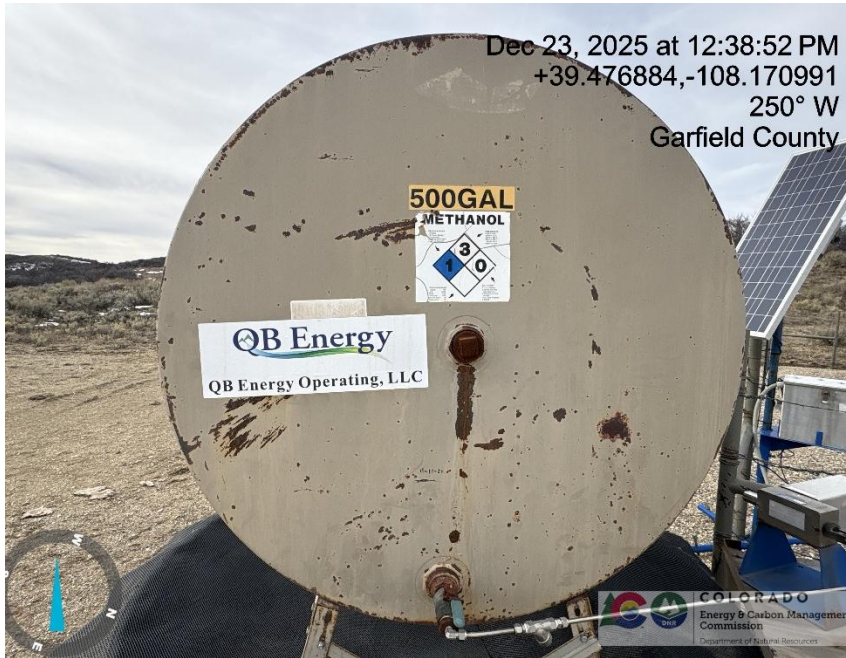
Photo # 5628 Methanol tank lacks required information

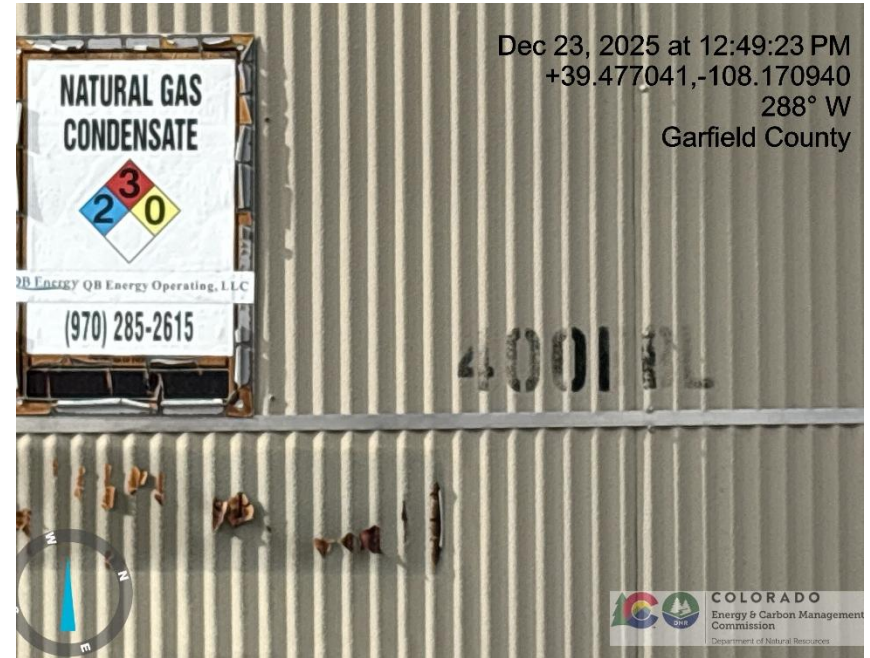
Photo # 5629 Capacity on production tank weathered & starting to become illegible
