Inspection/Audit Photos

Location: SCOUT ENERGY MANAGEMENT EMERALD #92X PAD

Location ID: 315816

Date: 12/15/2025

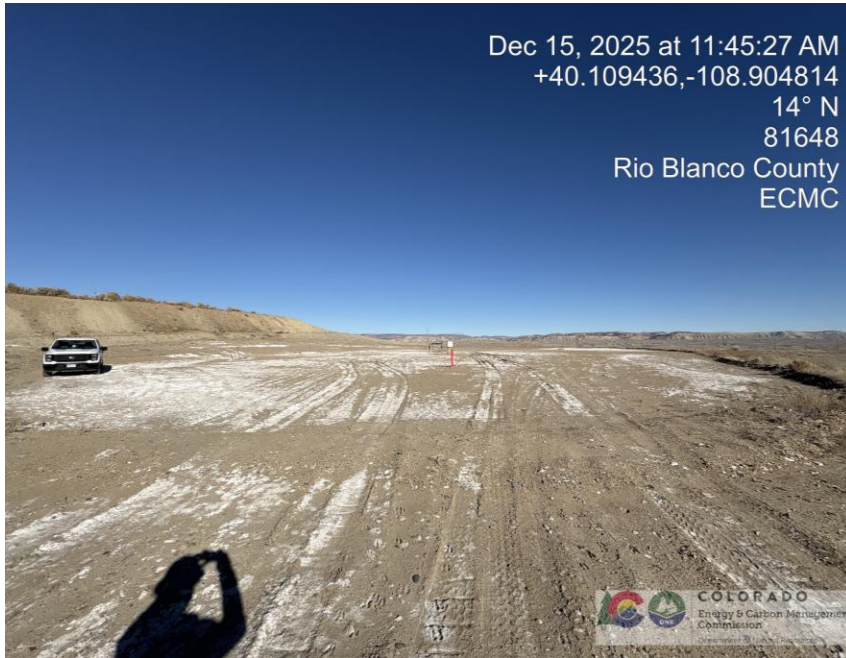
Photo # 0193 Entrance to location

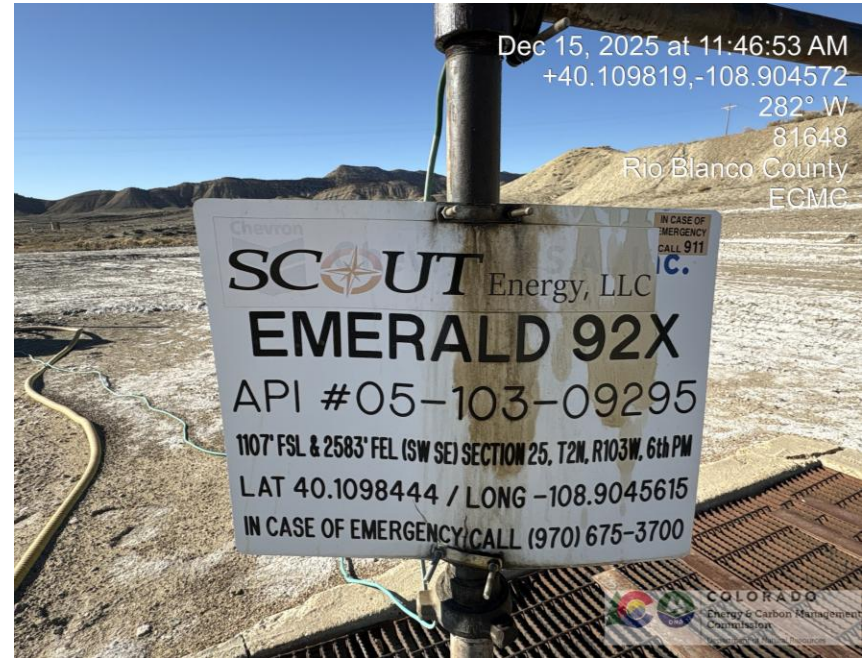
Photo # 0196 Sign lacks public road used to access the well.
No tank battery on location

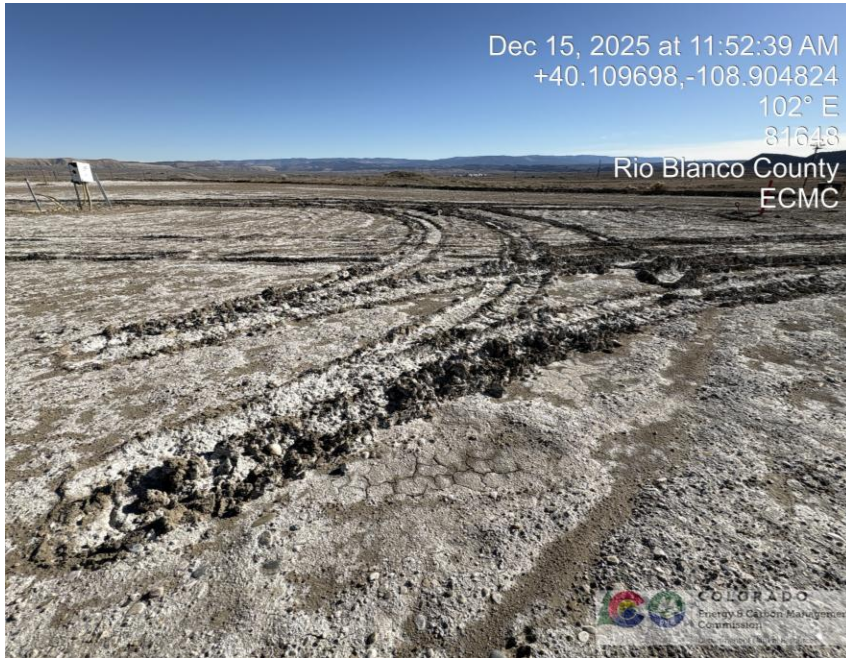
Photo # 0206 Lack of stabilization/Compaction on location

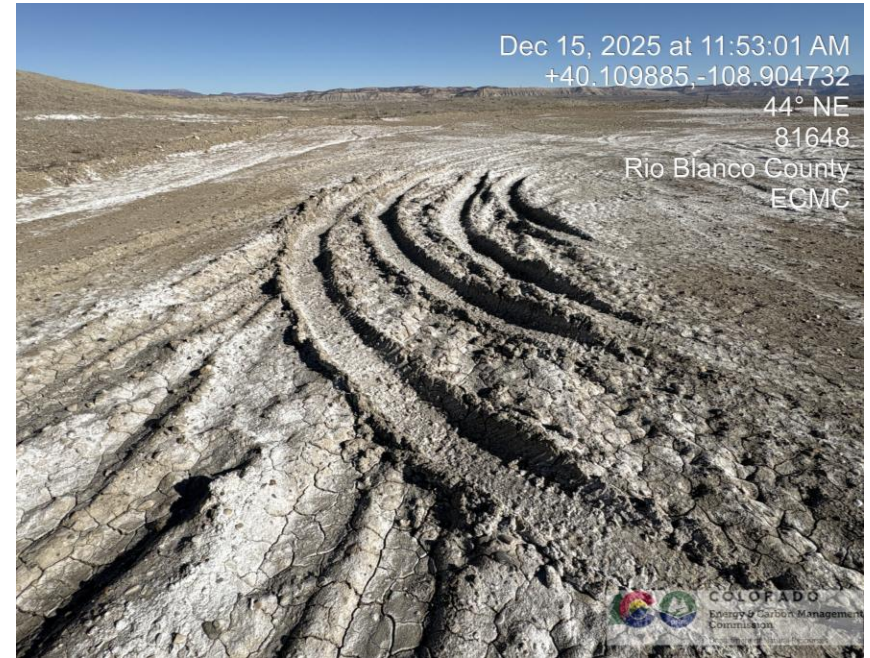
Photo # 0207 Lack of stabilization/Compaction on location

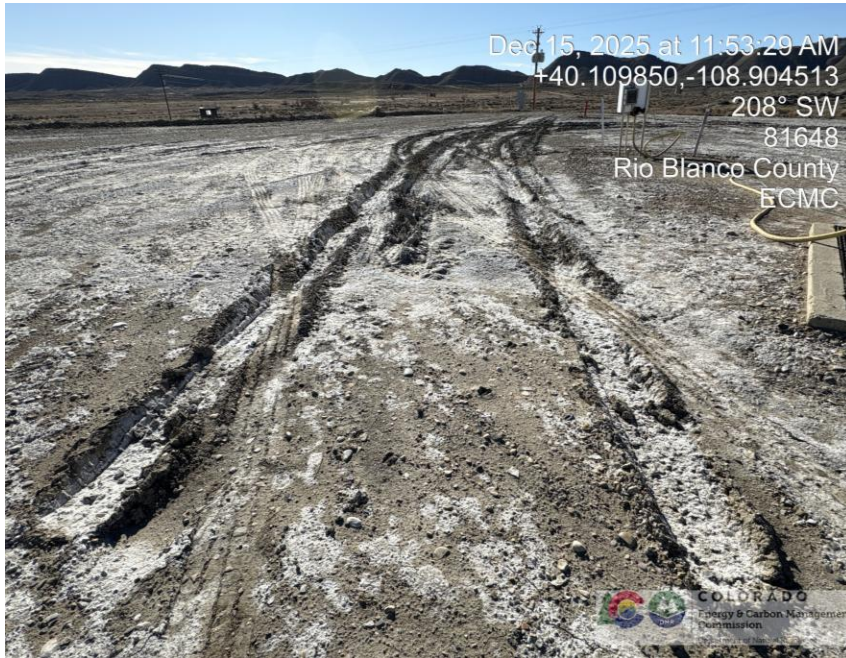
Photo # 0208 Lack of stabilization/Compaction on location

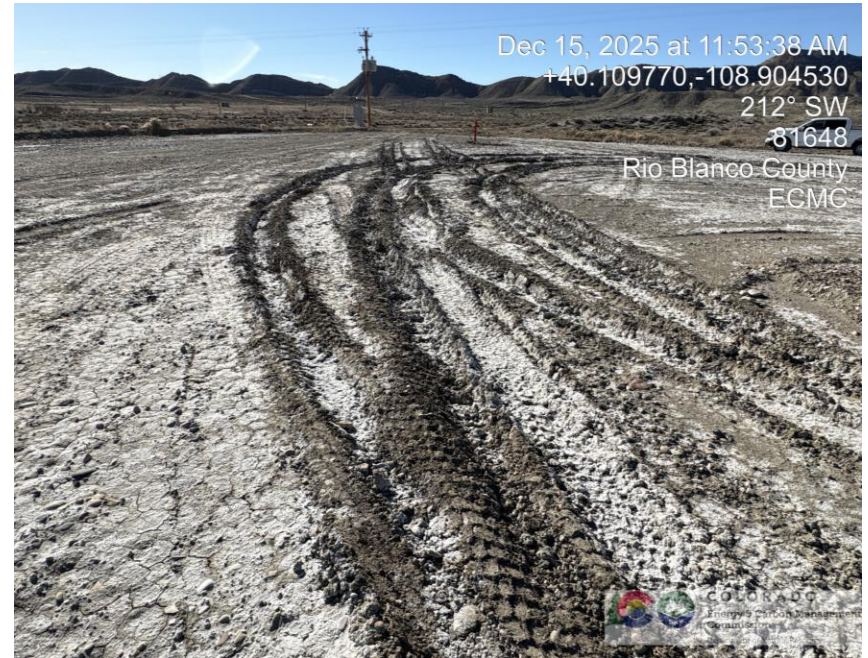
Photo # 0209 Lack of stabilization/Compaction on location

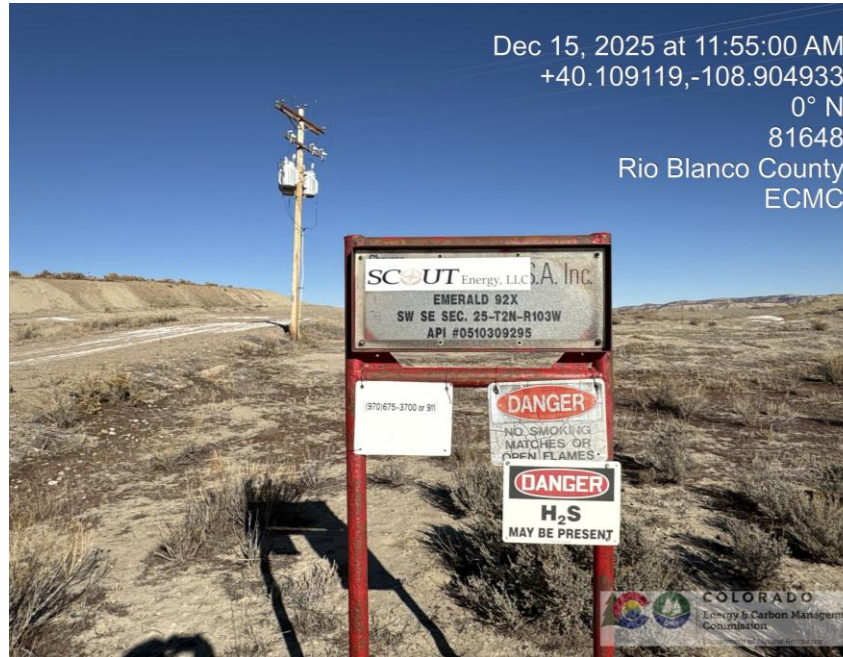
Photo # 0210 Entrance to location sign
