Inspection/Audit Photos

Location: SCOUT ENERGY MANAGEMENT LLC EMERALD #53X PAD

Location ID: 314841

Date: 12/15/2025

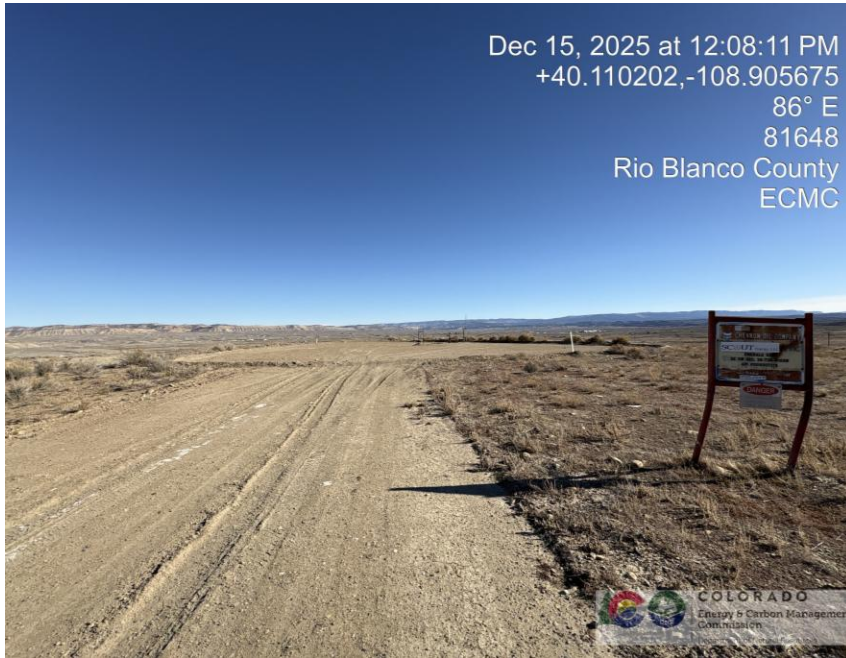
Photo # 2017 Entrance to location

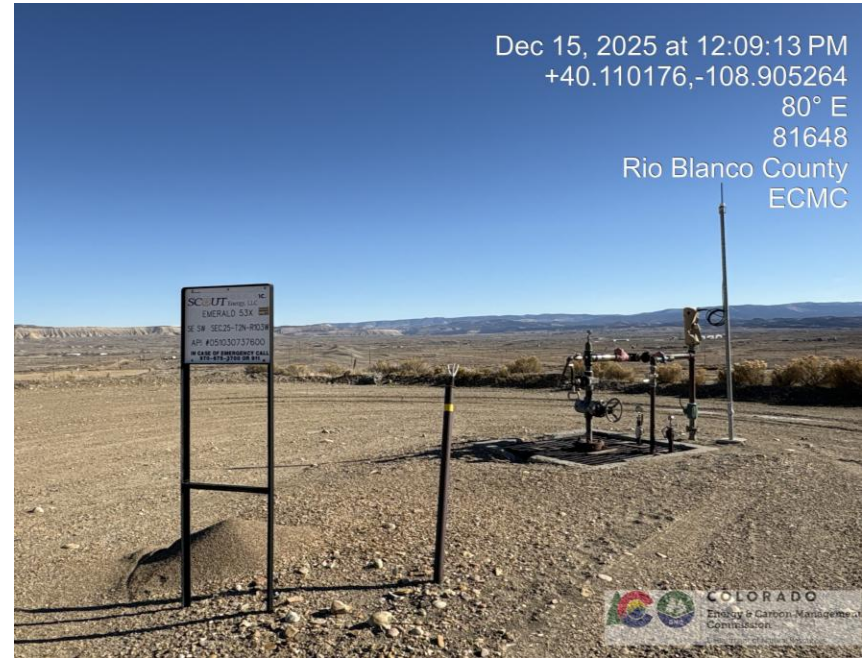
Photo # 0220 Location

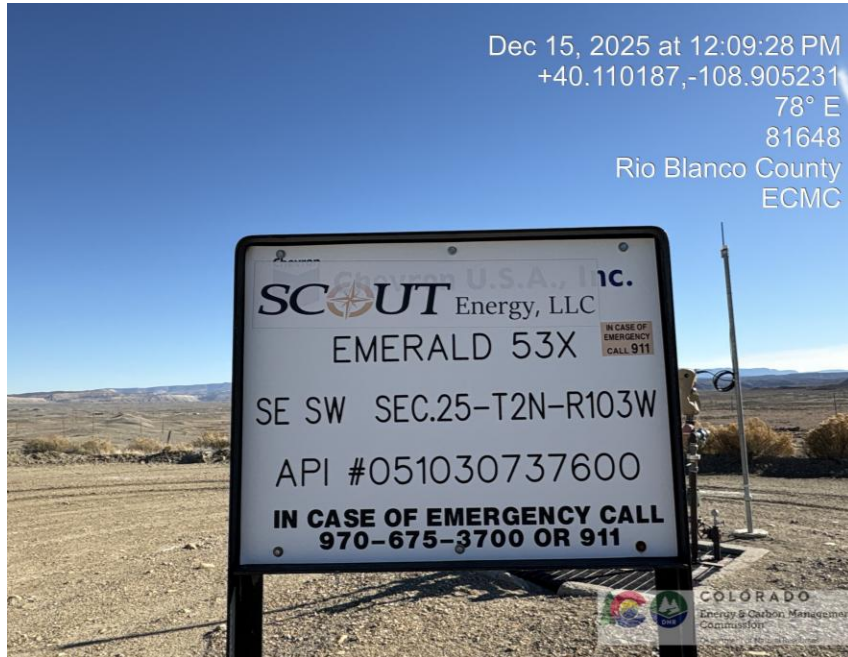
Photo # 0221 Sign near wellhead lacks public road used to access the well

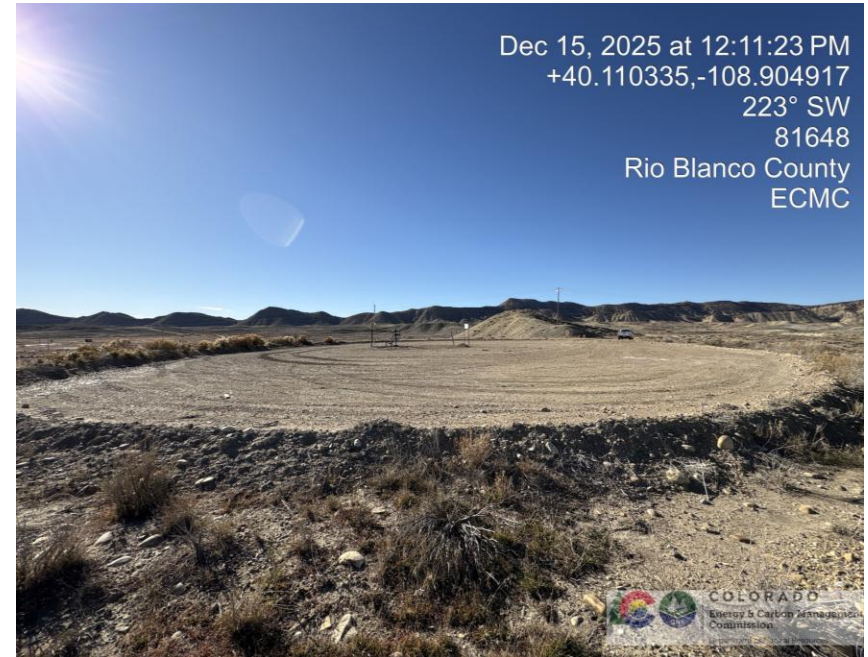
Photo # 0228 NE corner of location

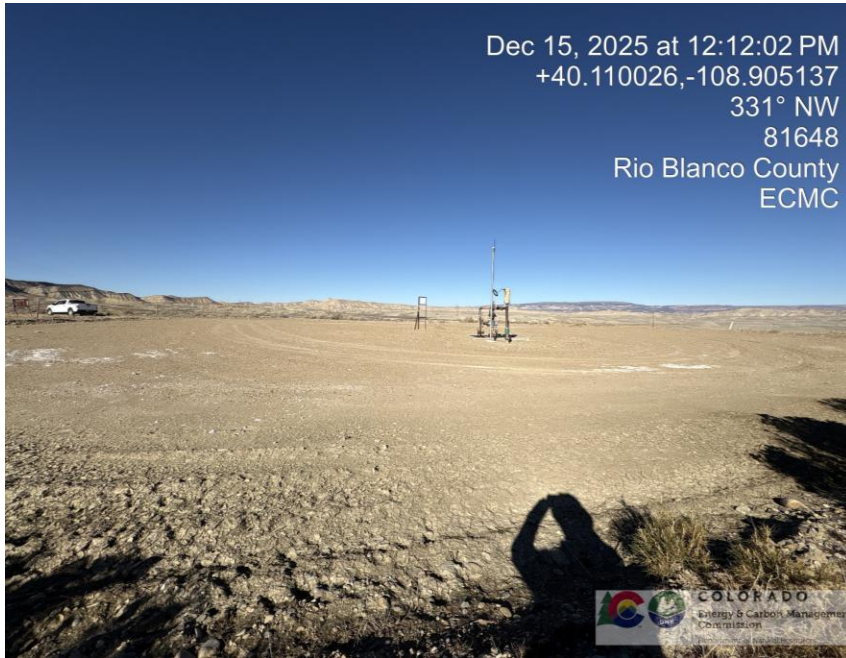
Photo # 0229 SE corner of location

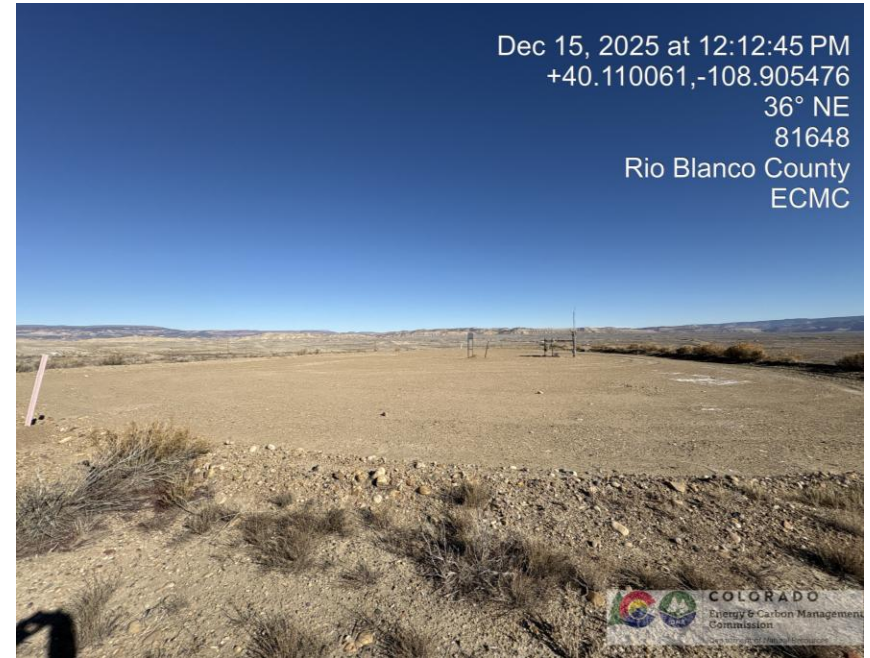
Photo # 0230 SW corner of location

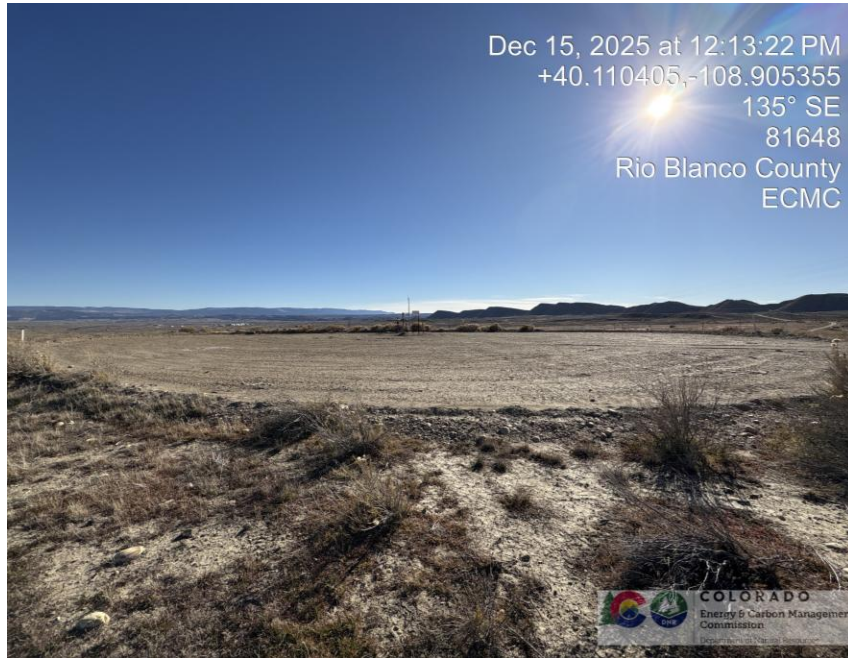
Photo # 0231 NW corner of location

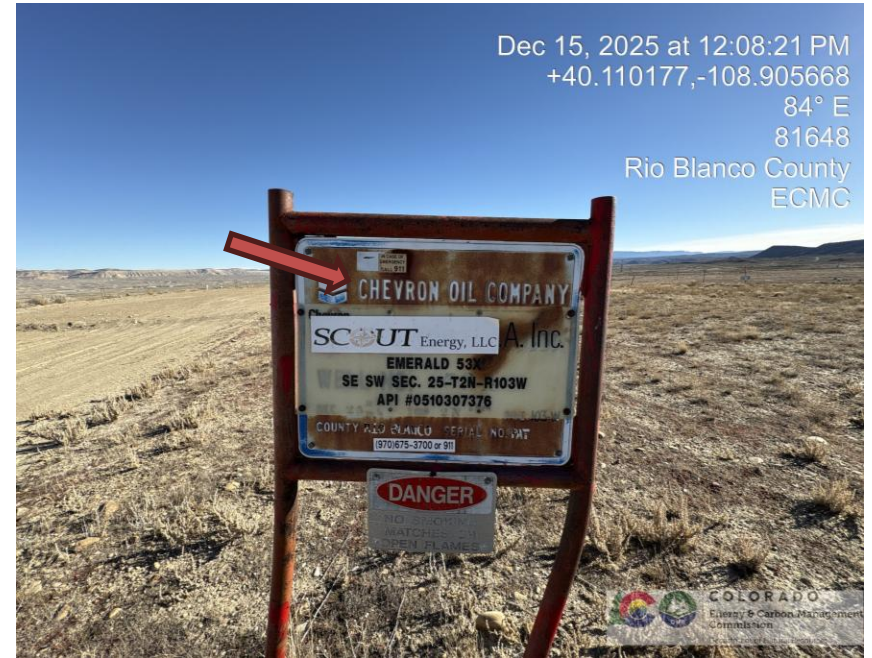
Photo # 0218 Sign at entrance to location contains previous operator name/not in compliance with CECMC rules
