# Inspection Photos

API: 071-08731

Operator: OGRIS OPERATING LLC

Inspection Date: 12/30/2025

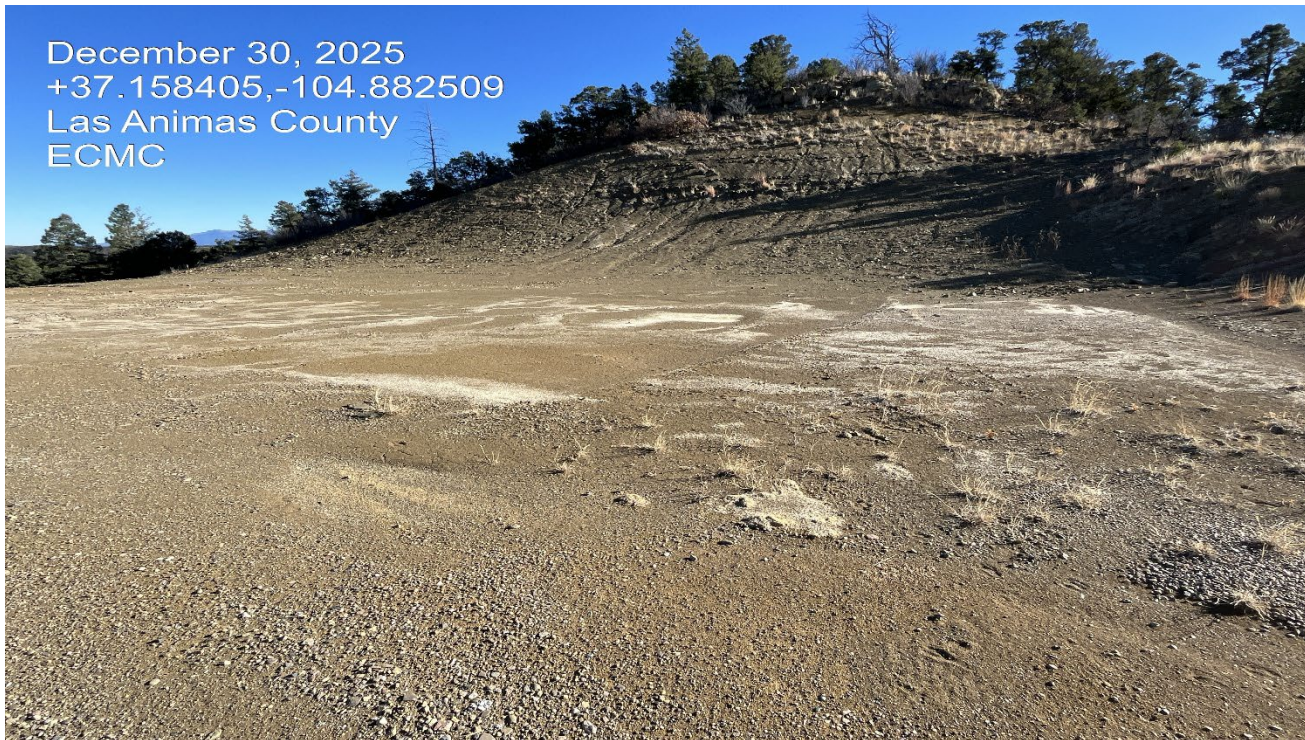
**Photo 1.** Facing southeast at the PA'd wellsite. The pit has been backfilled and equipment is removed.

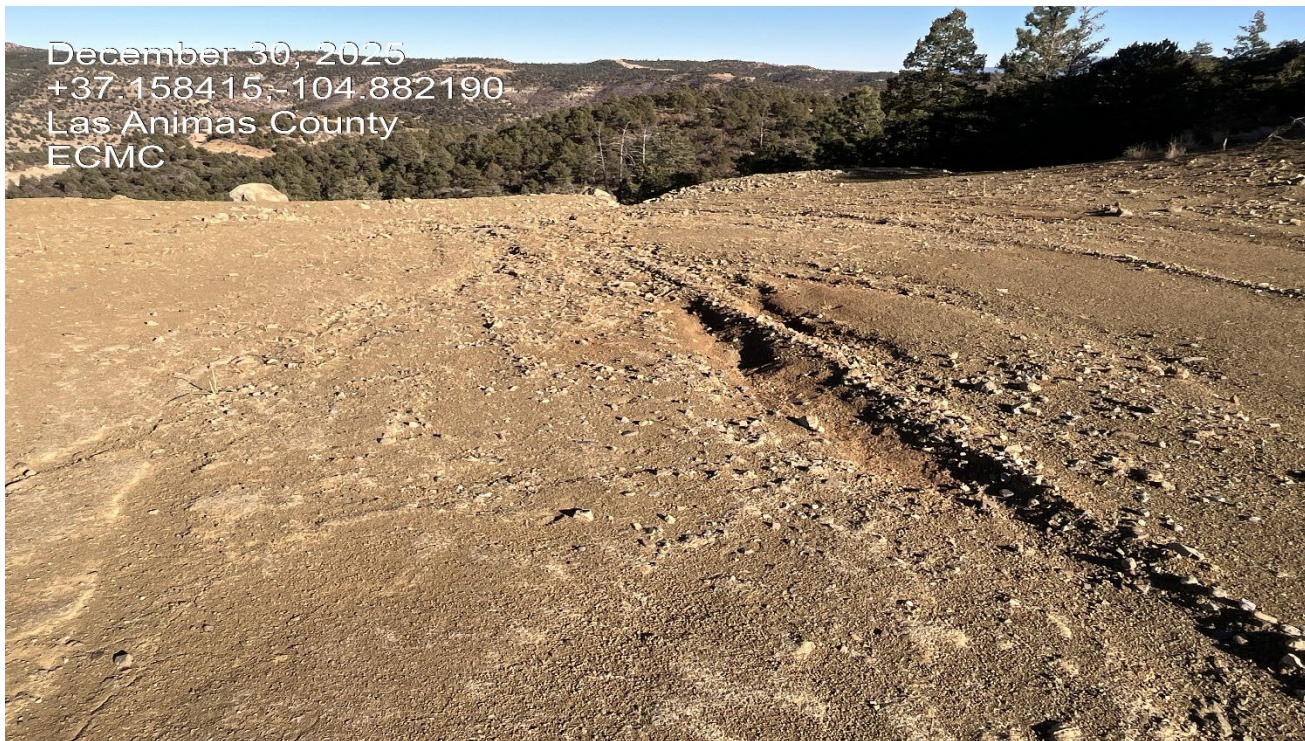
**Photo 2.** Facing toward the northeast side of the location. There are signs of erosion along this area of the location and soils are not stabilized.

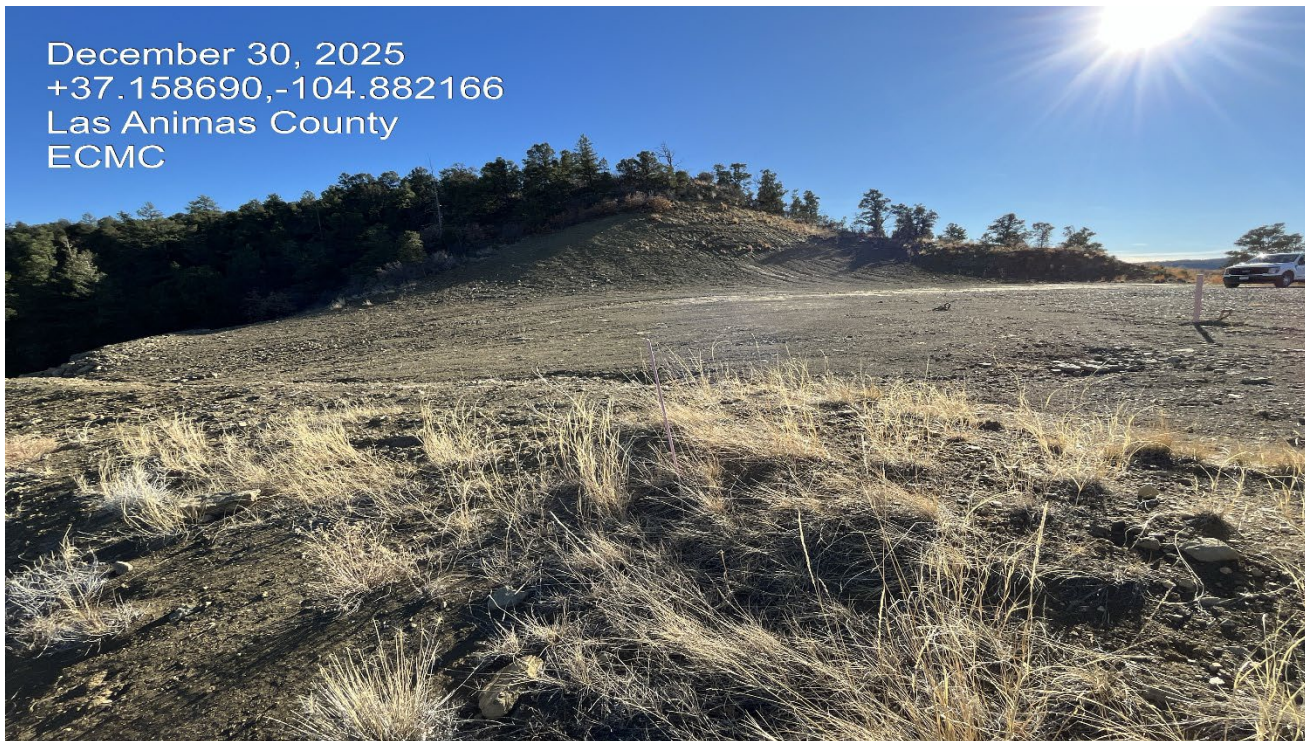
**Photo 3.** Facing southwest at the location. The fill slope will need to be recontoured back into the original contours to comply with 1004 Rules.

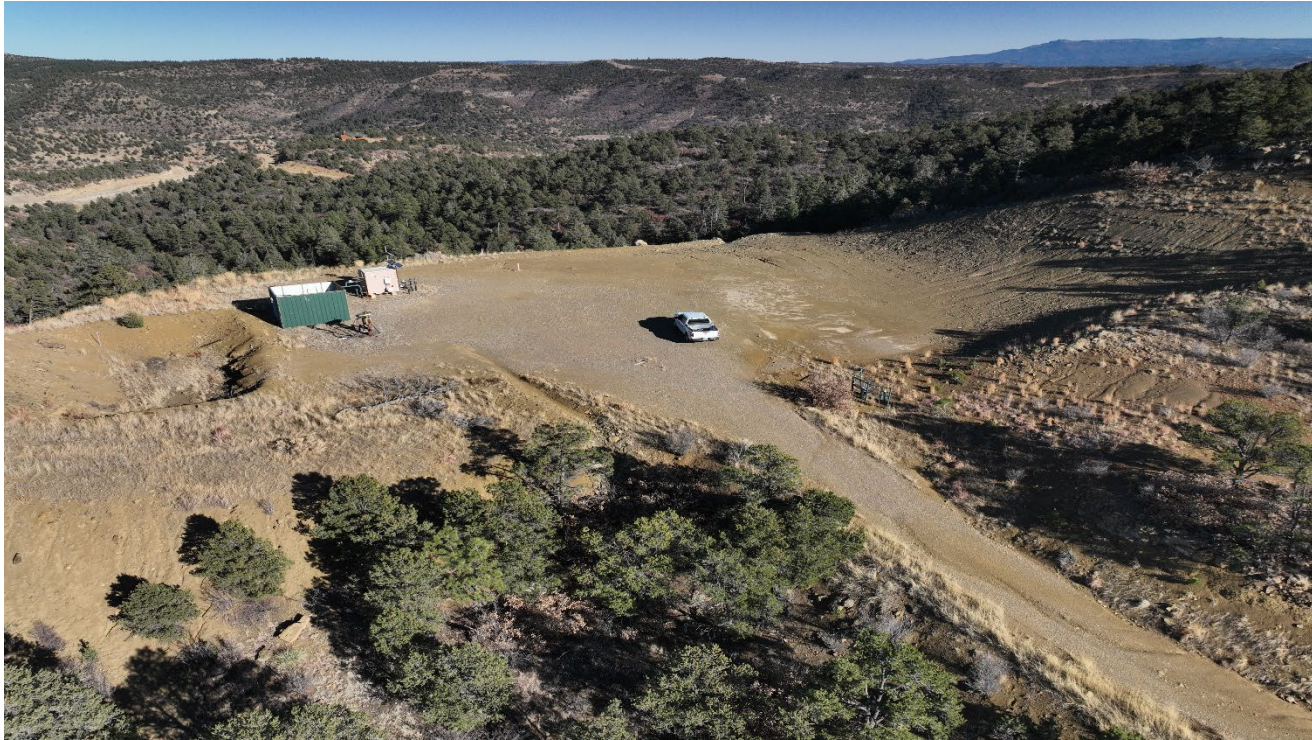
**Photo 4.** Drone aerial photo facing east overlooking the location.

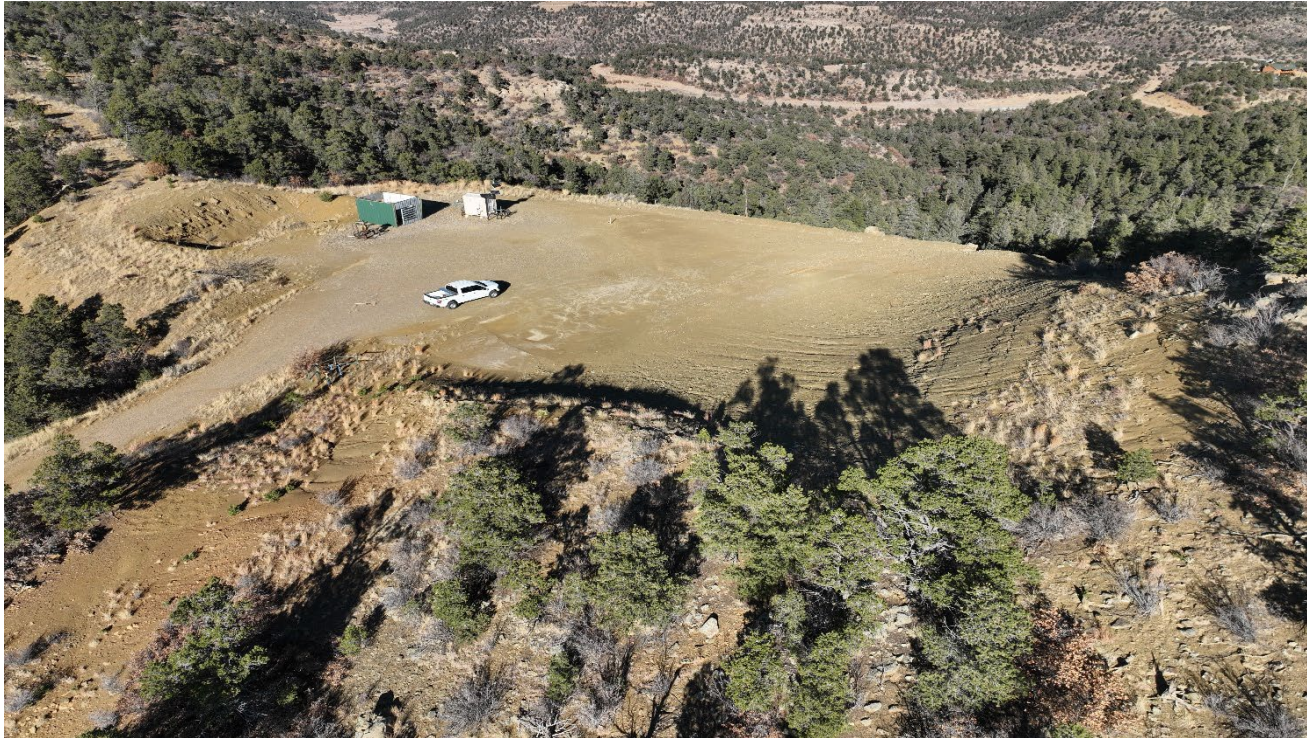
**Photo 5.** Drone aerial photo facing northeast overlooking the location.

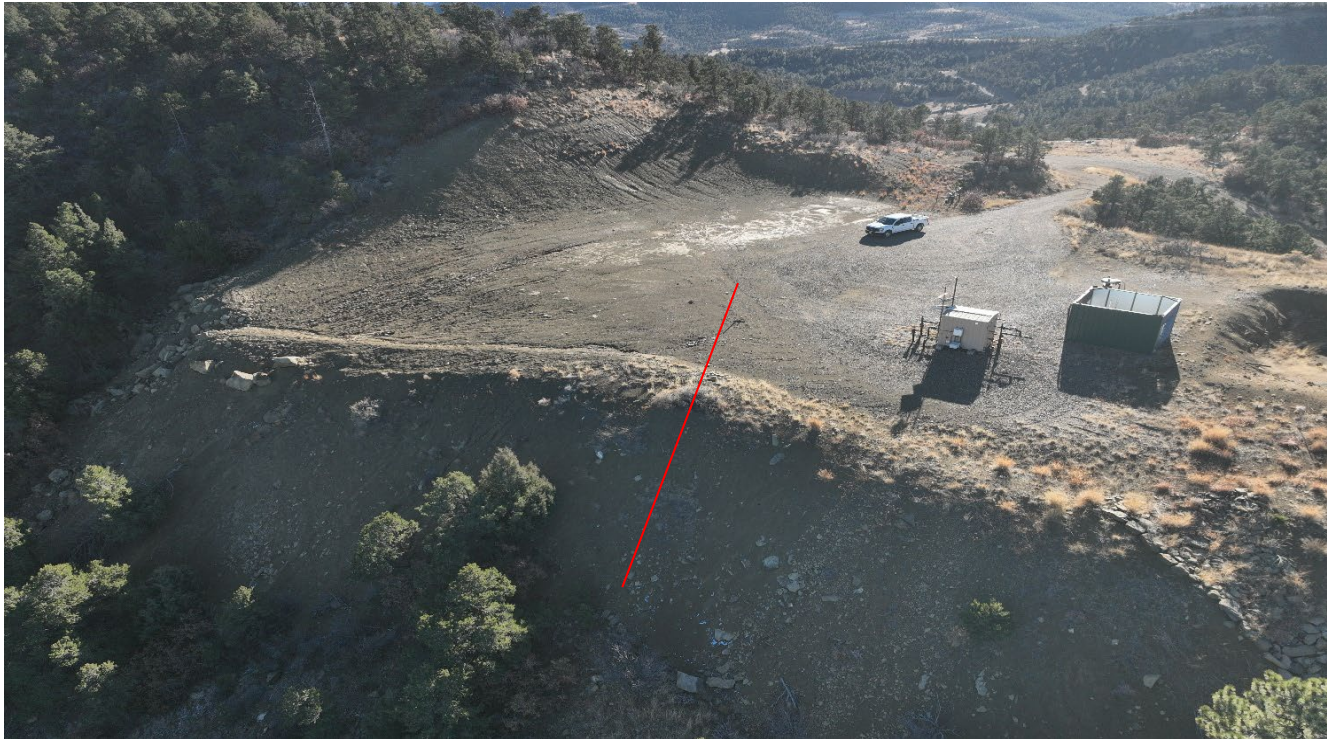
**Photo 6.** Drone aerial photo facing south. The fill slope material shown approximately to the left side of the line will need to be replaced back into the cut slope.

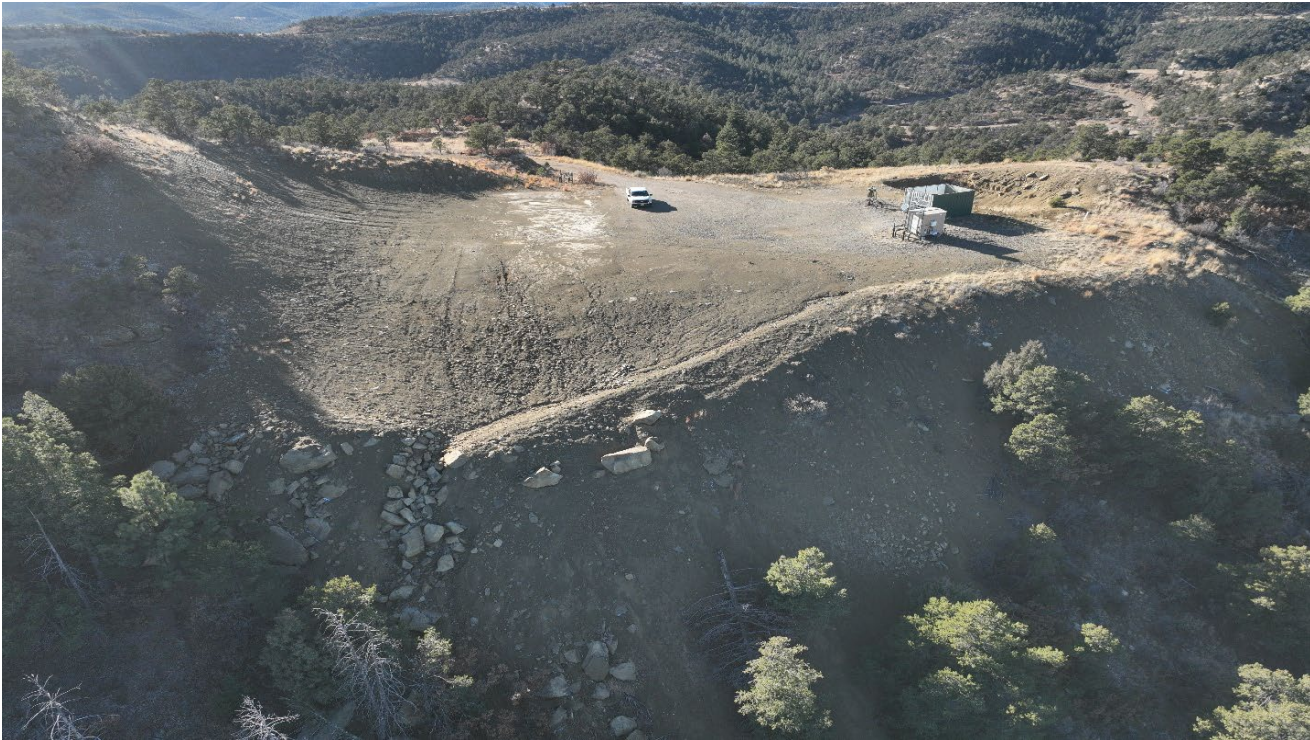
**Photo 7.** Drone aerial photo facing southwest.
