# Inspection/Audit Photos

Location: SCOUT ENERGY MANAGEMENT LLC U P #97 X 29 PAD

Location ID: 314968

Date: 12/16/2025

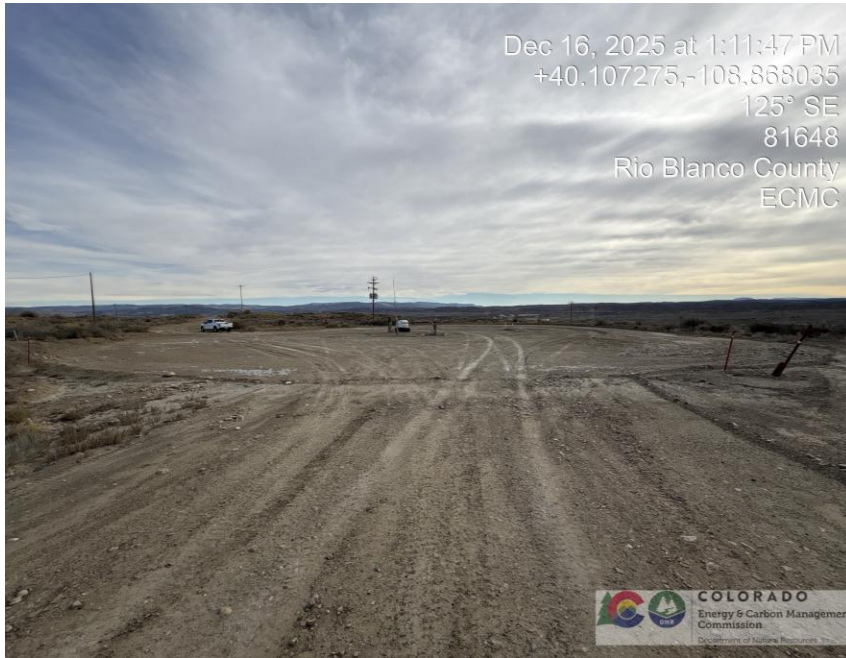
Photo # 0269 Entrance to location

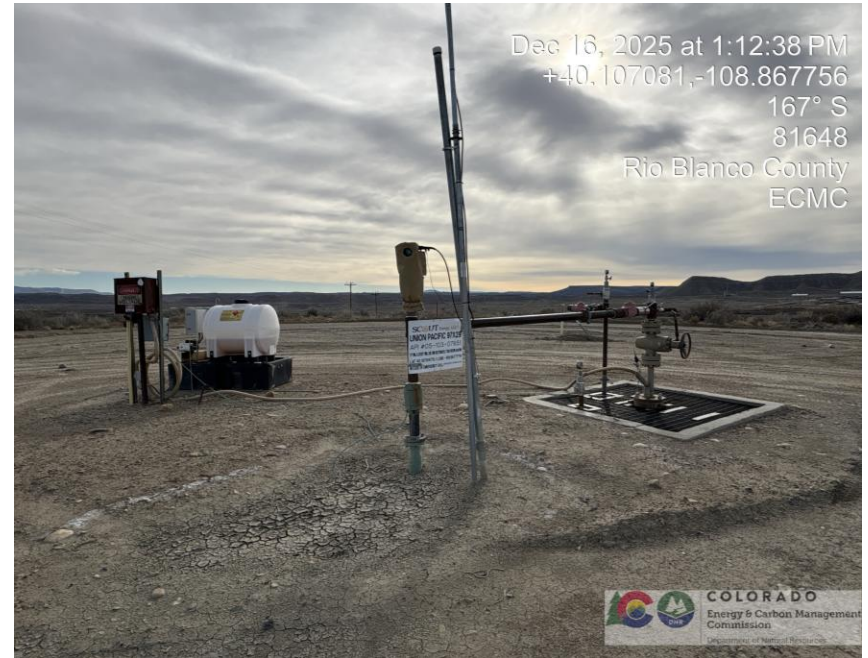
Photo # 0271 Location

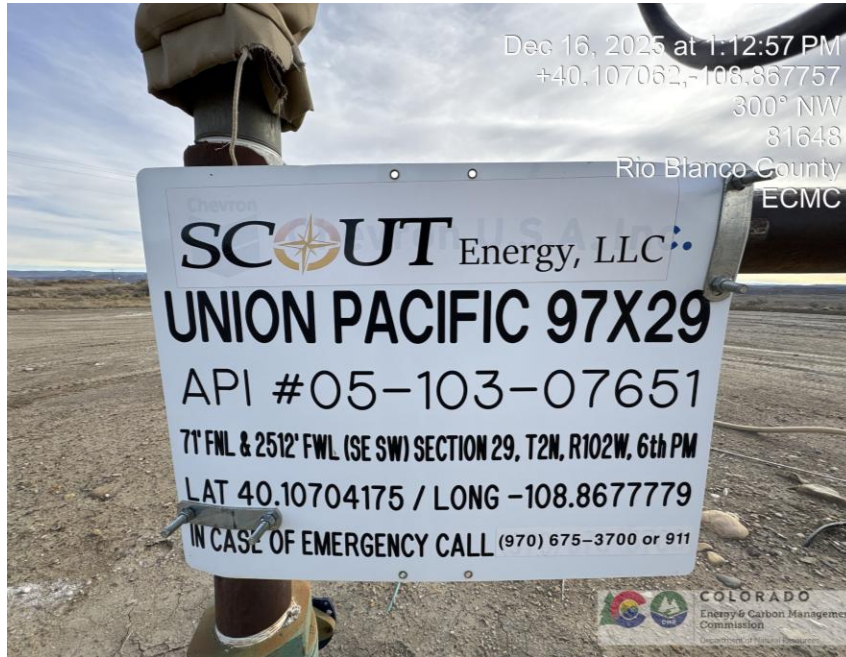
Photo # 0272 Wellhead sign lacks public road used to access the well

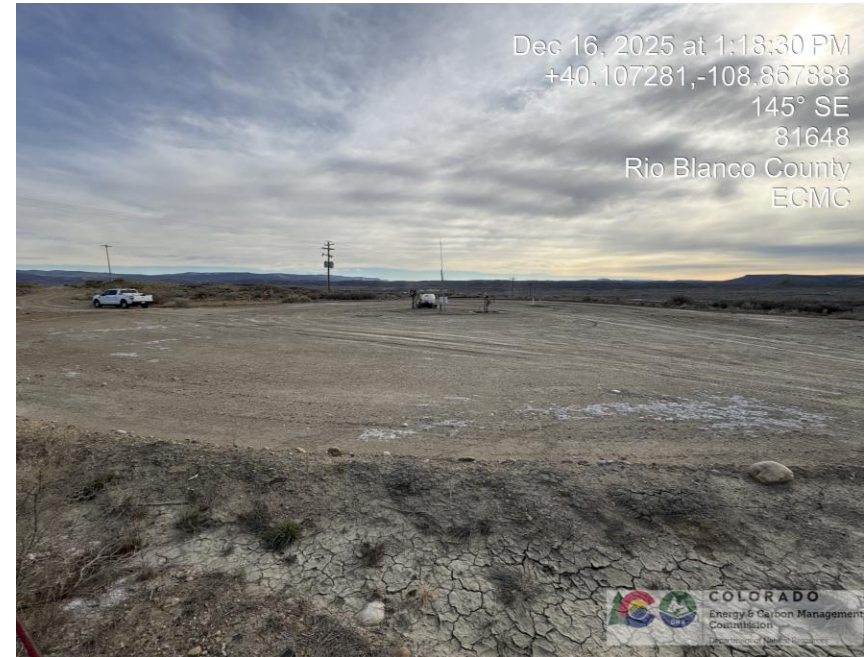
Photo # 0282 NW corner of location

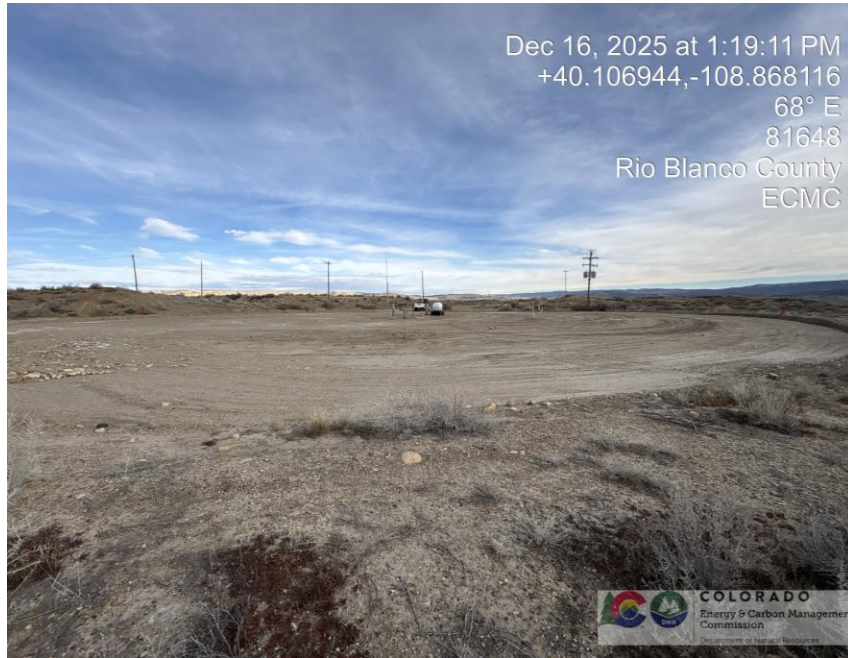
Photo # 0283 SW corner of location

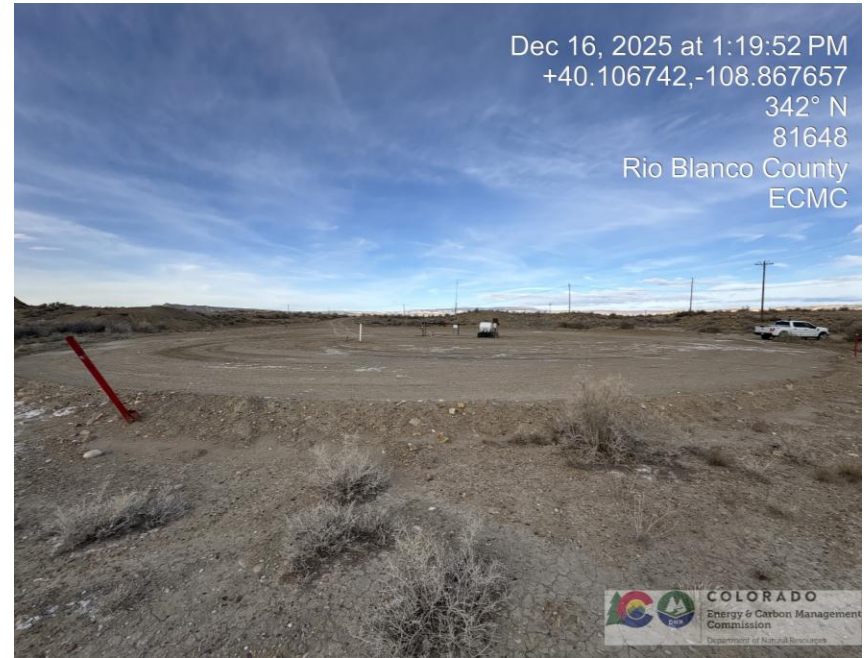
Photo # 0284 SE corner of location

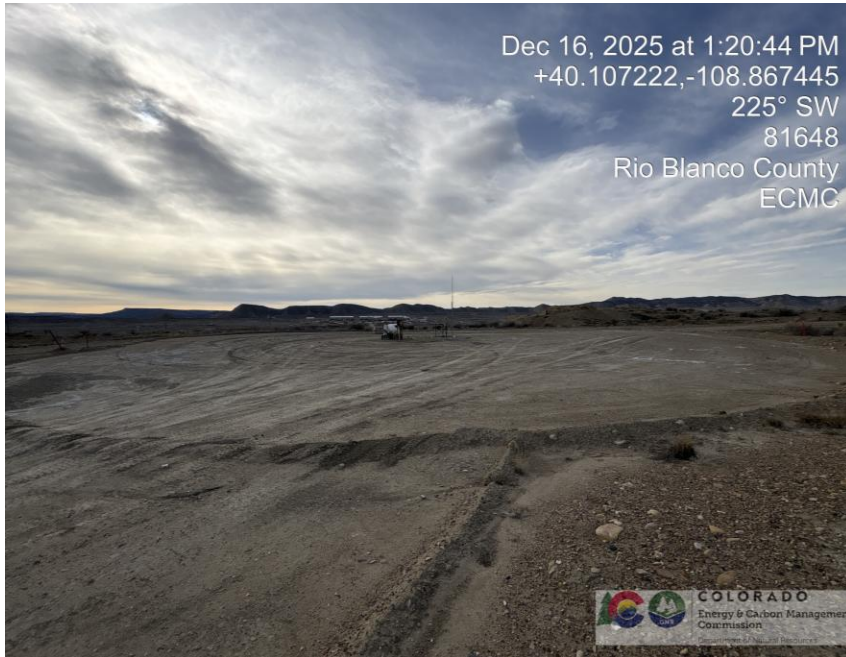
Photo # 0285 NE corner of location

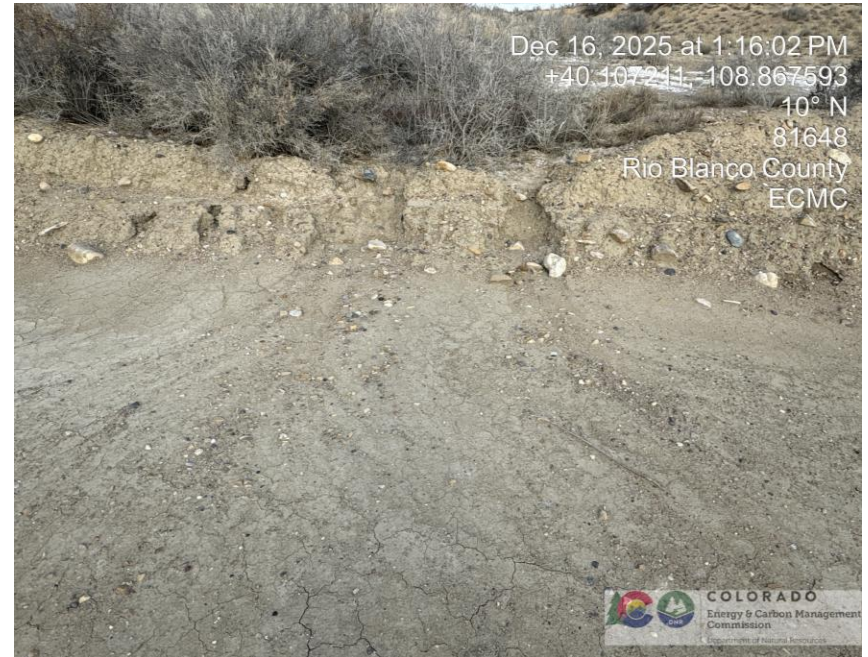
Photo # 0277 Loss of berm integrity due to erosion on north side of location/insufficient BMP's

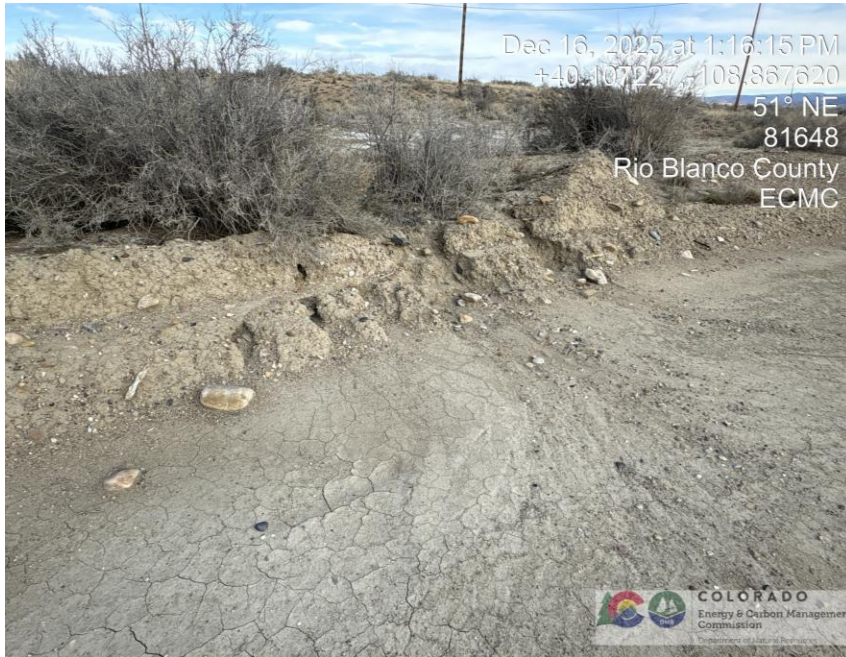
**Photo # 0279 Loss of berm integrity due to erosion on north side of location/insufficient BMP's**

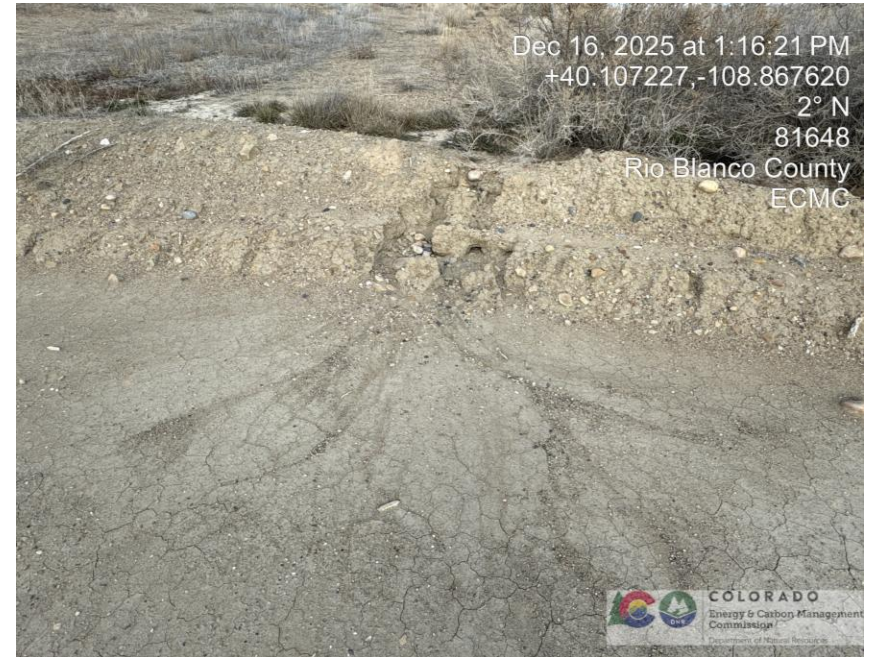
**Photo # 0280 Loss of berm integrity due to erosion on north side of location/insufficient BMP's**

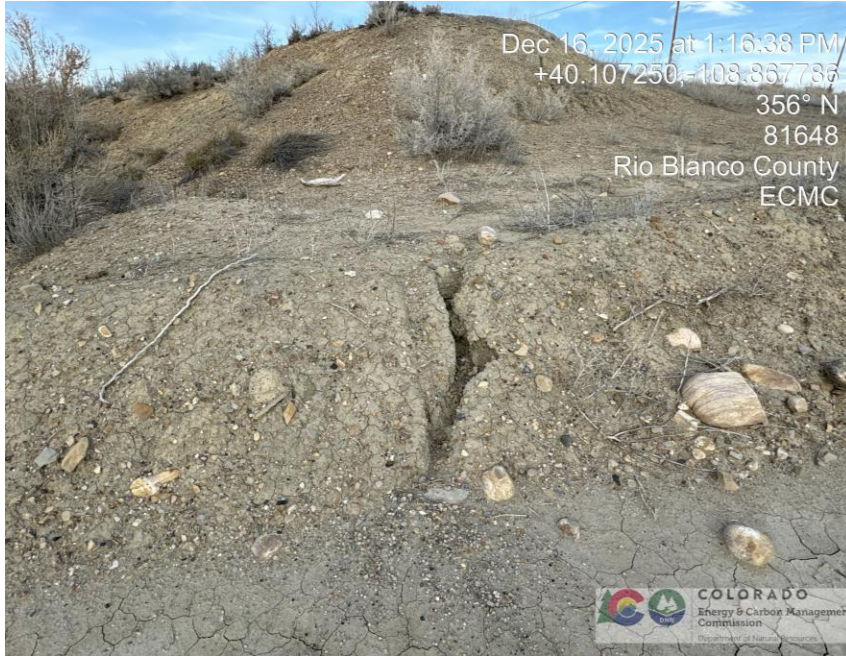
**Photo # 0281 Loss of berm integrity due to erosion on north side of location/insufficient BMP's**

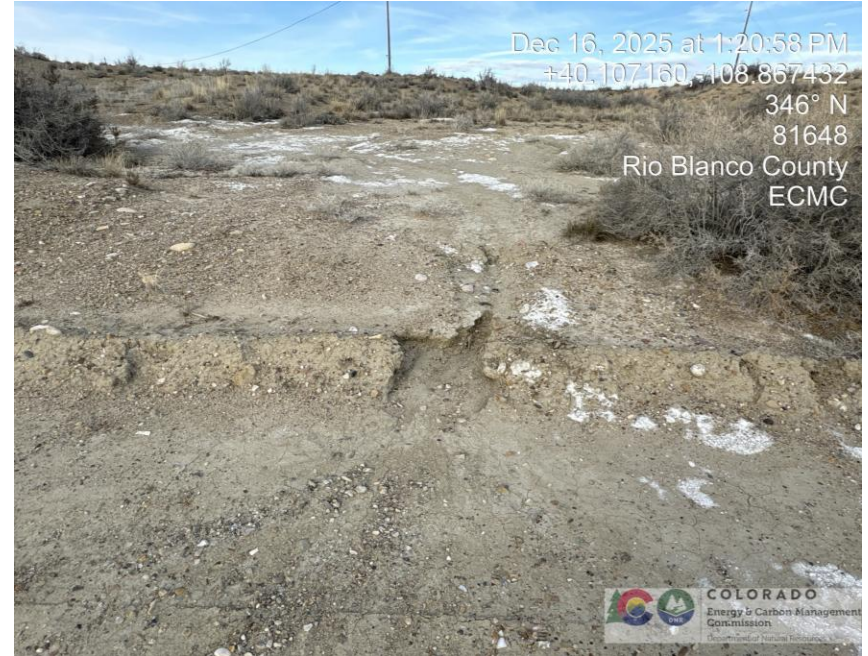
**Photo # 0286 Loss of berm integrity due to erosion on north side of location/insufficient BMP's**
