Inspection/Audit Photos

Location: SCOUT ENERGY MANAGEMENT LLC FEE #72X PAD

Location ID: 314767

Date: 12/16/2025

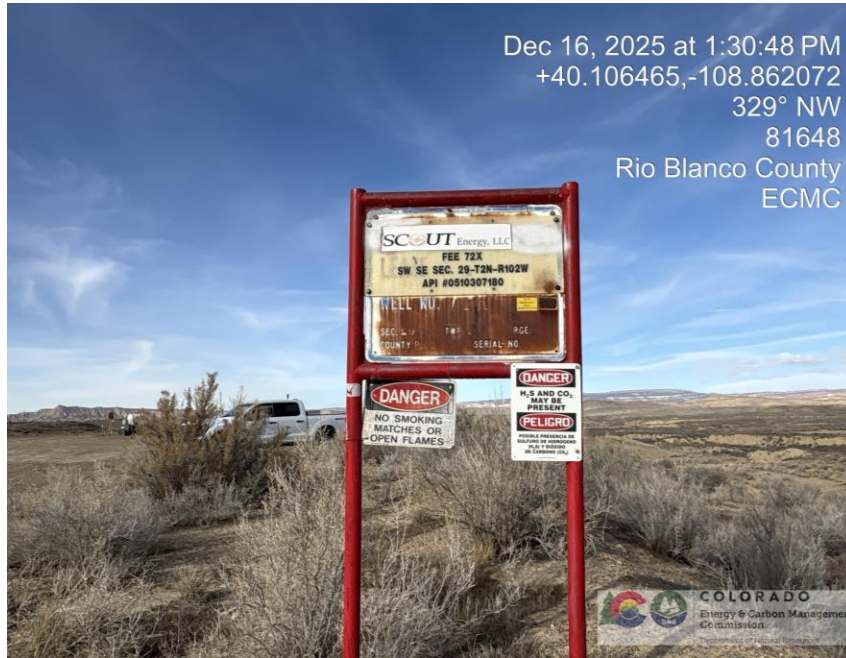
Photo # 0294 Sign at entrance to location

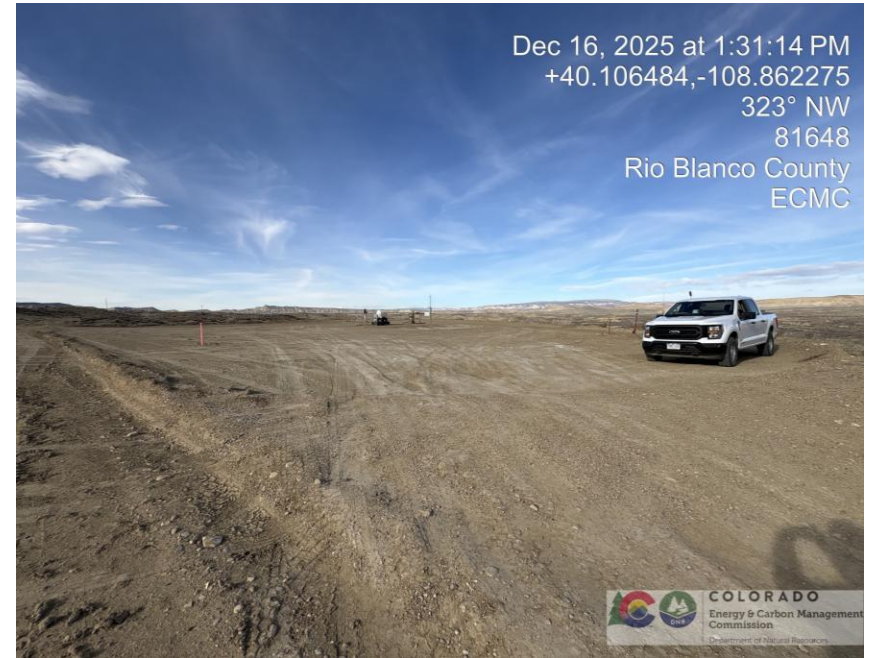
Photo # 0295 Entrance to location

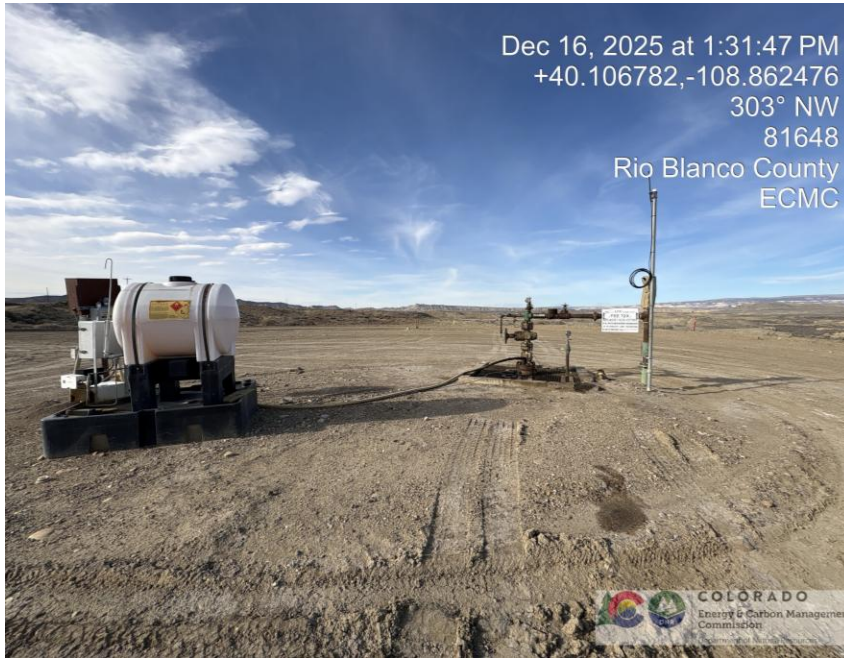
Photo # 0296 Location

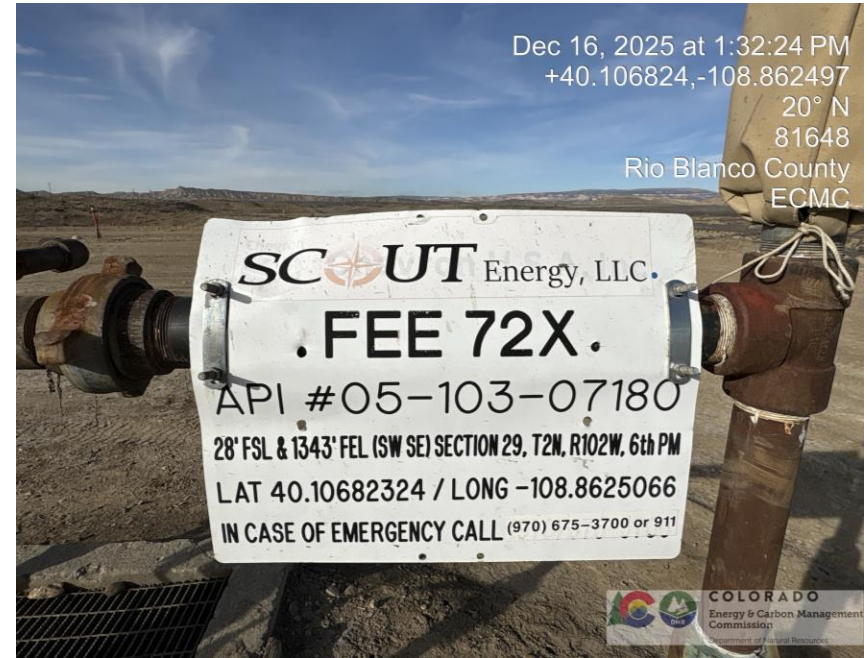
Photo # 0297 Wellhead sign lacks public road used to access the well

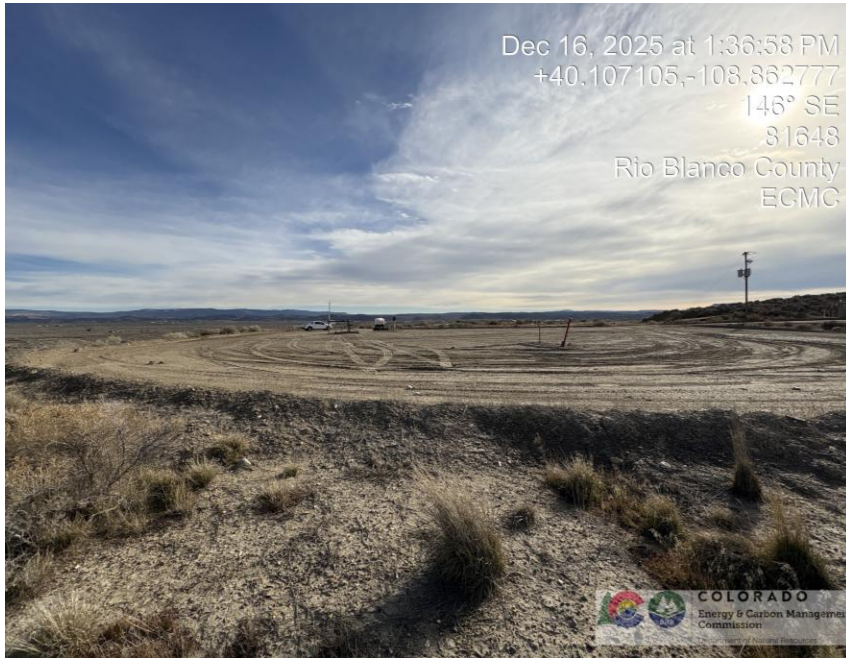
Photo # 0304 NW corner of location

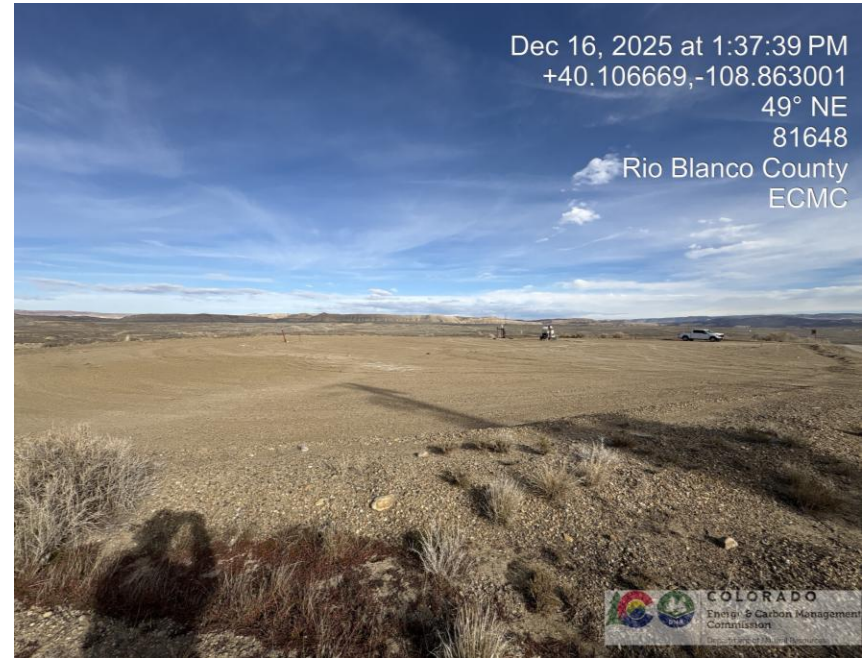
Photo # 0305 SW corner of location

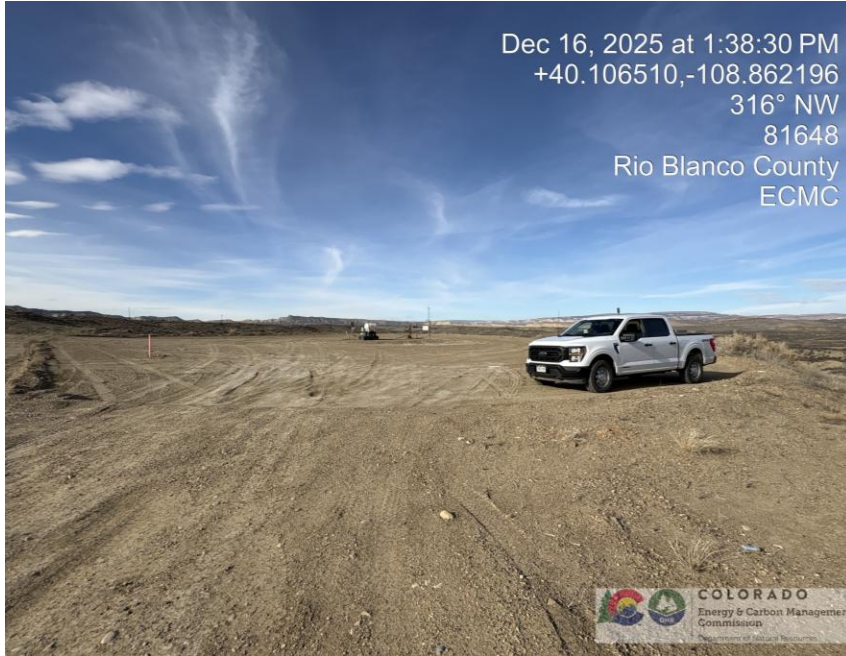
Photo # 0306 SE corner of location

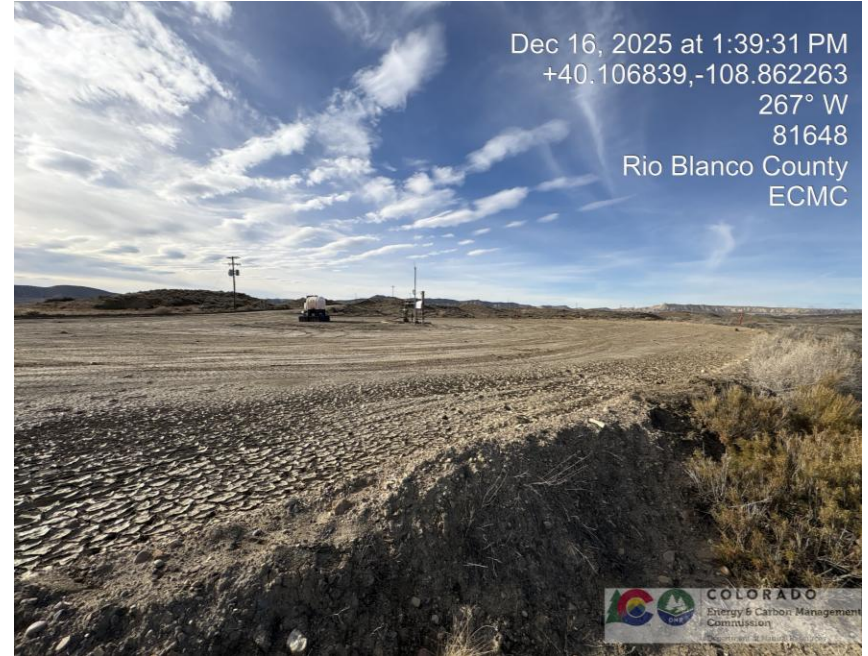
Photo # 0307 NE corner of location

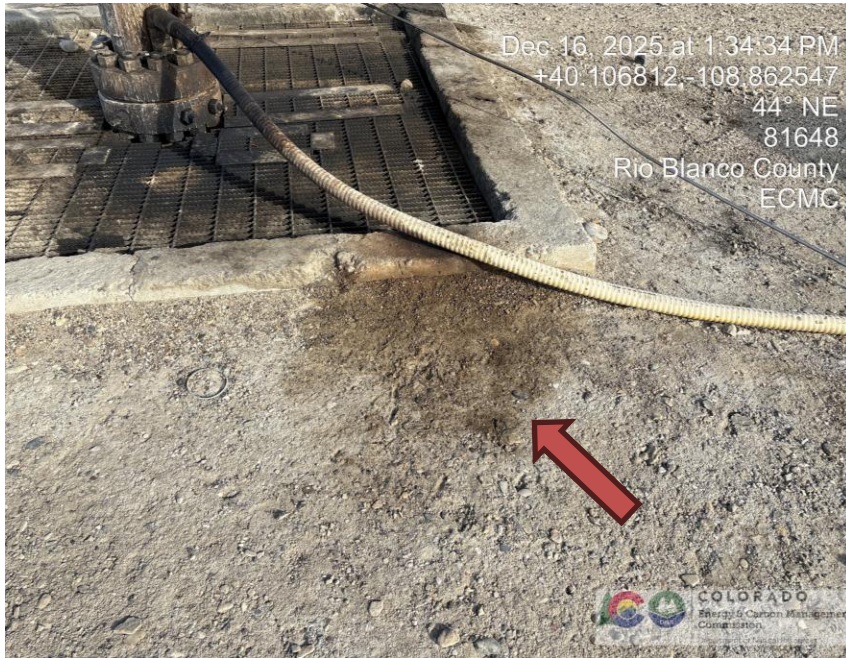
Photo # 0300 Staining on location

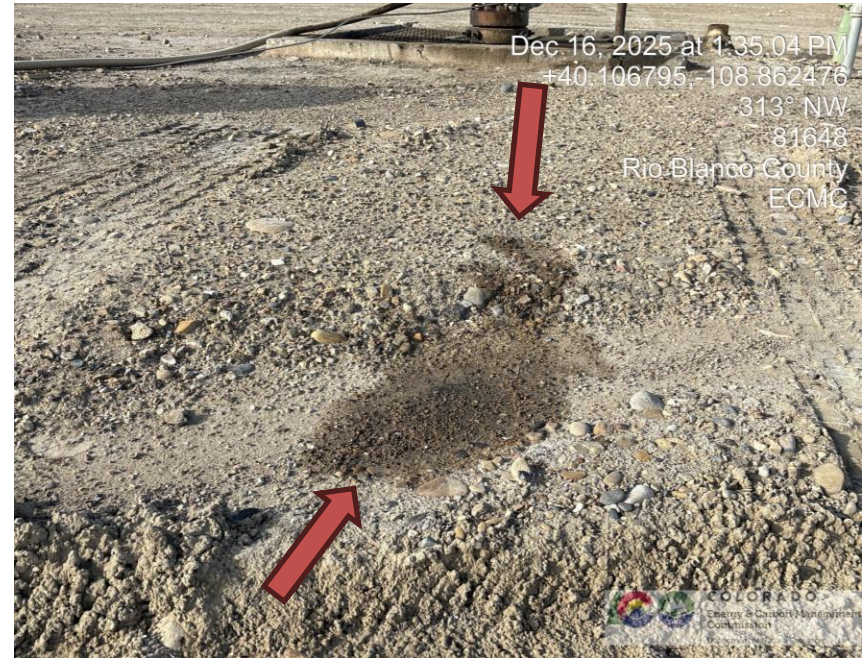
Photo # 0301 Staining on location

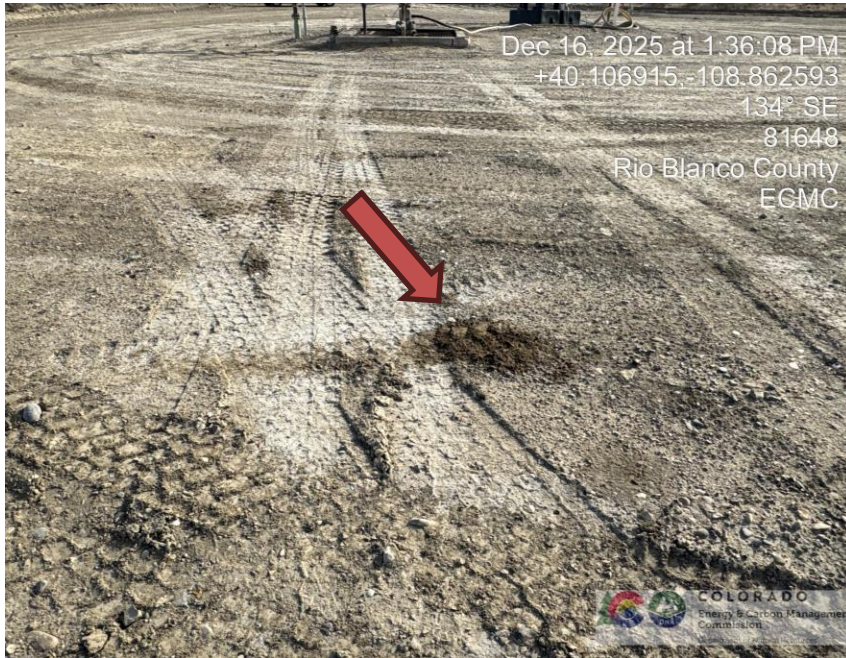
Photo # 0303 Staining on location

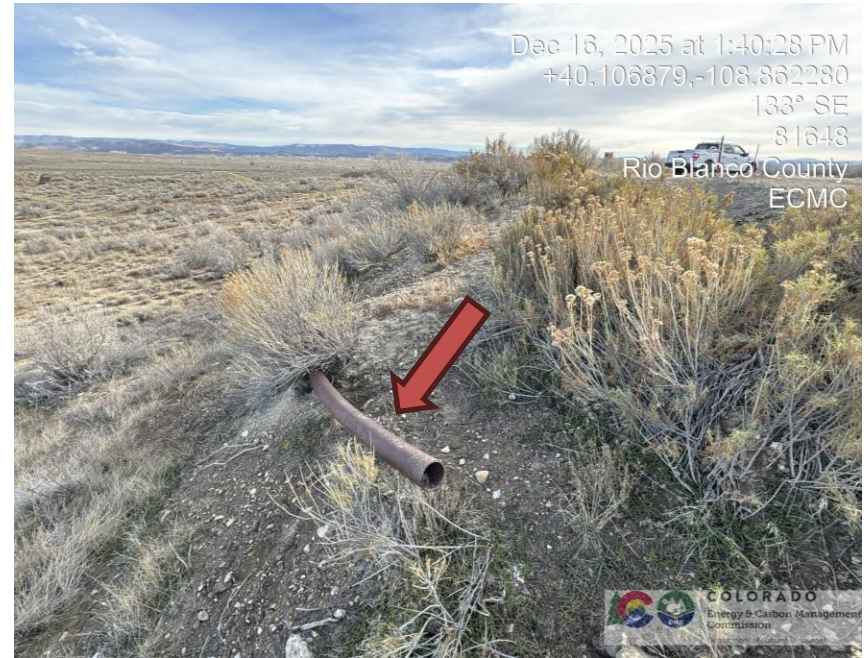
Photo # 0308 Debris on NE side of location

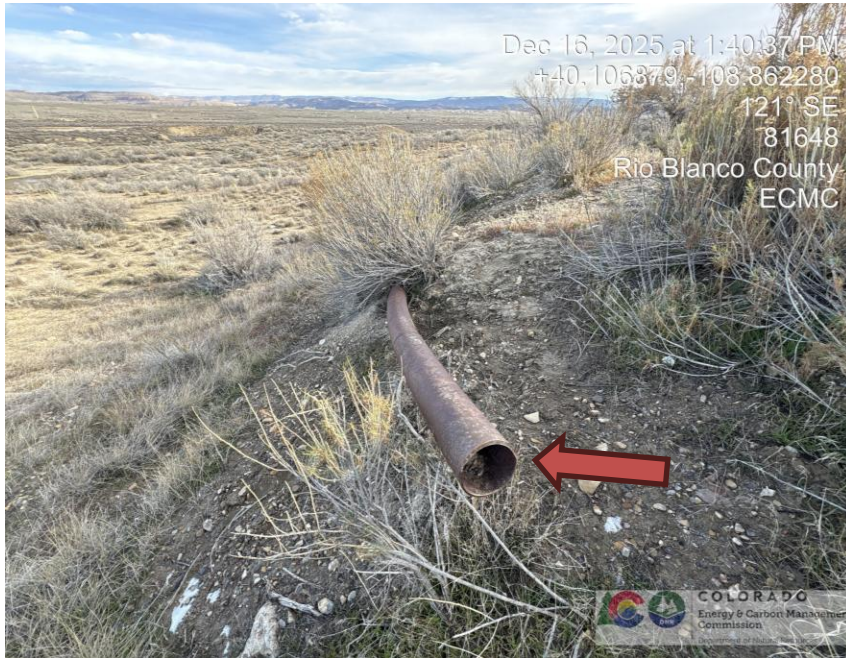
Photo # 0310 Debris on NE side of location

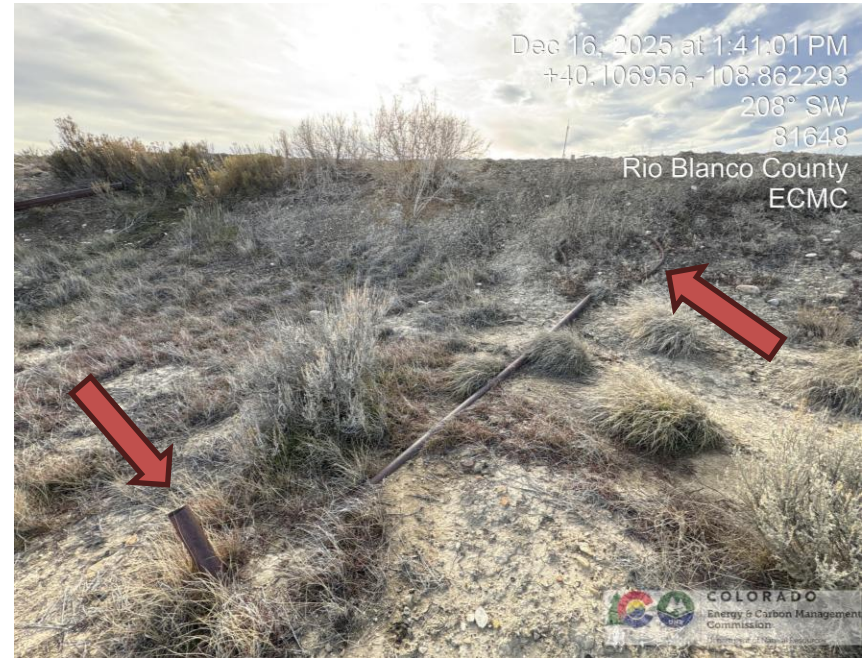
Photo # 0311 Debris on NE side of location
