Inspection/Audit Photos

Location: SCOUT ENERGY MANAGEMENT LLC U P #96 X 29 PAD

Location ID: 314967

Date: 12/16/2025

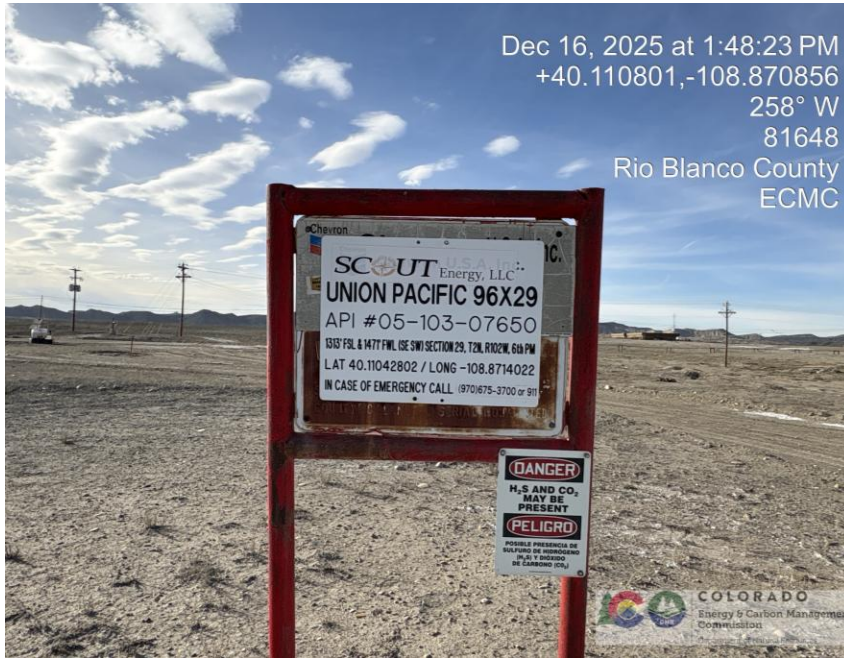
Photo # 0320 Sign at entrance to location/sign contains previous operator name on top left corner.

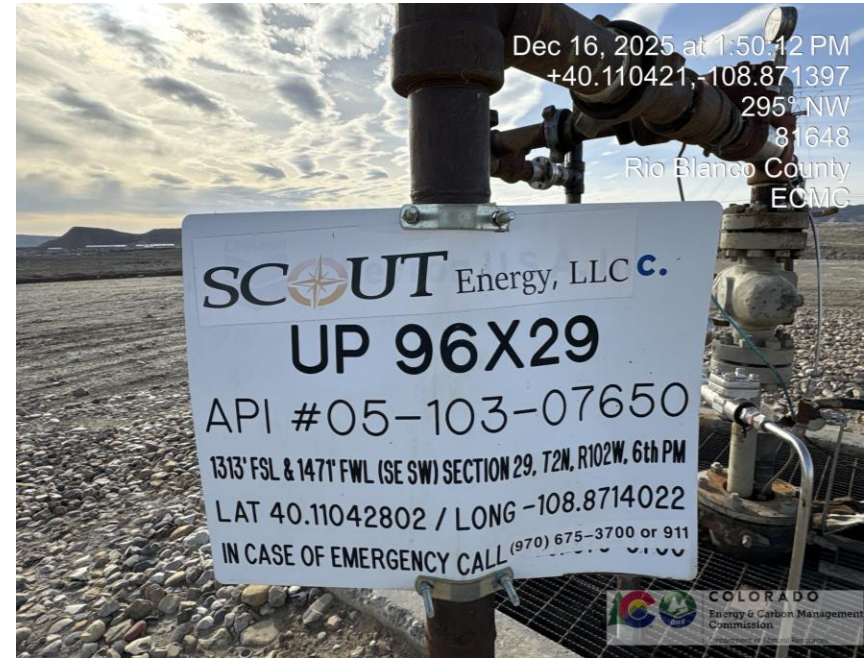
Photo # 0323 Wellhead sign lacks public road used to access the well

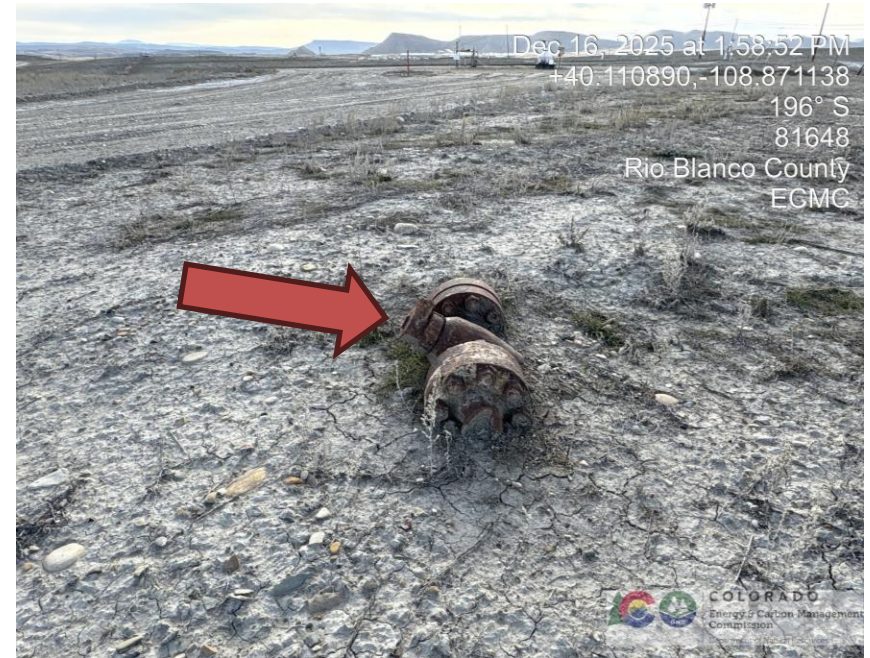
Photo # 0341 Debris on north side of location

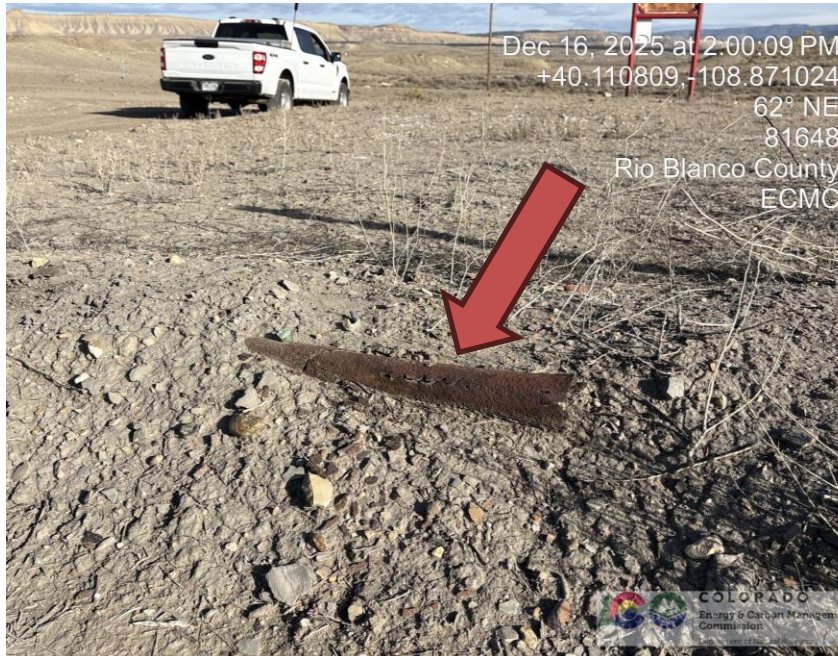
Photo # 0342 Debris on north side of location
