# Inspection Photos

Loc: 324797

Operator: WESTERN OPERATING COMPANY

Inspection Date: 1/5/2026

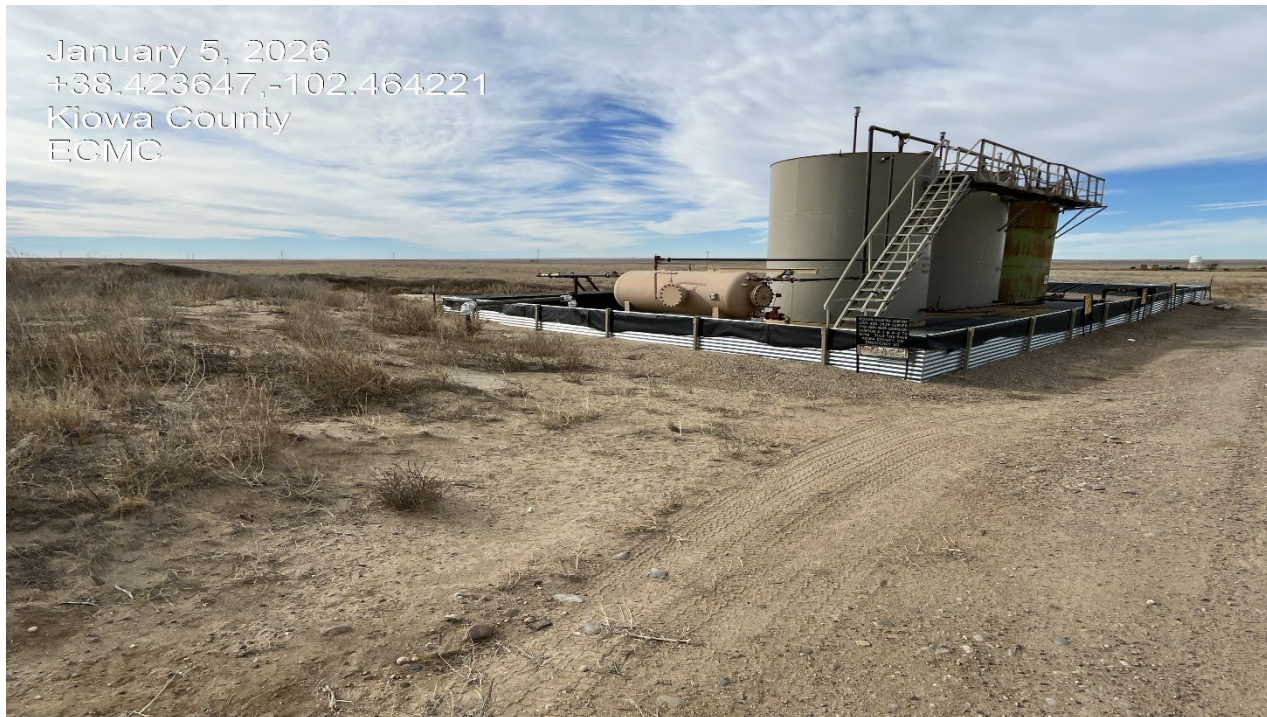
**Photo 1.** Facing southwest toward the Dawson A 1 tank battery.

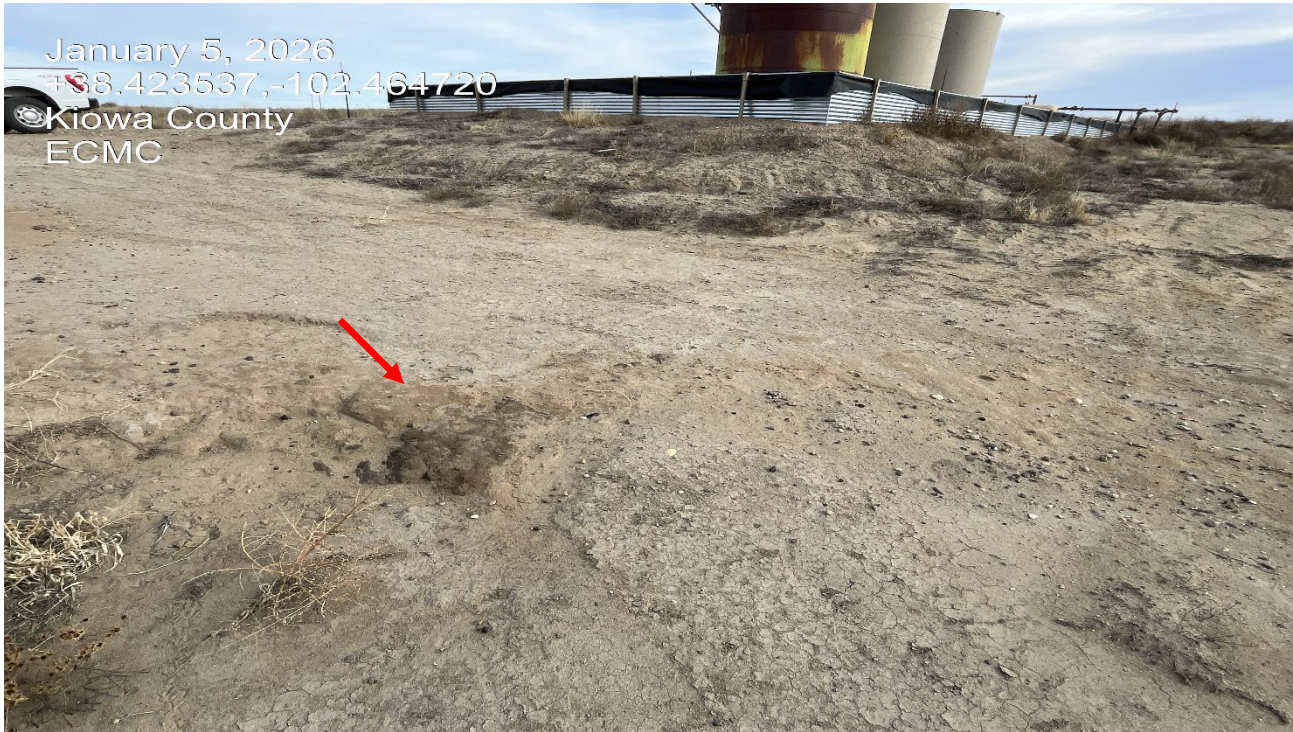
**Photo 2.** Facing northeast at the tank battery. There are still oily impacts shown at red arrow on the soil surface.

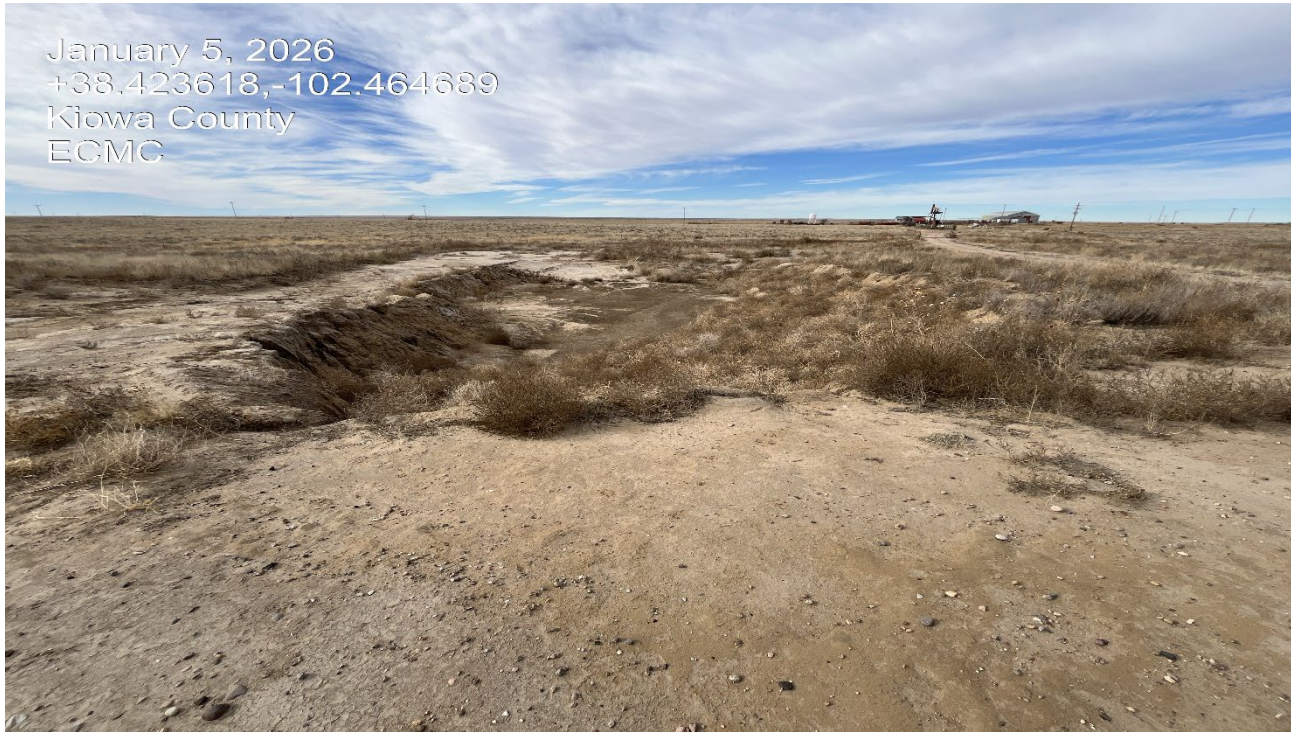
**Photo 3.** Facing east toward the remediation excavation area. Remediation remains in process and has been ongoing since 2022. There is undesirable weed debris accumulated inside the excavation.

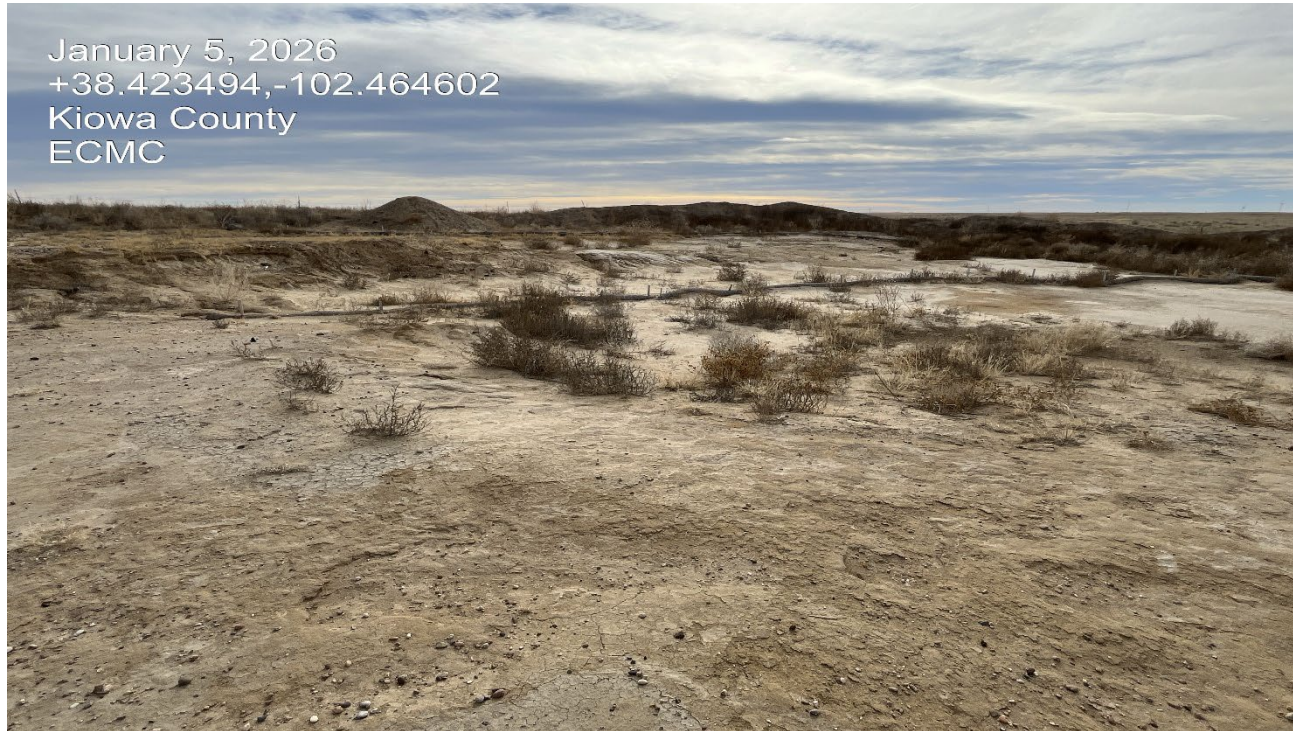
**Photo 4.** Facing southeast adjacent to the tank battery. This area disturbance needs to be reclaimed as it does not appear to be under active remediation.

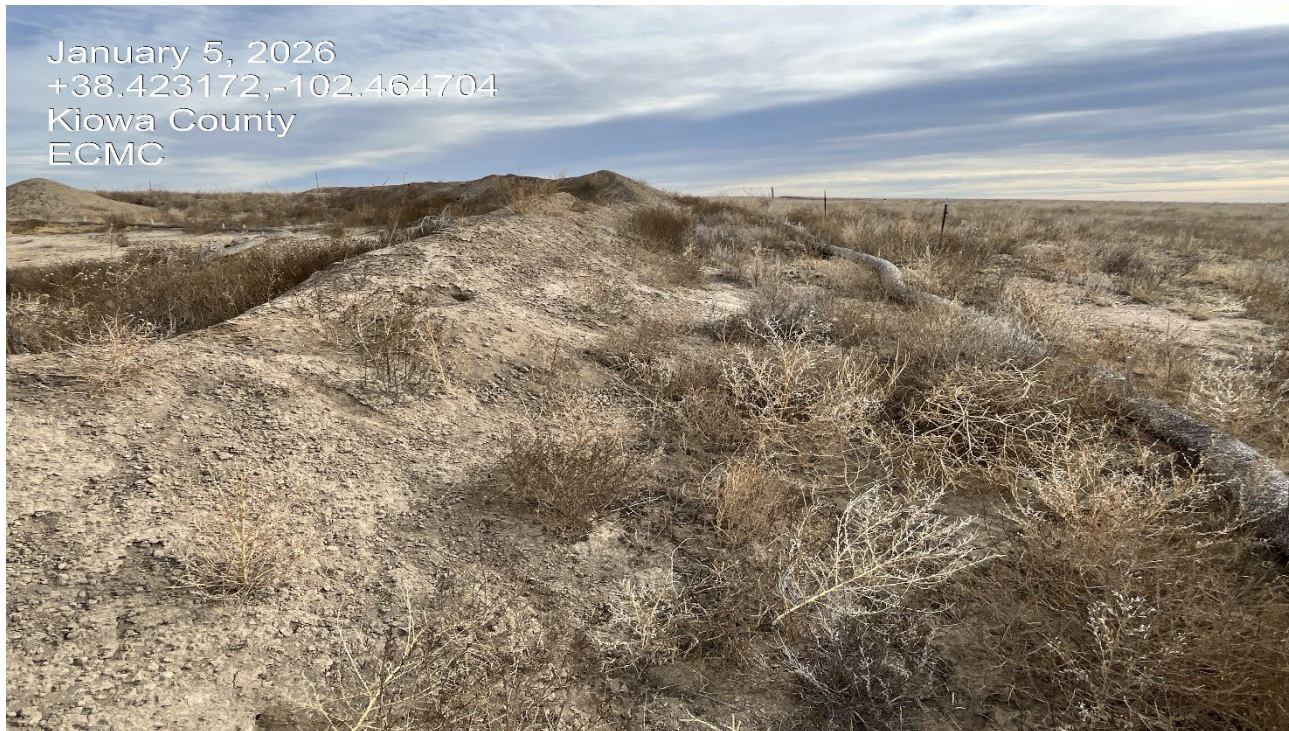
**Photo 5.** Facing toward the soil piles which have not been stabilized and weeds have not been controlled.

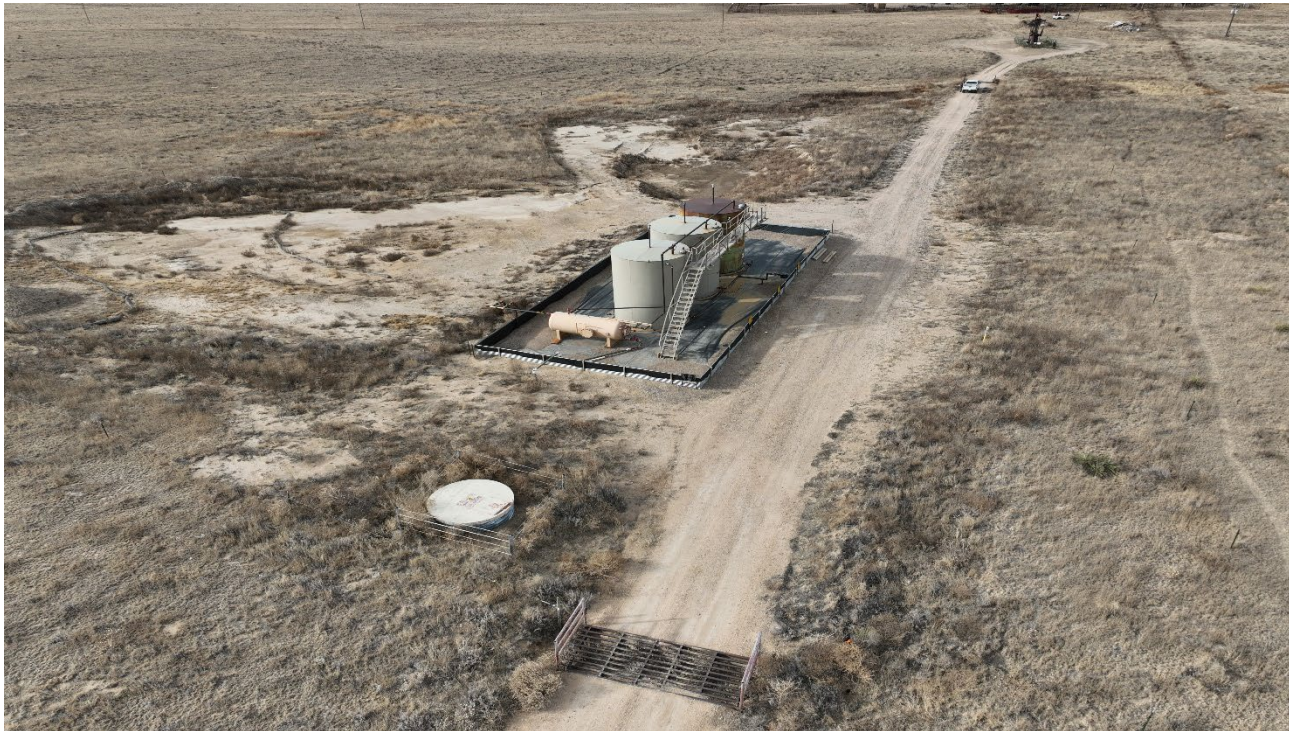
**Photo 6.** Drone aerial photo facing west toward the tank battery and wellsite. Remediation remains in process and has been ongoing since 2022.

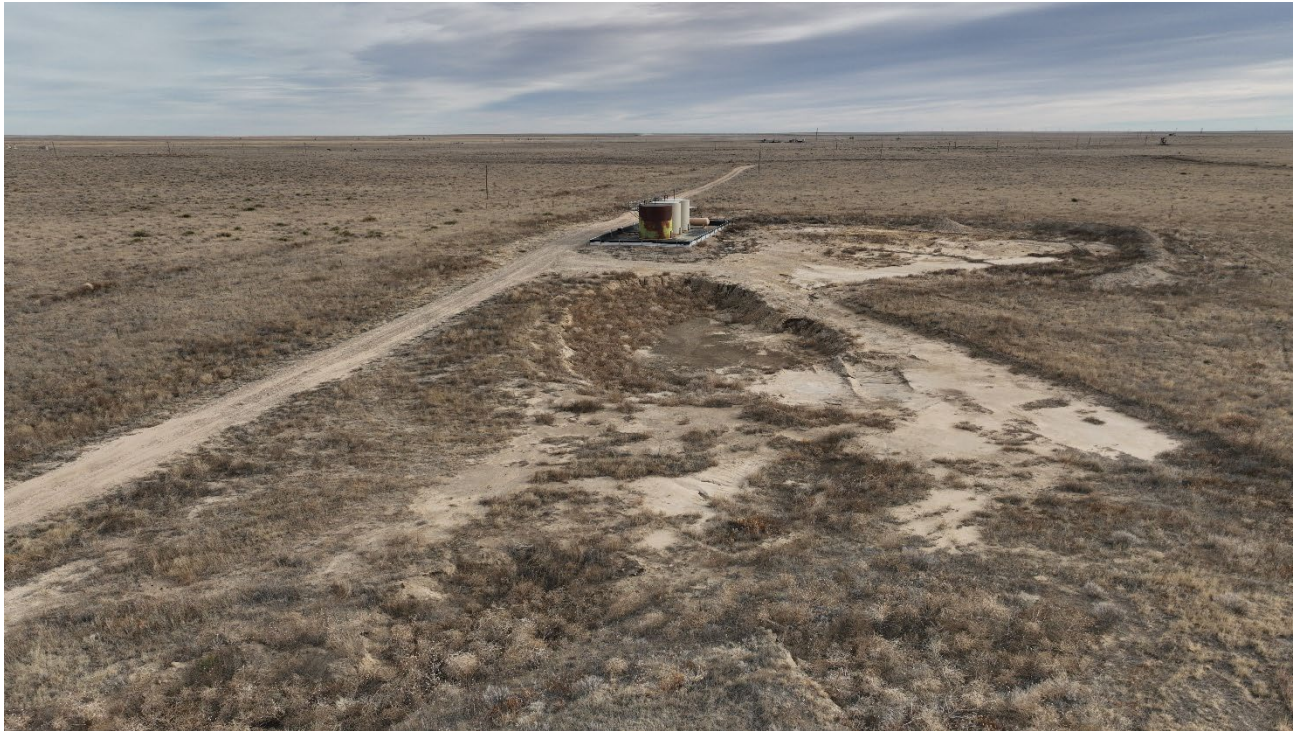
**Photo 7.** West side of the location facing east overlooking the remediation area and tank battery.
