Inspection Photos

Operator: American Helium Operating LLC – 10841

Location ID: 33462

Inspection Date: 12/18/2025 Inspection Document Number: 721100038

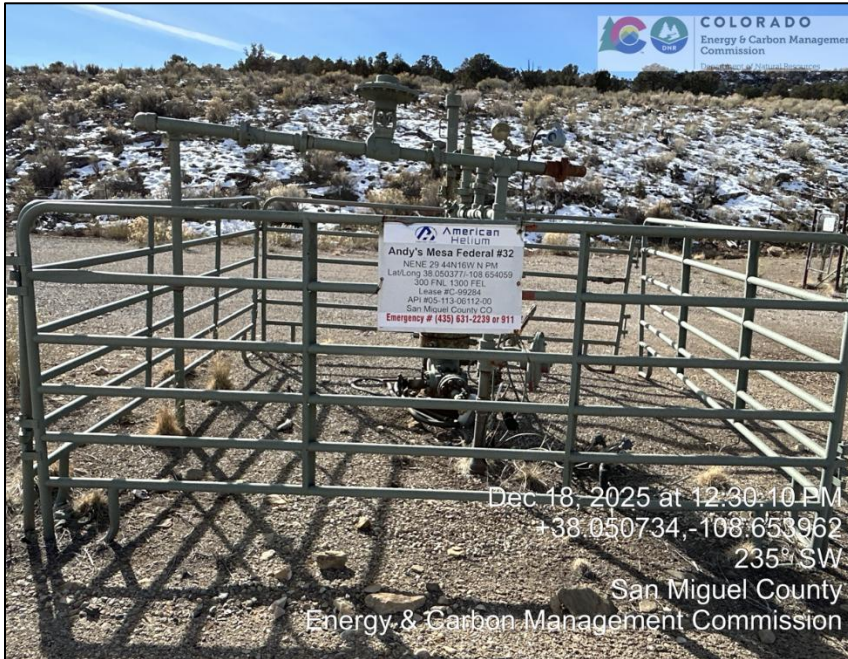
01.) Wellhead for Andy's Mesa Federal #32. API 05-113-06112-00.

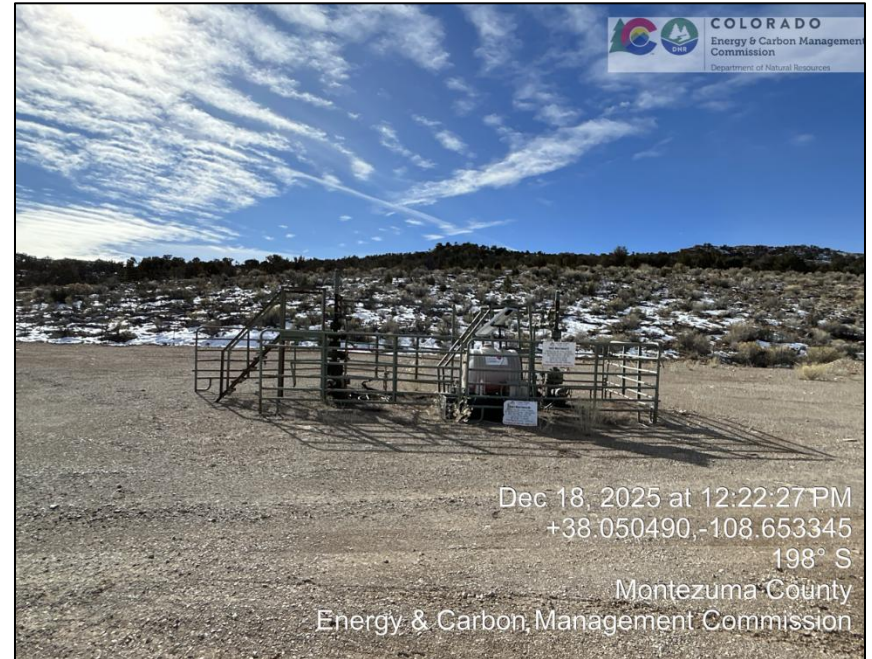
02.) Wellhead for Andy's Mesa Federal 66. API 05-113-06240. Wellhead for Andy's Mesa Federal 67. API 05-113-06239.

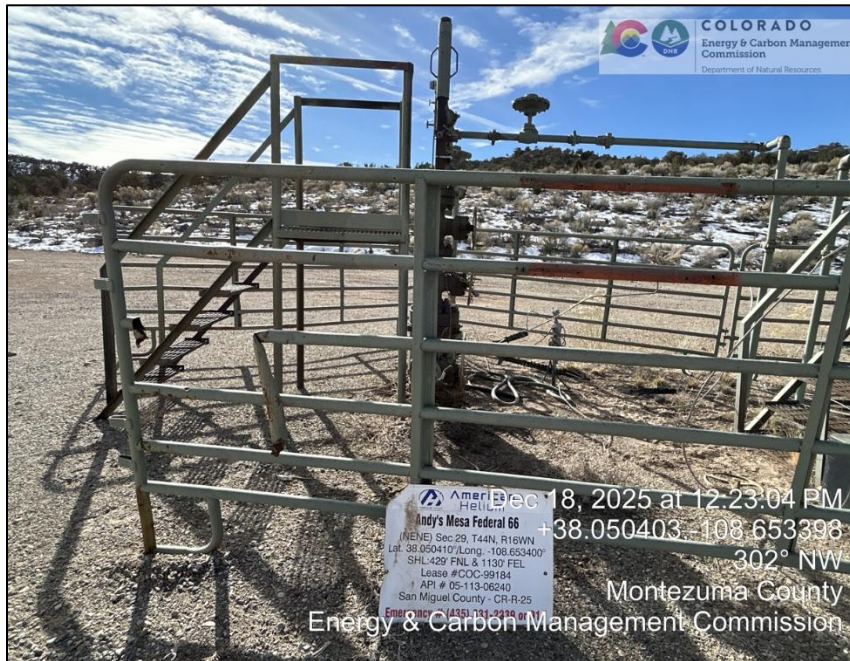
03.) Andy's Mesa Federal 66. Note that sign needs to be re-attached to fence. Sign is on ground and needs to be mounted on fence where it can be seen to comply with rule 605.a.

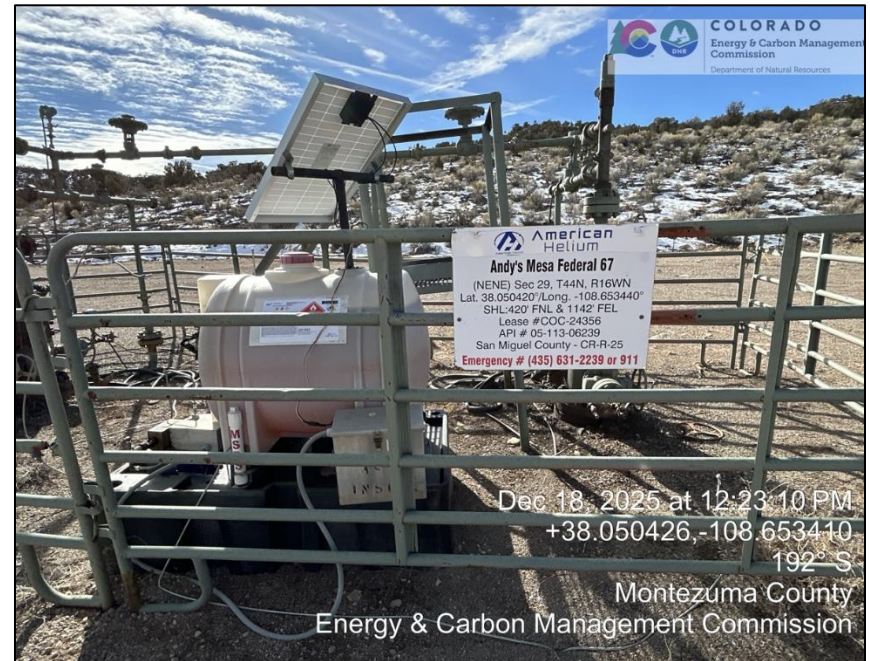
04.) Andy's Mesa Federal 67, Note that methylene injection system is hooked up to non-functioning equipment and is non-functional itself. Secondary containment appears to be about half full of water. Remove unused equipment to comply with rule 606.

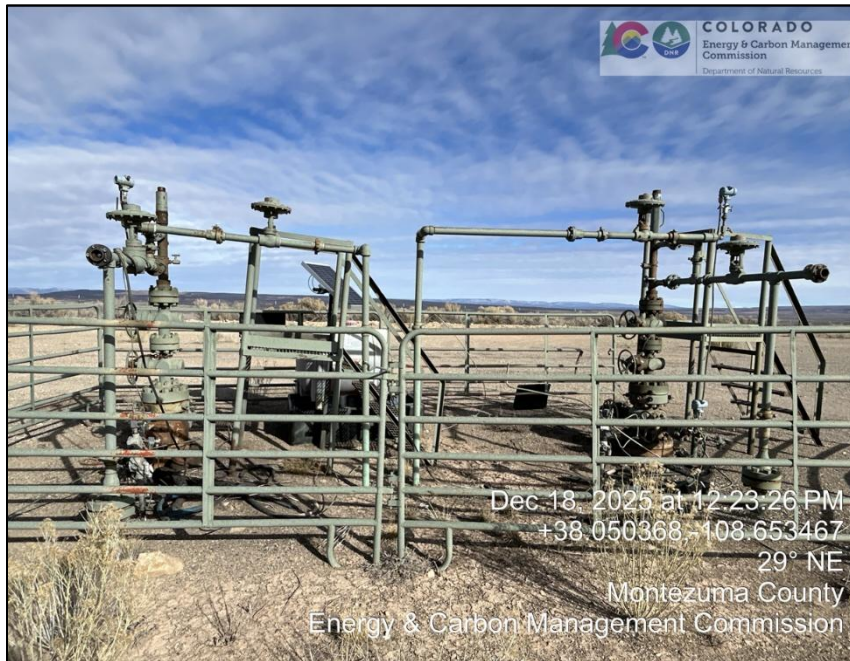
05.) Andy's Mesa Federal 67 (left) and 66 (right), view looking north towards Paradox Valley.

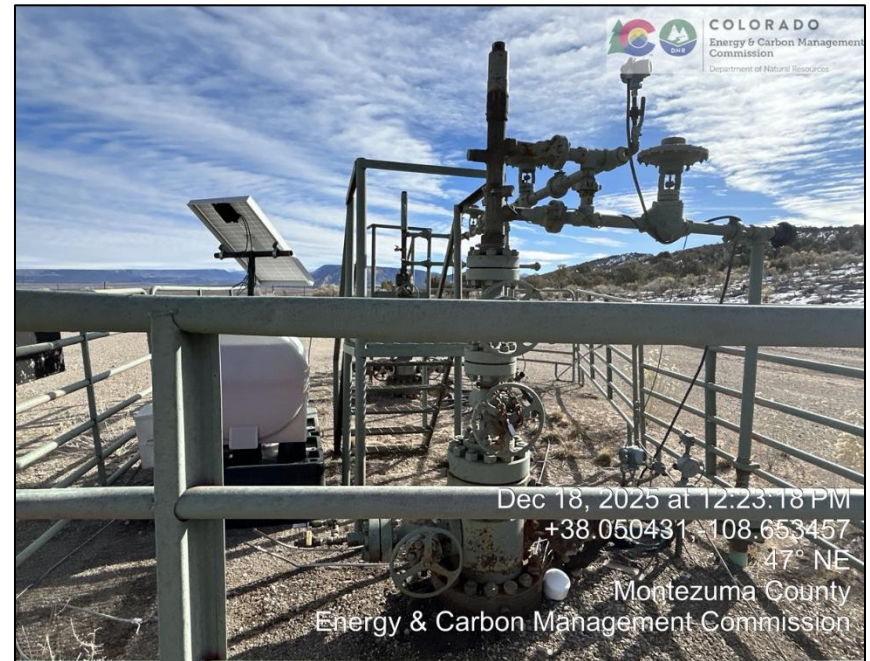
06.) Andy's Mesa Federal 67 (foreground) and 66 (background). Note that injection (methanol?) system is hooked up to non-functioning equipment and is non-functional itself. Secondary containment appears to be about half full of water.

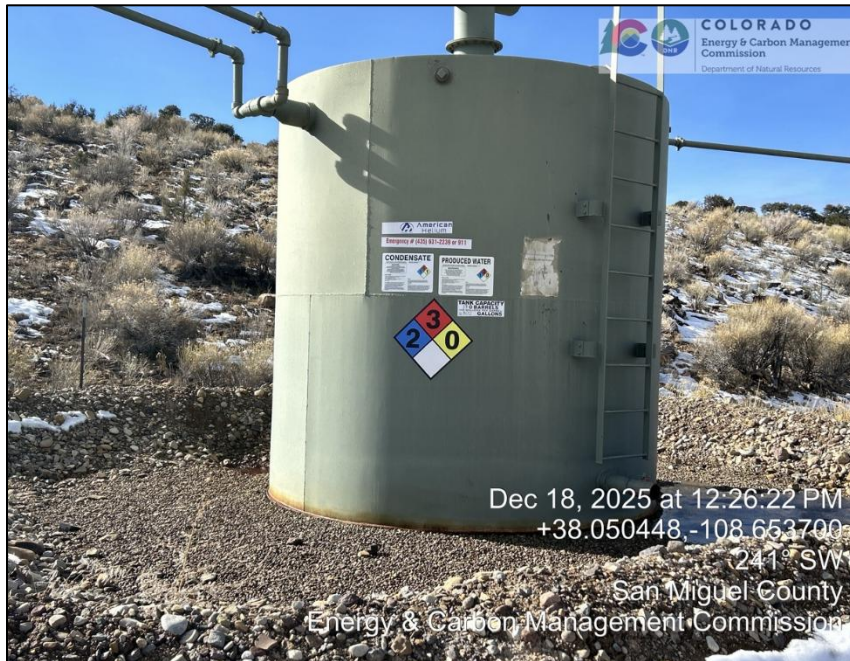
07.) Tank battery inside gravel containment berm. Capacity is 150 BBL. Tank valve is dripping. See next photo. HazCom label is displayed, but was not in previous inspection of 10/10/24.

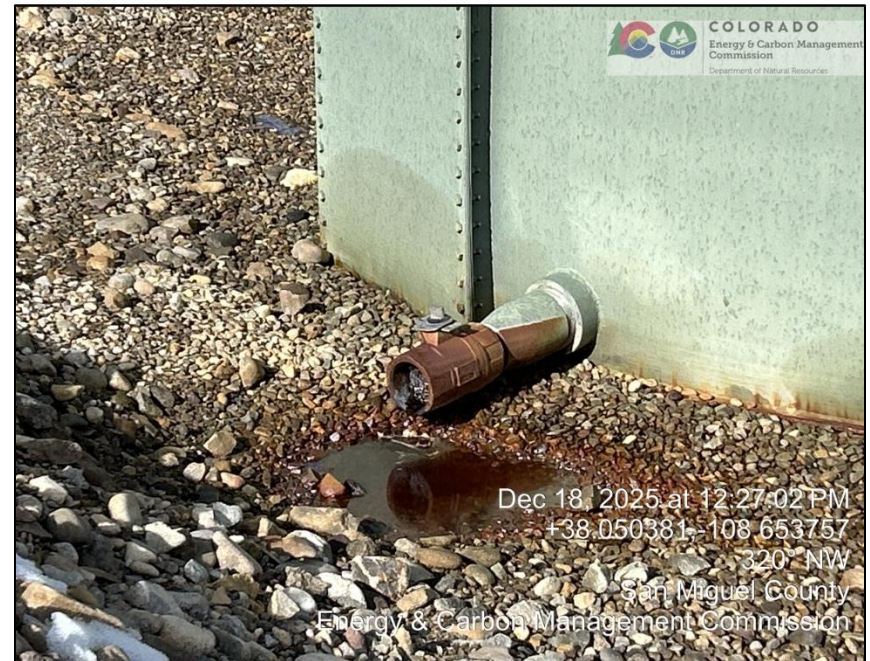
08.) Liquid dripping from drain valve of 150 BBL AST. Liquid with an oily sheen can be seen dripping from the valve. The valve appears to be gummed up with a tar-like substance. There is staining and discoloration on the gravel below. Clean stained soil to comply with 905.e.

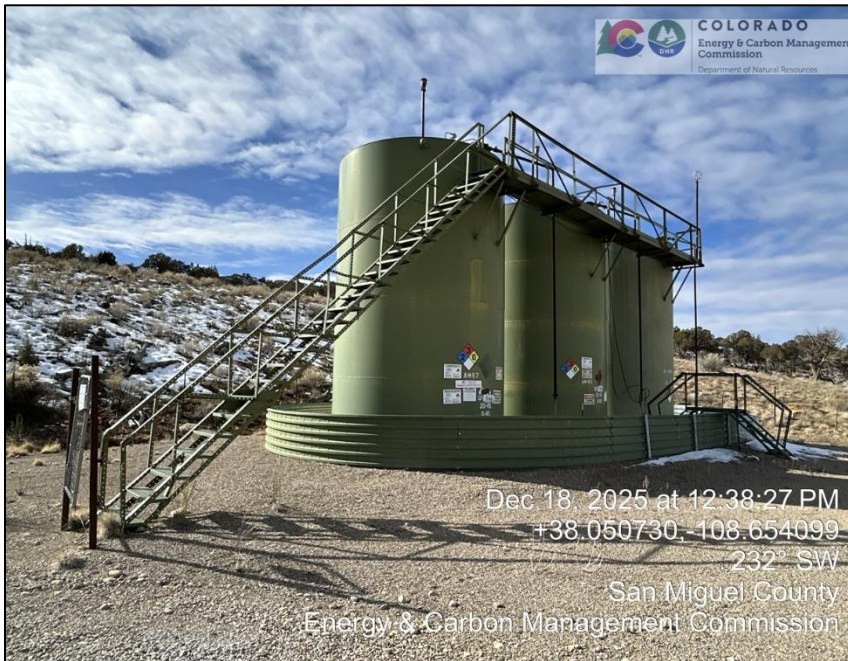
09.) Tank battery inside metal secondary containment. The tanks are for produced water and condensate. Each tank is 400 BBL capacity, for wells 67, 66 and 32 from left to right. There is a discolored soil beneath the drain valve for 32. HazCom label is displayed, but was not in previous inspection of 10/10/24.

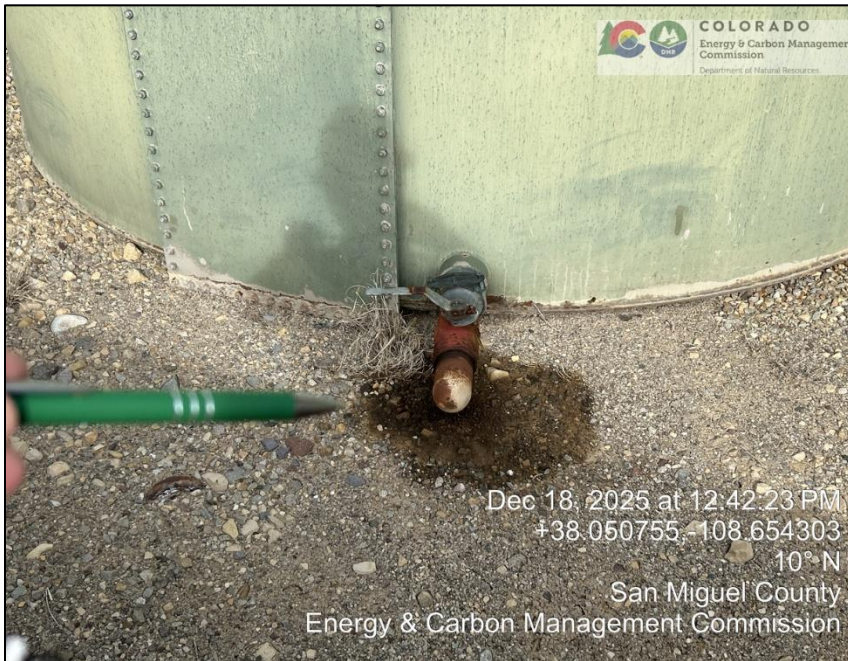
11.) Discolored soil beneath drain valve on produced water/condensate tank for well 32 (westernmost tank). Clean up to comply with rule 905.e.

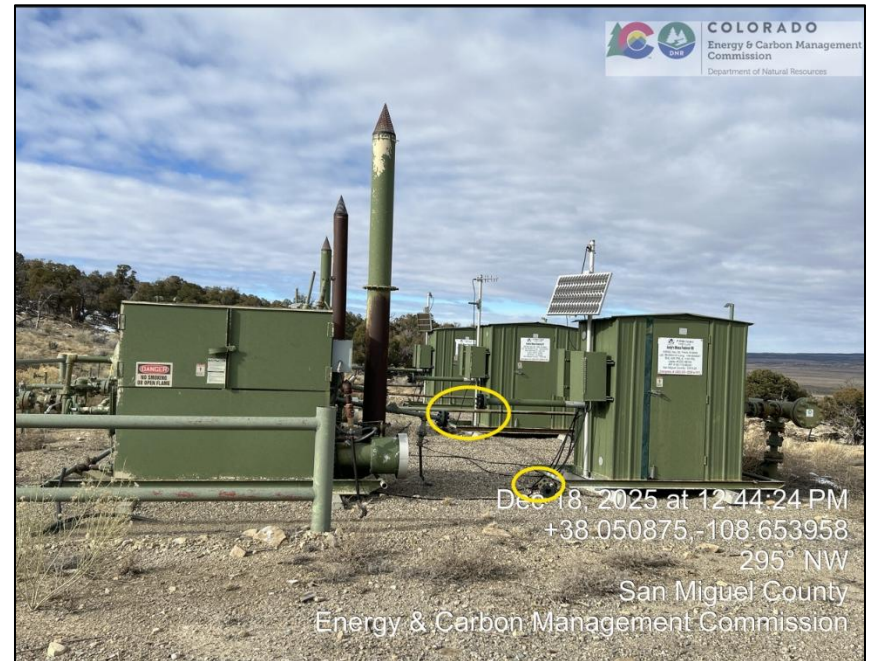
12.) Heated separators and meter runs with telemetry for Andy's Mesa #32, 66, and 67. Note that each of the separators has been physically disconnected by removing a valve and capping off the flange at both ends. The capped flanges and removed valve for Andy's Mesa 66 (the closest) are circled in yellow, but the same was done for all. Should be marked with OOSLAT tags. Tag flow lines to comply with rule 1105.b.

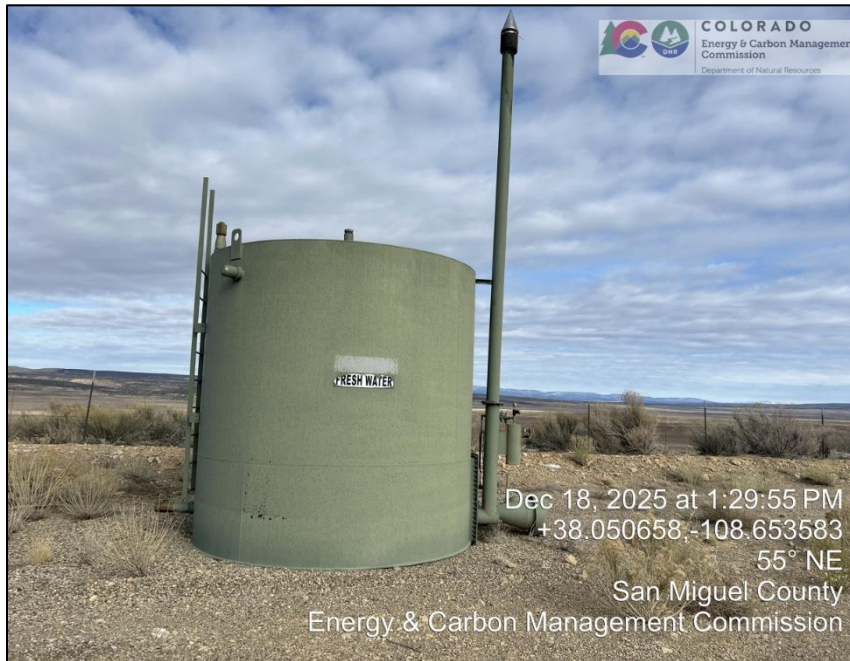
13.) 150 BBL (est) tank labelled “fresh water” sounds empty and does not appear to be in use. Should be hauled away if not in use to comply with rule 606.

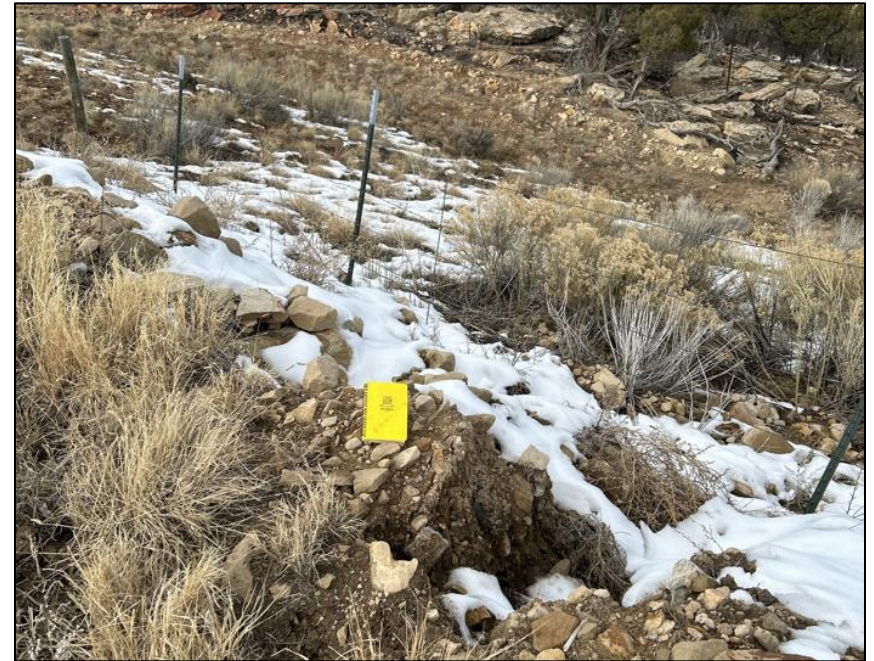
14.) Photo of erosion on berm on the northwest edge of the well pad. Note how the berm has been eroded to below grade and is no longer functioning. Berm needs to be fixed. Photo has been cropped to better frame the erosion. 38.050993, -108.654083. Taken 12/18/25 at 2:07:52 PM.
