Inspection Photos

Location Name: Kinder Morgan Doe Canyon Unit DC #6

API #: 05-033-06134

Inspector: Jamie Blair. Inspection Date: 01/02/2026

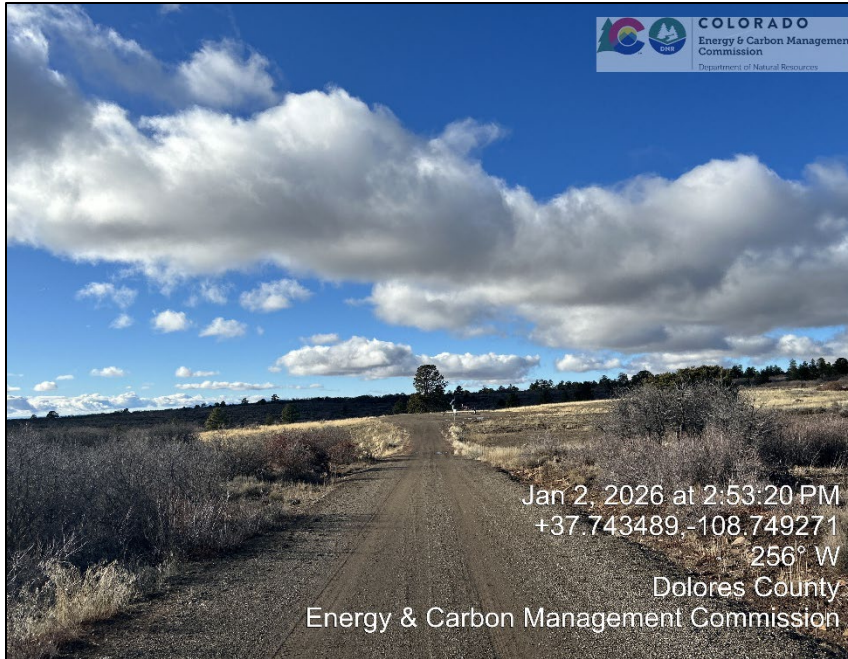
01. Access to Kinder Morgan Well DC #6. The road condition was acceptable.

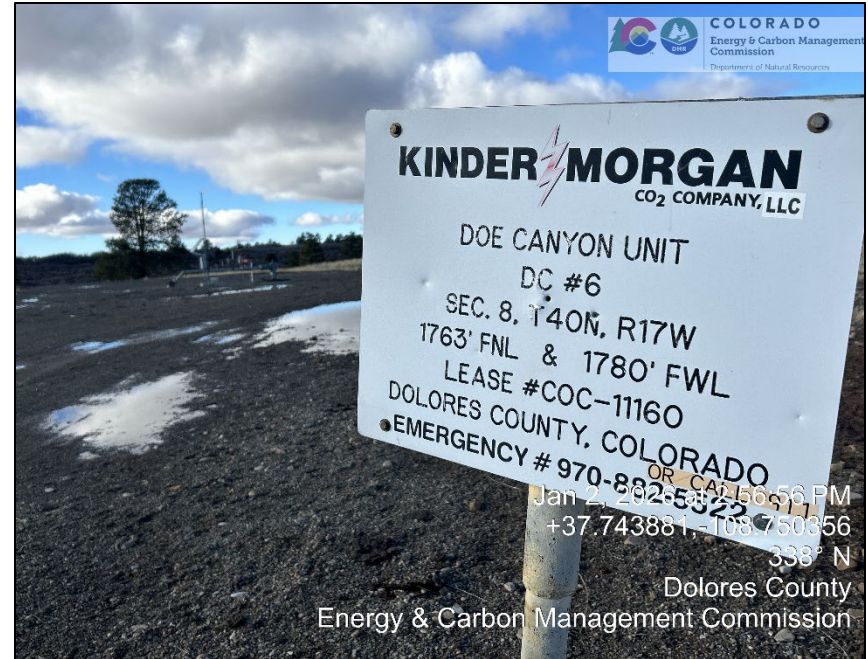
02. Well sign for Kinder Morgan DC #6. The sign lacks an API number. Include API Number next time sign is updated.

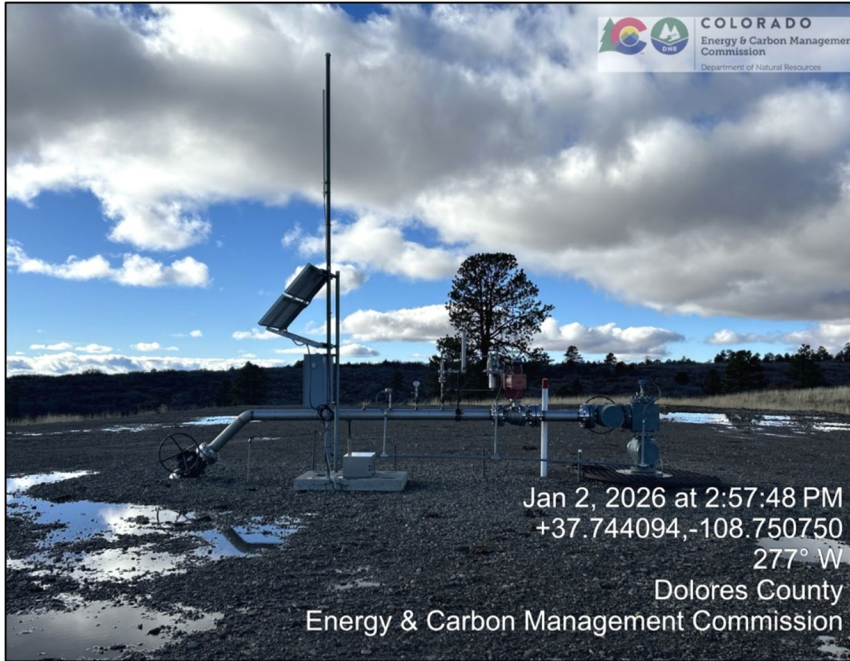
03. Kinder Morgan DC #6 well head assembly and meter run.

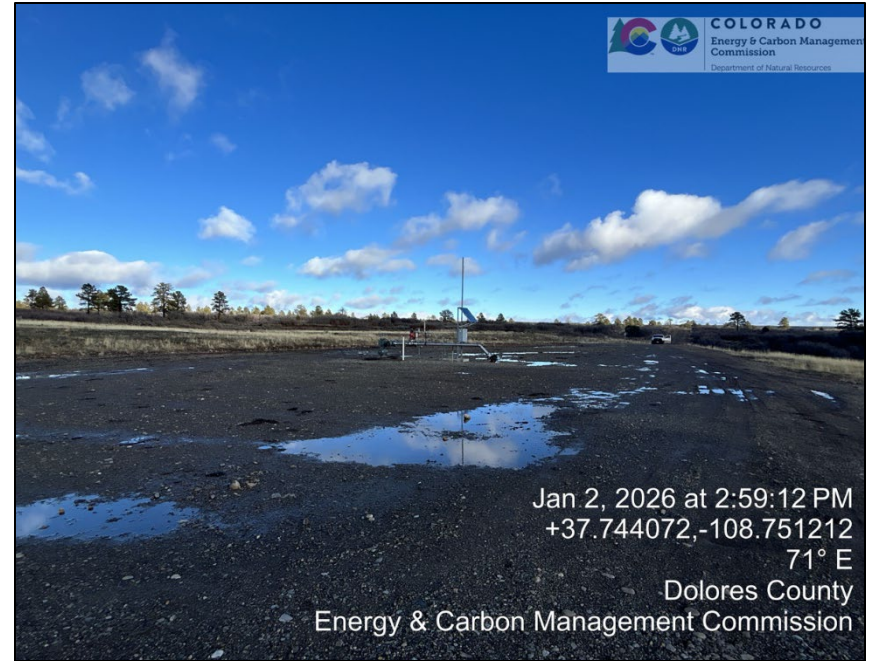
04. DC #6 well pad looking east.

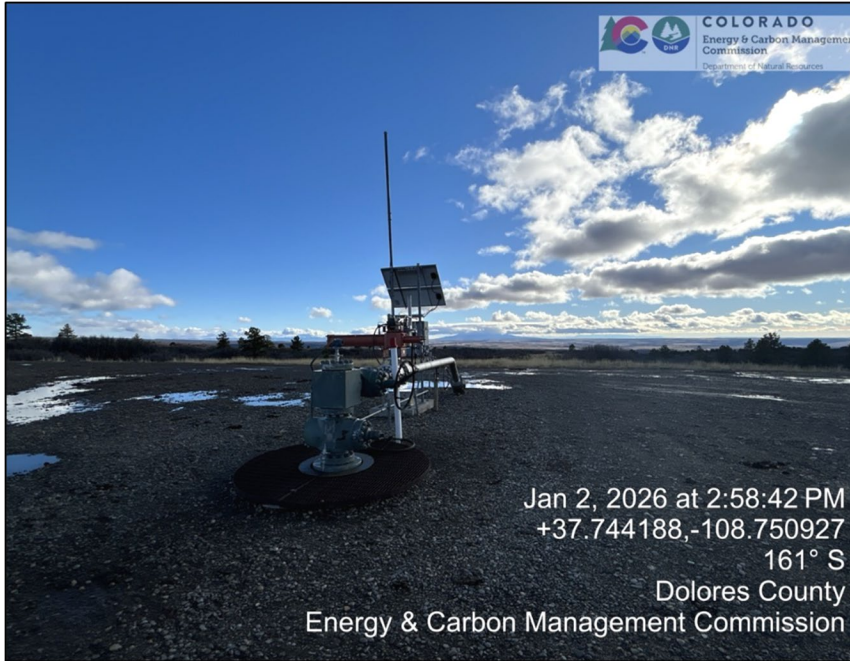
05. Kinder Morgan DC #6, looking south.

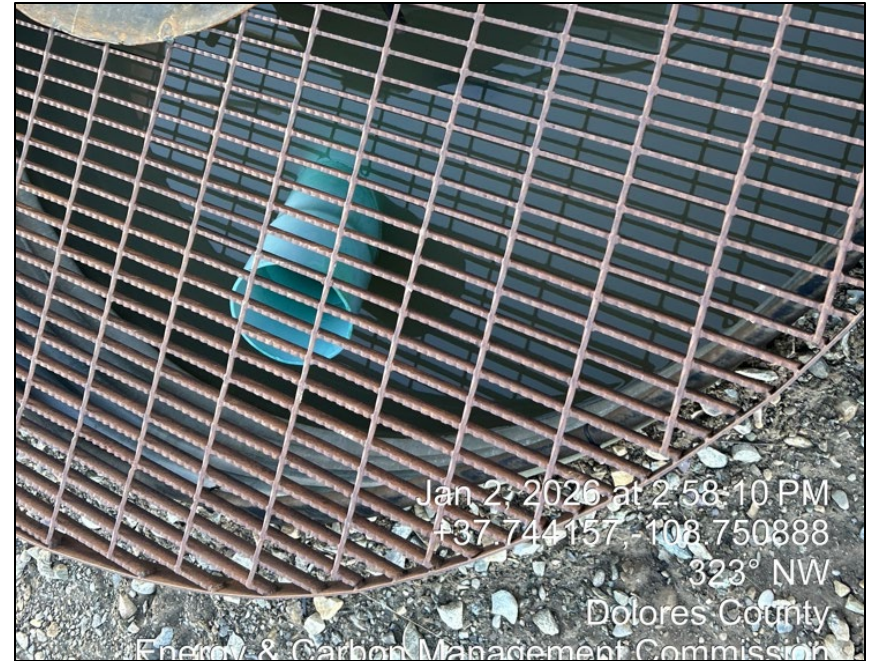
06. DC #6 well cellar. Cellar is half full of water. Bradenhead access appears to be inside of PVC pipe.
