Inspection Photos

API:061-06010

Operator: WESTERN OPERATING COMPANY

Inspection Date: 1/5/2026

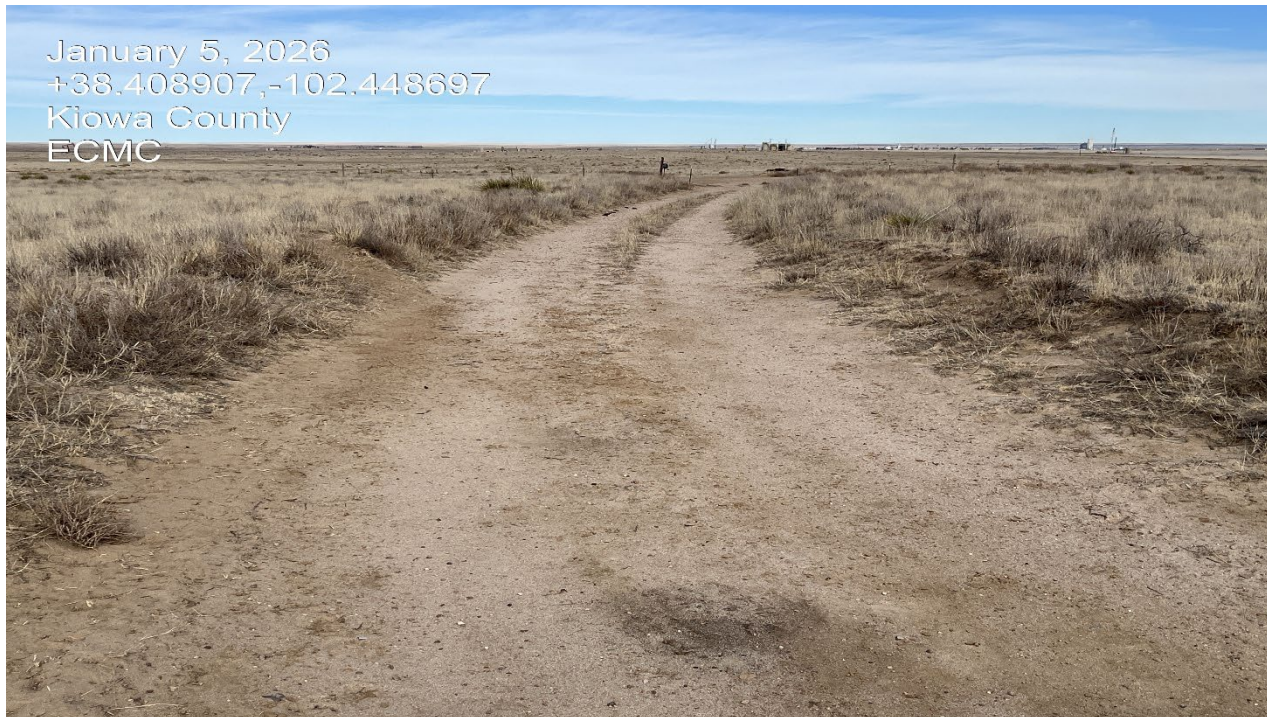
Photo 1. Facing north toward the access road which will need to be recontoured and reclaimed.

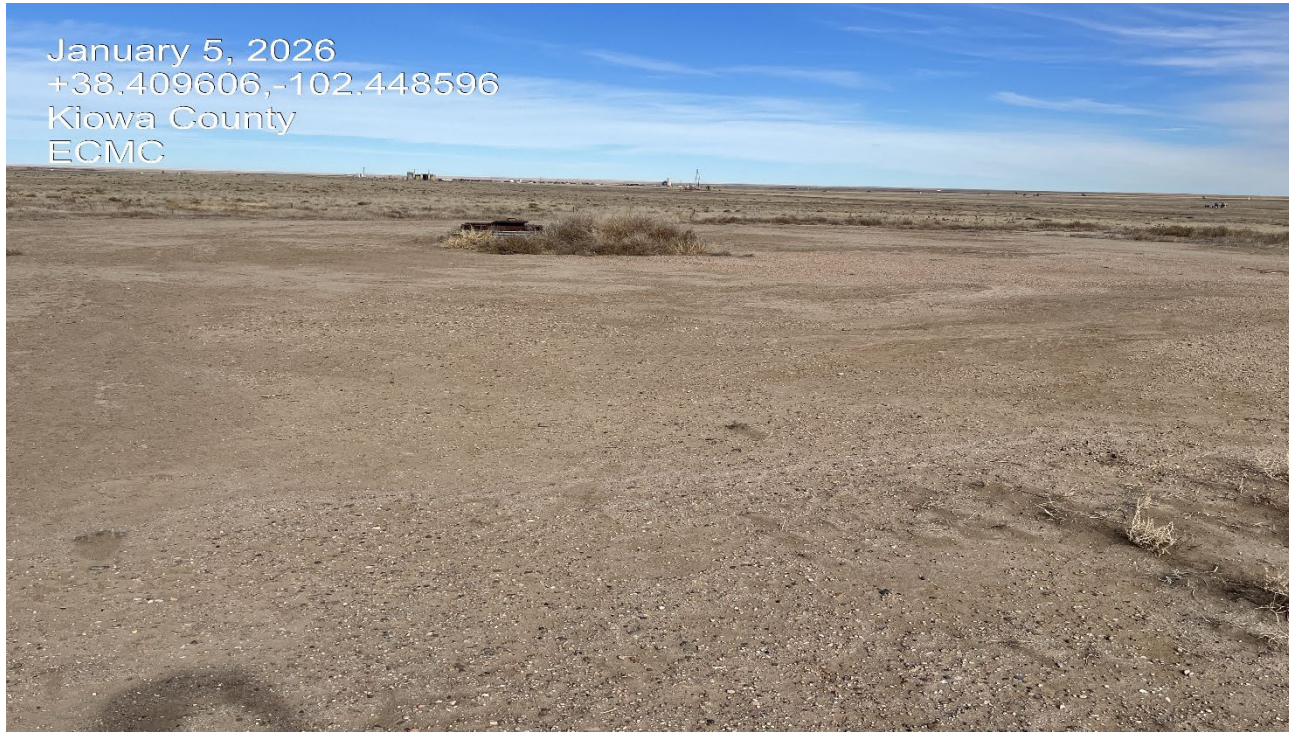
Photo 2. Facing north toward the former tank battery location. Reclamation has not been performed.

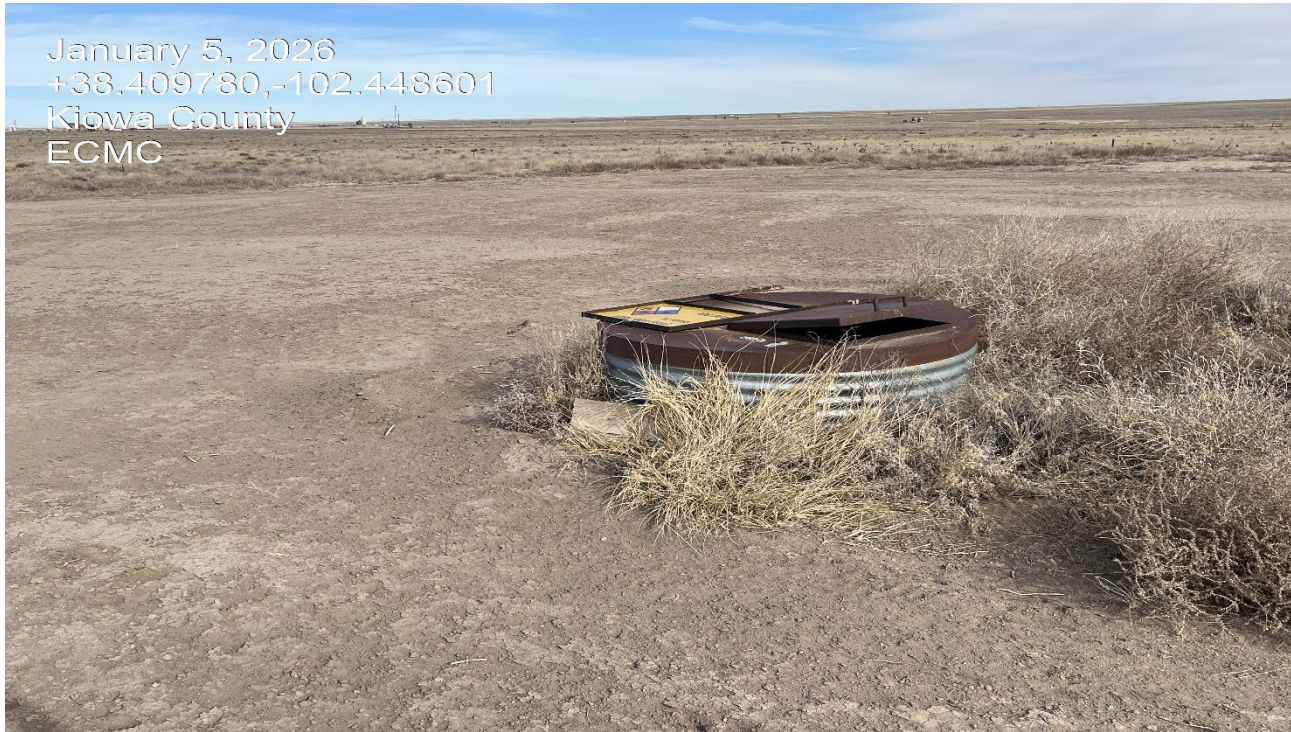
Photo 3. There is a metal flowline culvert that needs to be removed. Flowlines must be abandoned per 1100 rules.

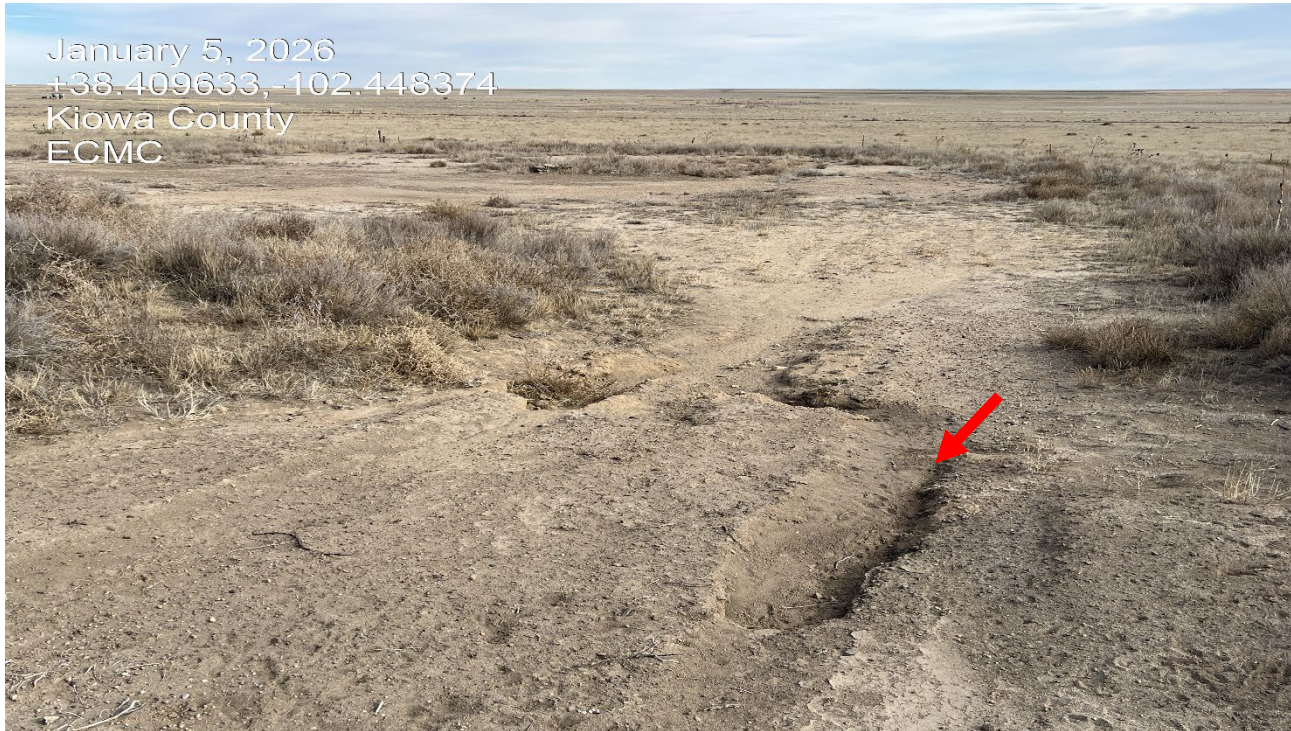
Photo 4. Facing northeast toward the wellsite location. There is erosion in this area beginning to occur.

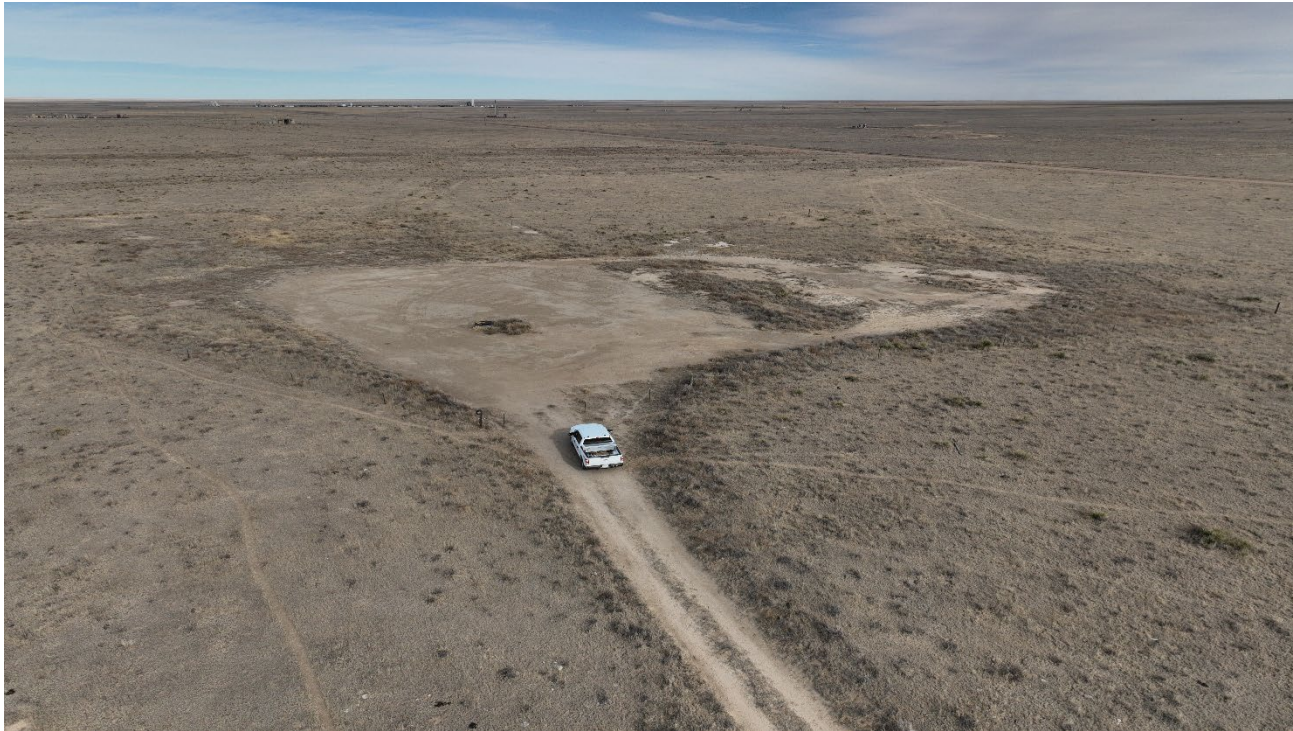
Photo 5. Drone aerial photo facing north toward the access road and location.

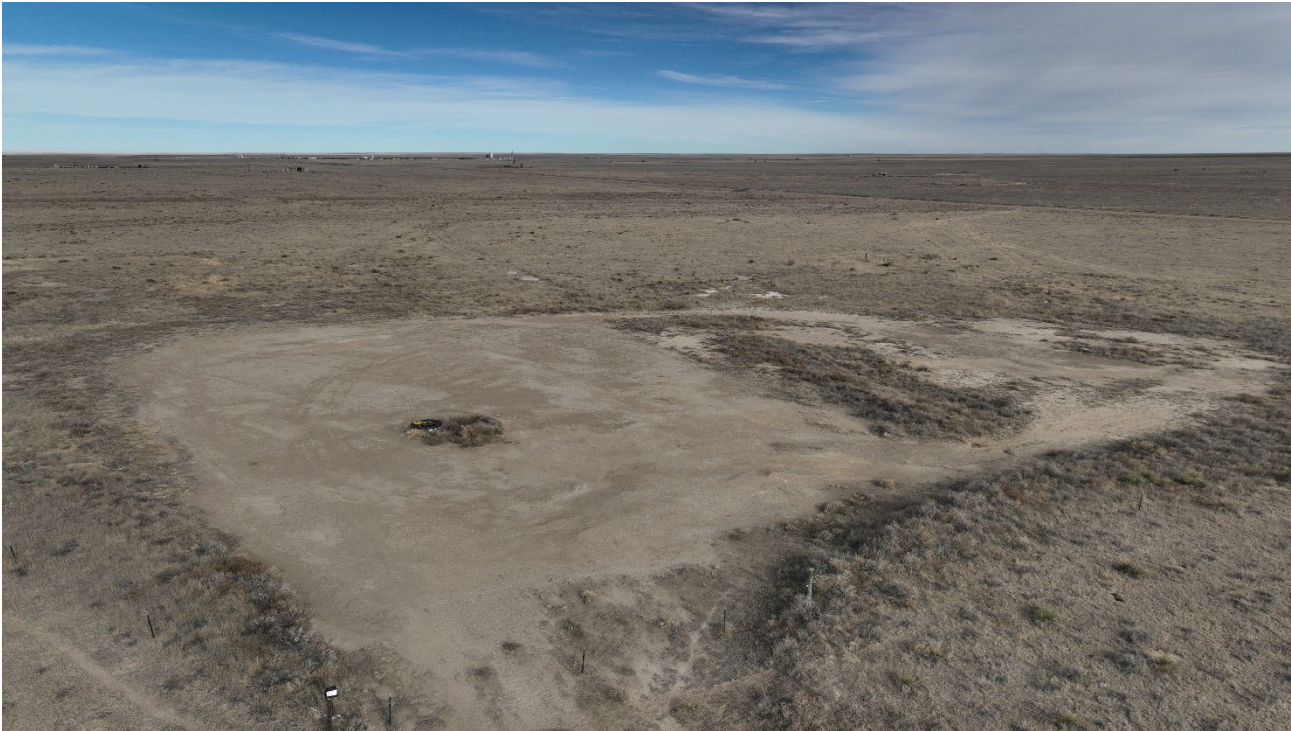
Photo 6. Drone aerial photo overlooking the location disturbance.

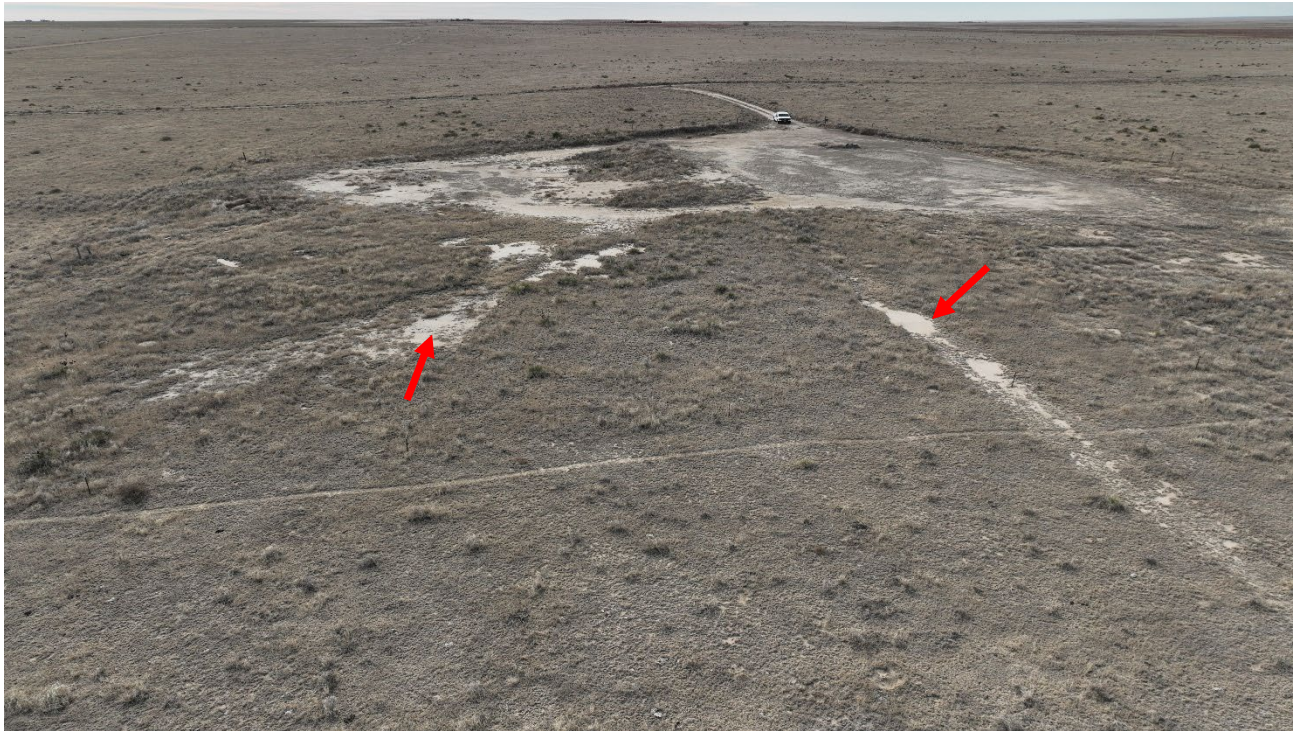
Photo 7. Drone aerial photo facing south. There are impacted soils shown at red arrows from historical spill.

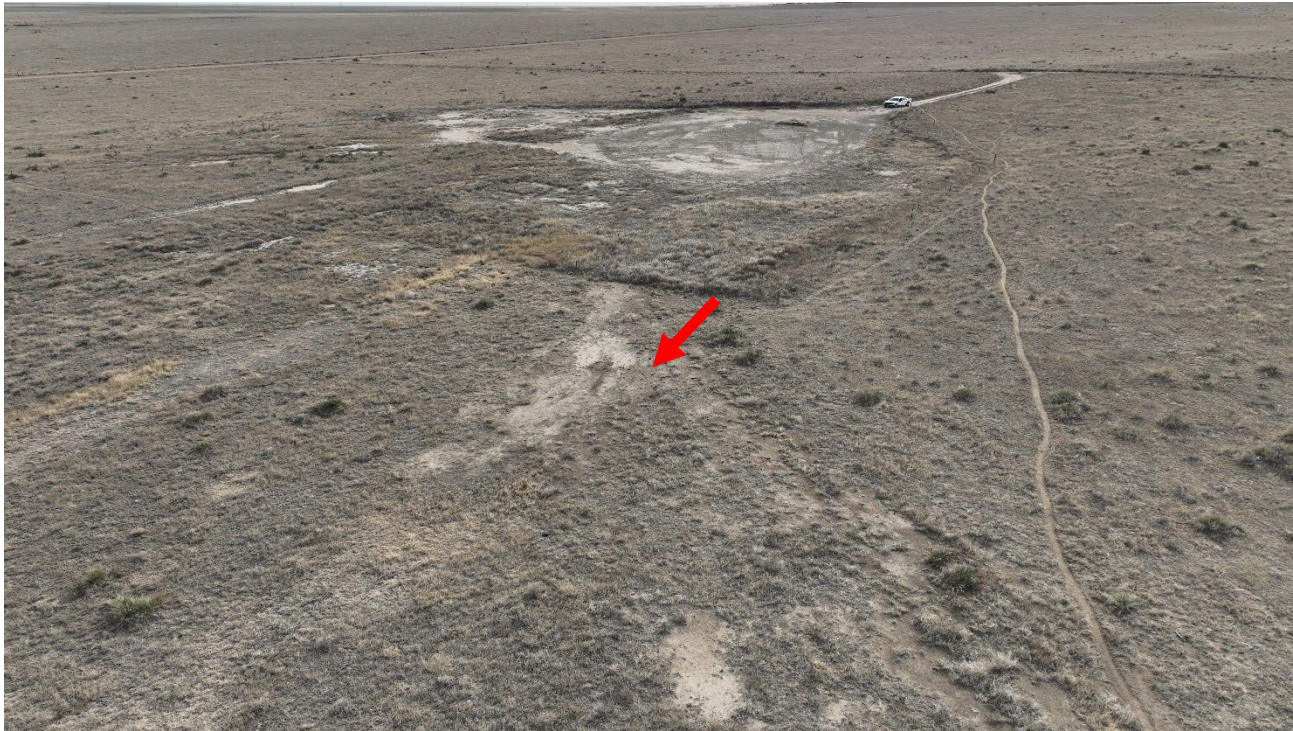
Photo 8. Drone aerial photo facing southeast. There are impacted soils shown at red arrow from historical spill.
