Inspection/Audit Photos

Location Name: QB ENERGY OPERATING LLC PUCKETT 22B-7 (Mesa 23)

Location #: 334728

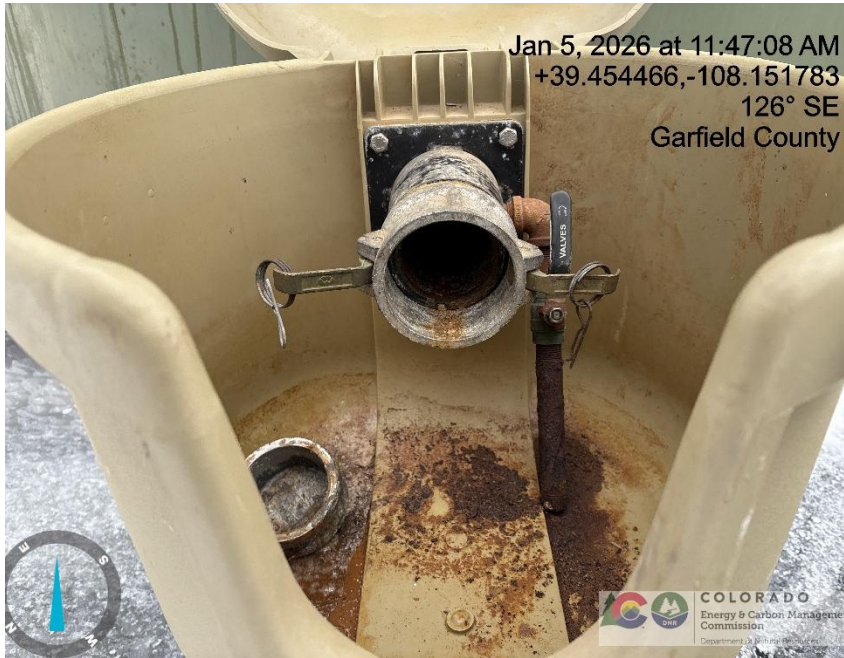
Photo # 7670 Open ended load line

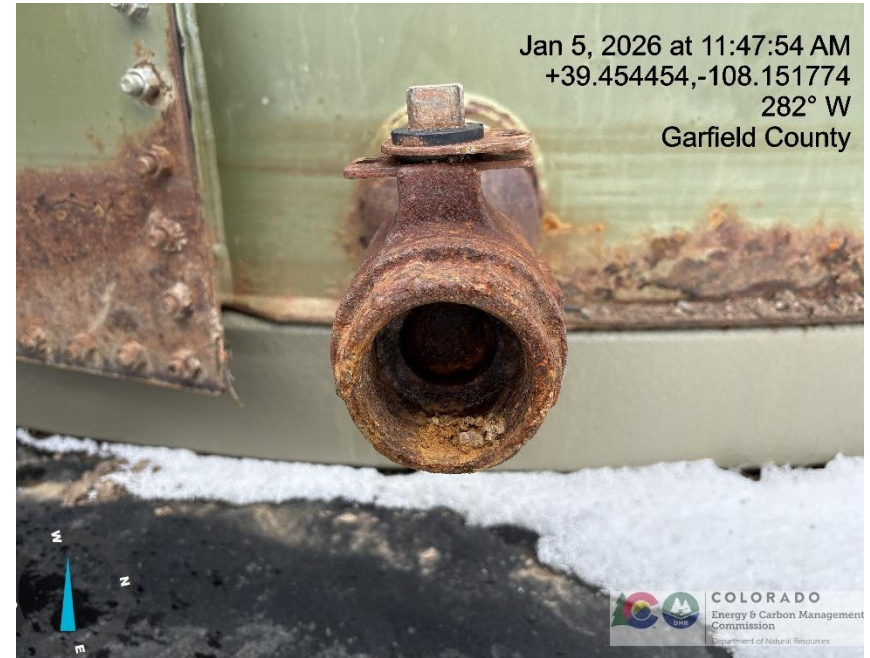
Photo # 7671 Open ended load line

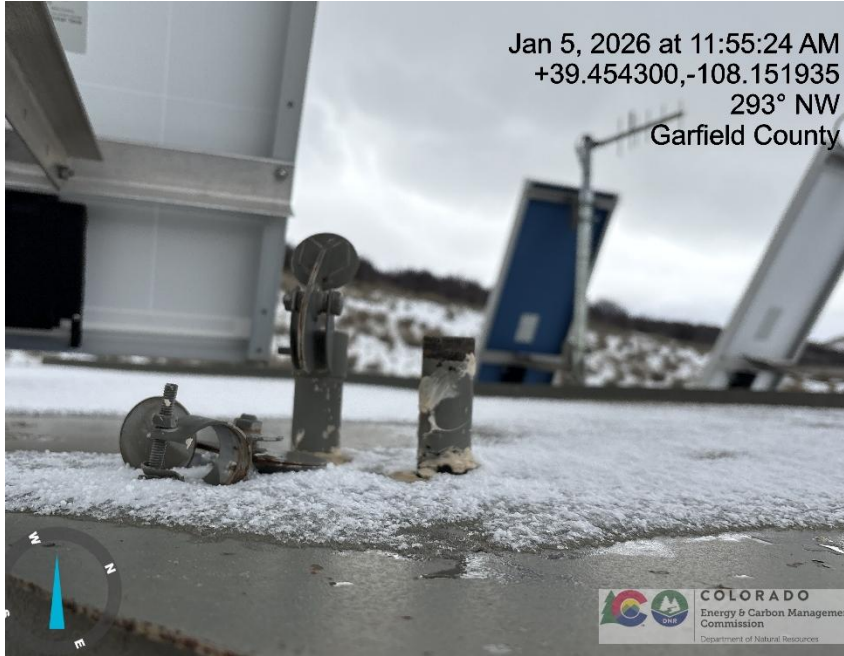
Photo # 7672 PRV vent line does not comply with CECMC pressure safety device rules

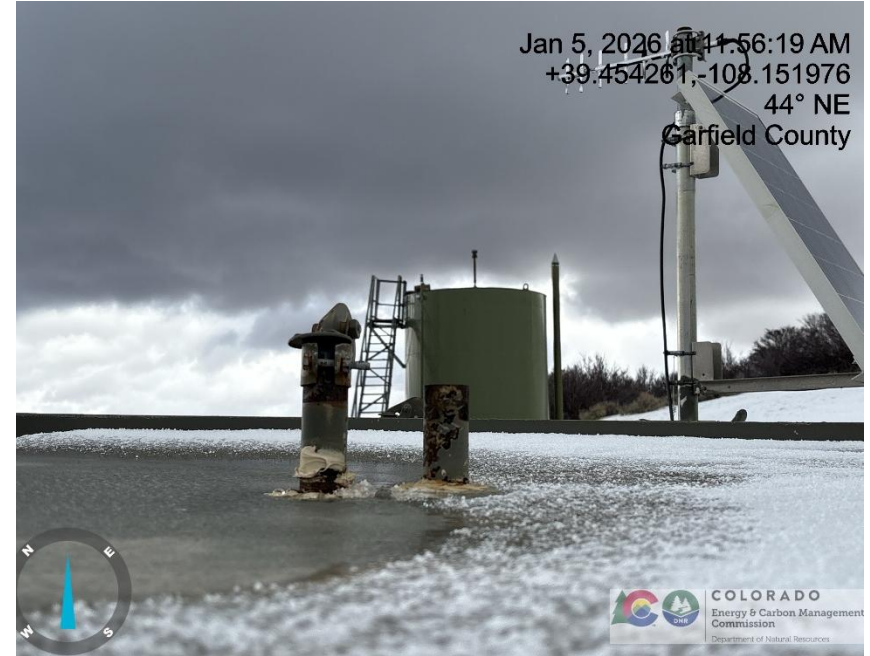
Photo # 7673 Rupture disc vent line does not comply with CECMC pressure safety device rules
