Inspection/Audit Photos

Location Name: QB ENERGY OPERATING LLC PUCKETT 11A-18D (Mesa 3)

Location # 334704

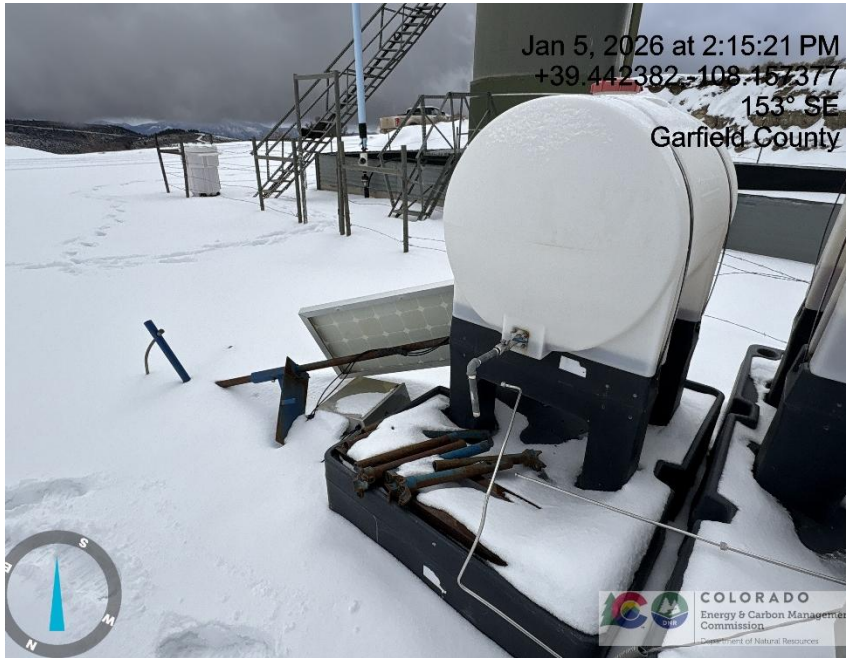
Photo # 8108 Unused equipment

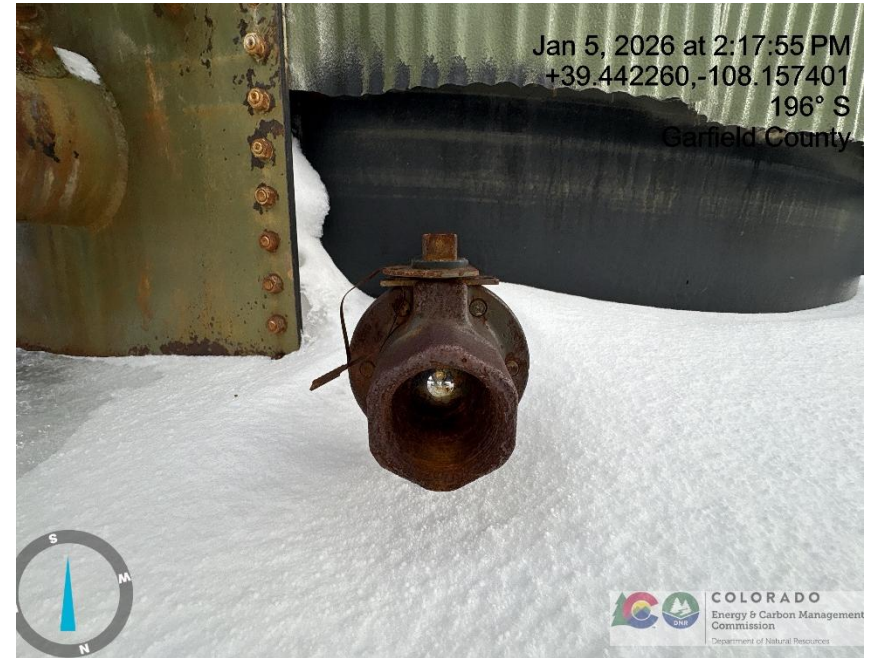
Photo # 8109 Open ended load line

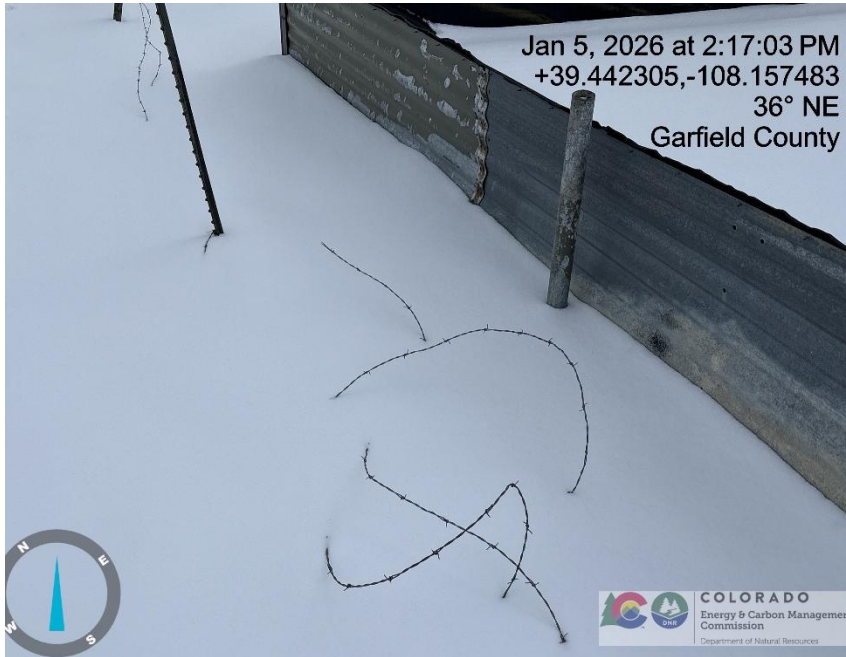
Photo # 8110 Barbed wire fence needs maintenance/wildlife hazard

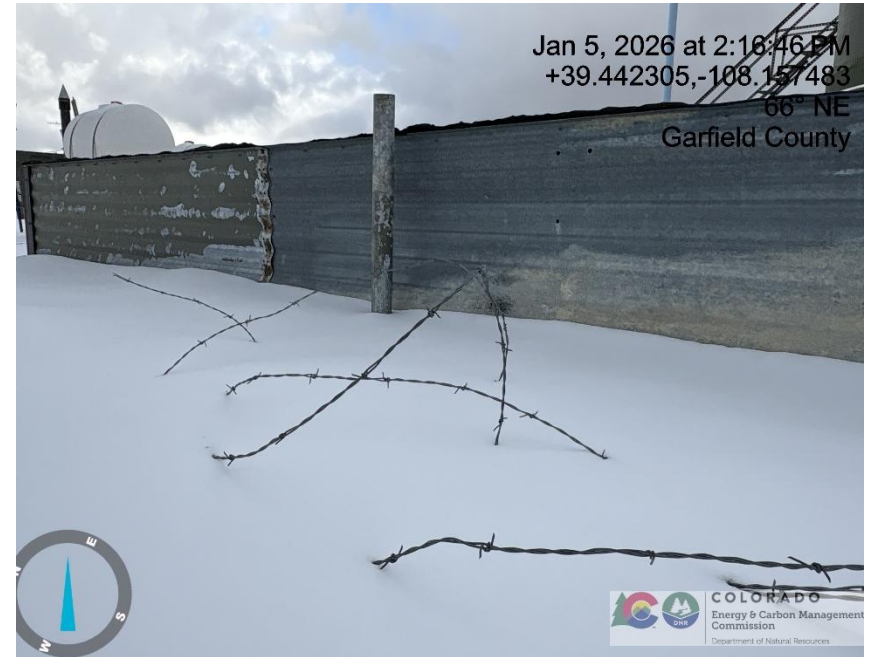
Photo # 8111 Barbed wire fence needs maintenance/wildlife hazard

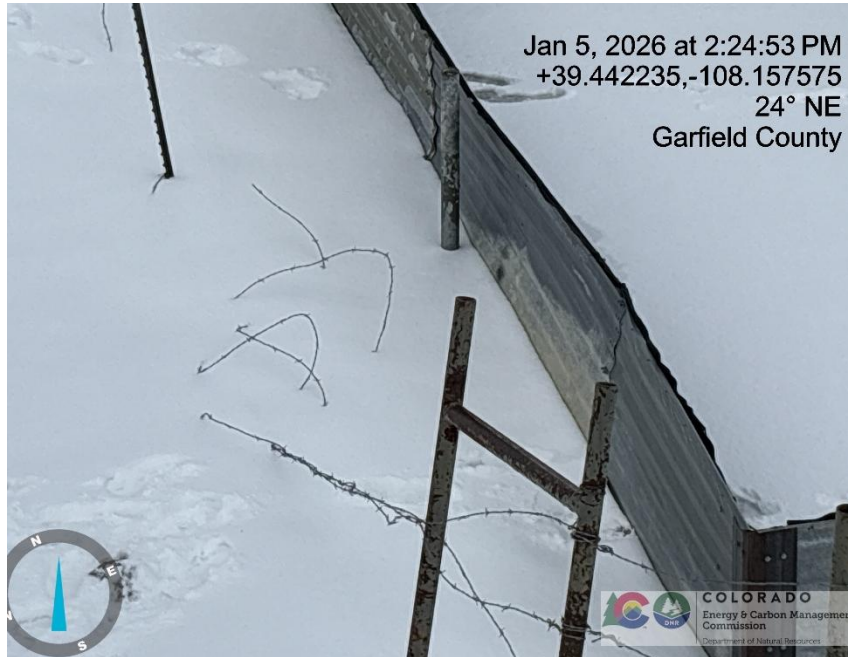
Photo # 8112 Barbed wire fence needs maintenance/wildlife hazard
