Inspection Photos
Location Name: Williams 14-21
API Number: 125-07897

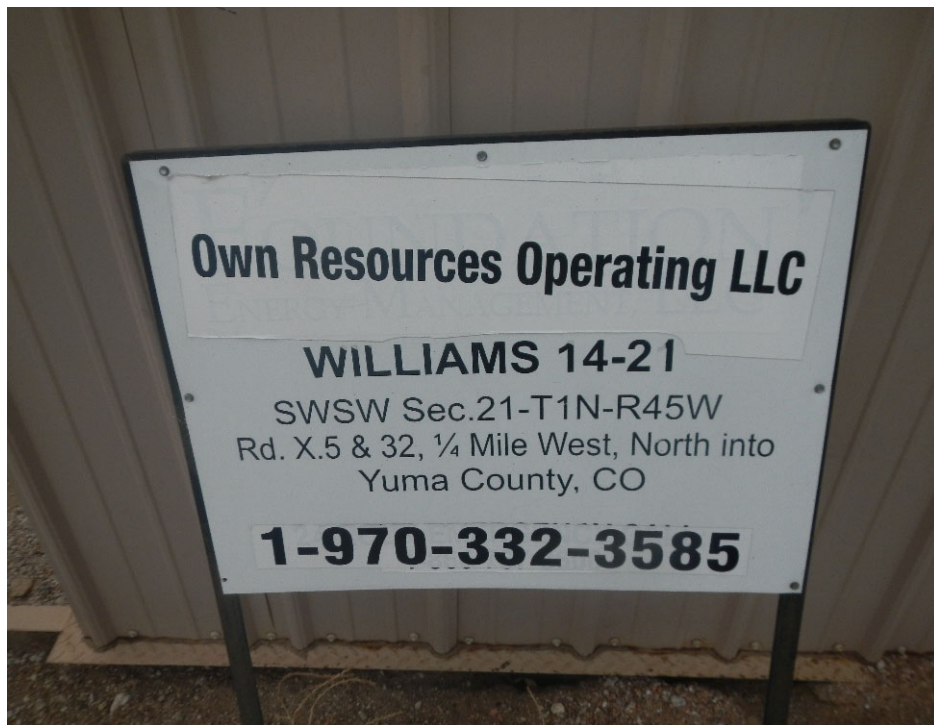
1. Lease sign at well location.

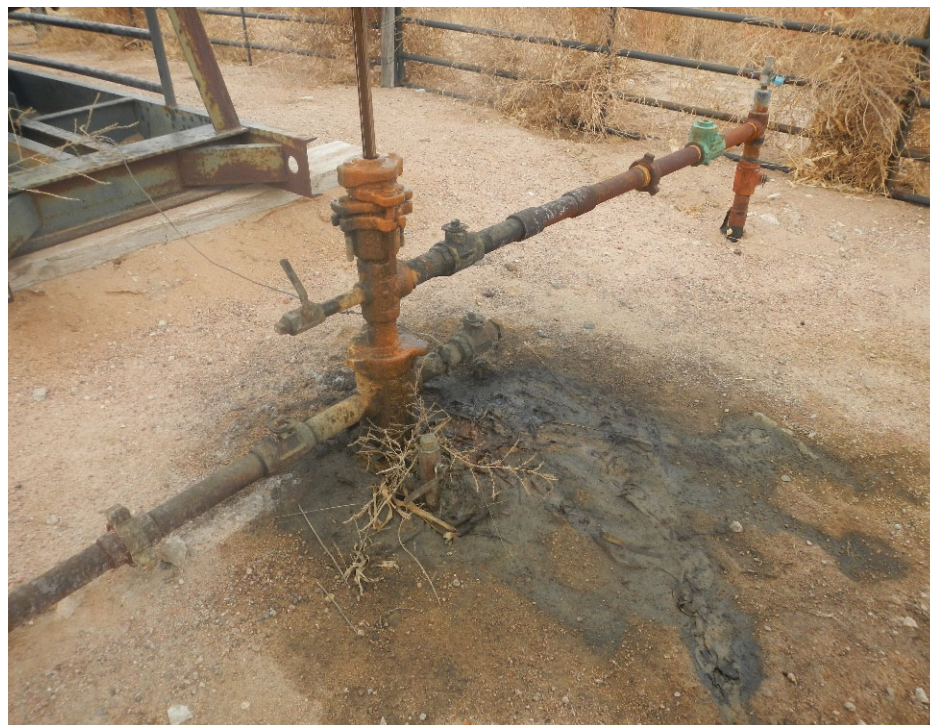
2. View of wellhead. Well was discovered leaking at packing. Leak has been repaired . Lease Operator will clean up and turn soil around wellhead.

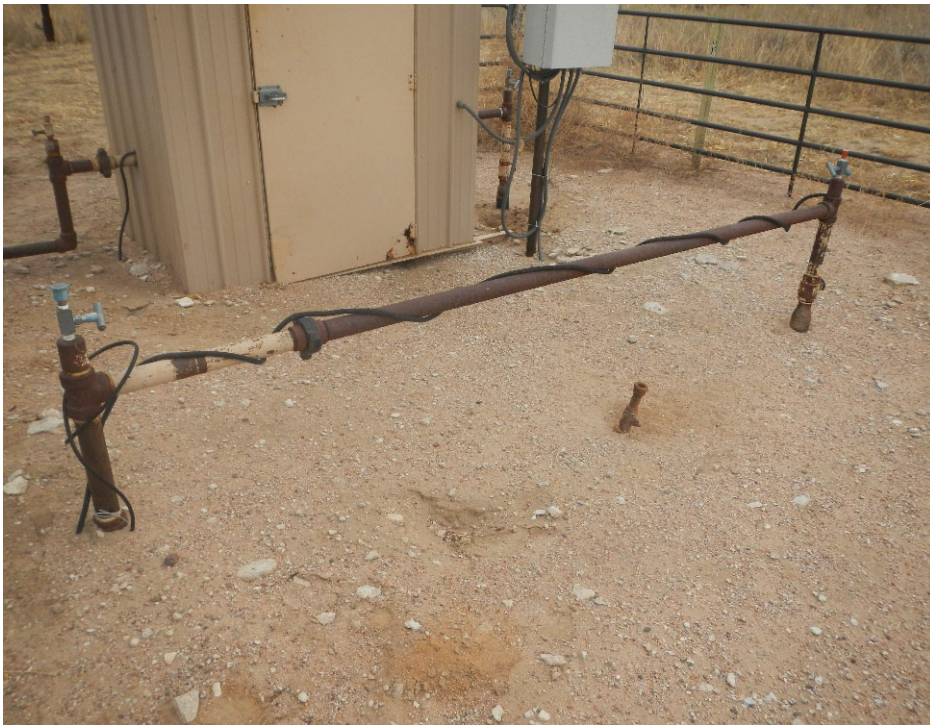
3. View of flowline risers at well location. Note open ended valve.

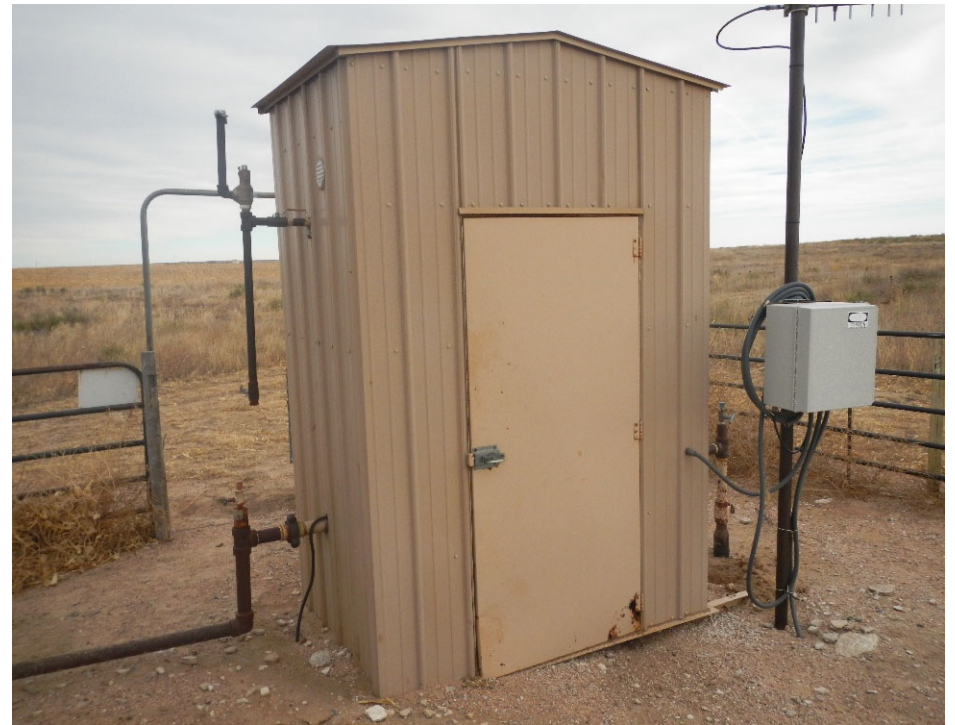
4. View of Separator/Meter Shed at well location.

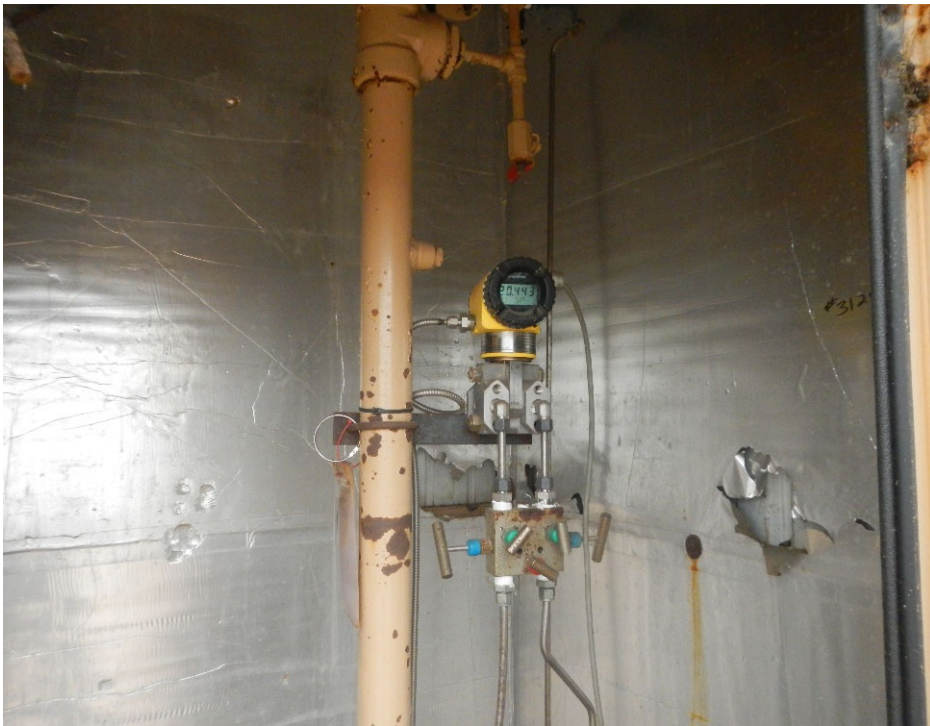
5. Gas Meter inside Meter Shed.

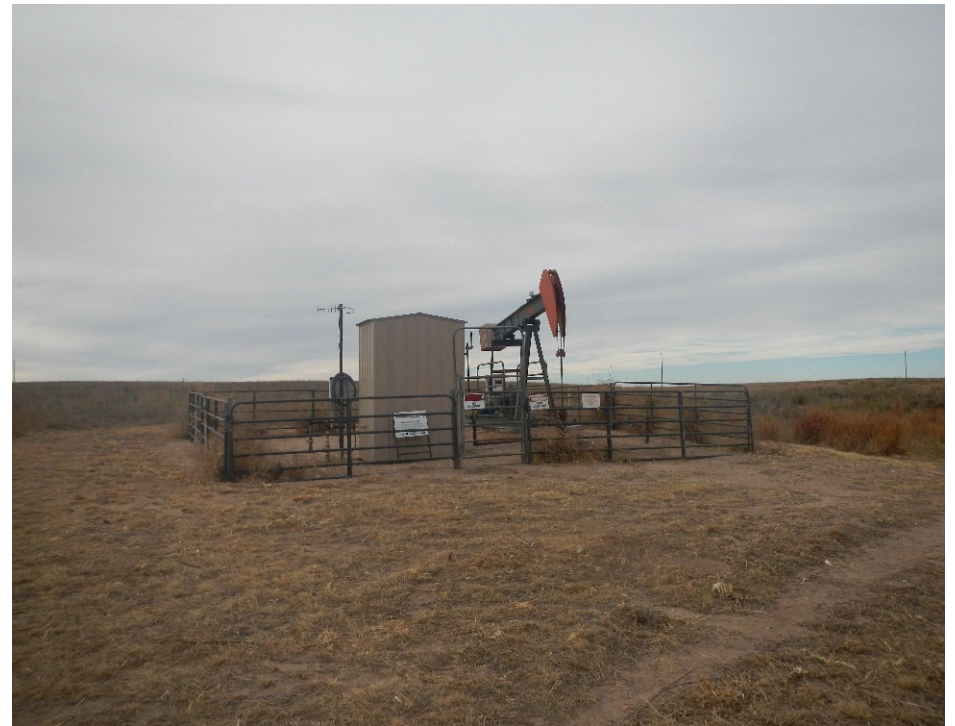
6. Well location overview.
