**Inspection Photos**  
**Location Name: Williams 24-21**  
**API Number: 125-09062**

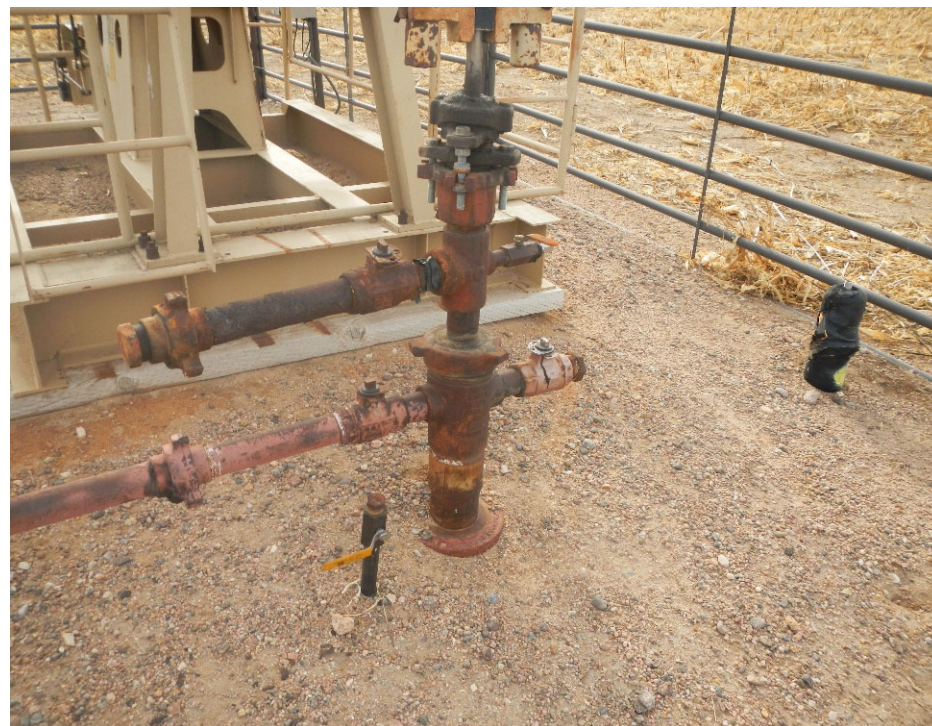
**2. View of wellhead. Note one of the three risers at well location right of frame.**

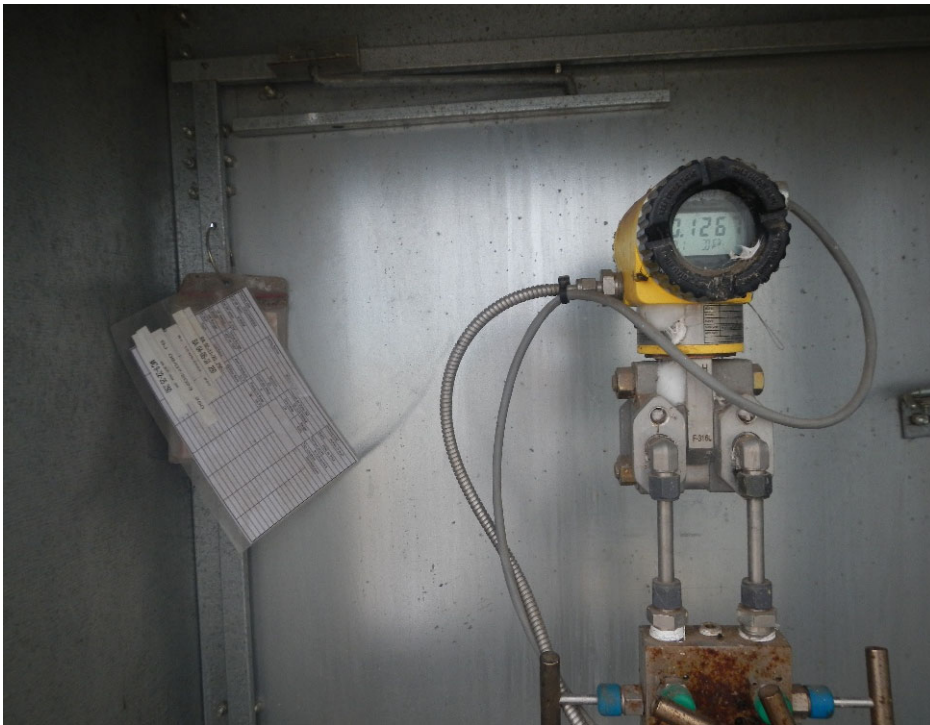
**3. Gas Meter inside Flowline mounted Meter Box.**

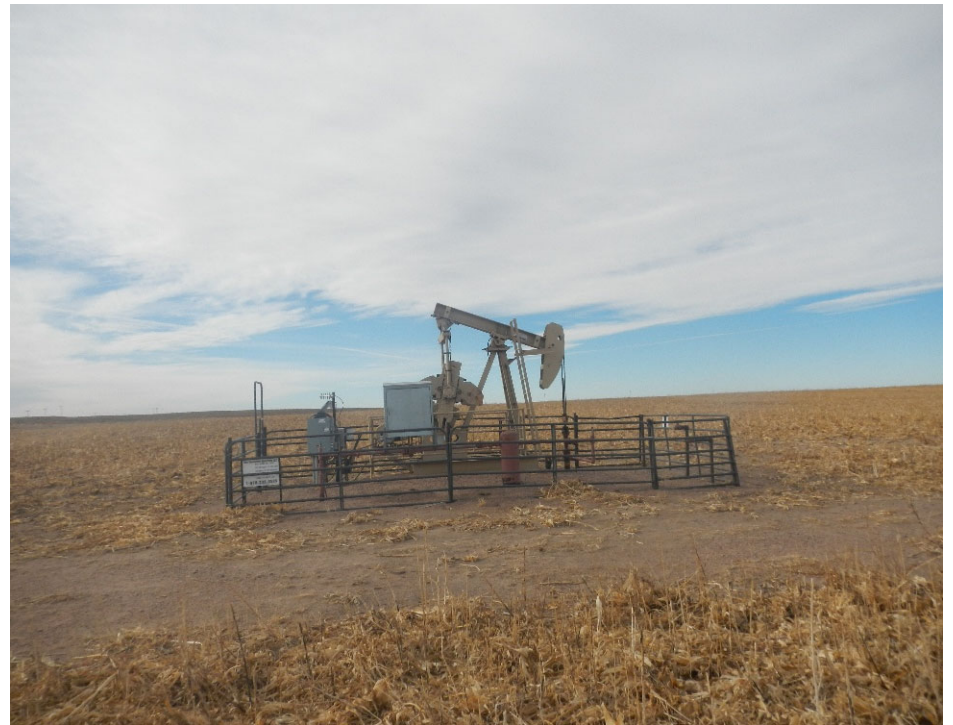
**6. Well location overview.**

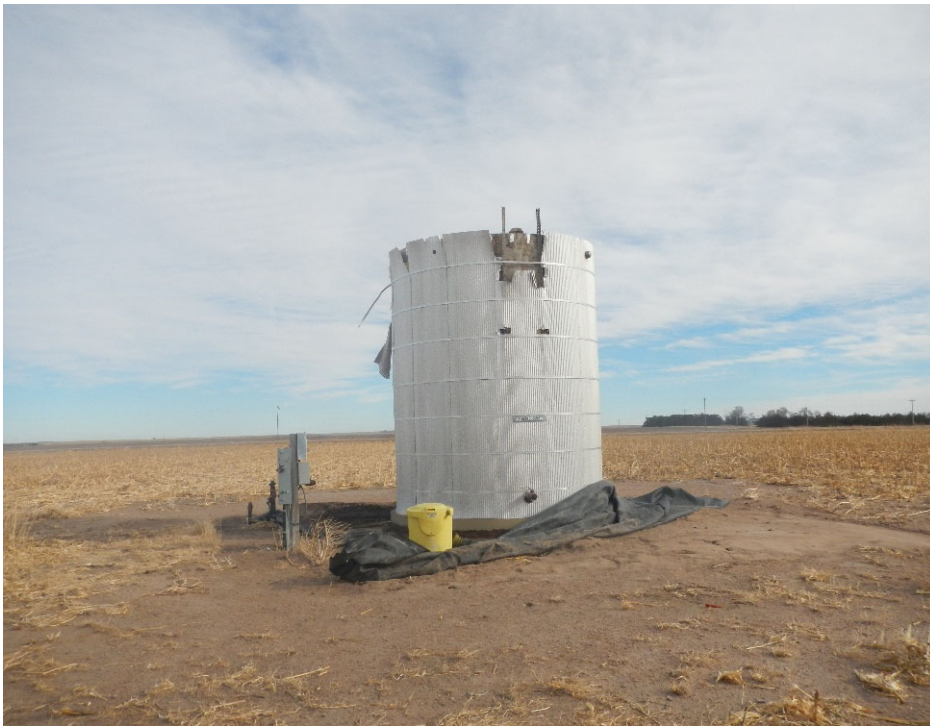
**5. View of production tank.**

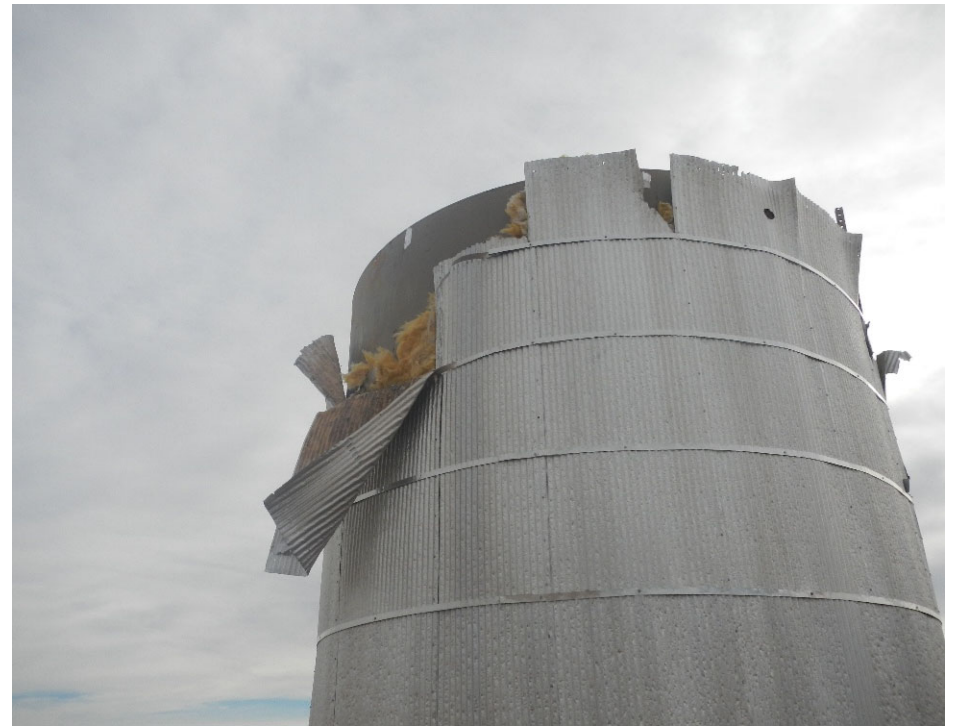
**6. View of production tank with insulation visible and metal covering peeling off tank.**

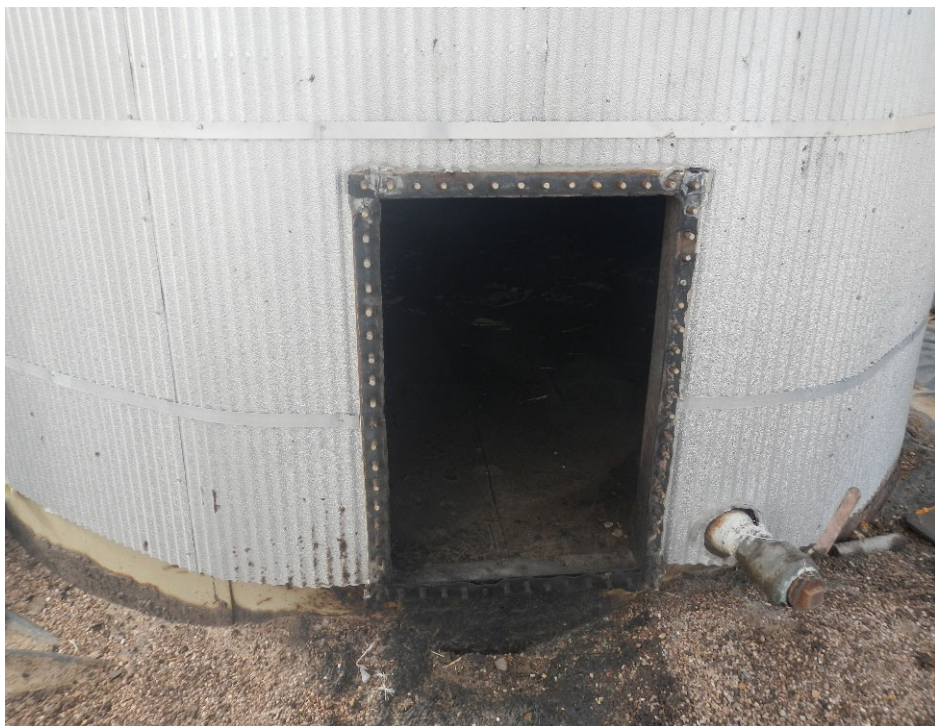
**7. Production tank entry hatch removed. Note hydrocarbons on ground outside of entry. No caution or warning signs in place.**

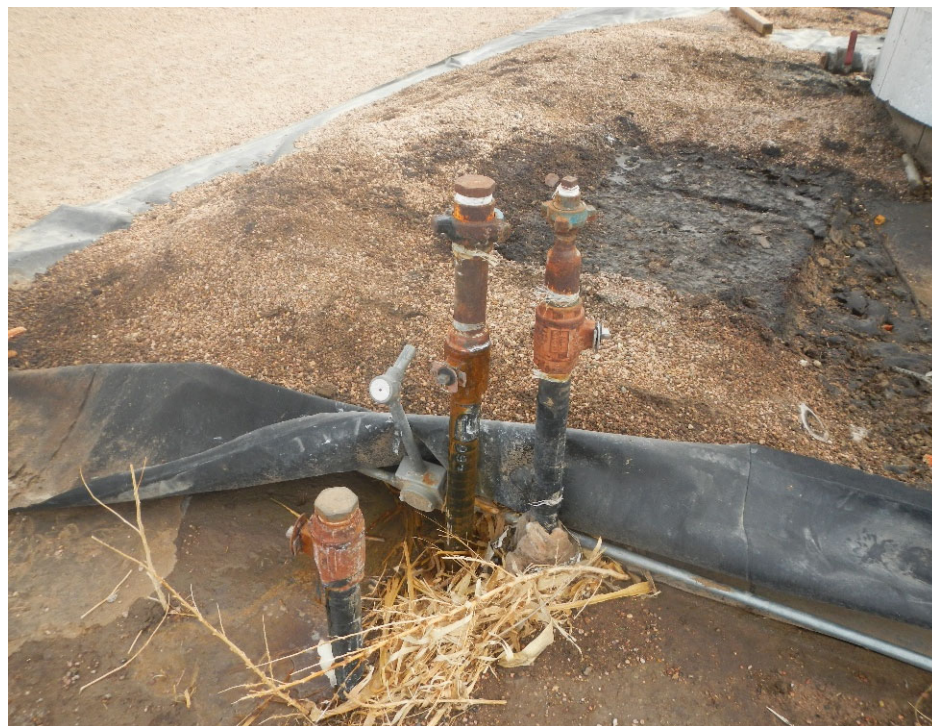
**8. View of oily gravel and soil mixture in upper right of frame and flowline risers in center of frame.**

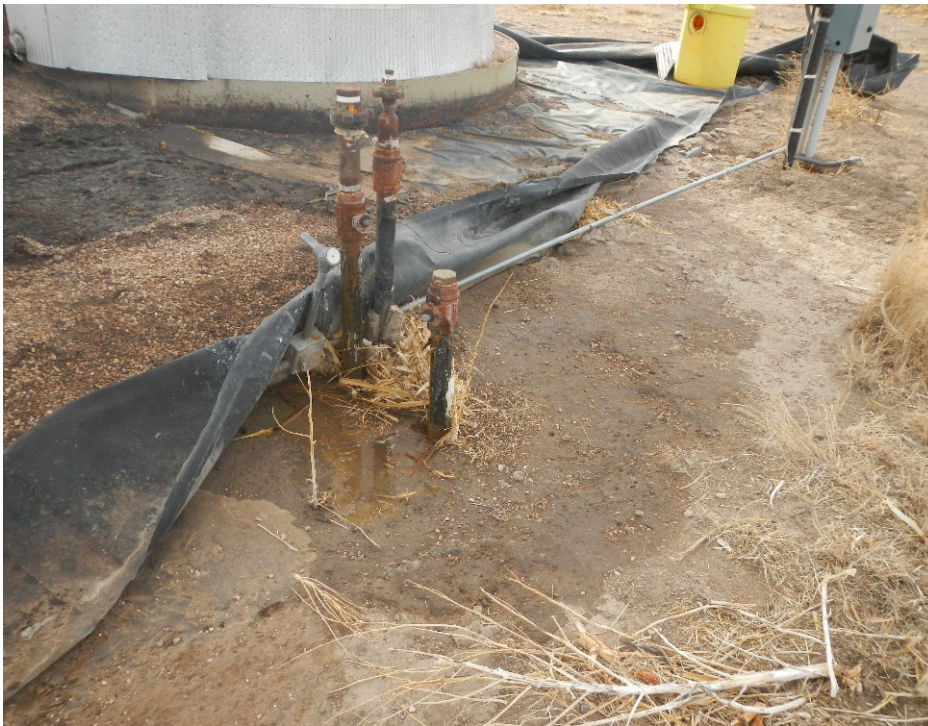
**9. Additional view of flowline risers and fluid release around piping and under liner.**

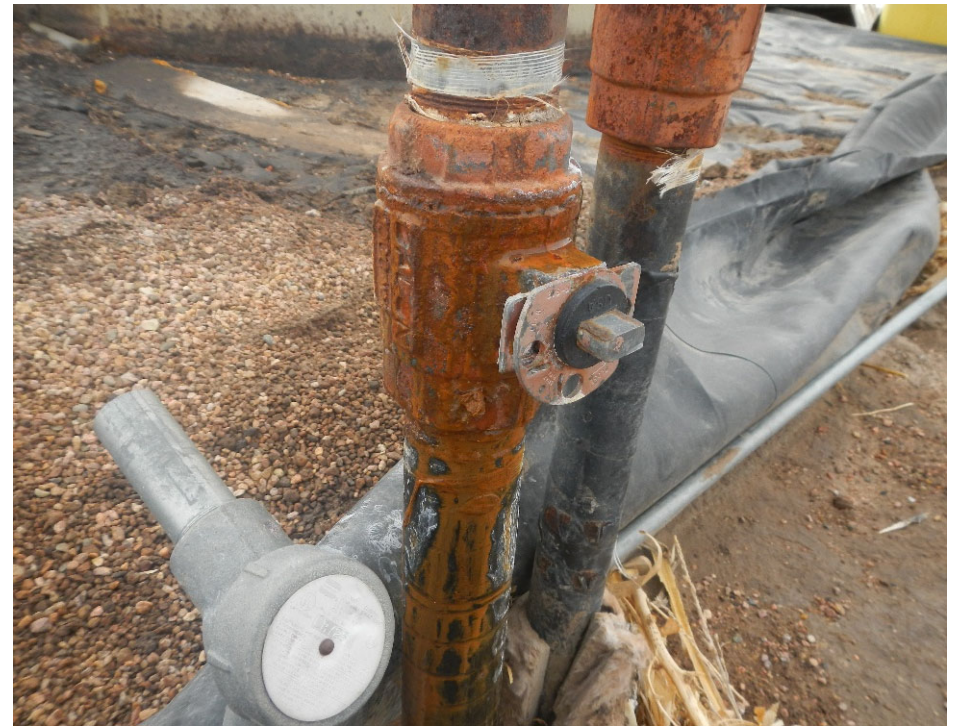
**10. One of two flowline risers leaking from valve body and flowline to valve connection.**

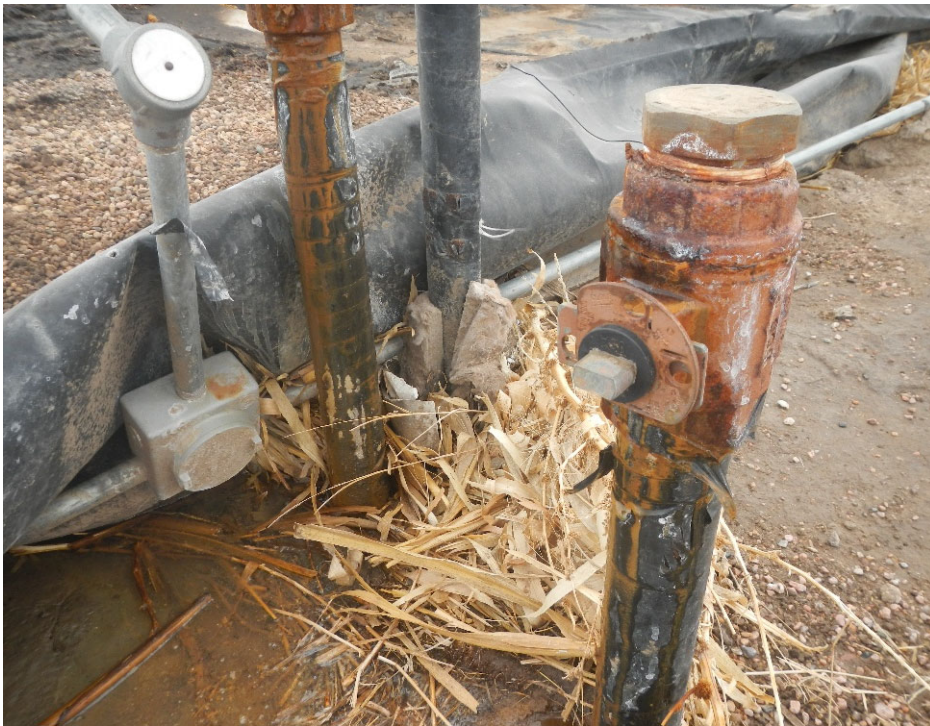
**11. Two of two flowline risers leaking from valve body and flowline to valve connection.**

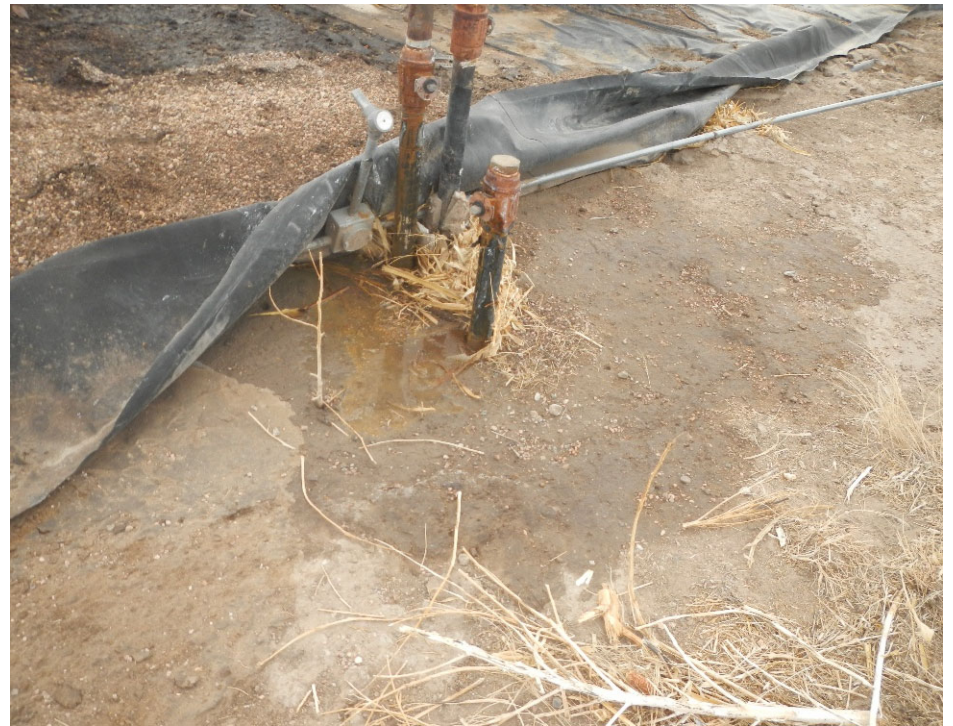
**12. Additional view of impacted area with saturated soil under liner.**
