Inspection Photos for Doc #7211000057

Location Name: Beeman Gladys #2

API # 05-067-09363

Inspector Name: James Blair Inspection Date: 01/09/2026

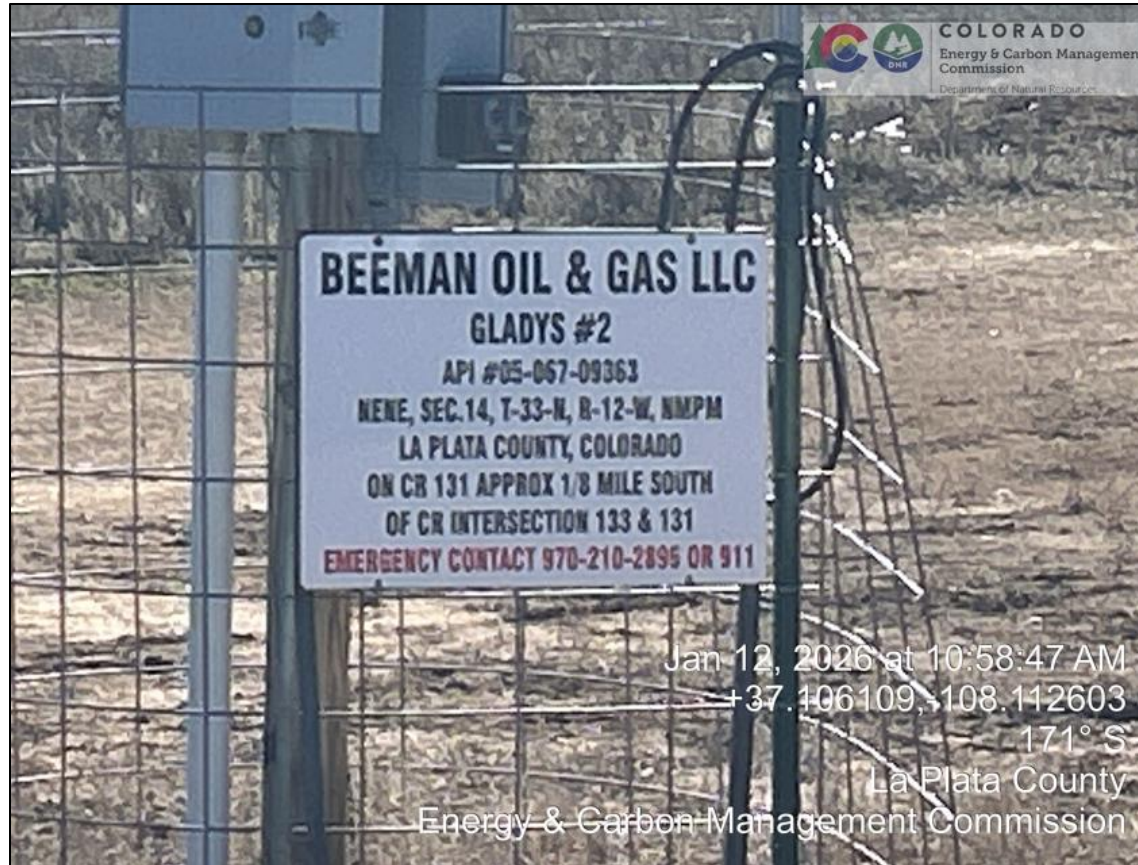
01) Well Sign: Beeman Oil and Gas LLC – Gladys #2 – API #05-067-09363.

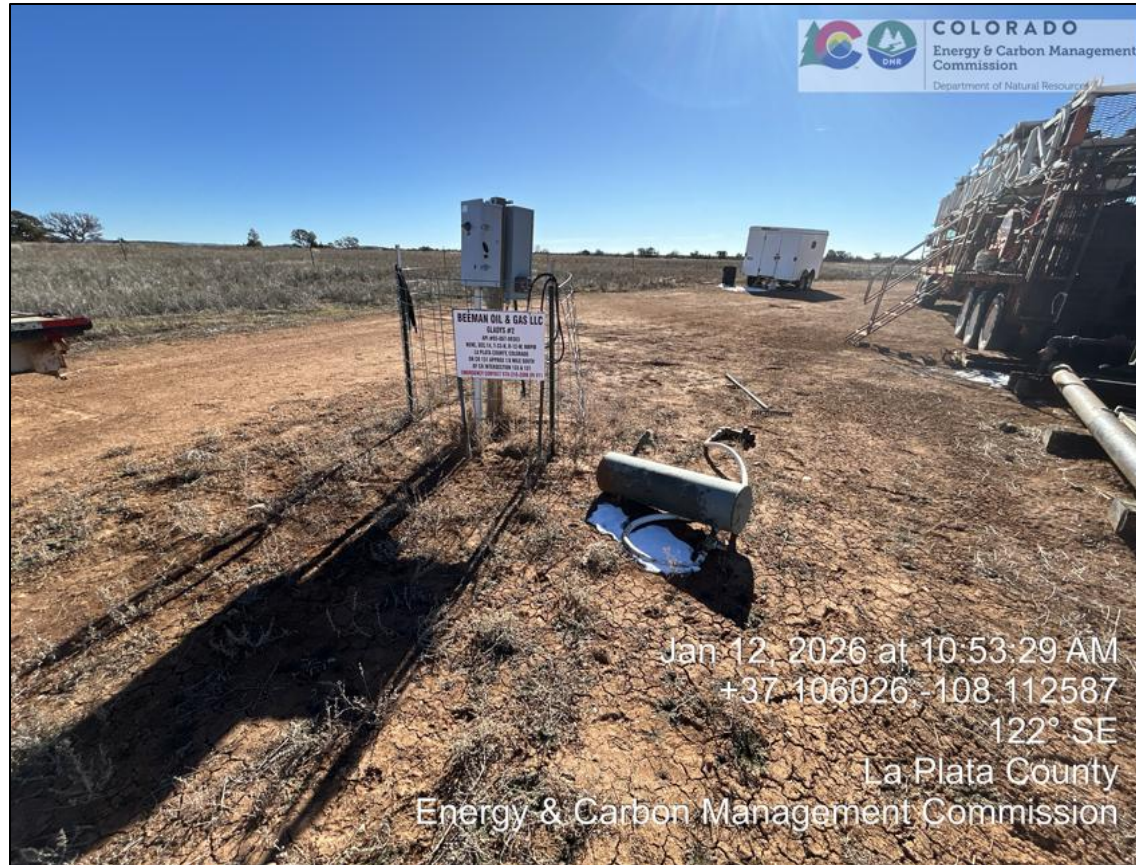
02) Well sign next to electrical control box. Unused, detached dehydrator is on ground. White box trailer and drill rig on right.

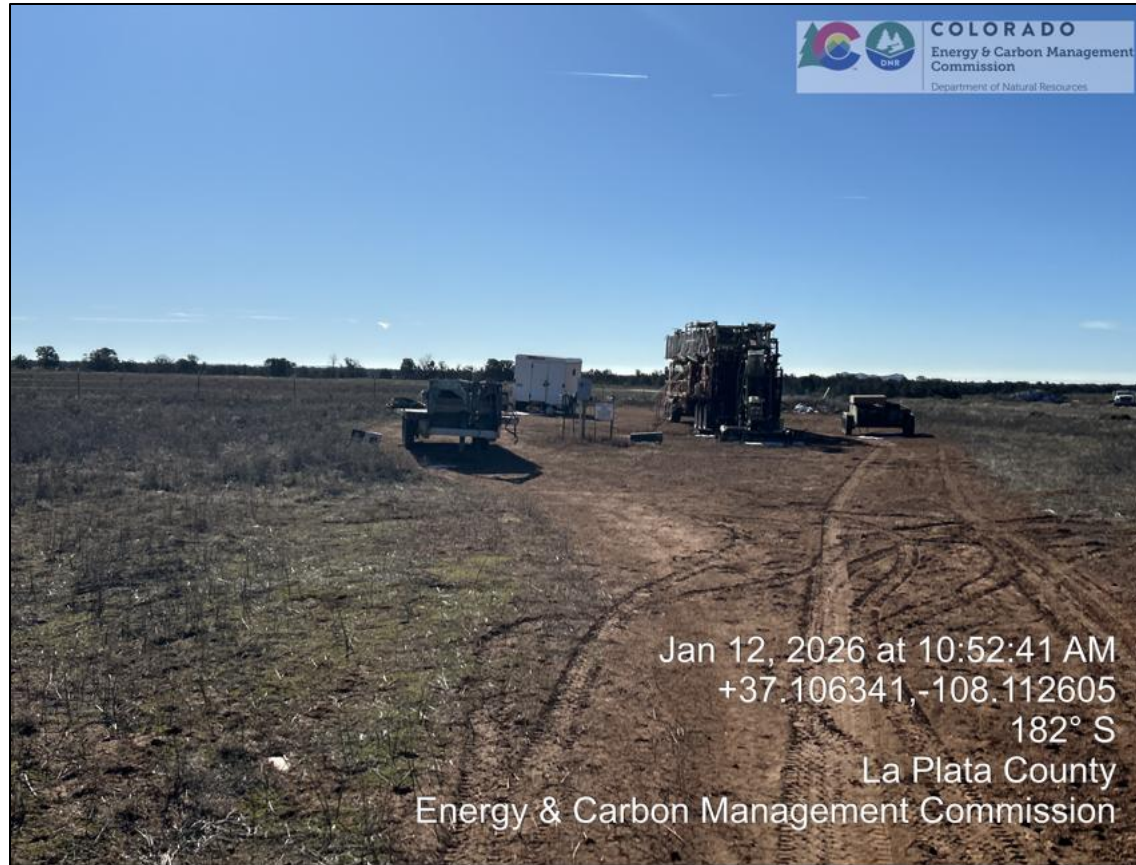
03) Beeman Gladys #2 well site. There is an unnecessary equipment not required for operations, including (left to right) a flat bed utility trailer, a box utility trailer, a drill rig, and an old open-topped trailer filled with what appears to be a mixture of oily E&P waste and meteoric water. View looking south.

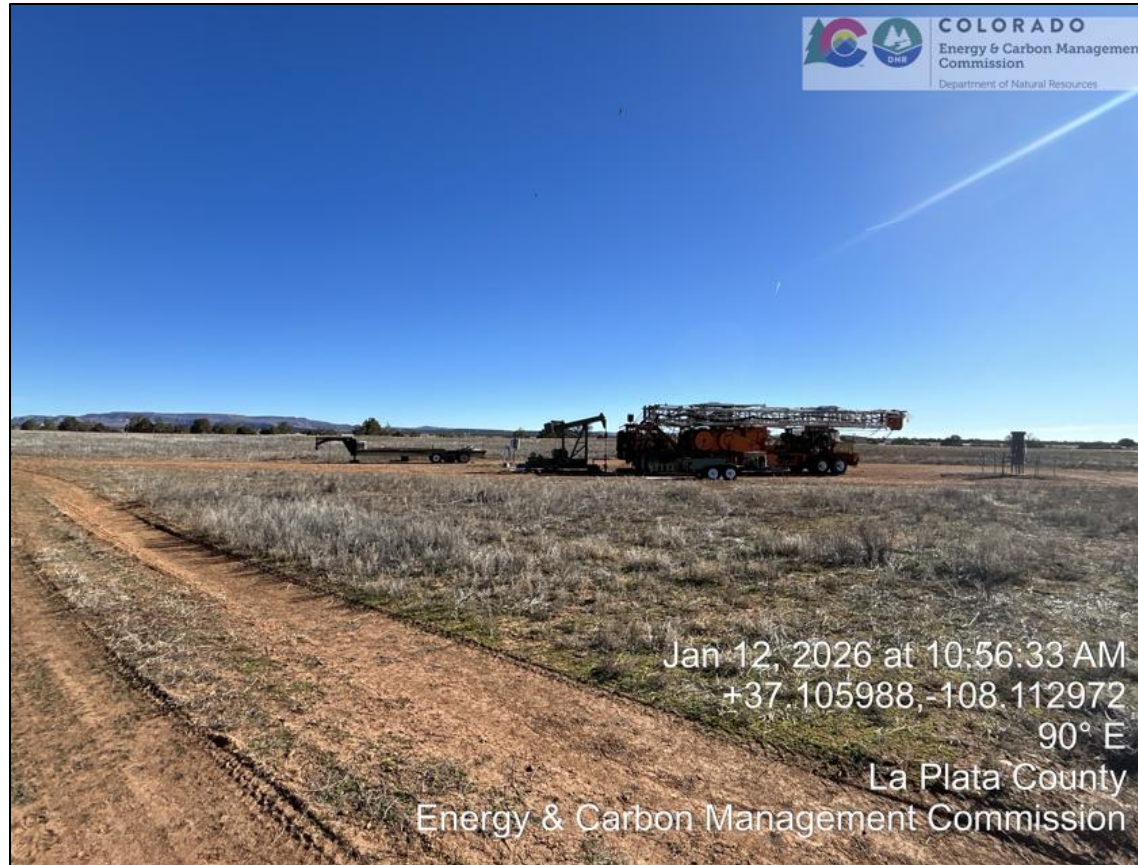
04) Beeman Gladys #2 well site. There is an unnecessary equipment not required for operations, including (left to right) a pipe/equipment trailer, a box utility trailer, and an old open-topped trailer filled with what appears to be a mixture of oily E&P waste and meteoric water. View looking east. The pump jack and gas combuster are also present.

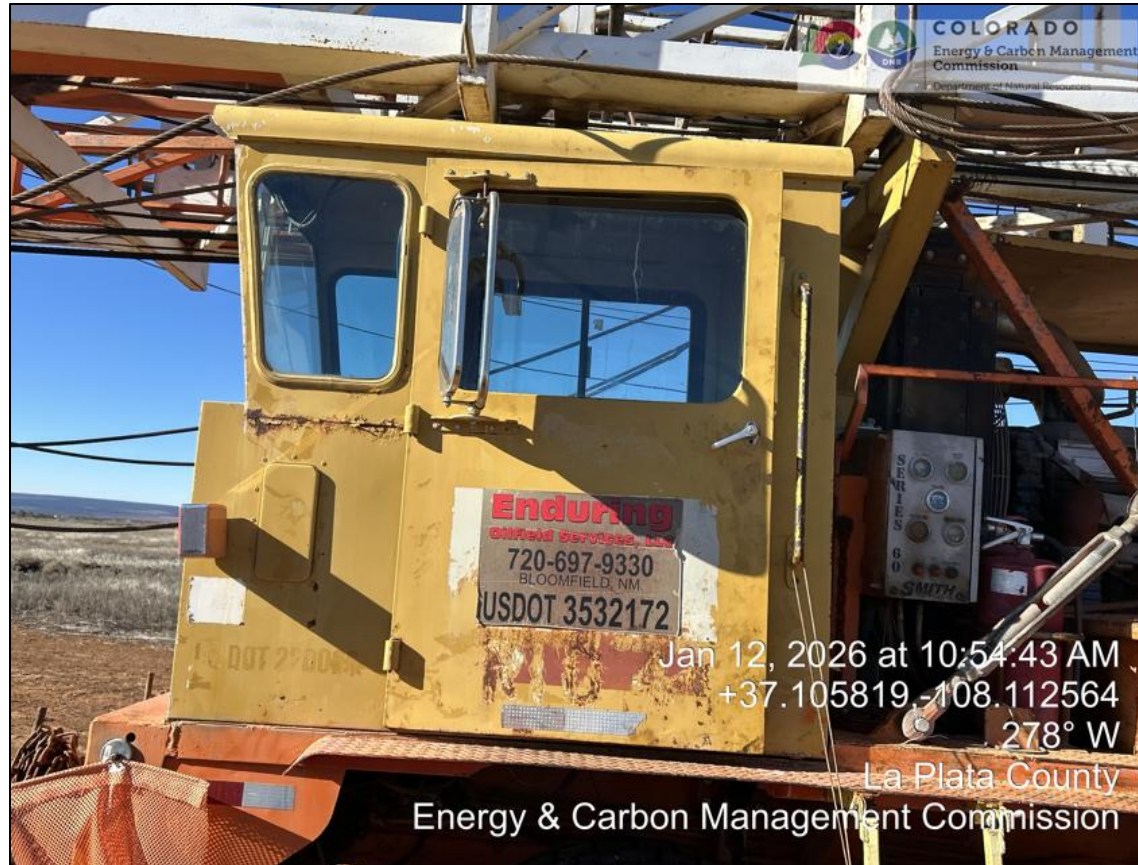
05) Sign on drill rig: “Enduring Oilfield Services, LLC. 720-697-9330 Bloomfield, NM USDOT 3532172.”

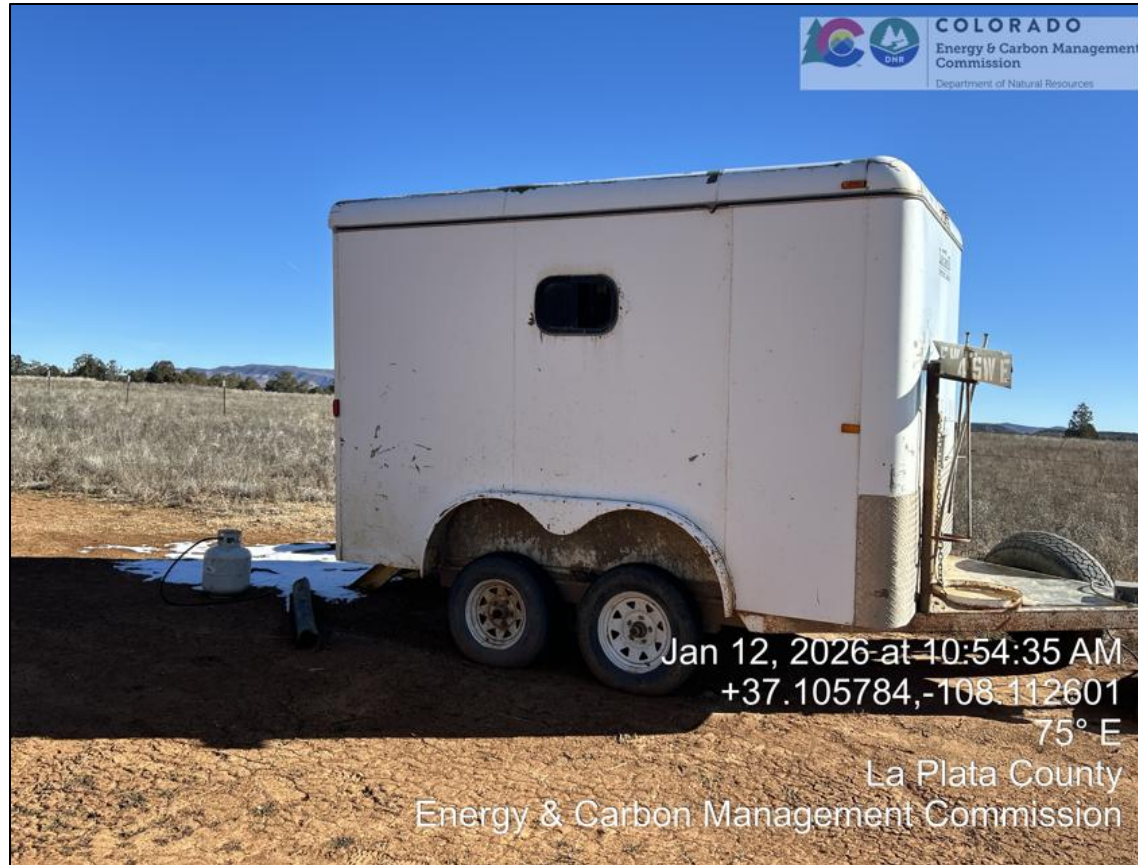
06) Box utility trailer and propane tank are not needed for operations and are being stored on site.

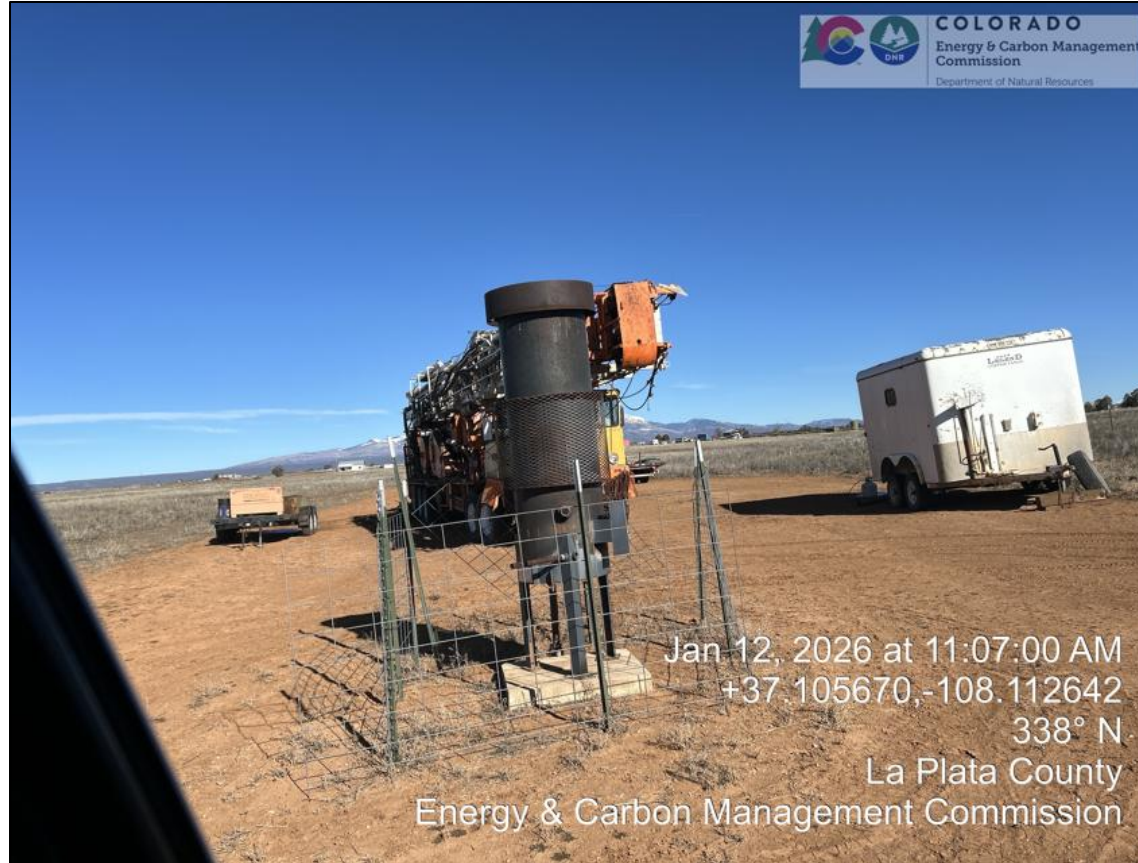
07) Combustor for Gladys 2 in front center of photo

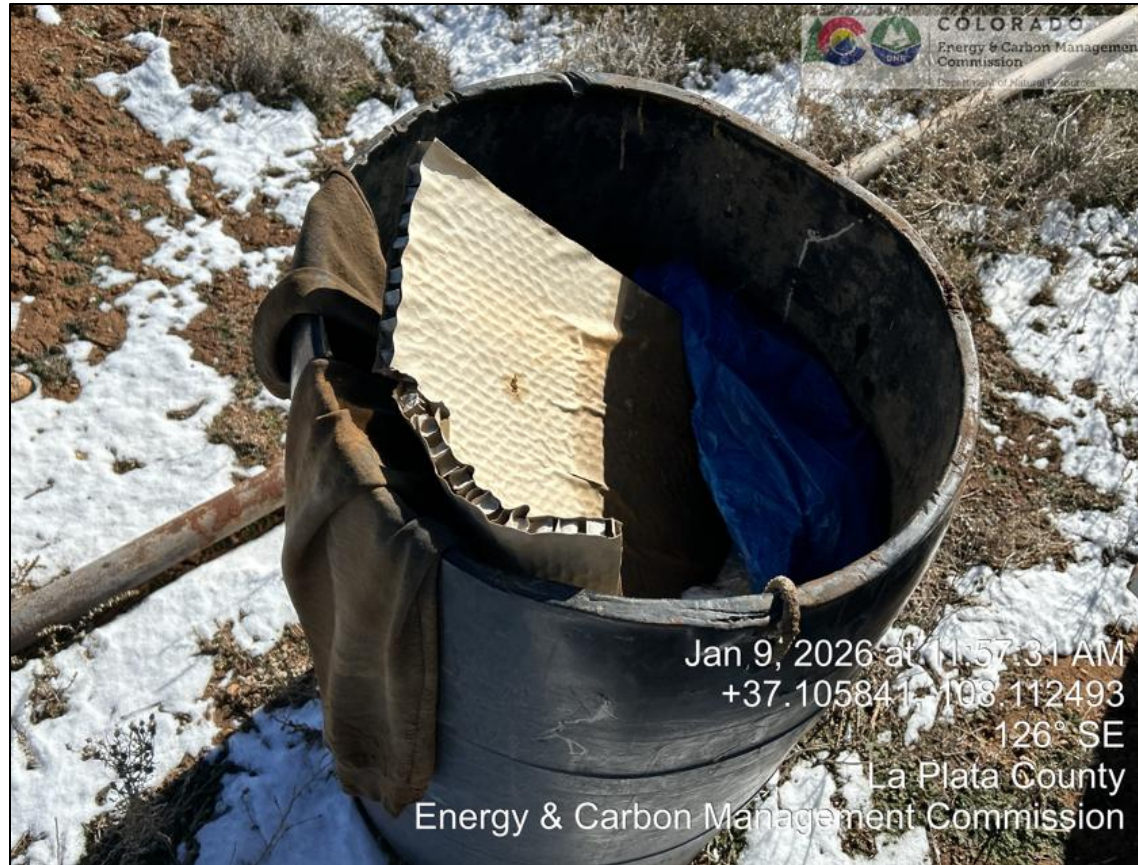
08) Oily rags and trash in plastic barrel with no lid. Fire hazard.

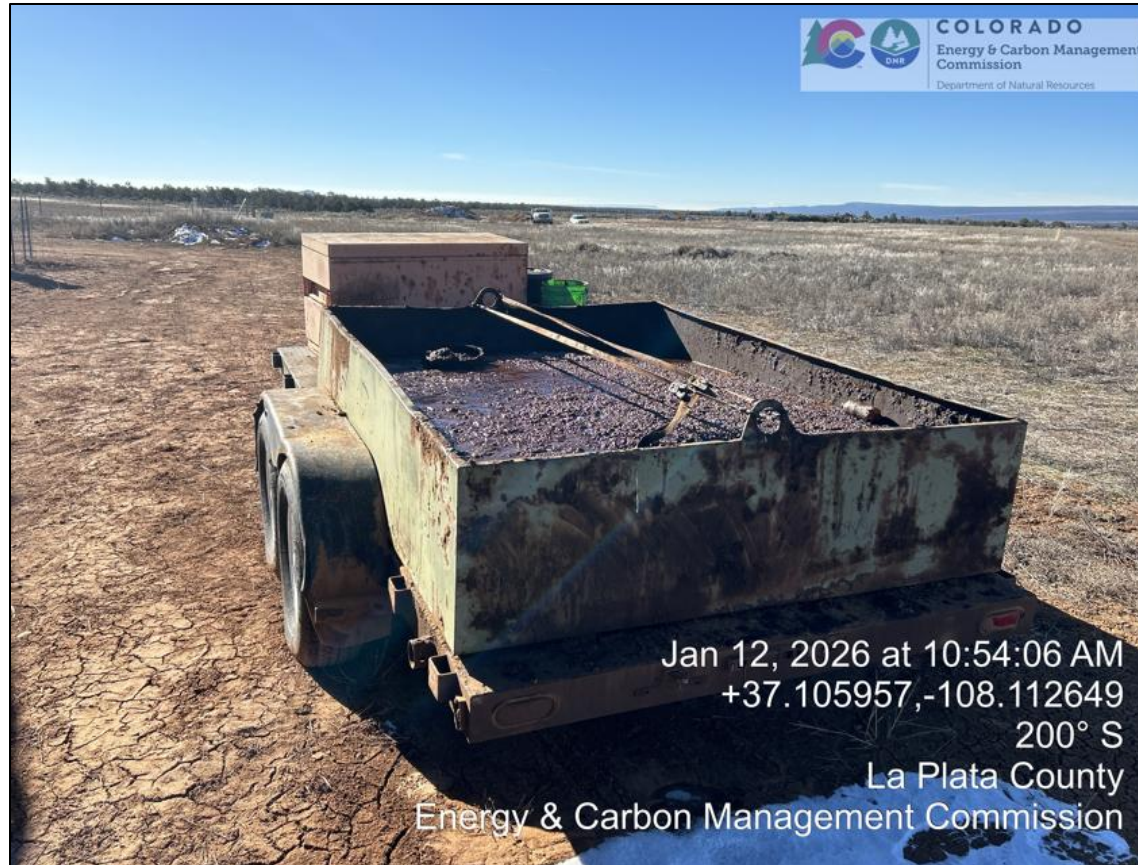
09) Oily E&P waste is being stored on site in open-topped trailer with no secondary containment. This trailer, and all of the waste on it will need to be moved off site. Waste must be disposed of properly.

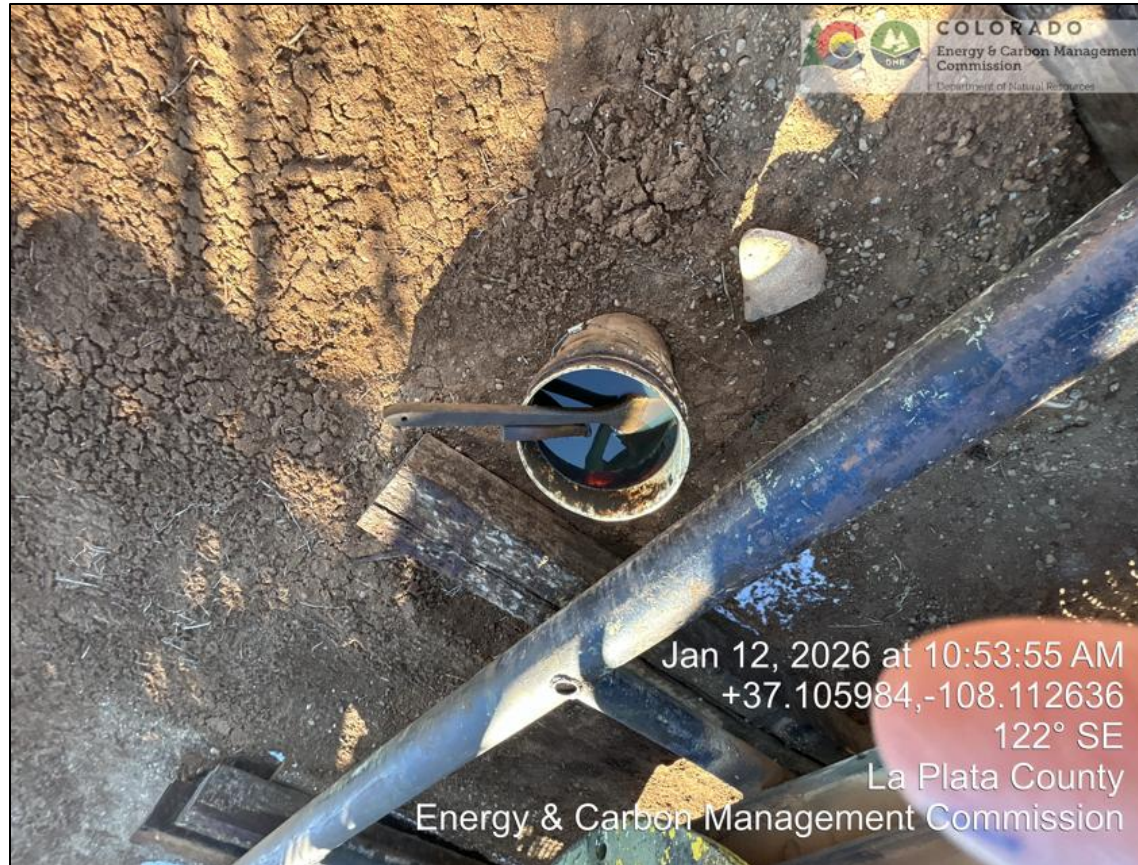
10) Oily waste and meteoric water inside 5 gallon bucked left on ground outside of any containment, no lid.

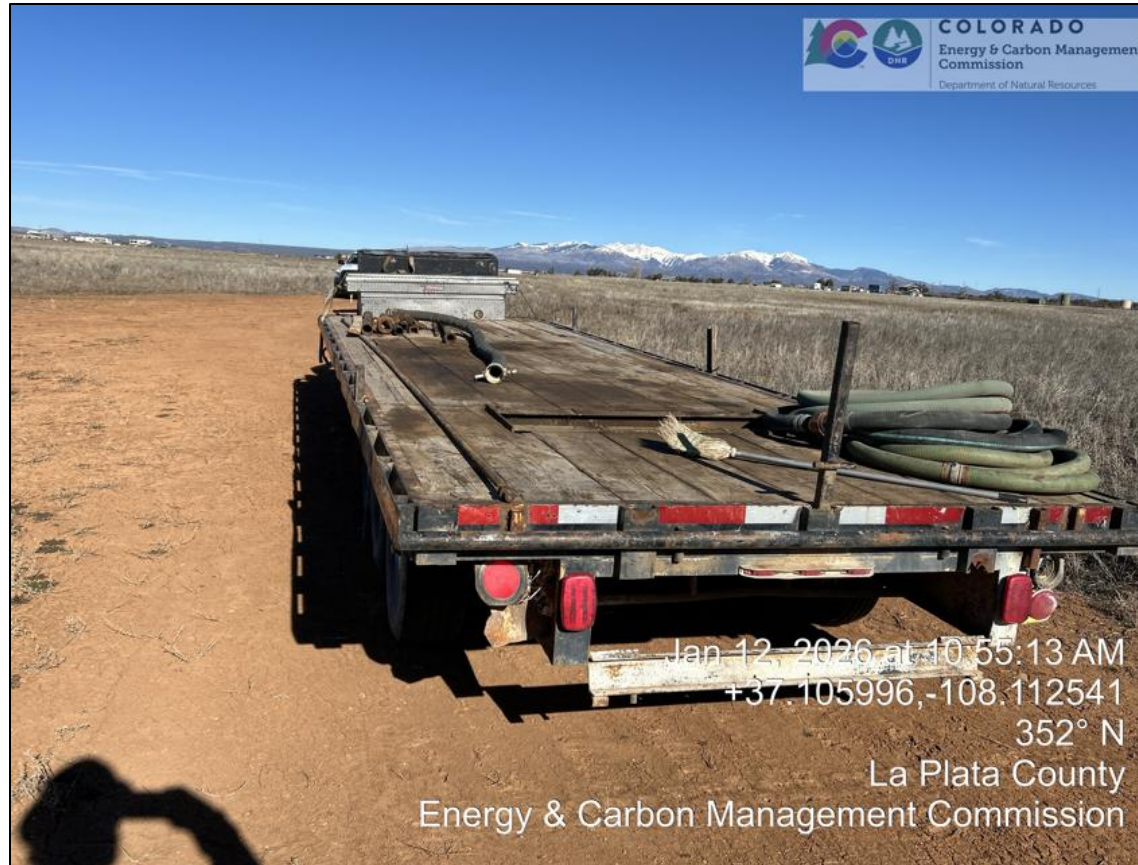
11) Flat bed utility trailer.
