Final Reclamation Inspection

Operator: Kerr McGee Oil & Gas Onshore - 47120

Location ID: 332613

Location Name: Morning 24-10 and Morning 25-10

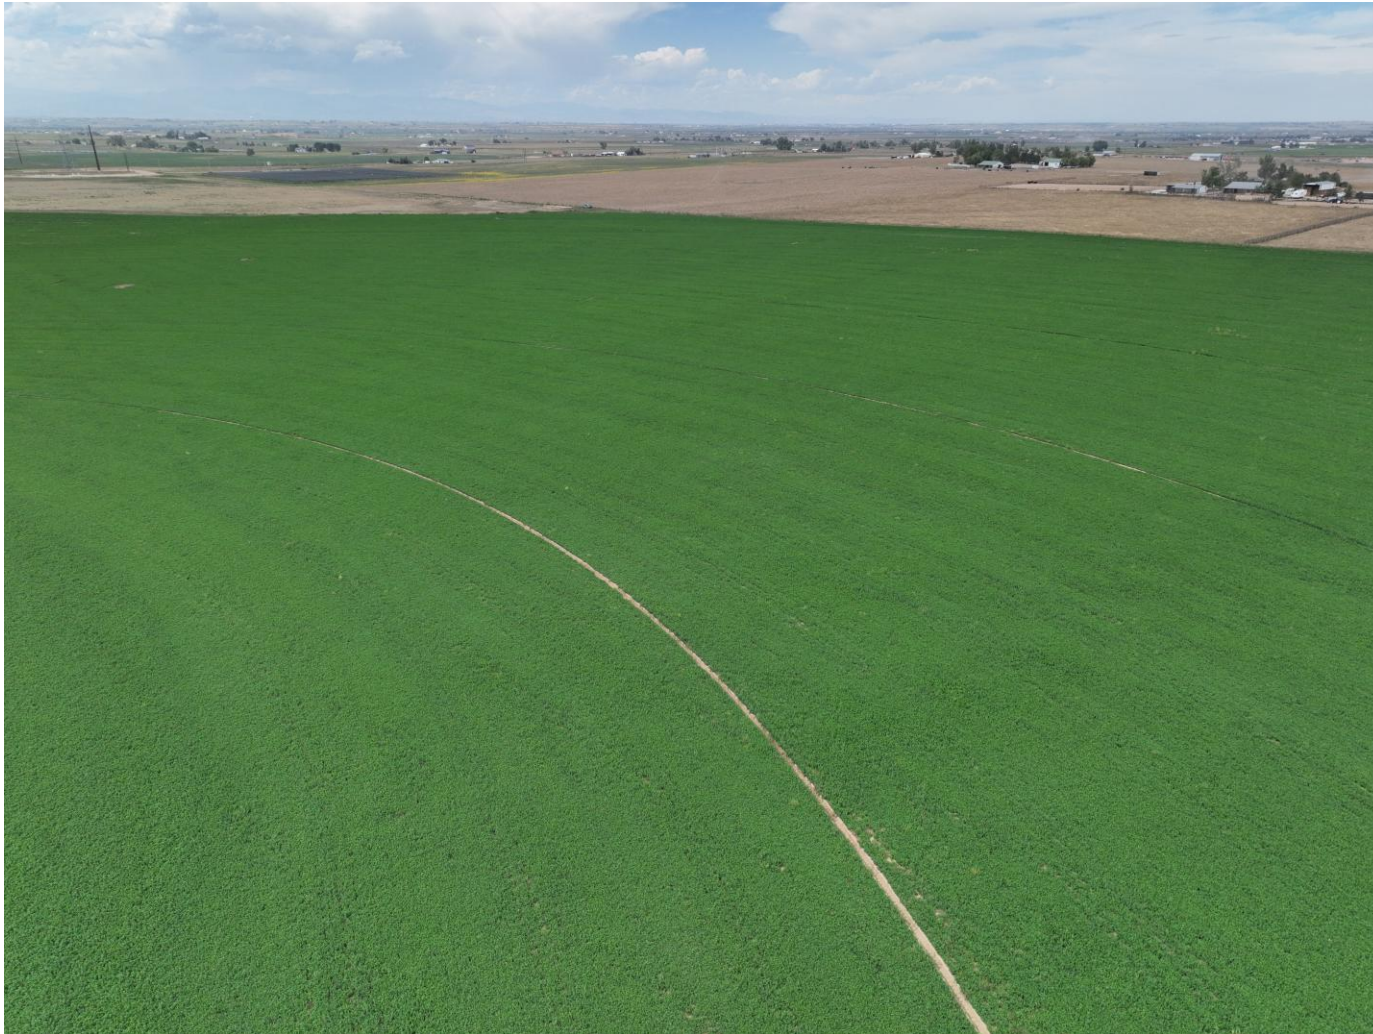
Photo 3. Drone aerial imagery taken south of well locations, facing north (displaying the wells and access road). Crop vegetation at the well pad and access road appears consistent with adjacent reference areas.

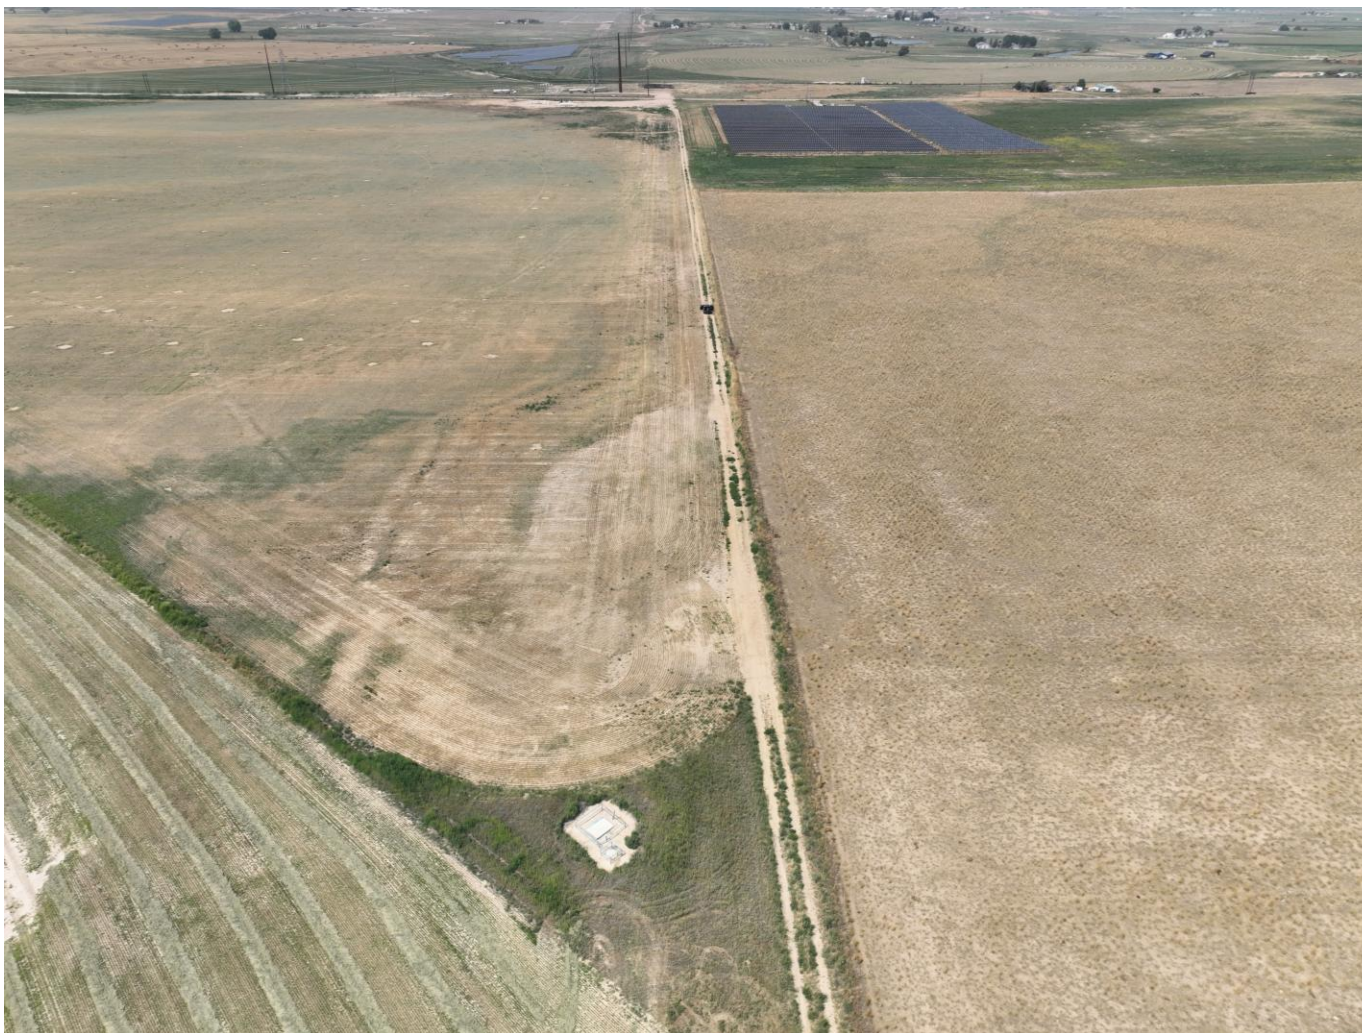
Photo 13. Drone aerial imagery taken east of the tank battery location, facing west (displaying the TB). Note: tank battery falls in a corner crop area with was recently harvested.
