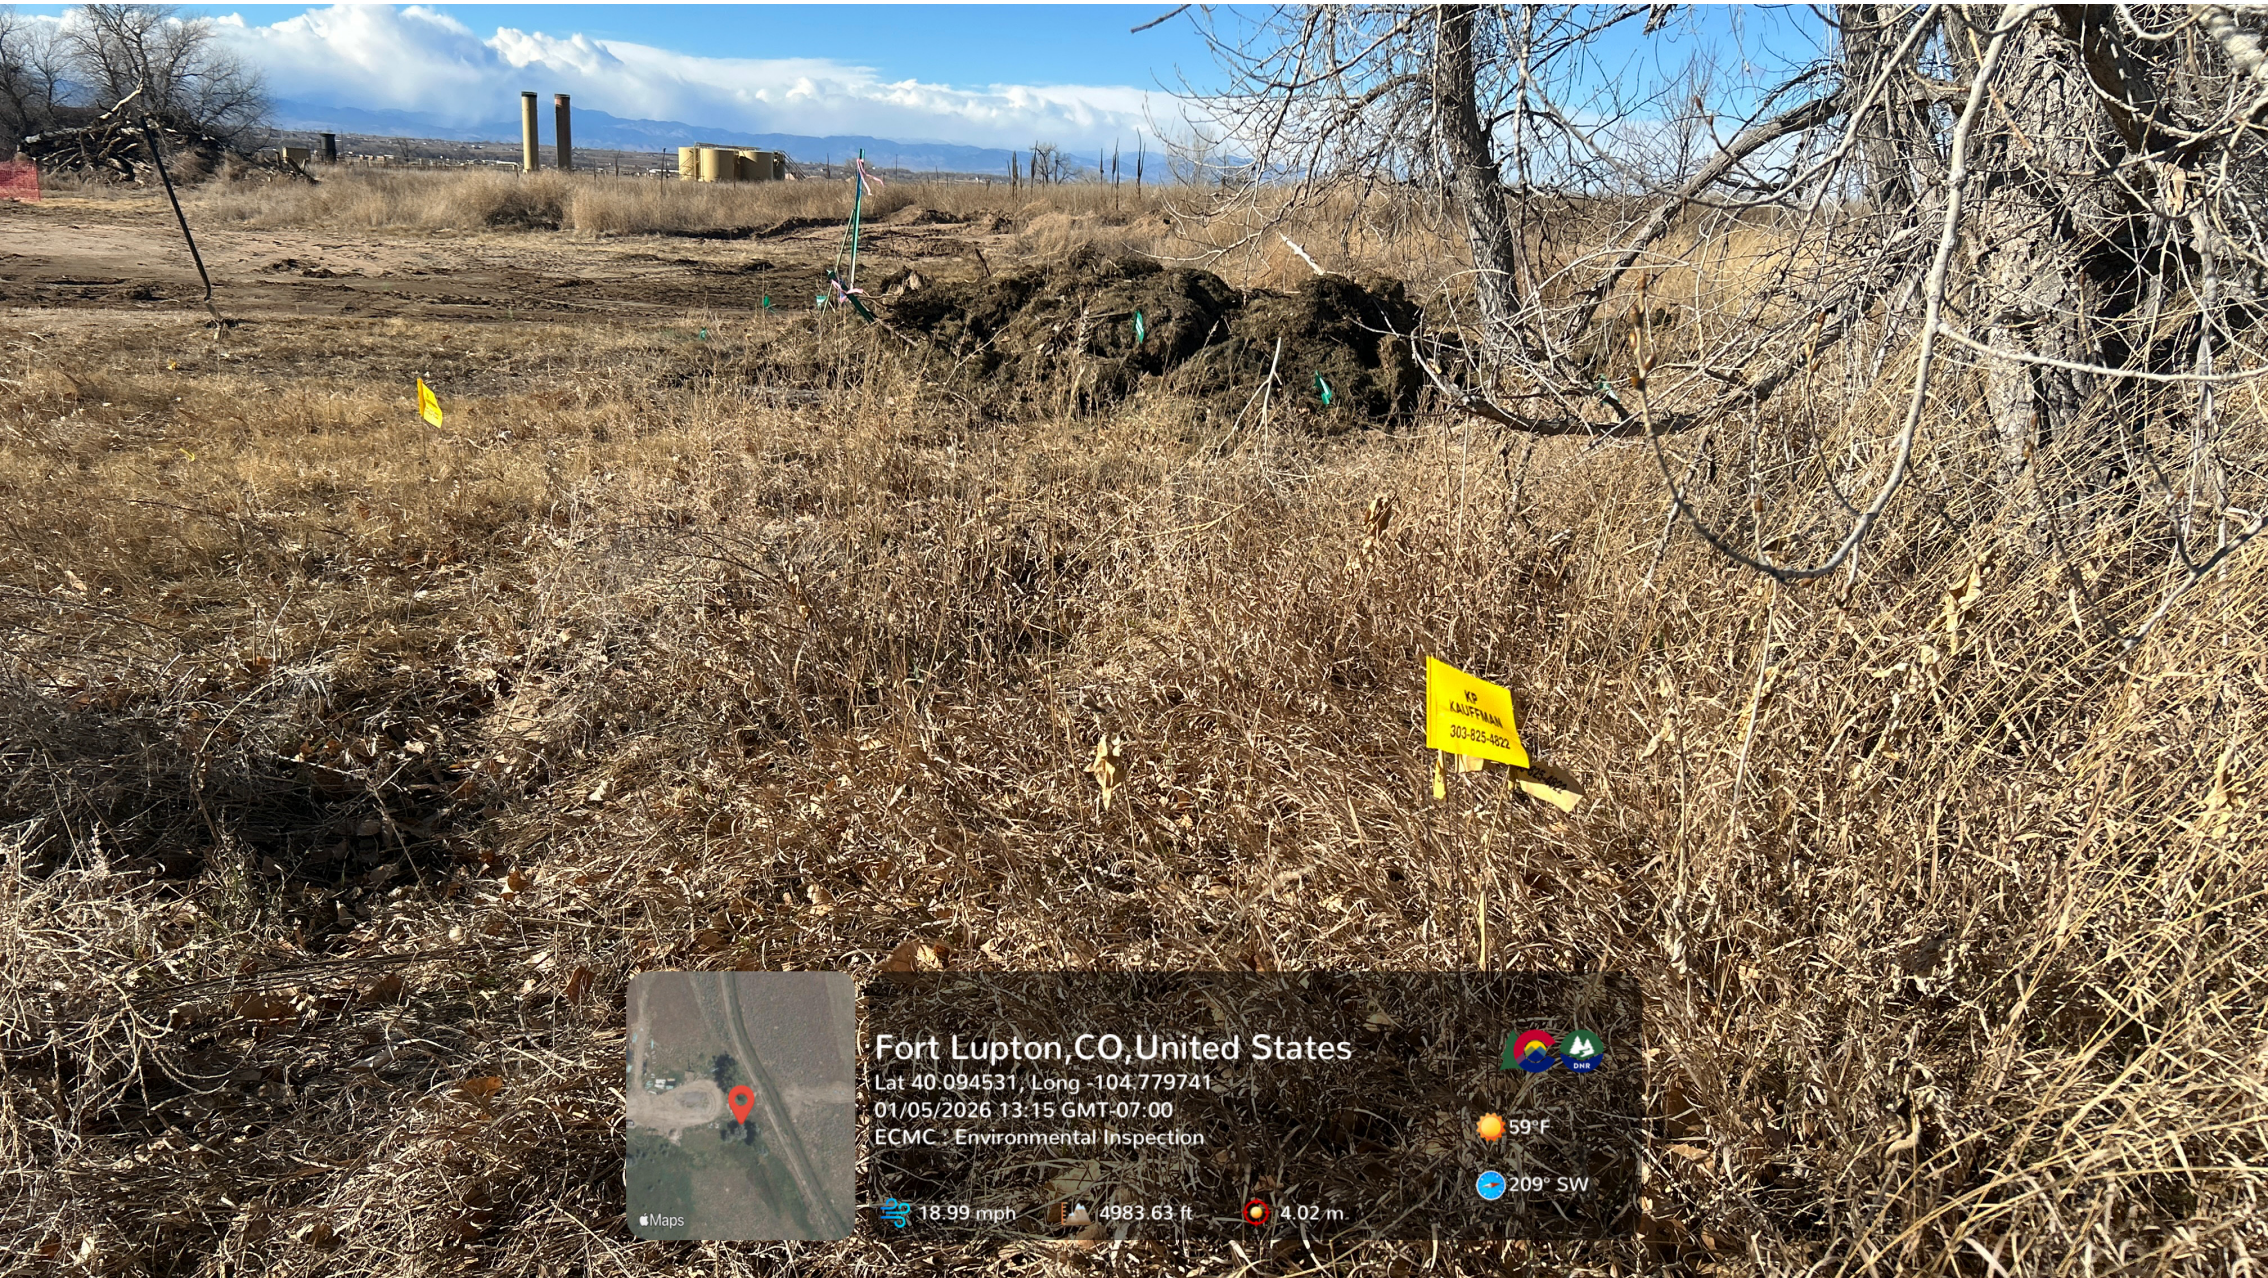
Looking at the eastern extent of visible surficial impacts to soil. A strong petroleum hydrocarbon odor was observed throughout the spill area. A strong petroleum hydrocarbon odor was observed throughout the spill area. Some soil appears to have been scraped, however, stained soil remains visible in situ.

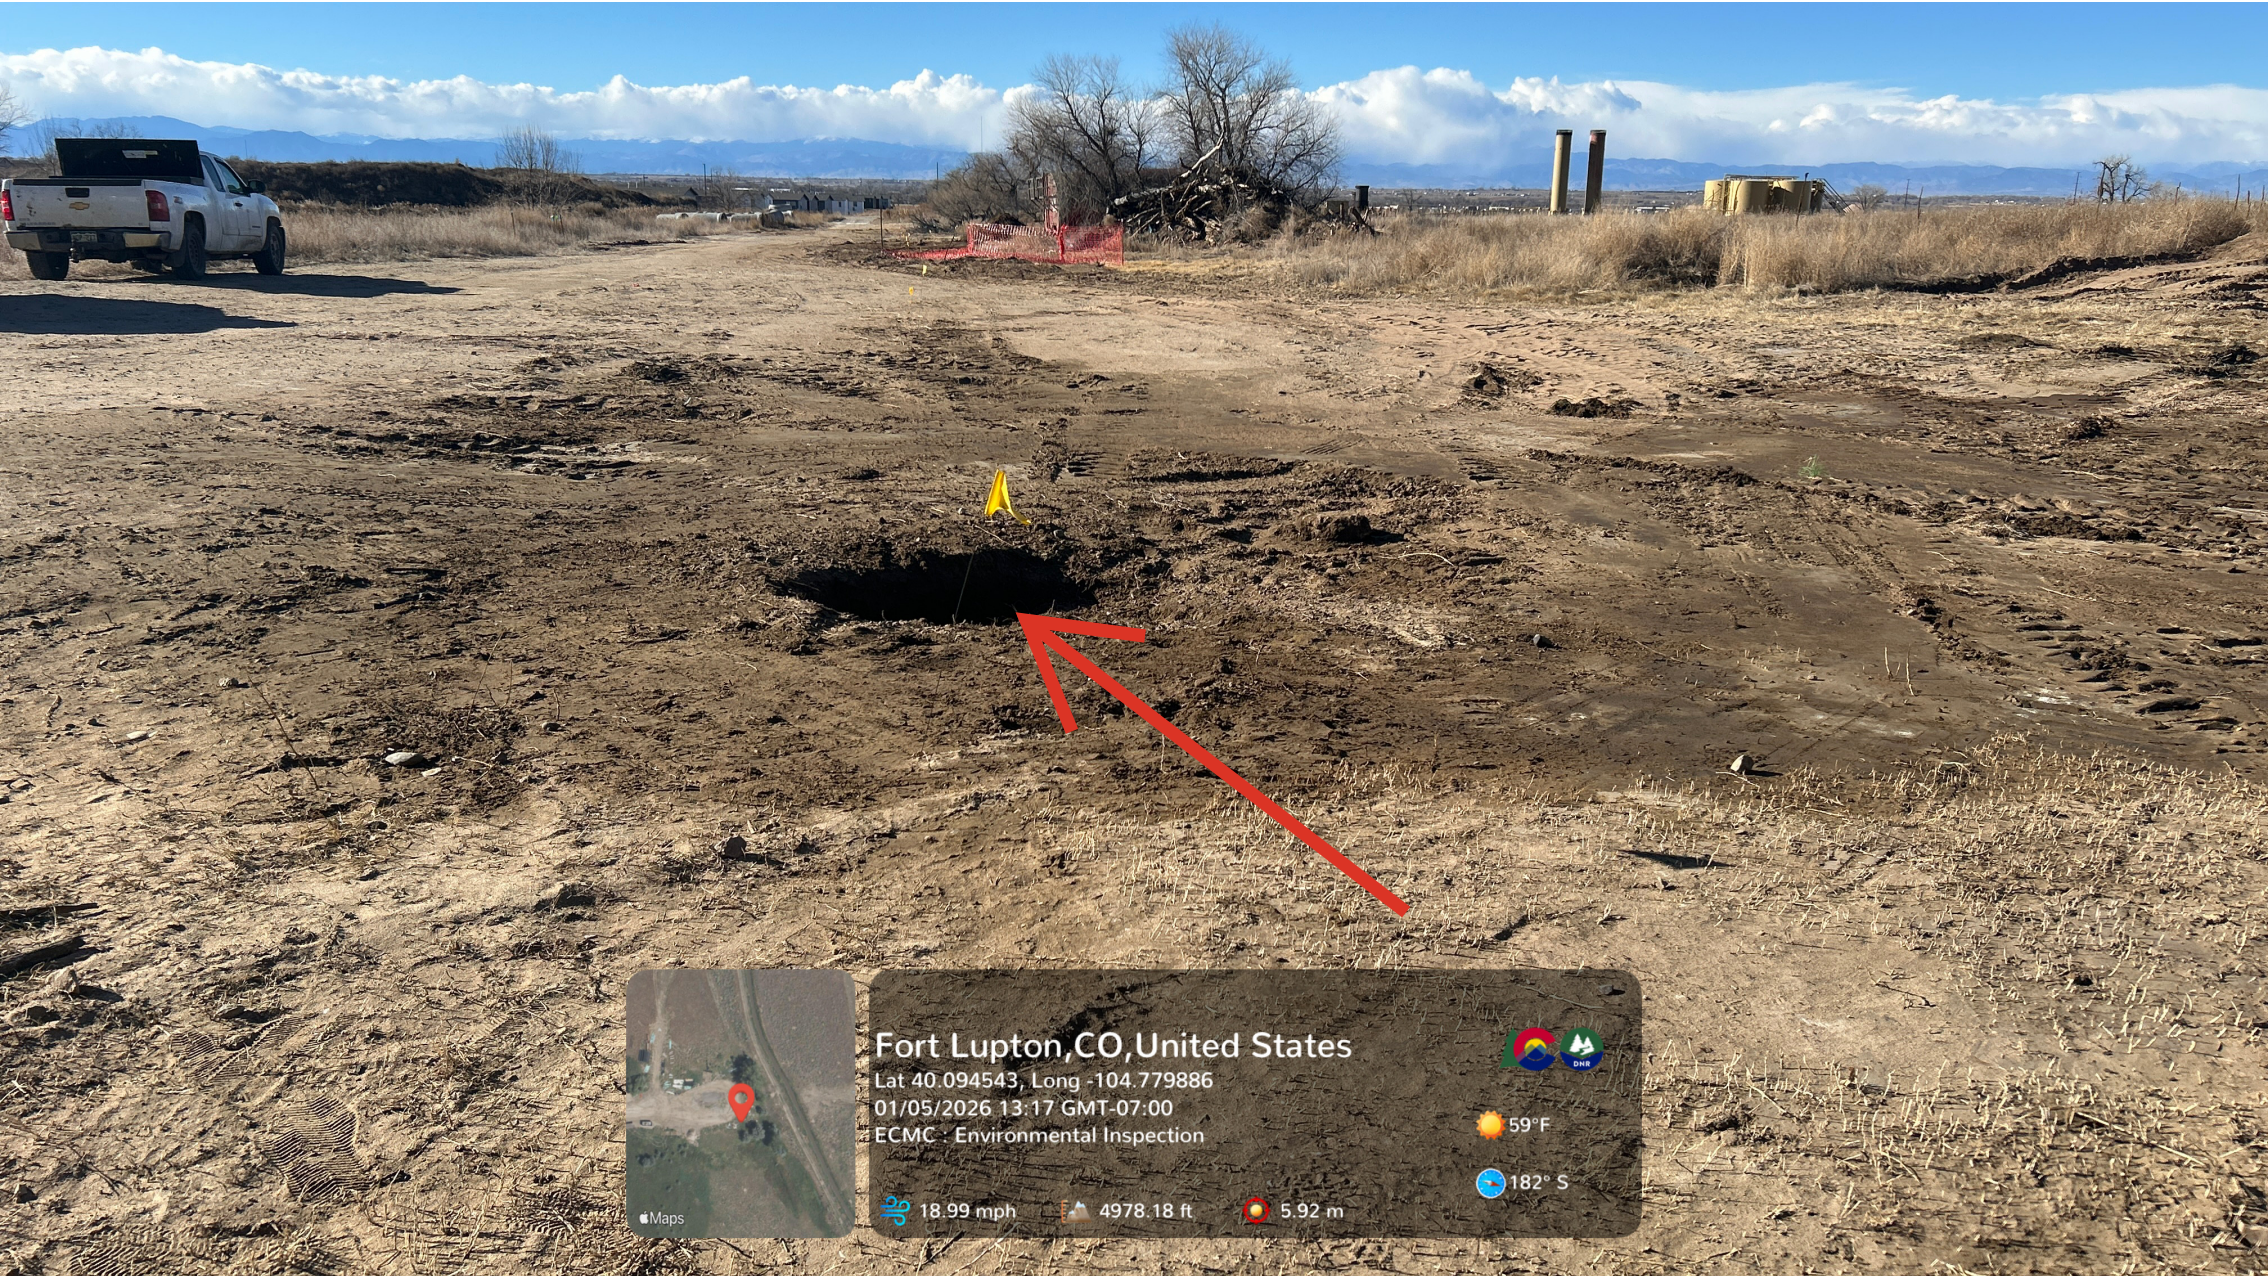
Looking at the origin point of Spill/Release Point ID 492701. A hole is visible at the eastern extent of surficial stained soil. Operator personnel report that the hole is the point at which fluid was observed daylighting from the subsurface and that this fluid then flowed primarily west on the ground surface. Some soil appears to have been scraped, however, stained soil is visible on the surface.

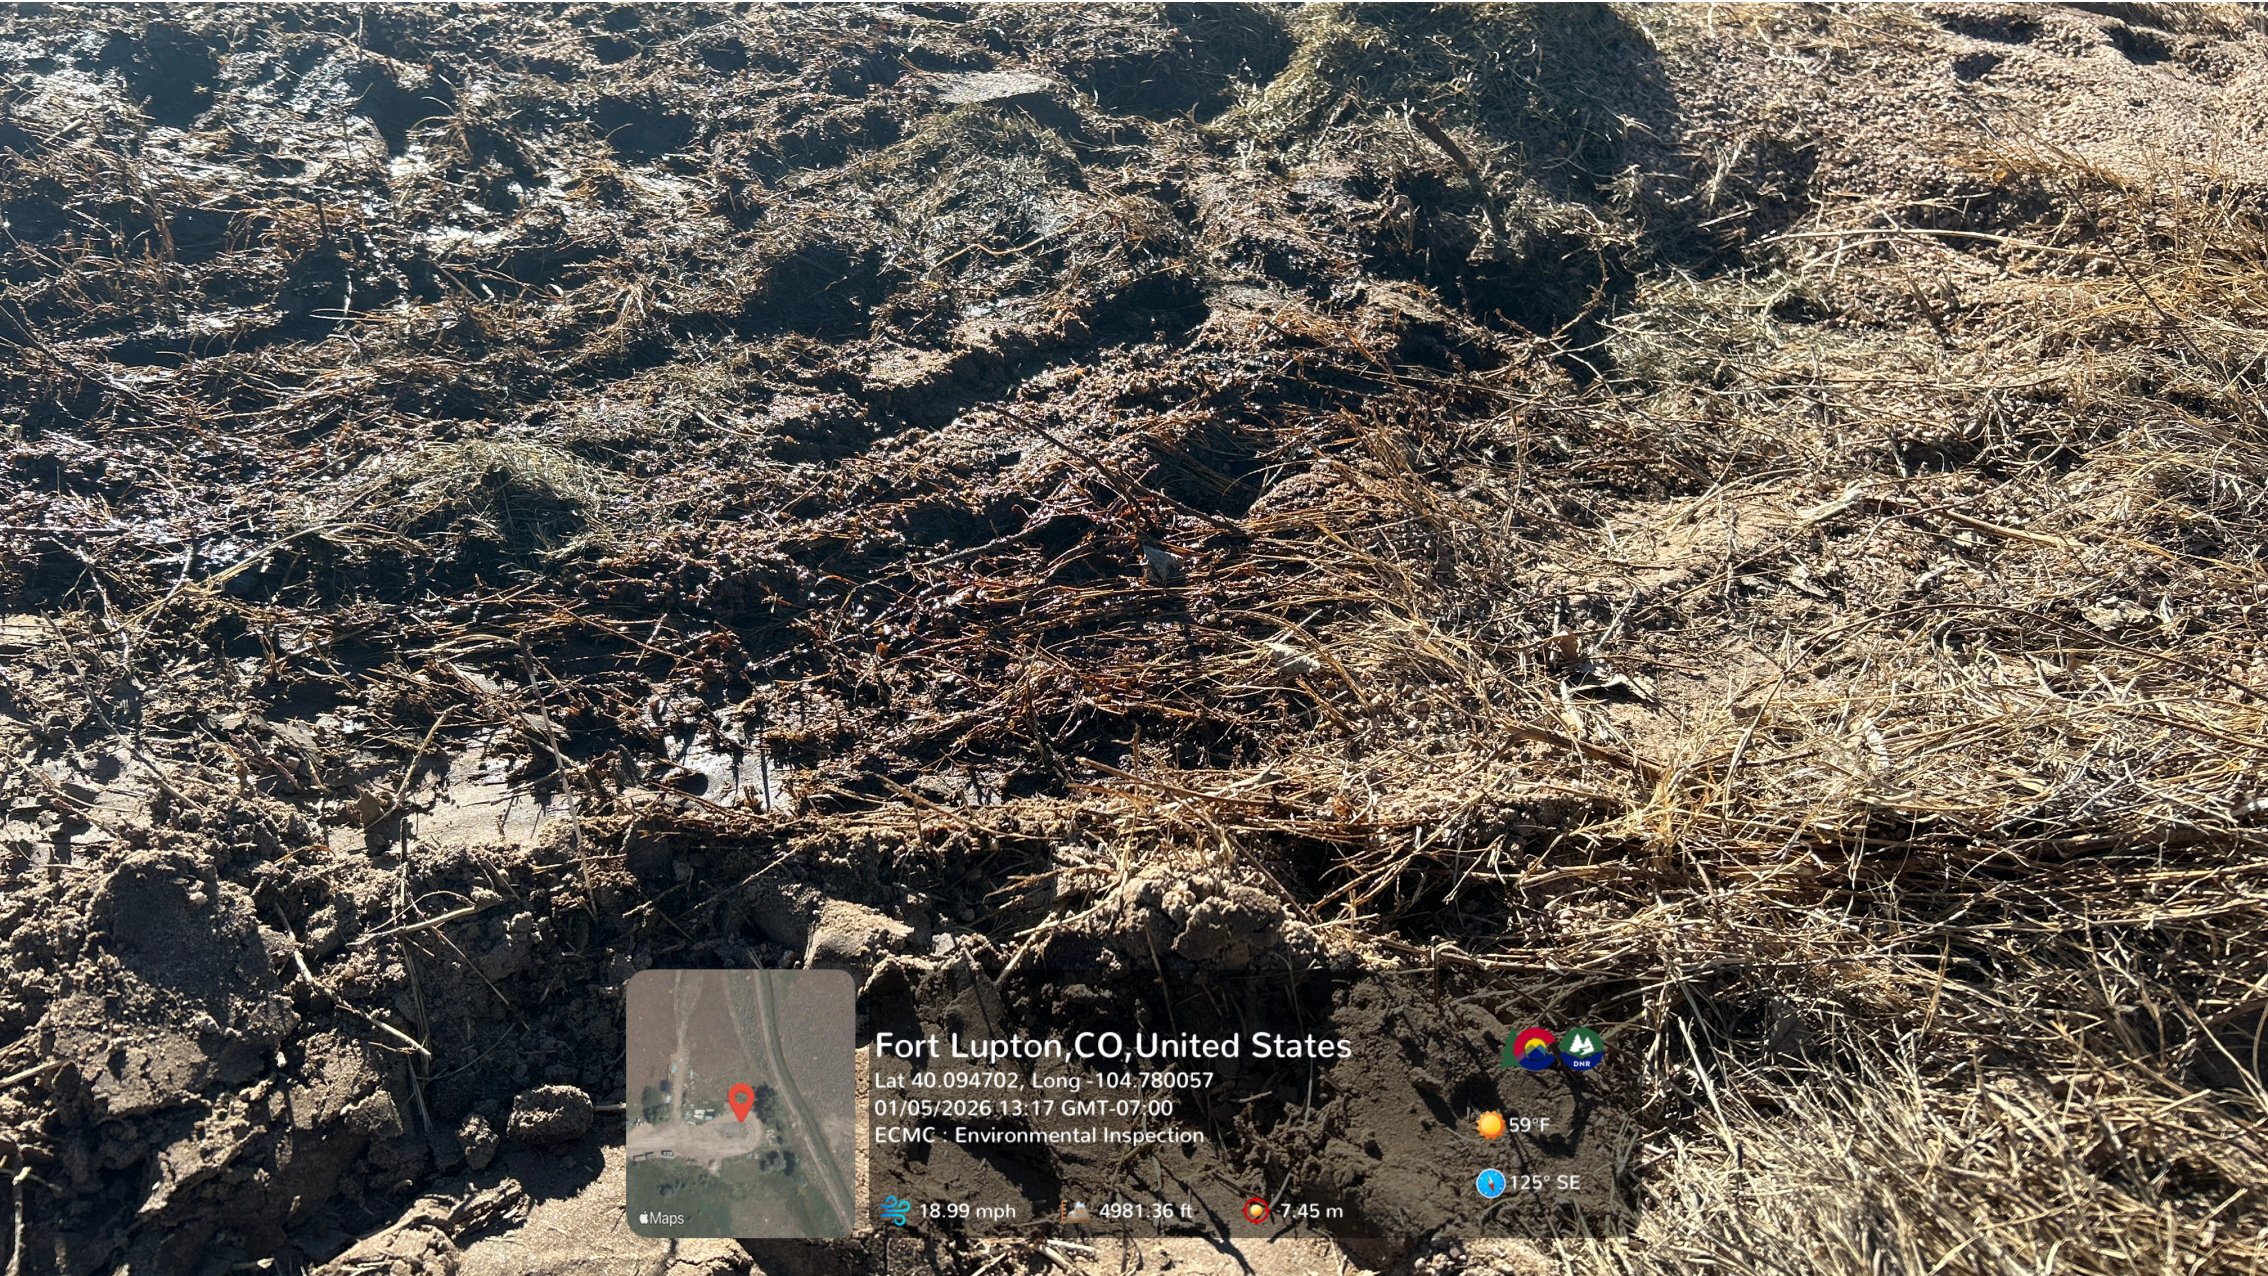
Petroleum hydrocarbon fluid saturated soil and vegetation are visible along the spill location.

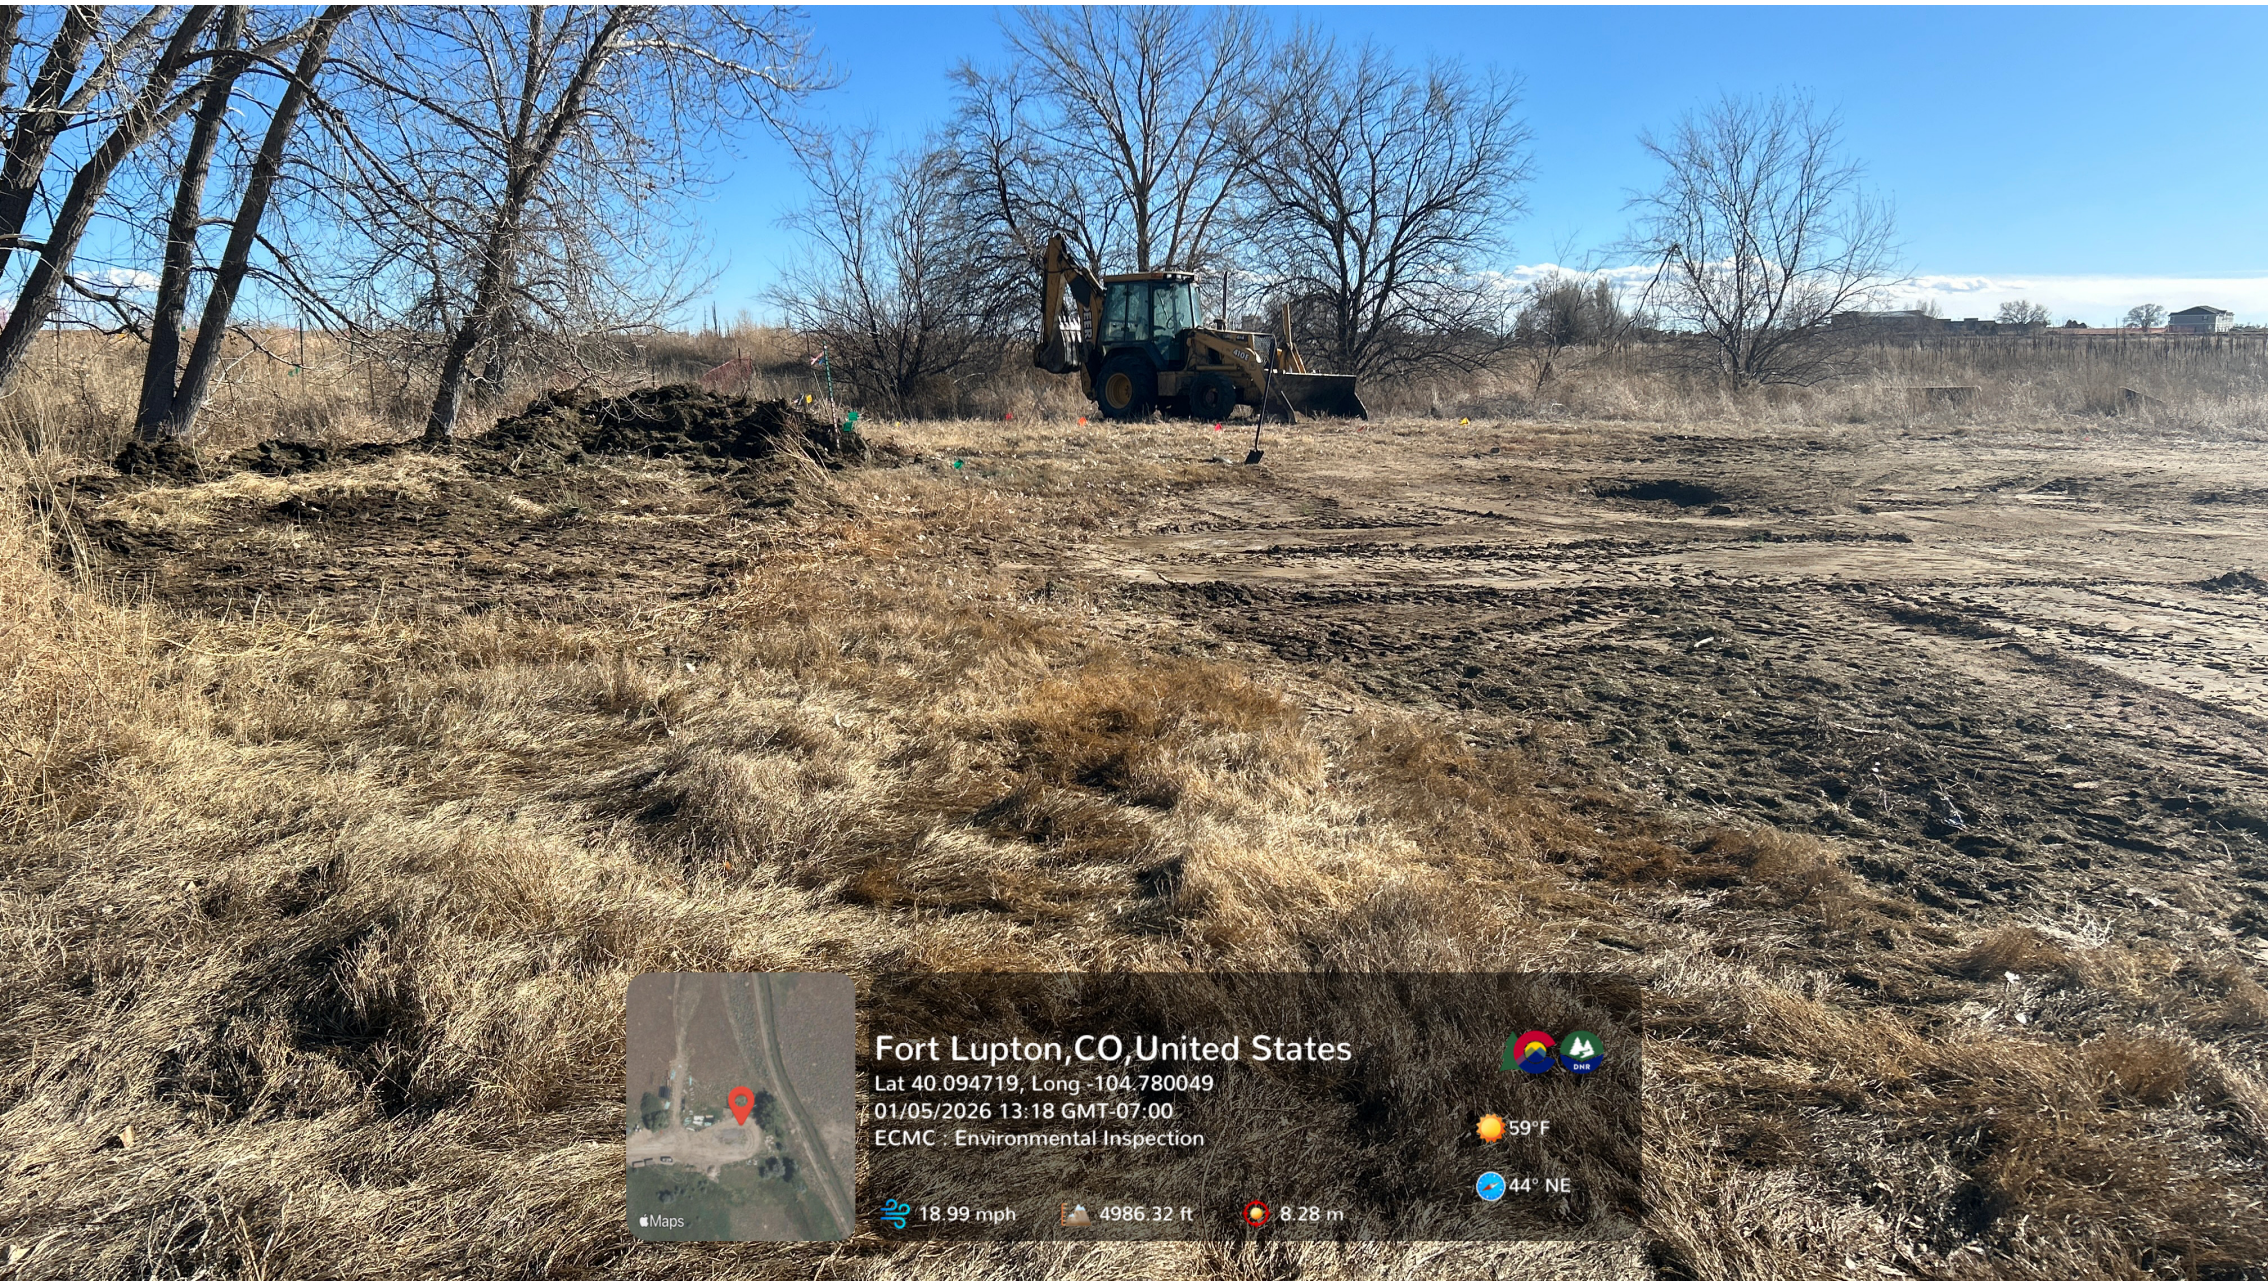
Looking east at the point at which fluid was observed daylighting from the subsurface.

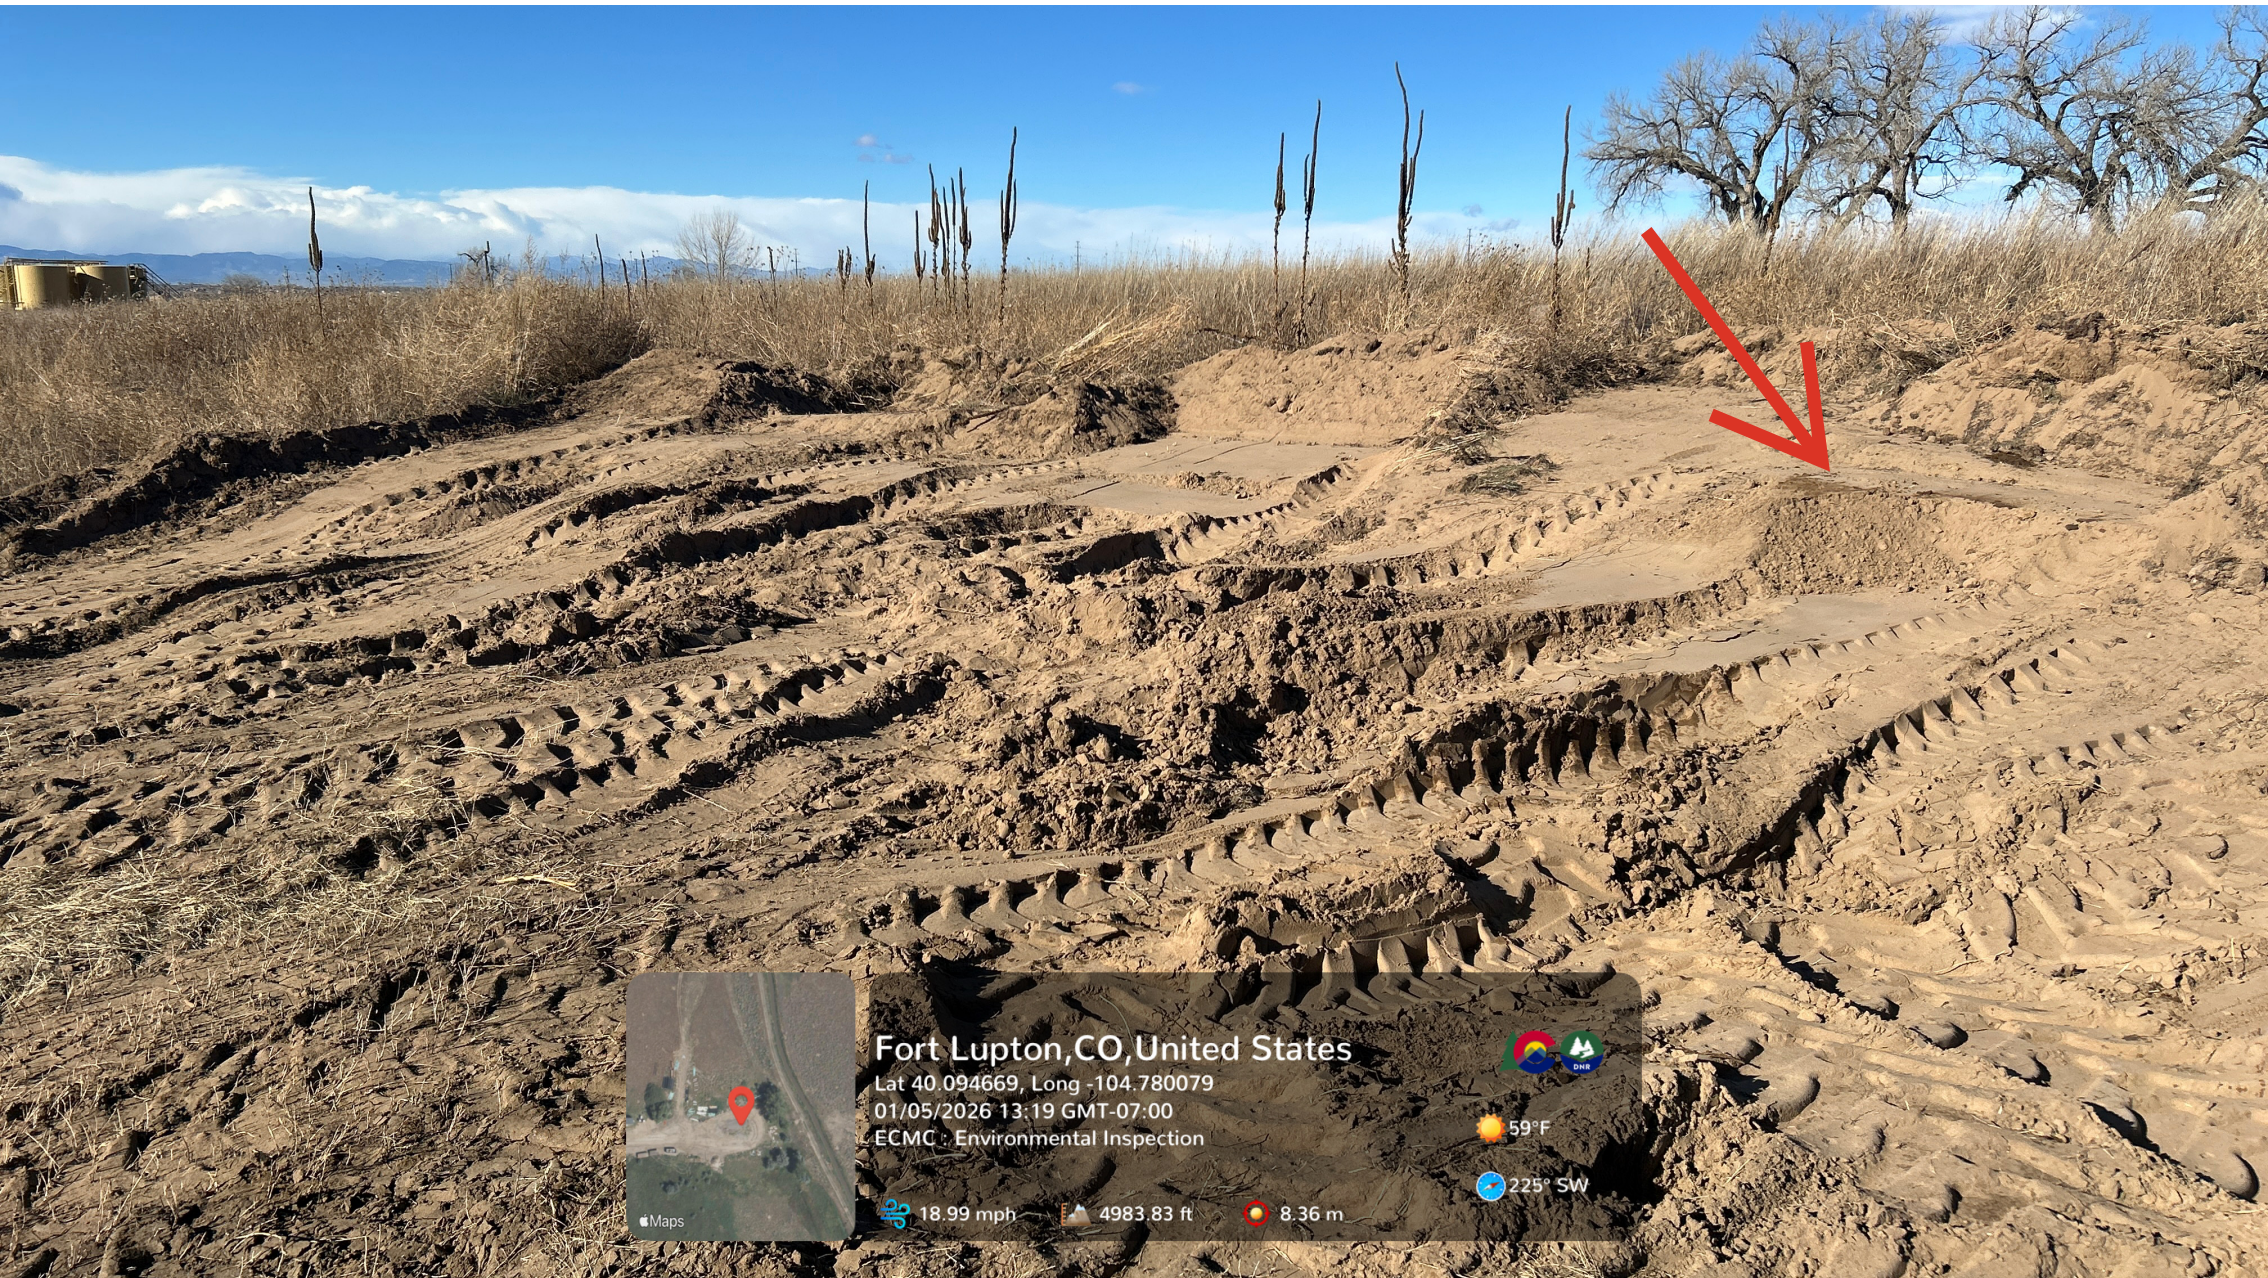
An area of scraped soil is visible at the northern edge of the spill location. Localized areas of stained soil are visible adjacent to vehicular tracks.

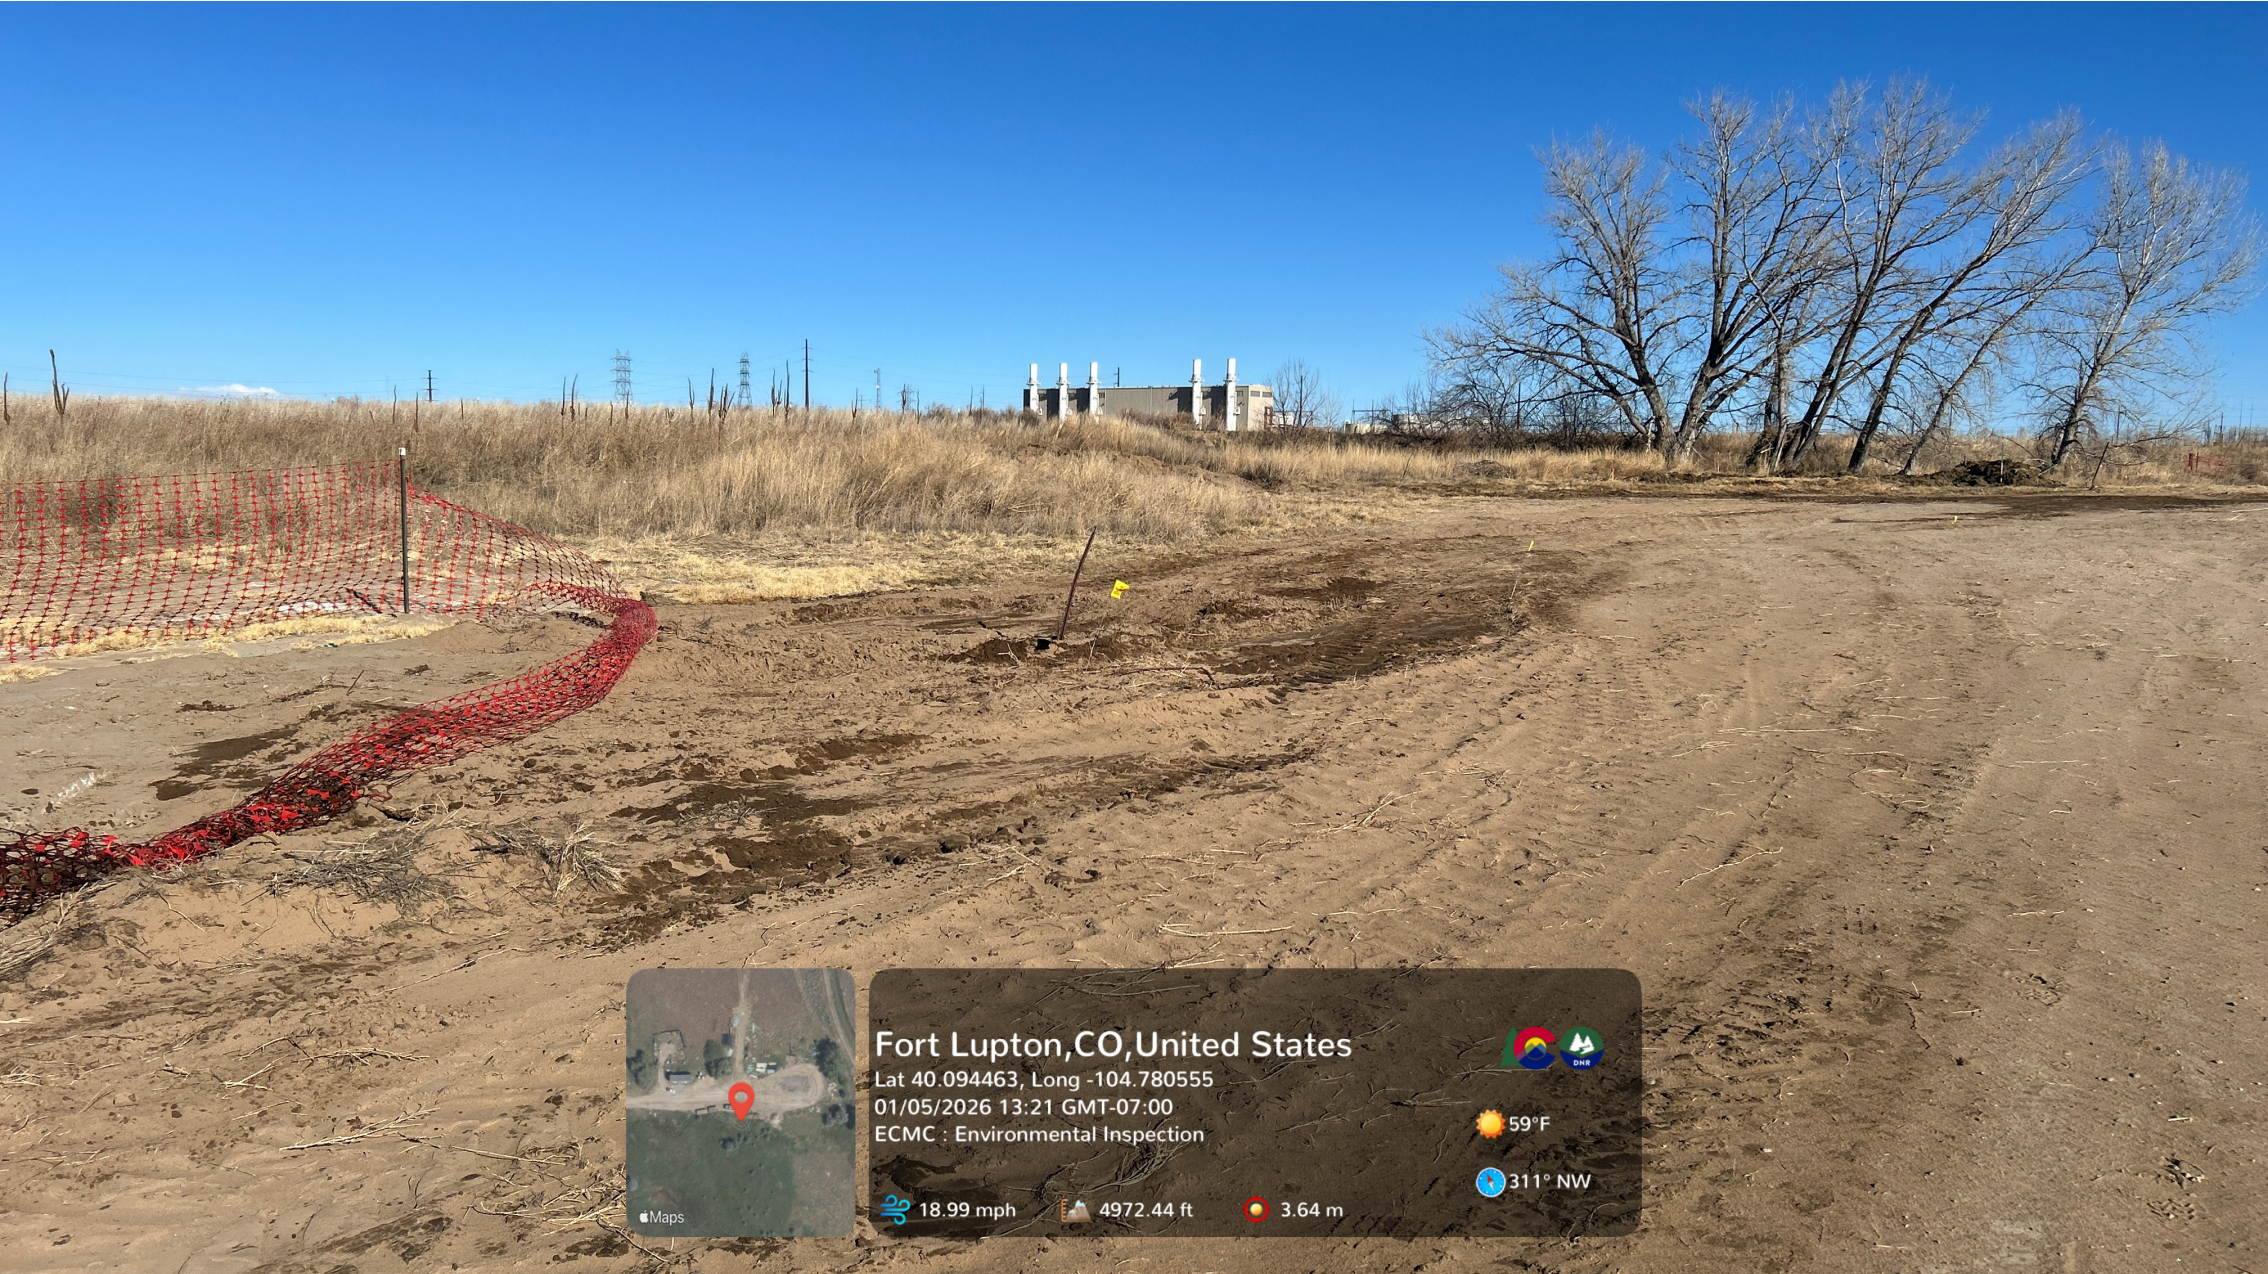
Looking along spill location, where Operator reports the fluid flowed after daylighting. Some soil appears to have been scraped, however, stained soil is visible on the surface. Stained soil is also visible in the trafficked area of the access road.

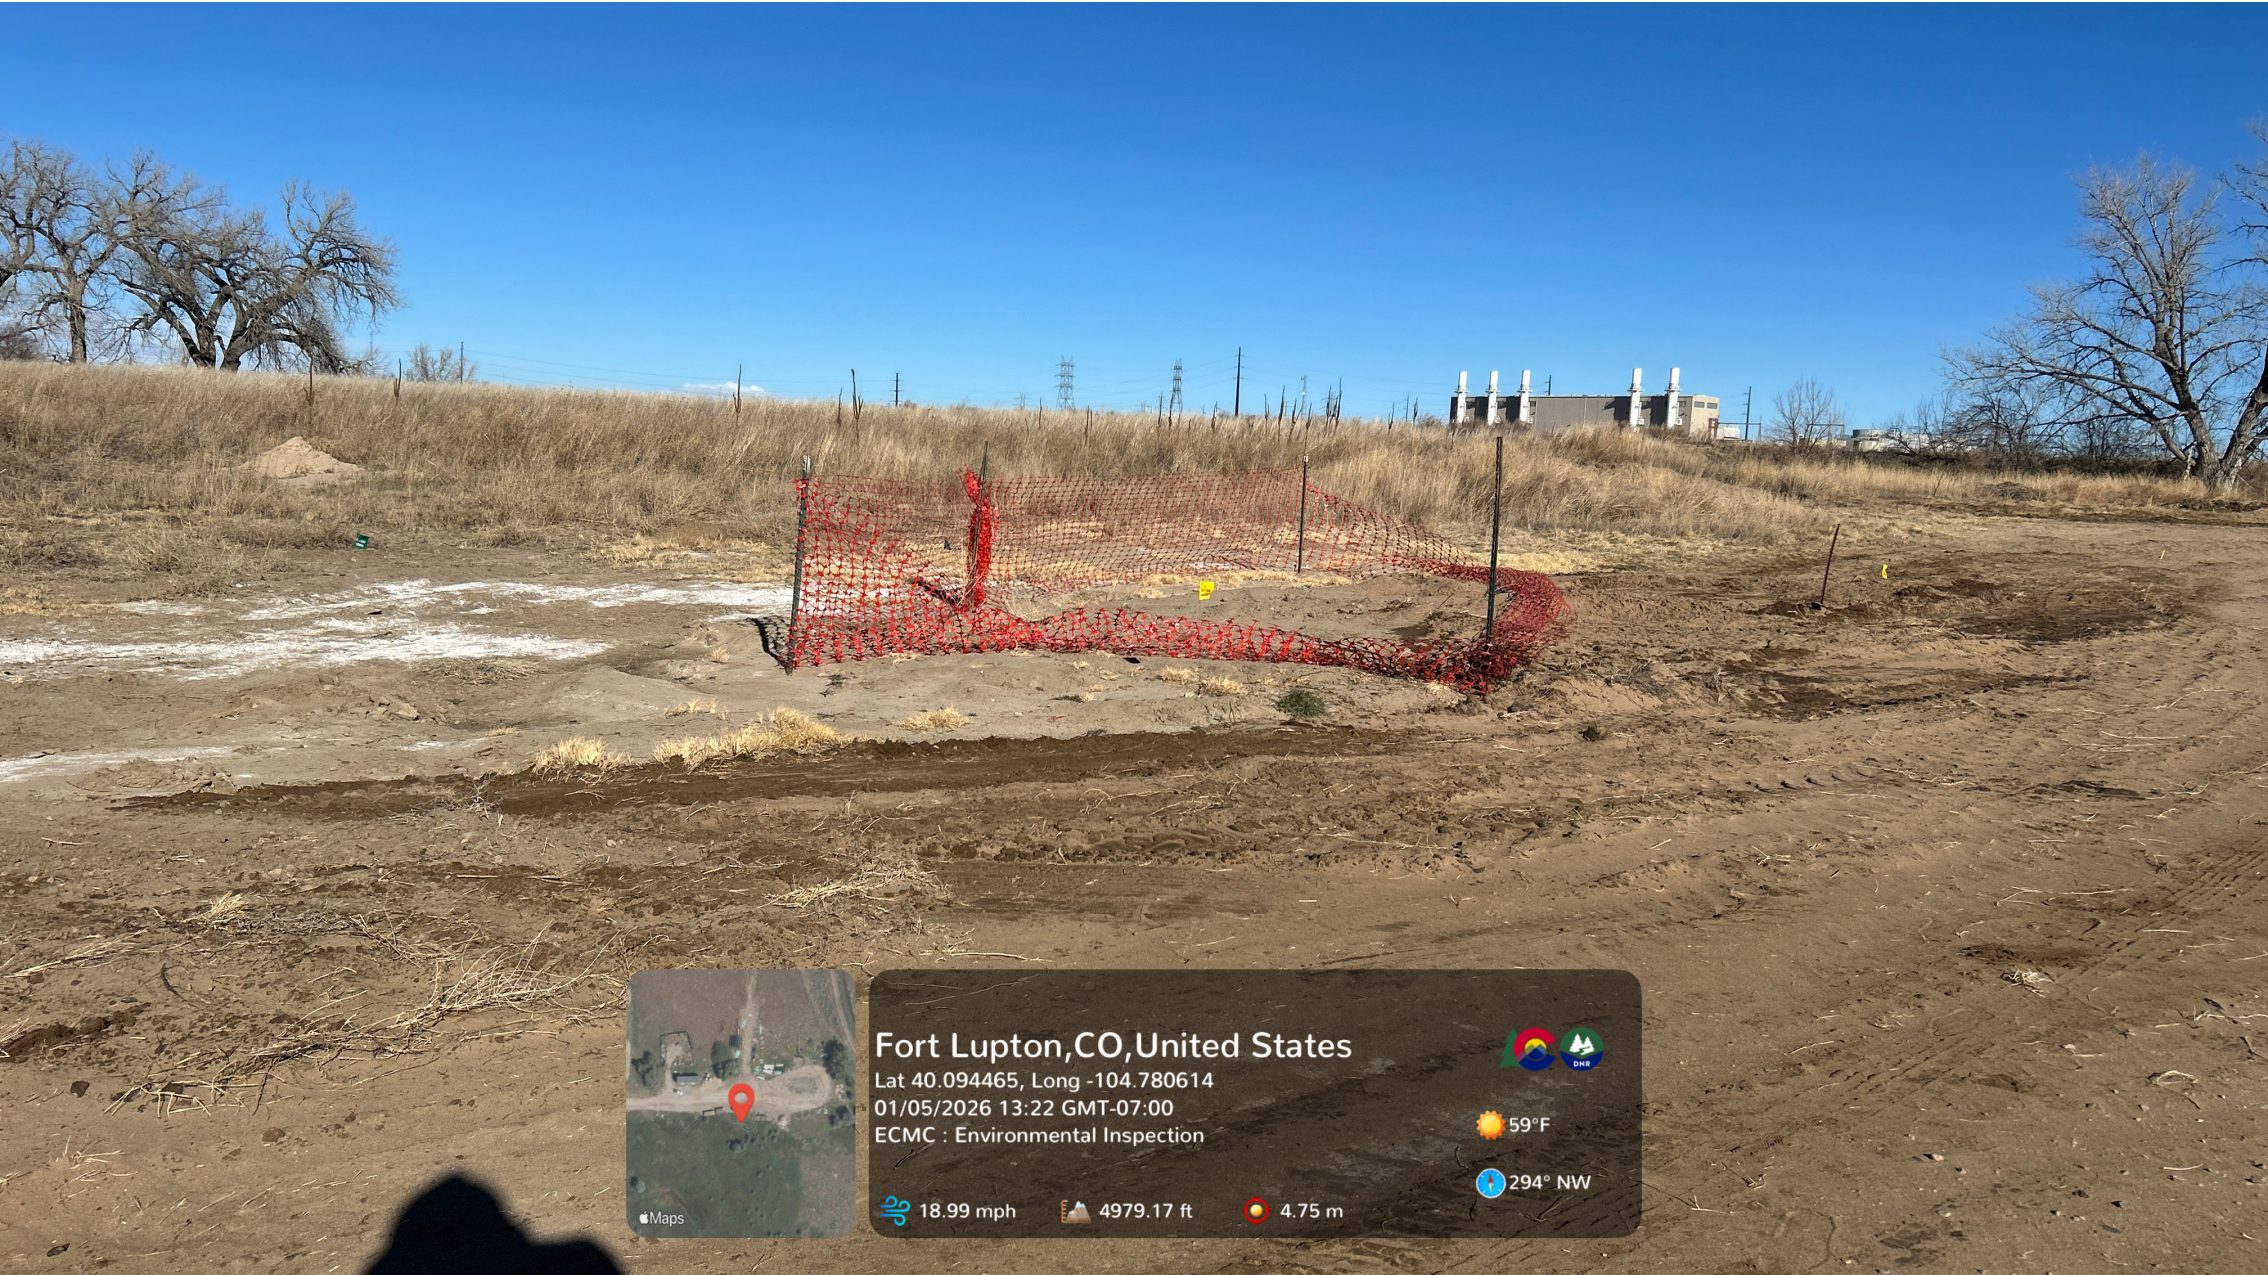
Salt crusting is visible at the spill location.
