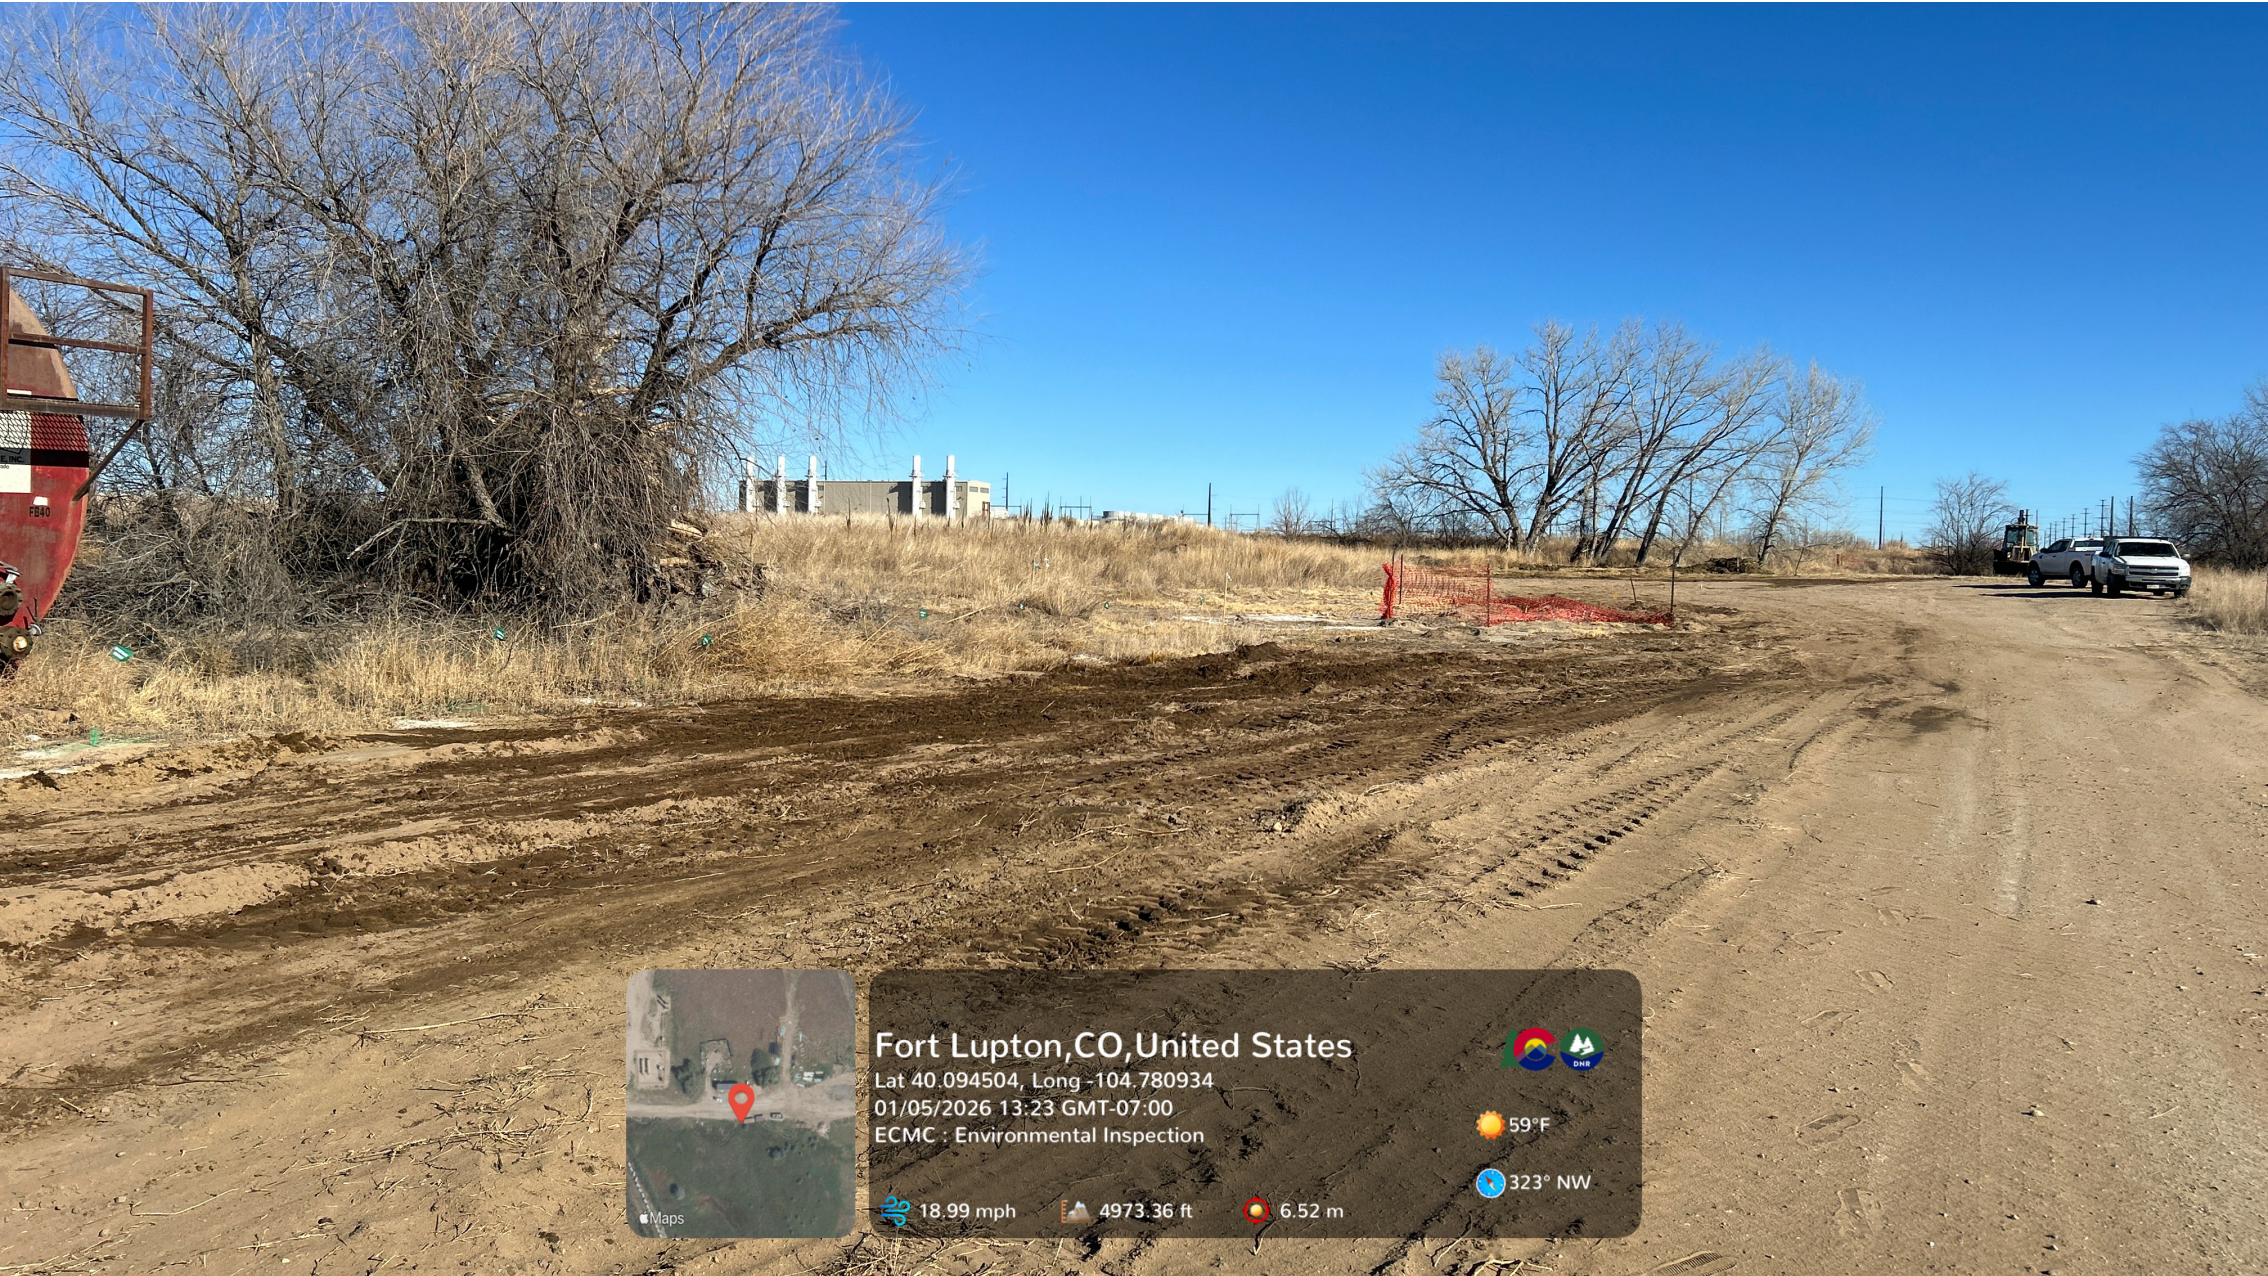
Looking at general location Operator personnel approximated the material of flowline system Facility ID 478832 changed between 8" steel and 3" HDPE. See attached map, "2026_0105_Facility 2 Consolidation 1.4.26 Spill Map".

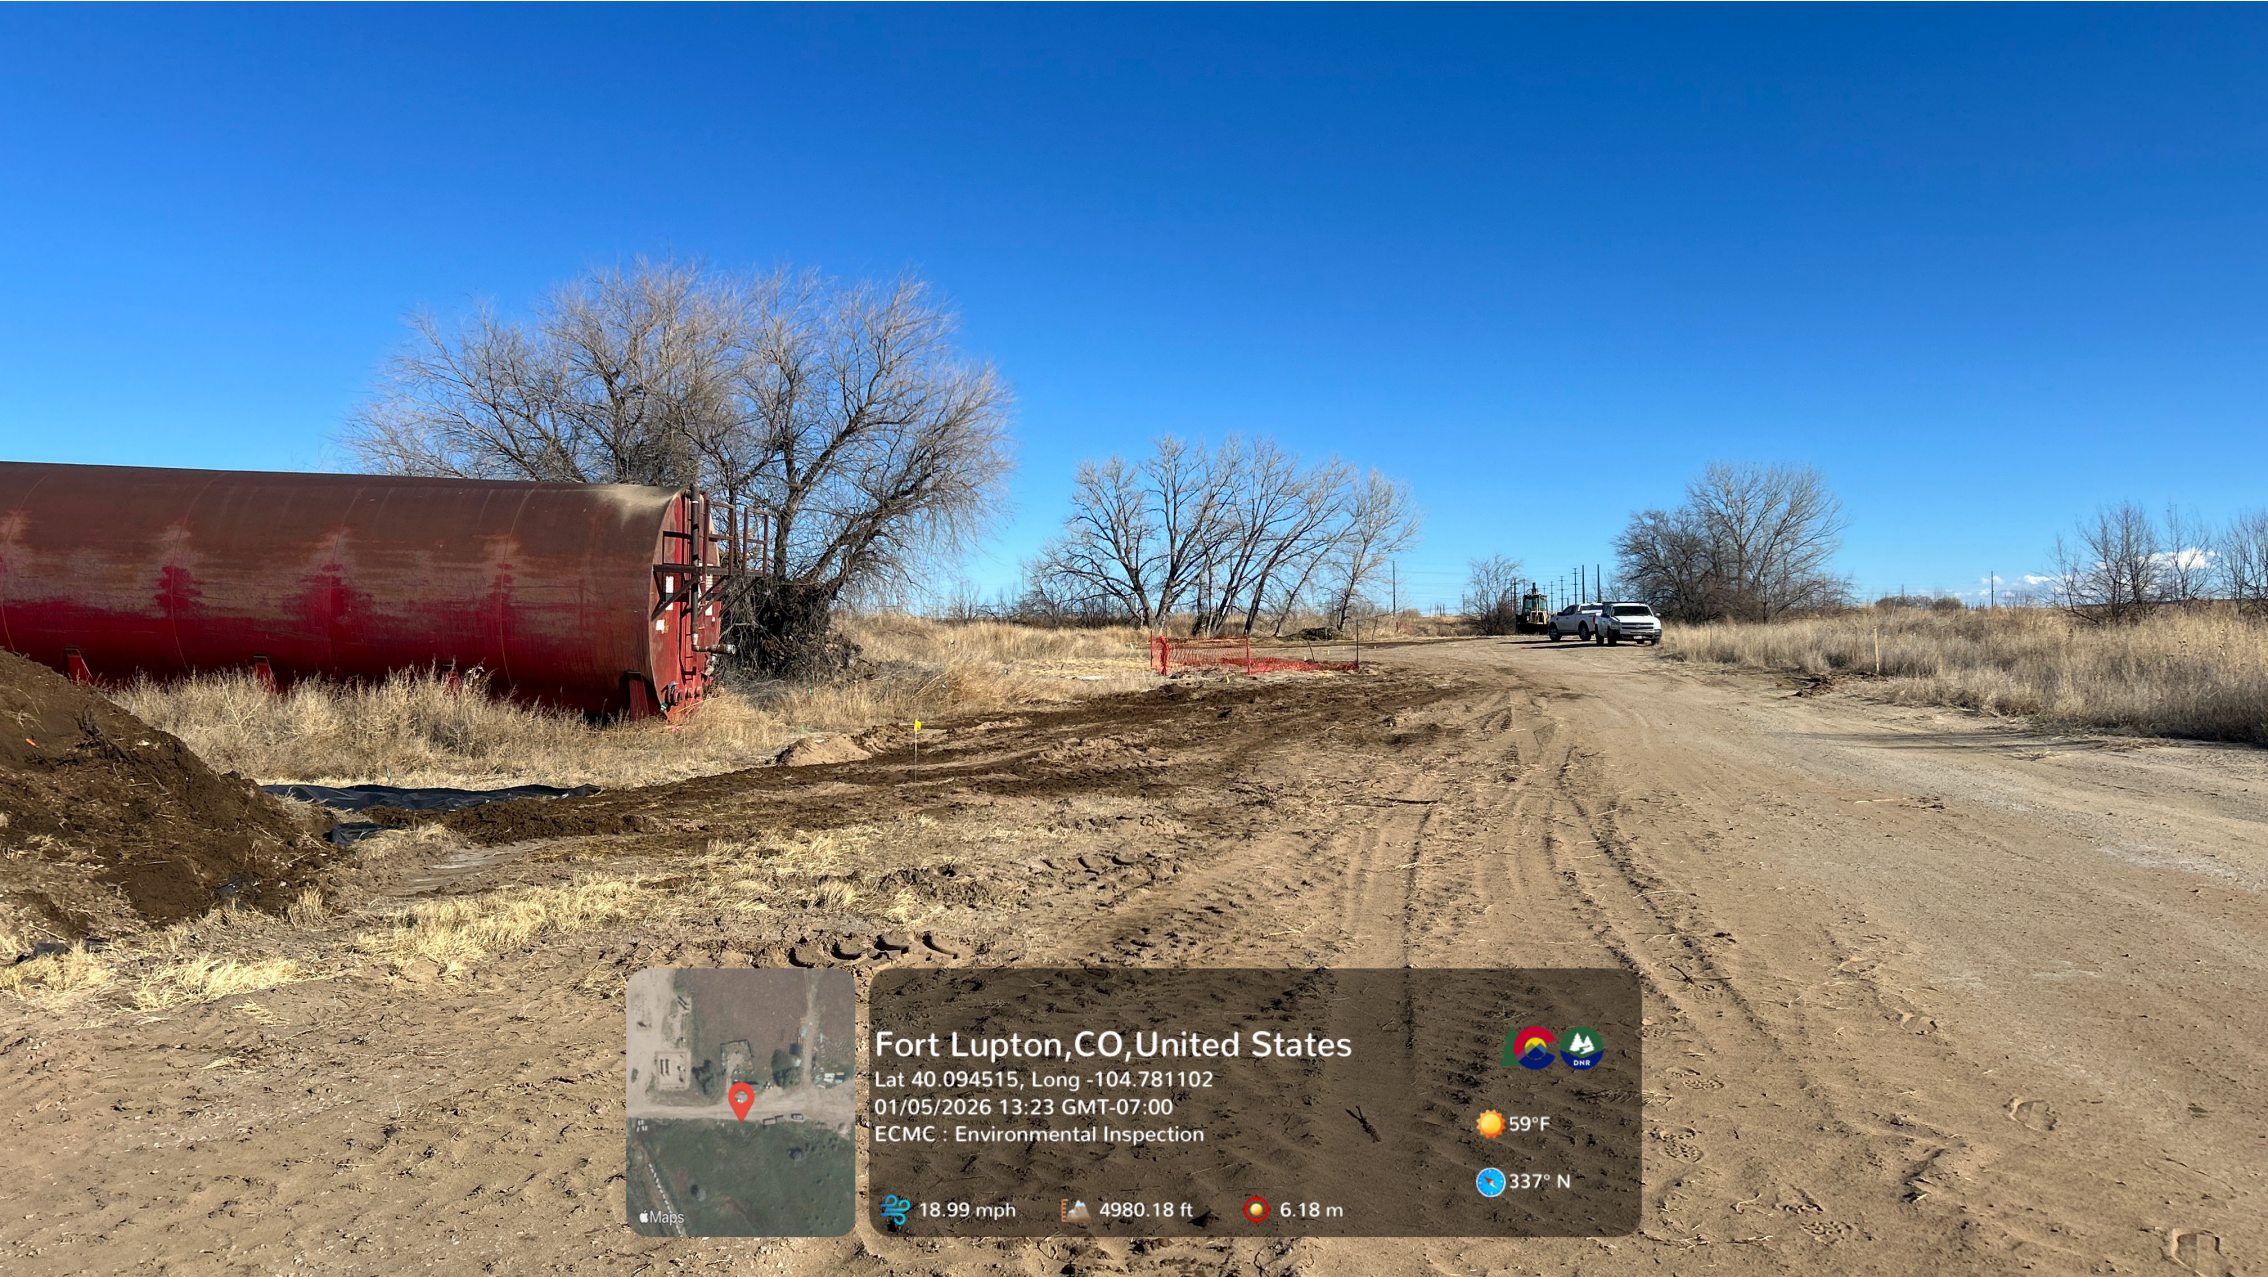
Looking along spill location, where Operator reports the fluid flowed after daylighting.

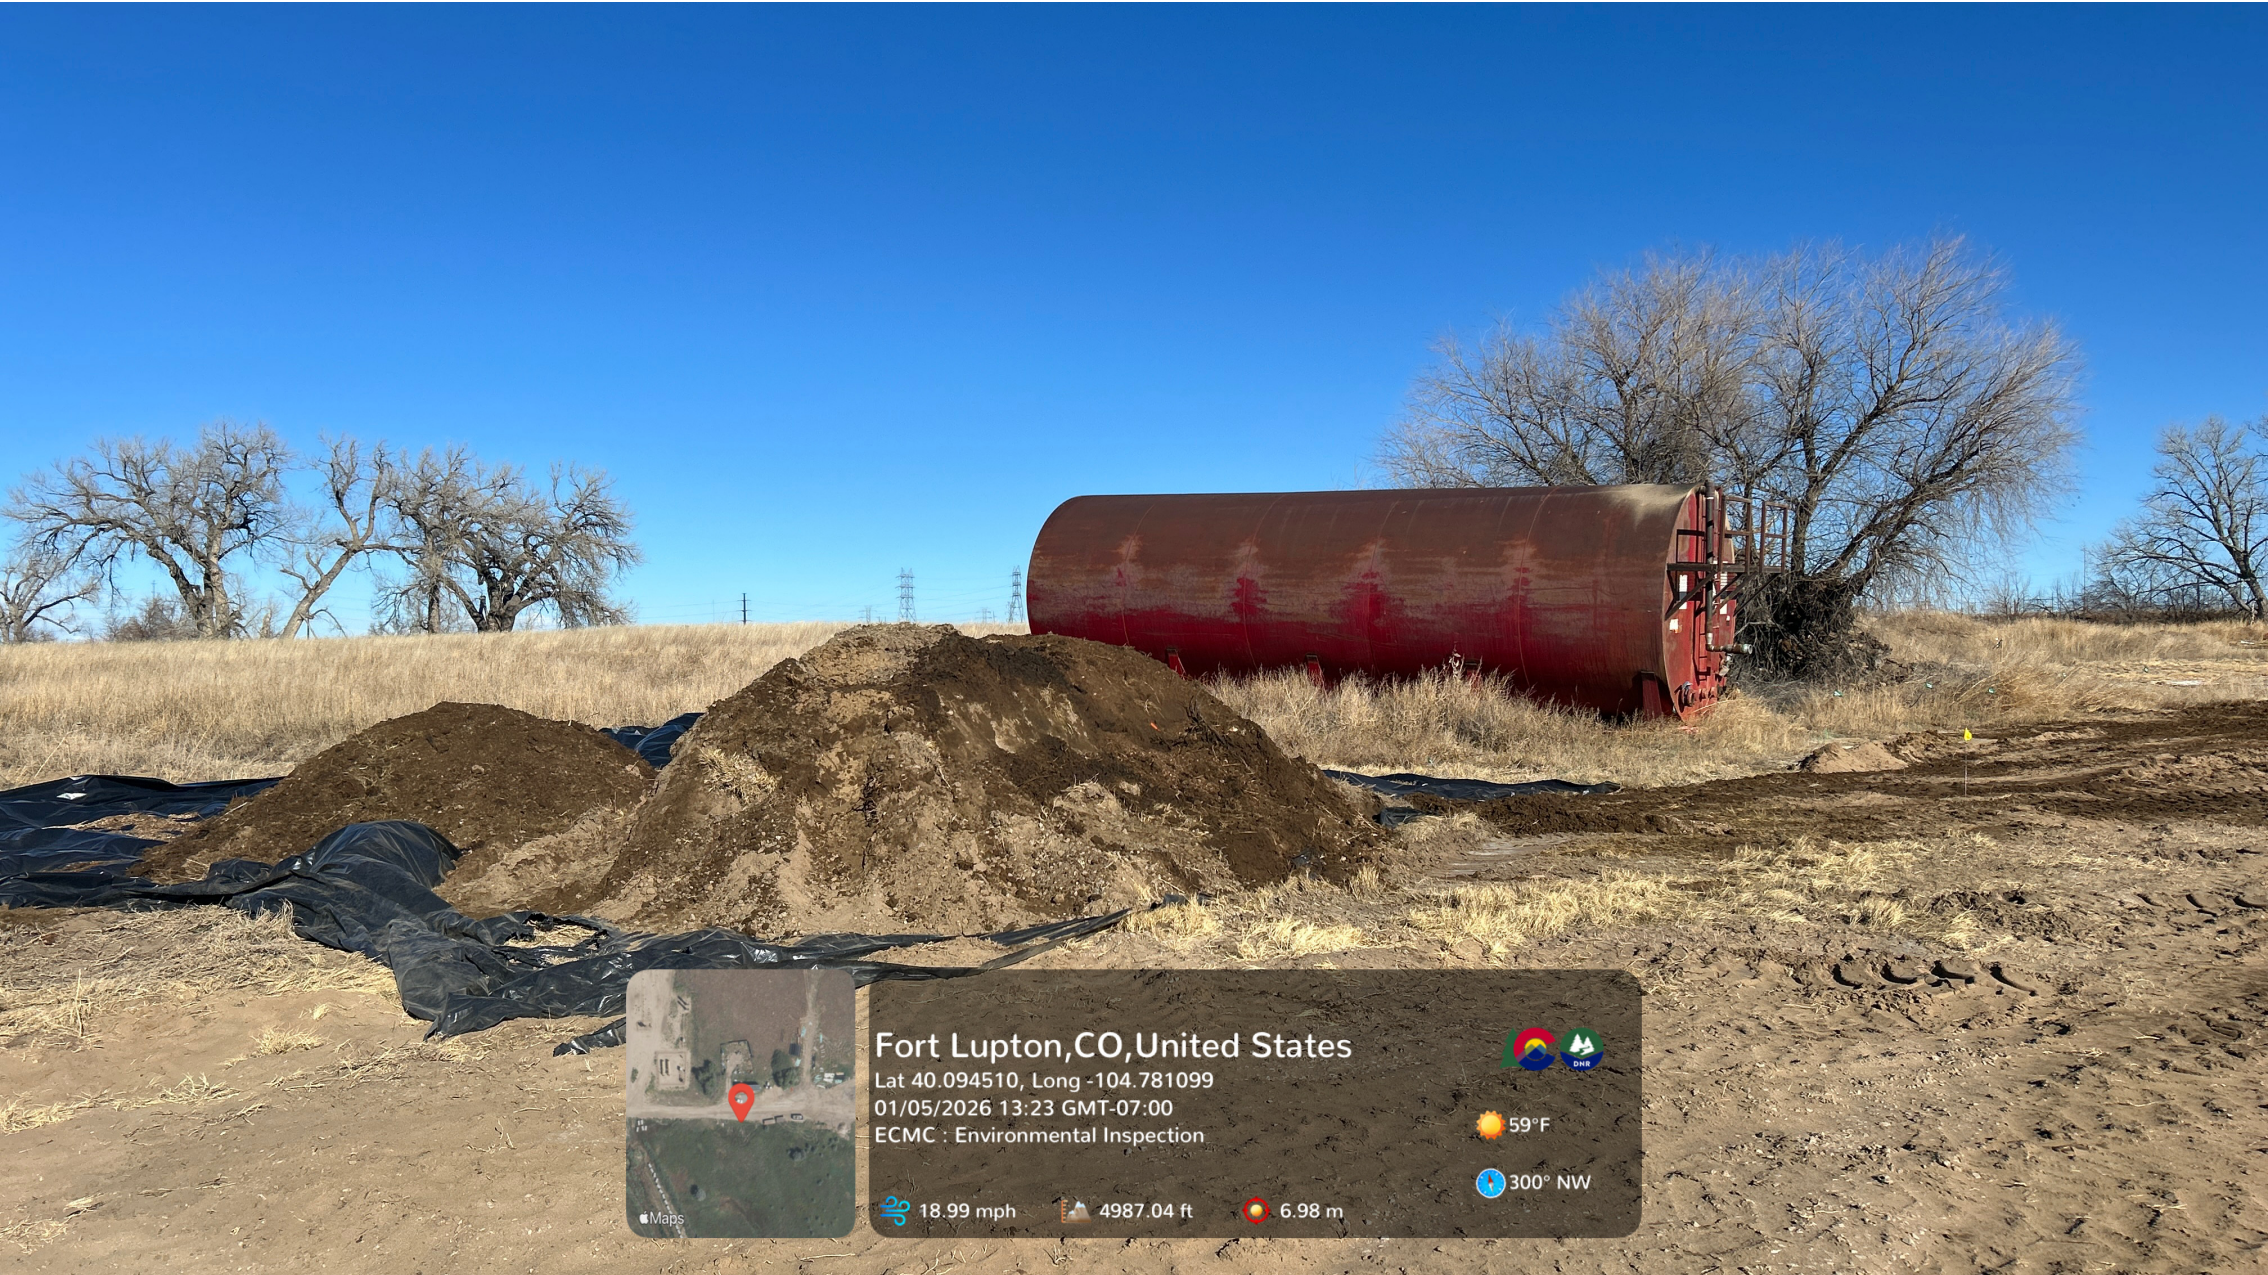
An unmarked soil stockpile is visible near the western extent of surficial stained soil. A liner is visible beneath the majority of the stockpile; however, the liner has holes/tears, and the soil does not have a berm and has spread off of the liner.

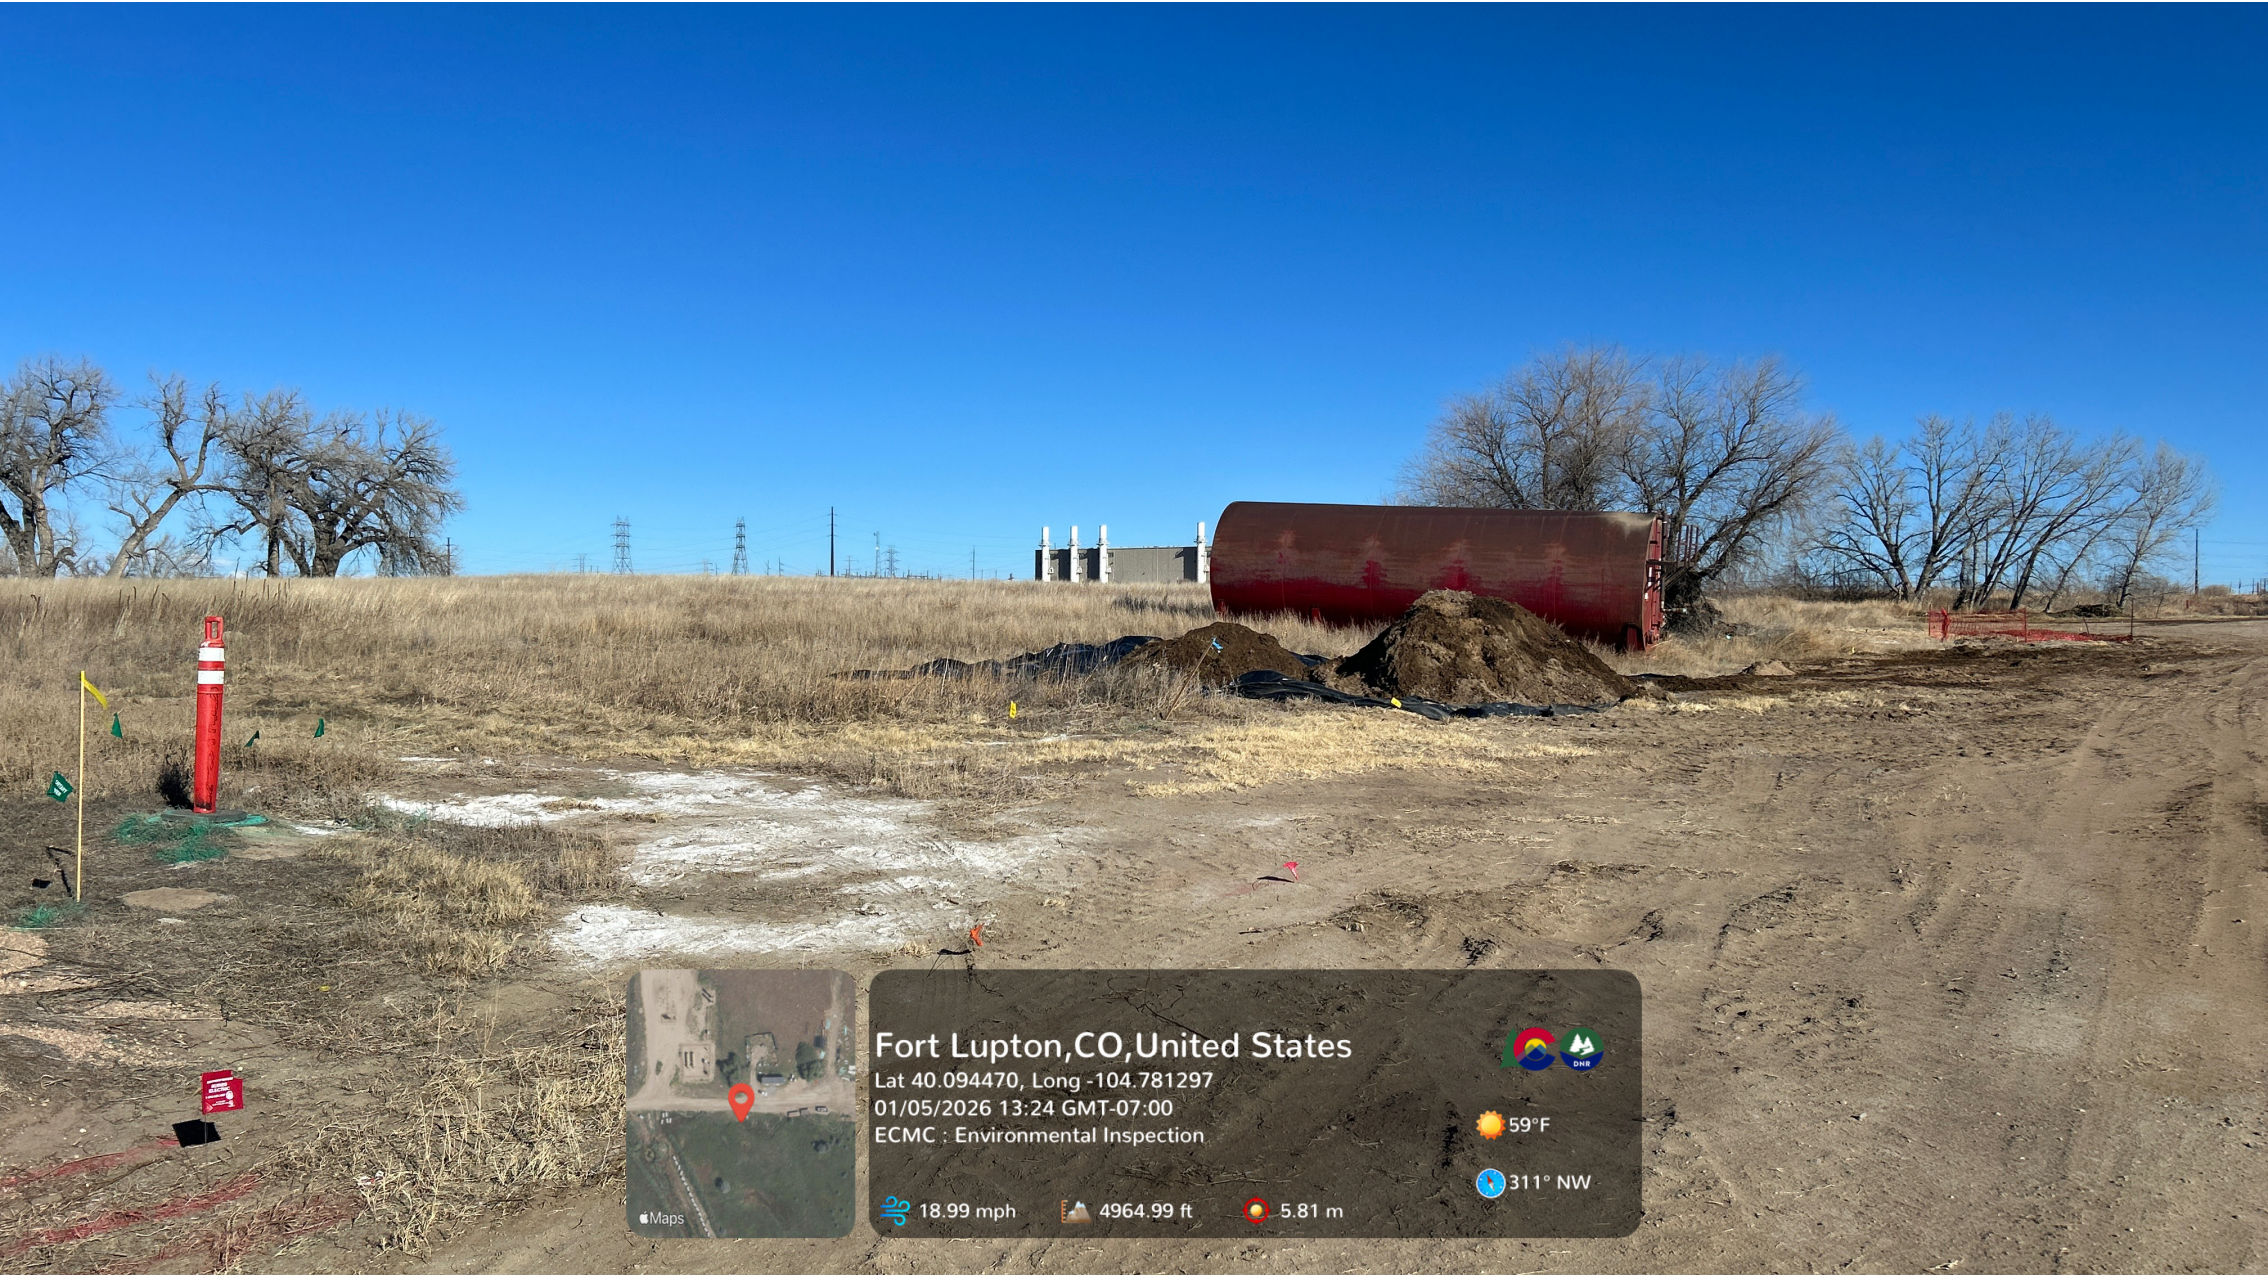
Salt crusting is visible at the spill location.

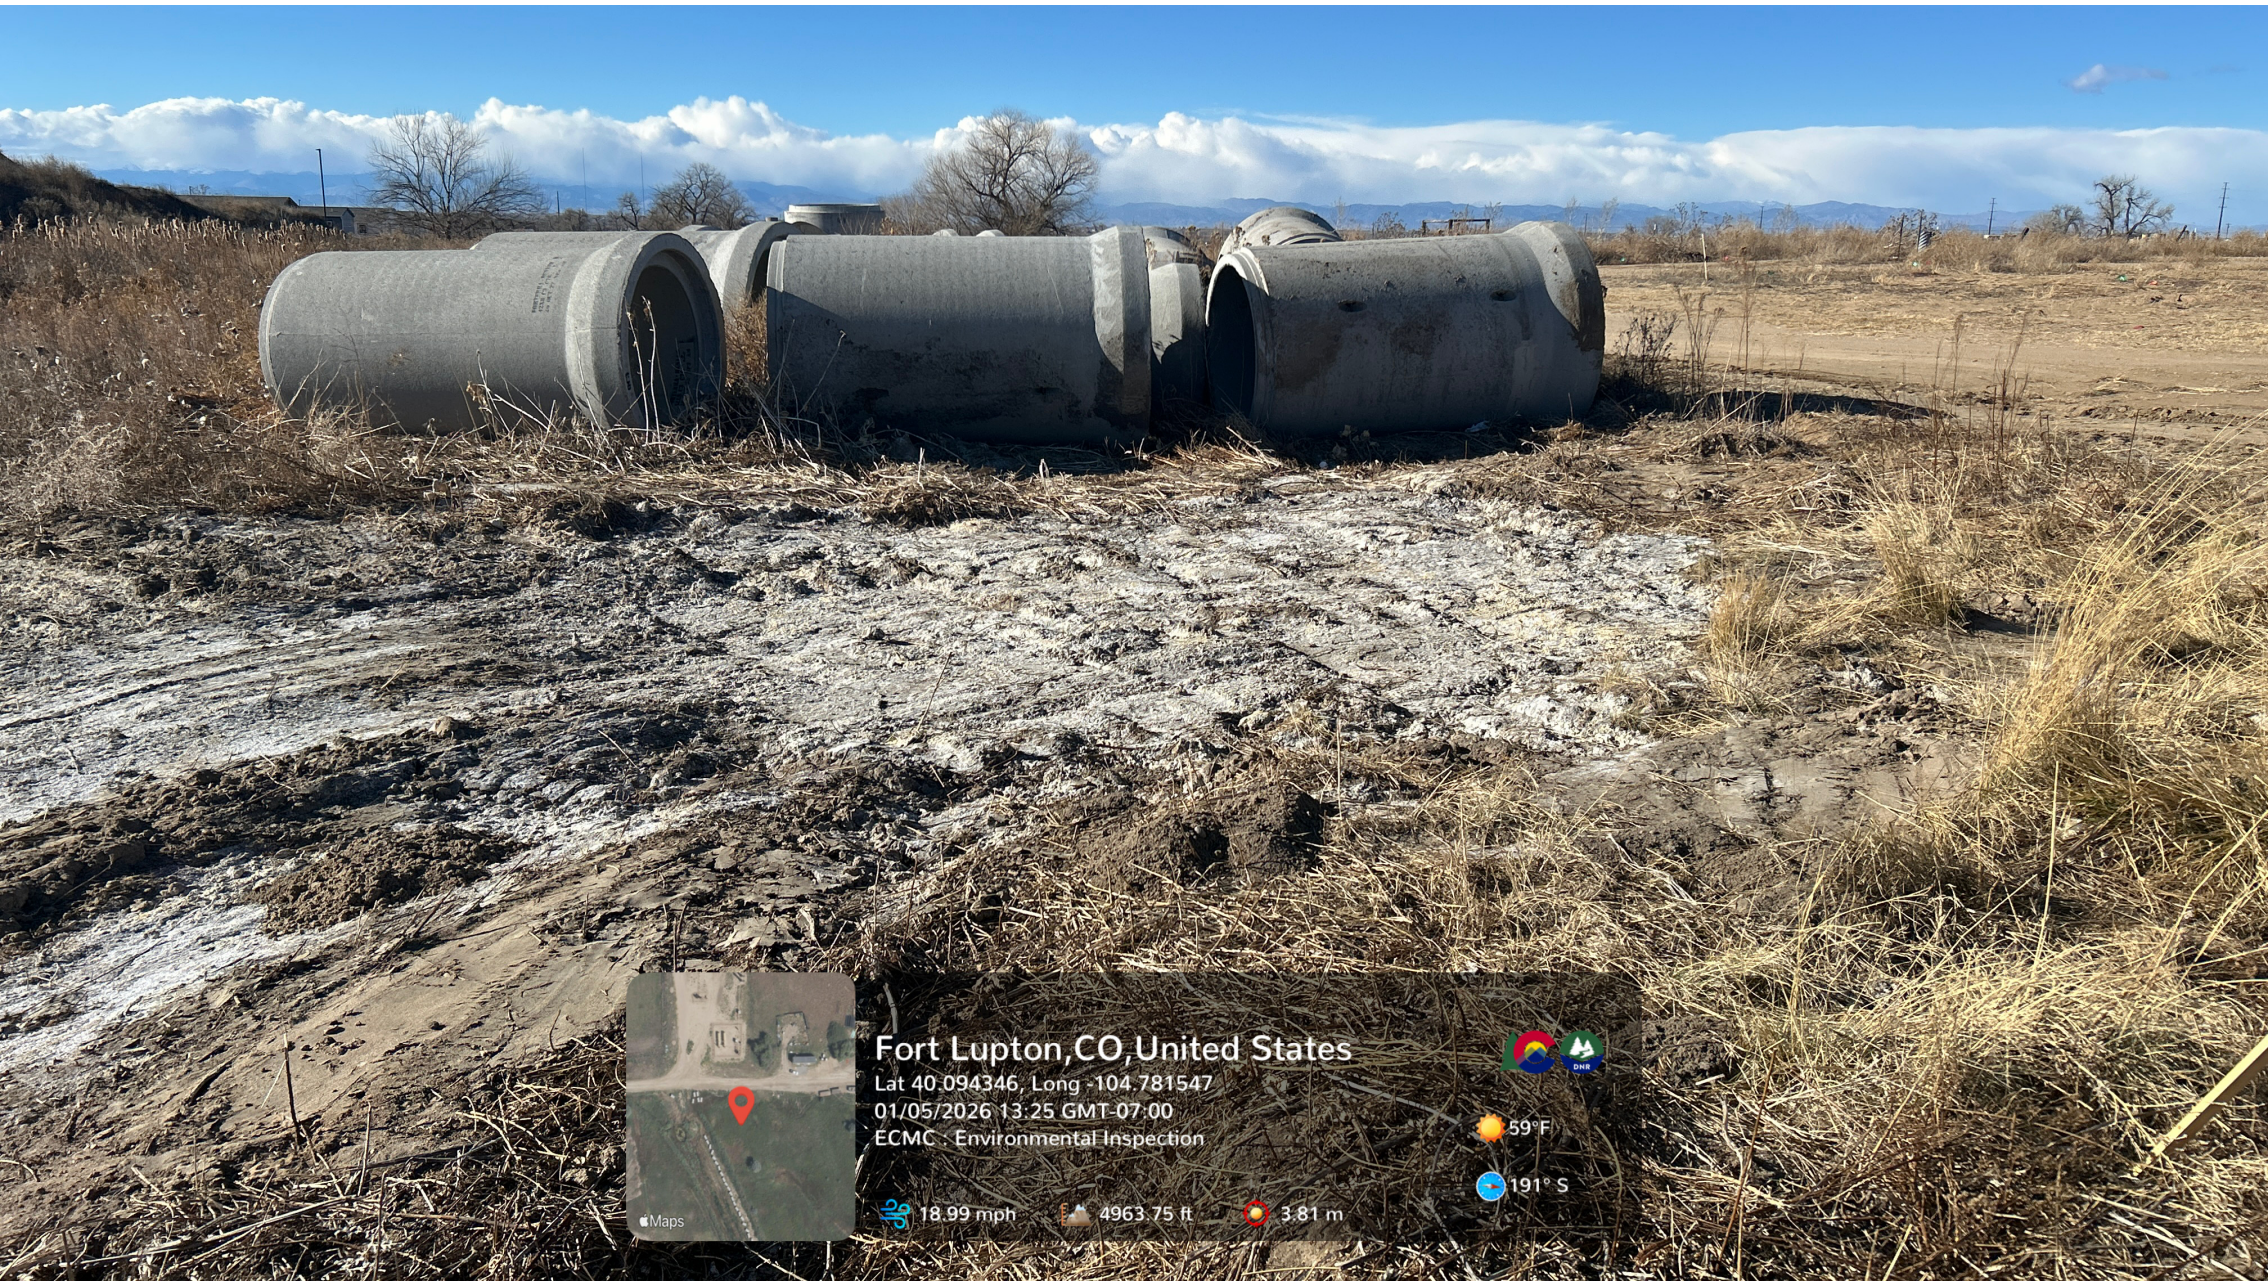
Looking at salt crusting south of Spill ID 490663. Areas of soil appear to have been scraped.

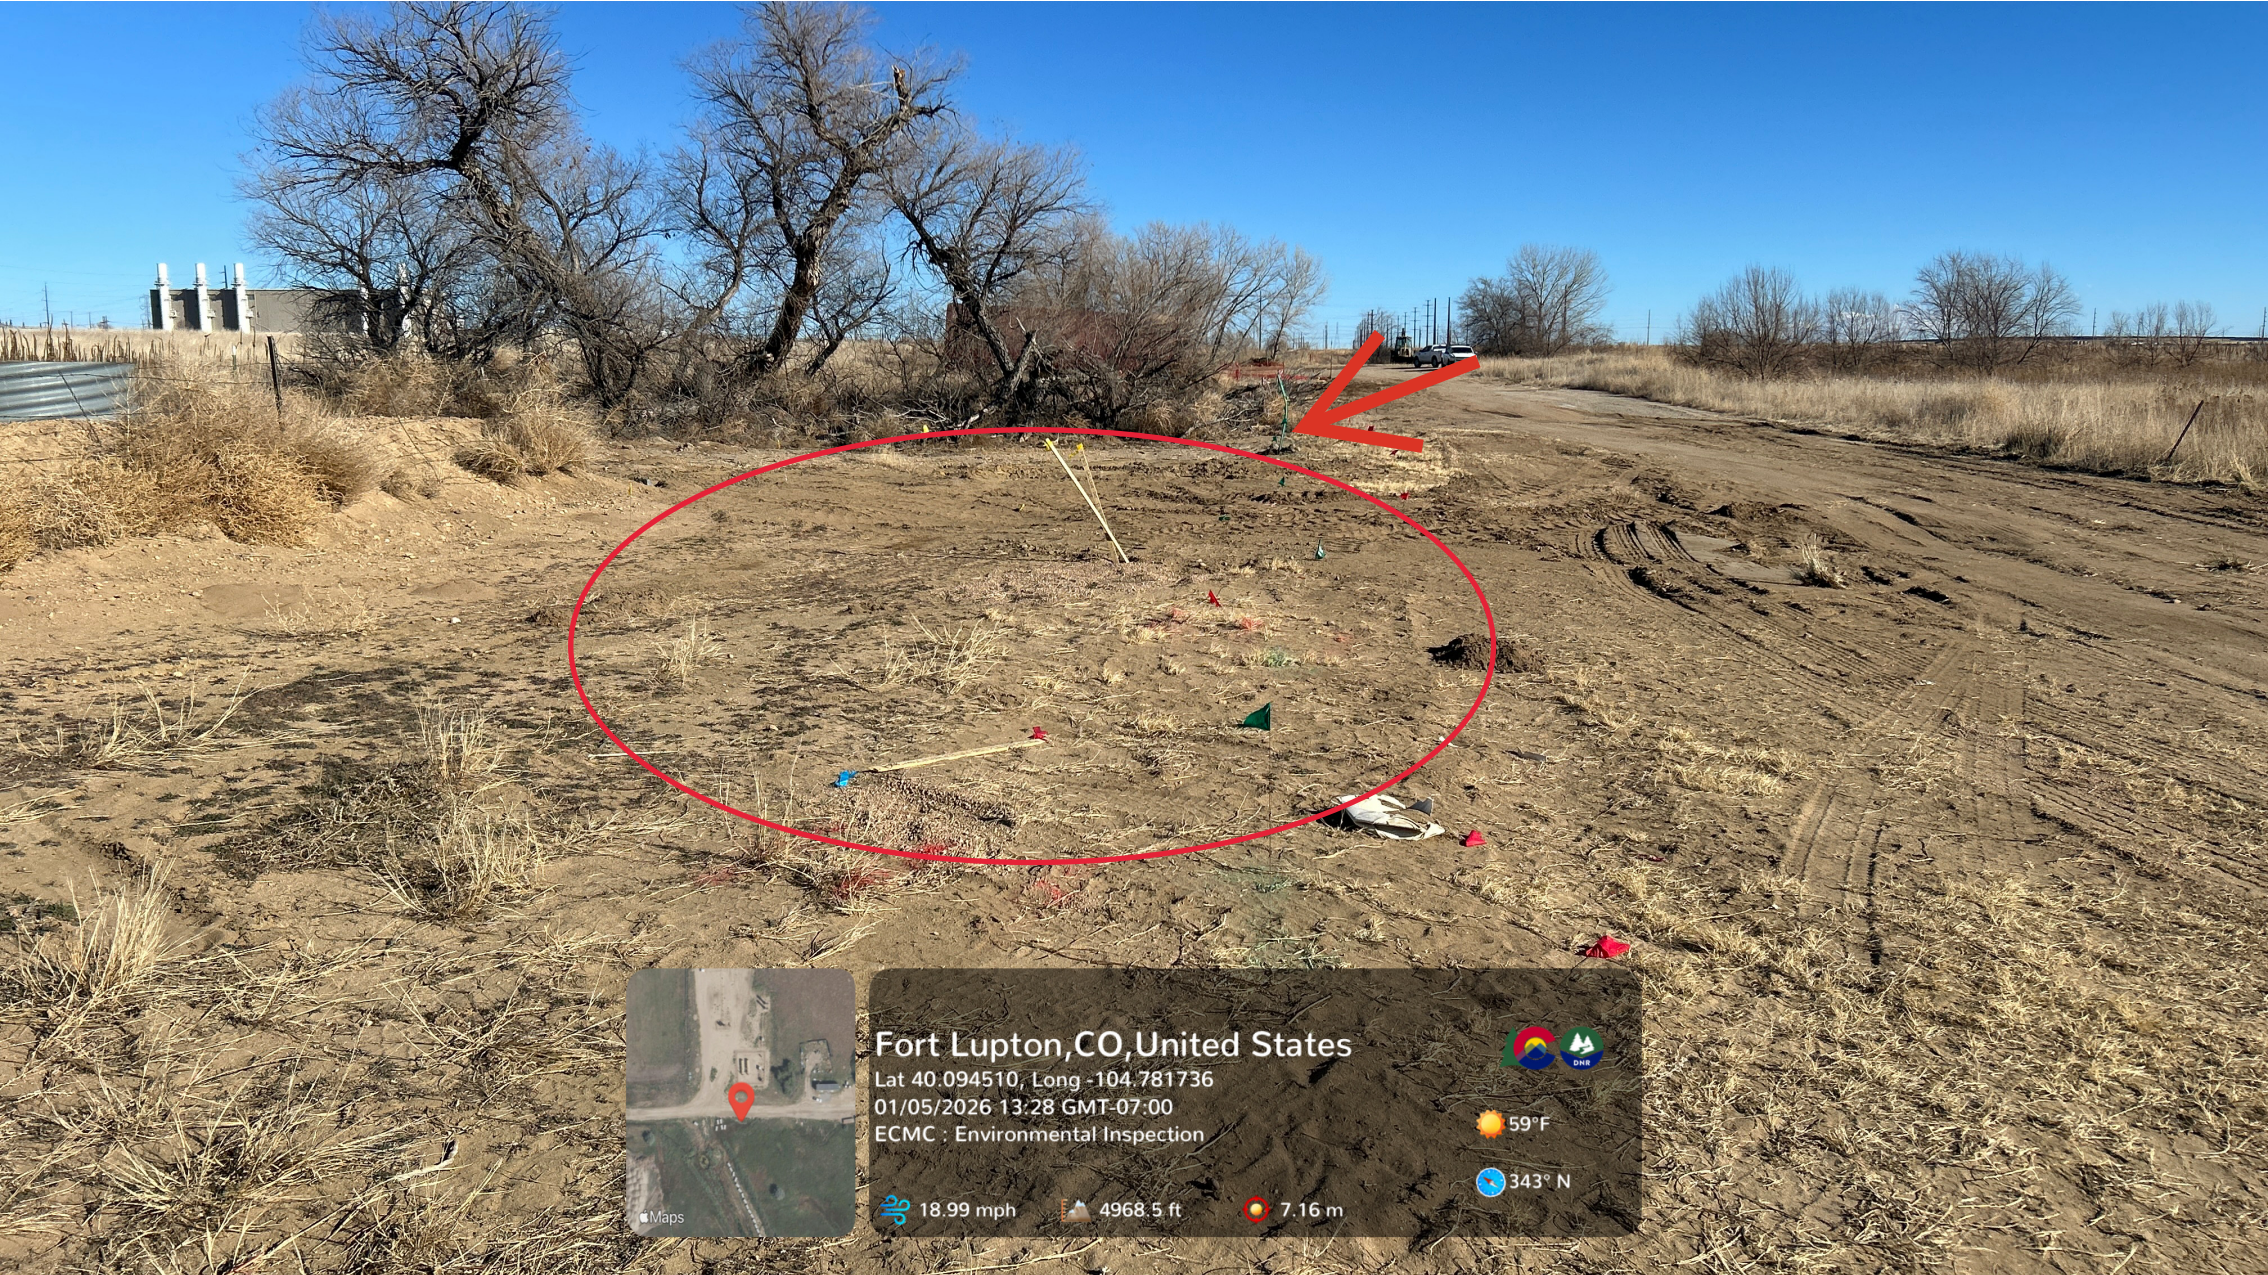
Looking at the approximate location of Spill ID 490663, discovered 06/12/2025 (circled). The excavations at this spill location have been backfilled. Stained soil associated with Spill ID 492701 is visible on the access road Looking also at the general location Operator personnel approximated the material of flowline system Facility ID 478832 changed between 8" steel and 3" HDPE (arrow). See attached map, "2026_0105_Facility 2 Consolidation 1.4.26 Spill Map".

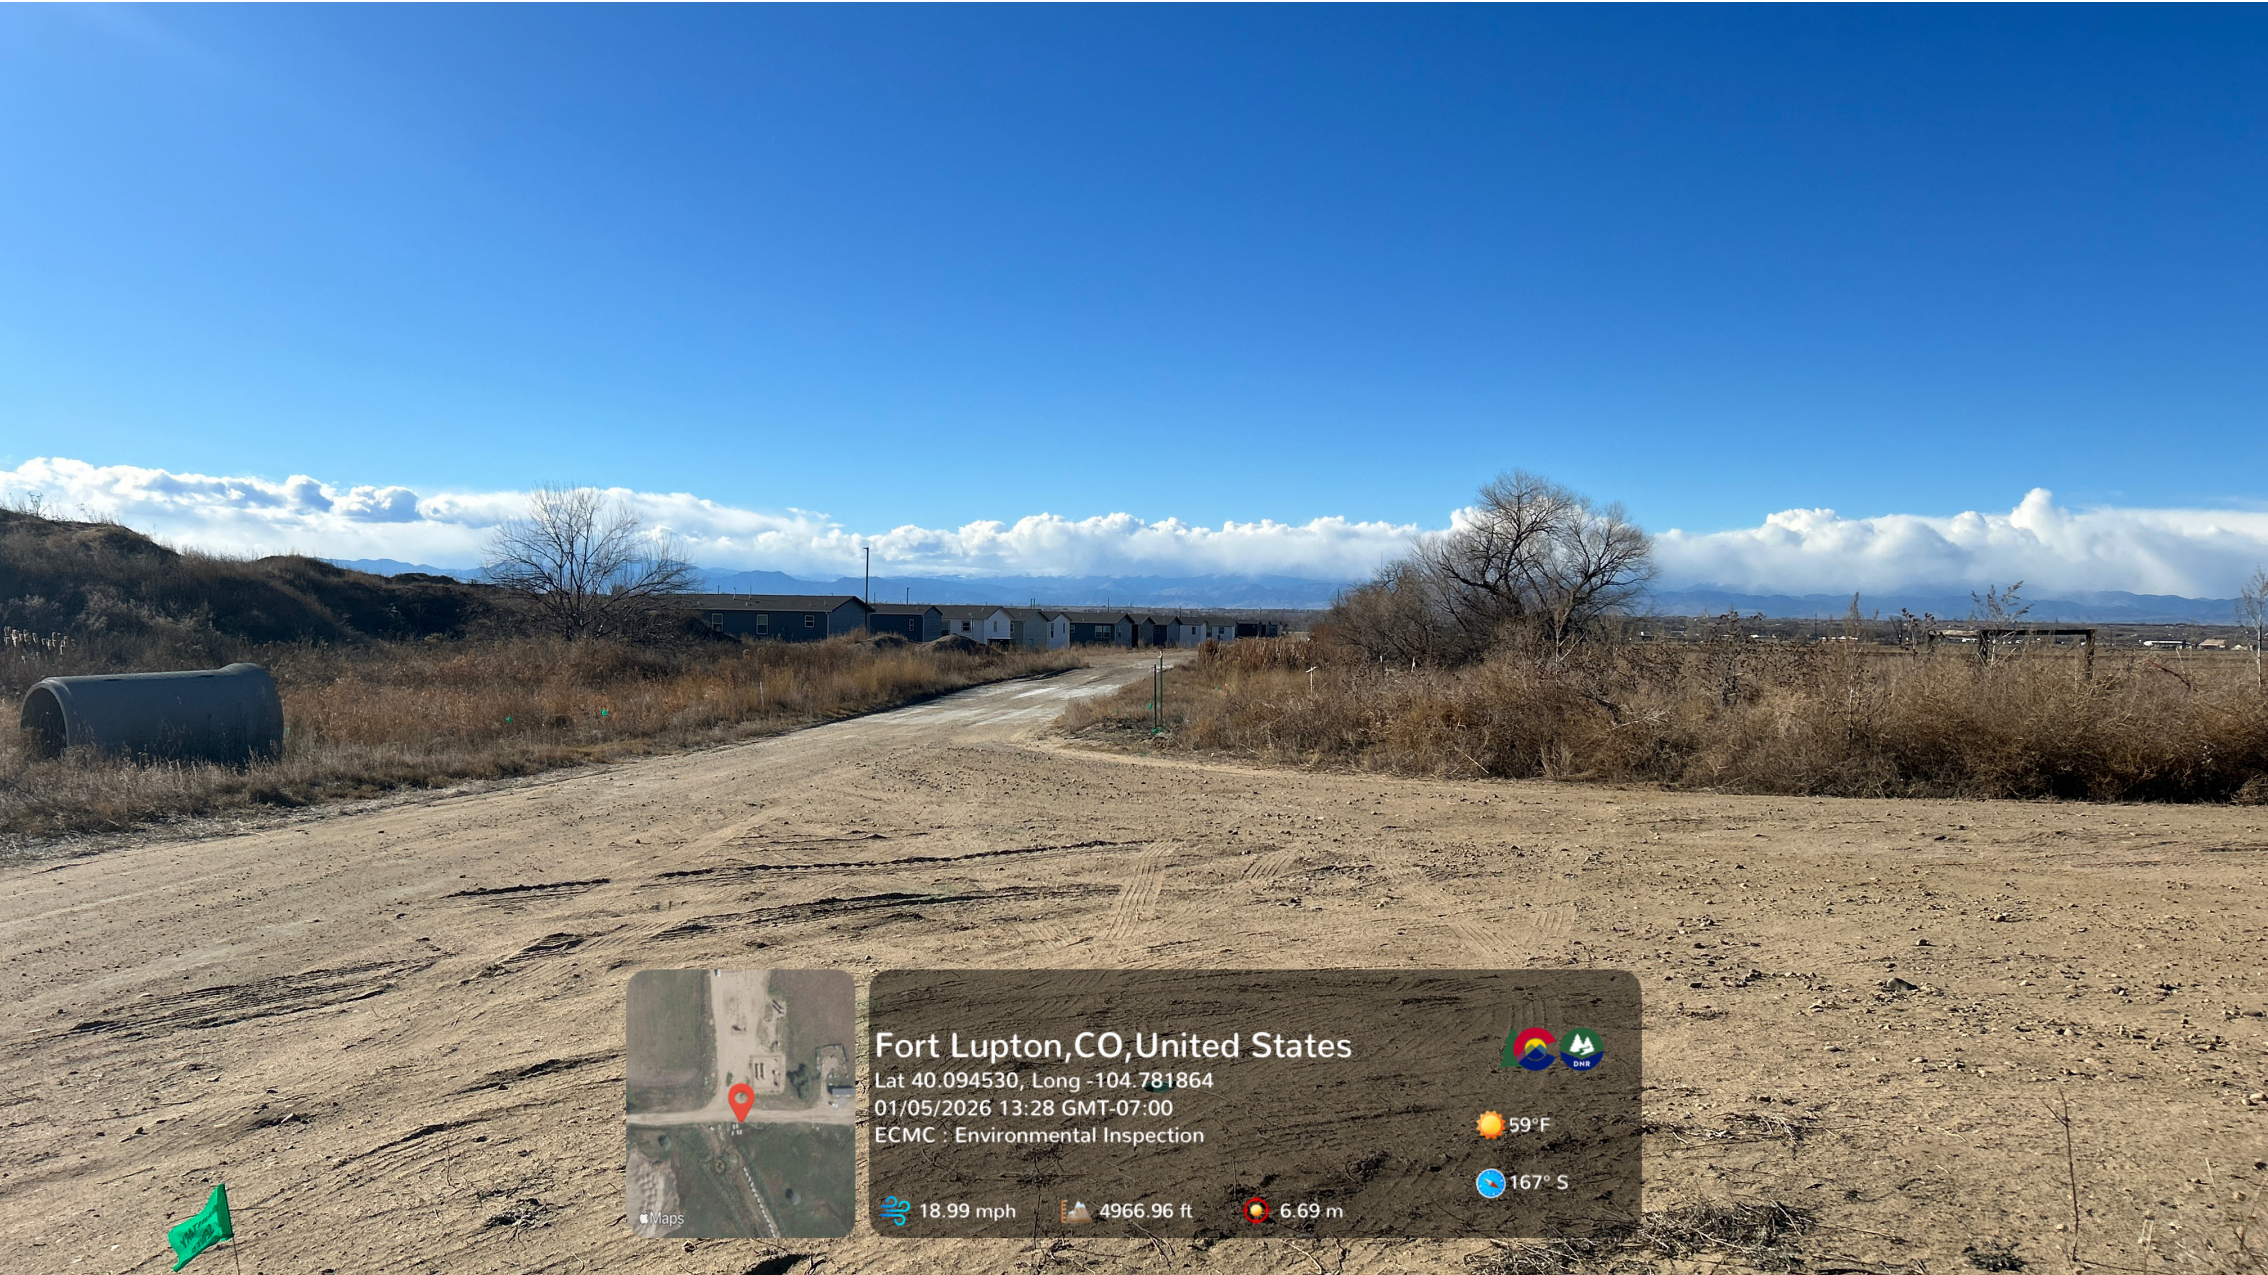
Salt crusting is visible along the access road, west of the surficial soil impacts.
