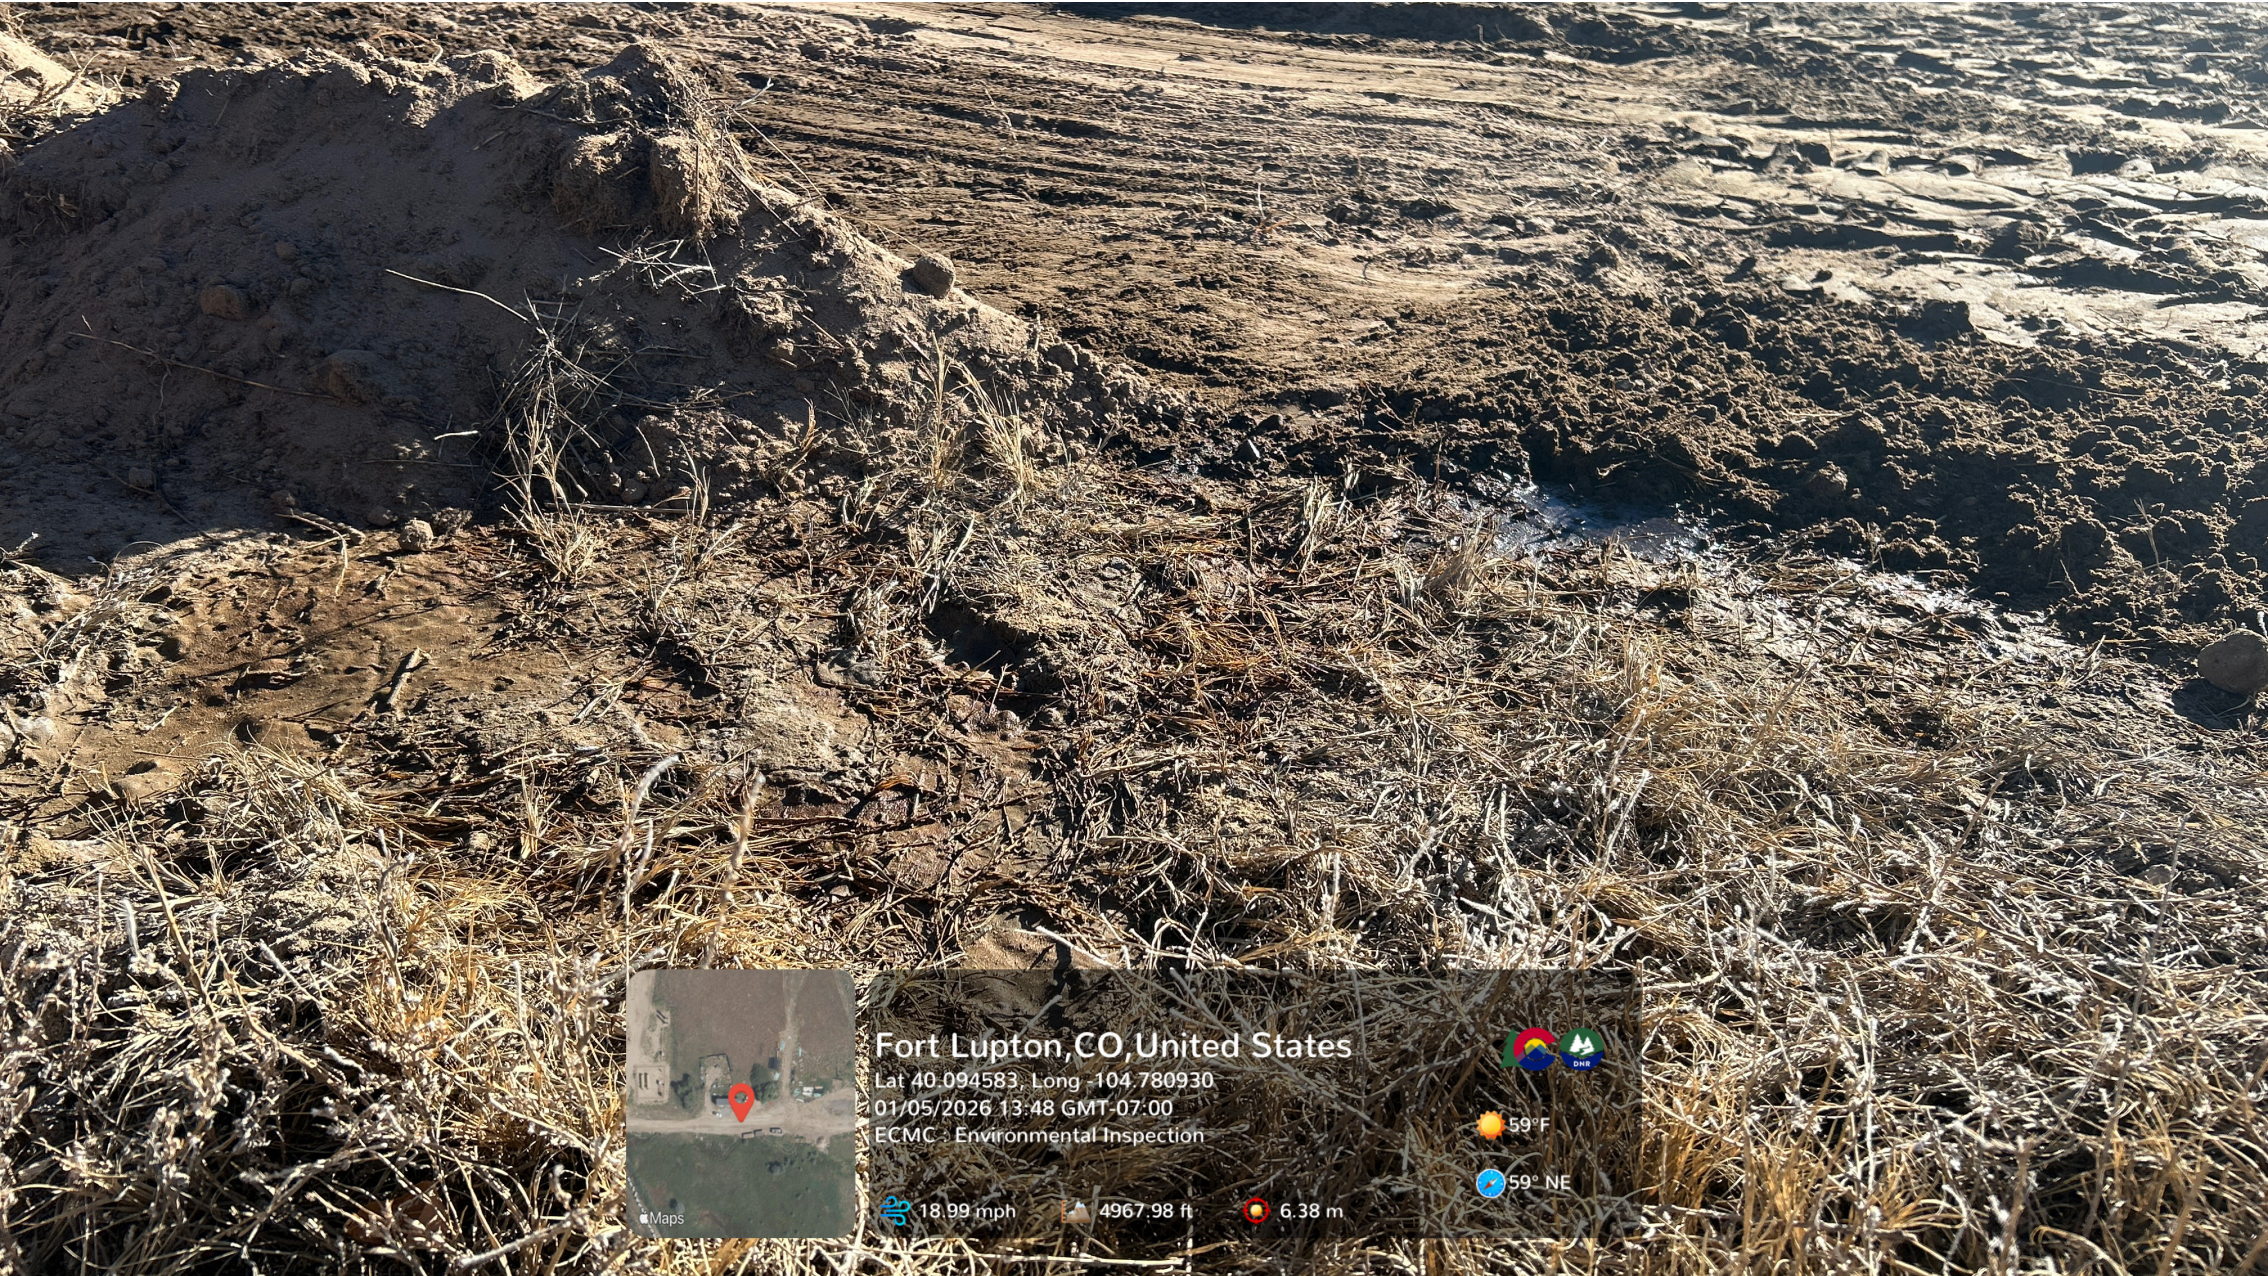
Pooled petroleum hydrocarbon fluid is visible at the spill location.

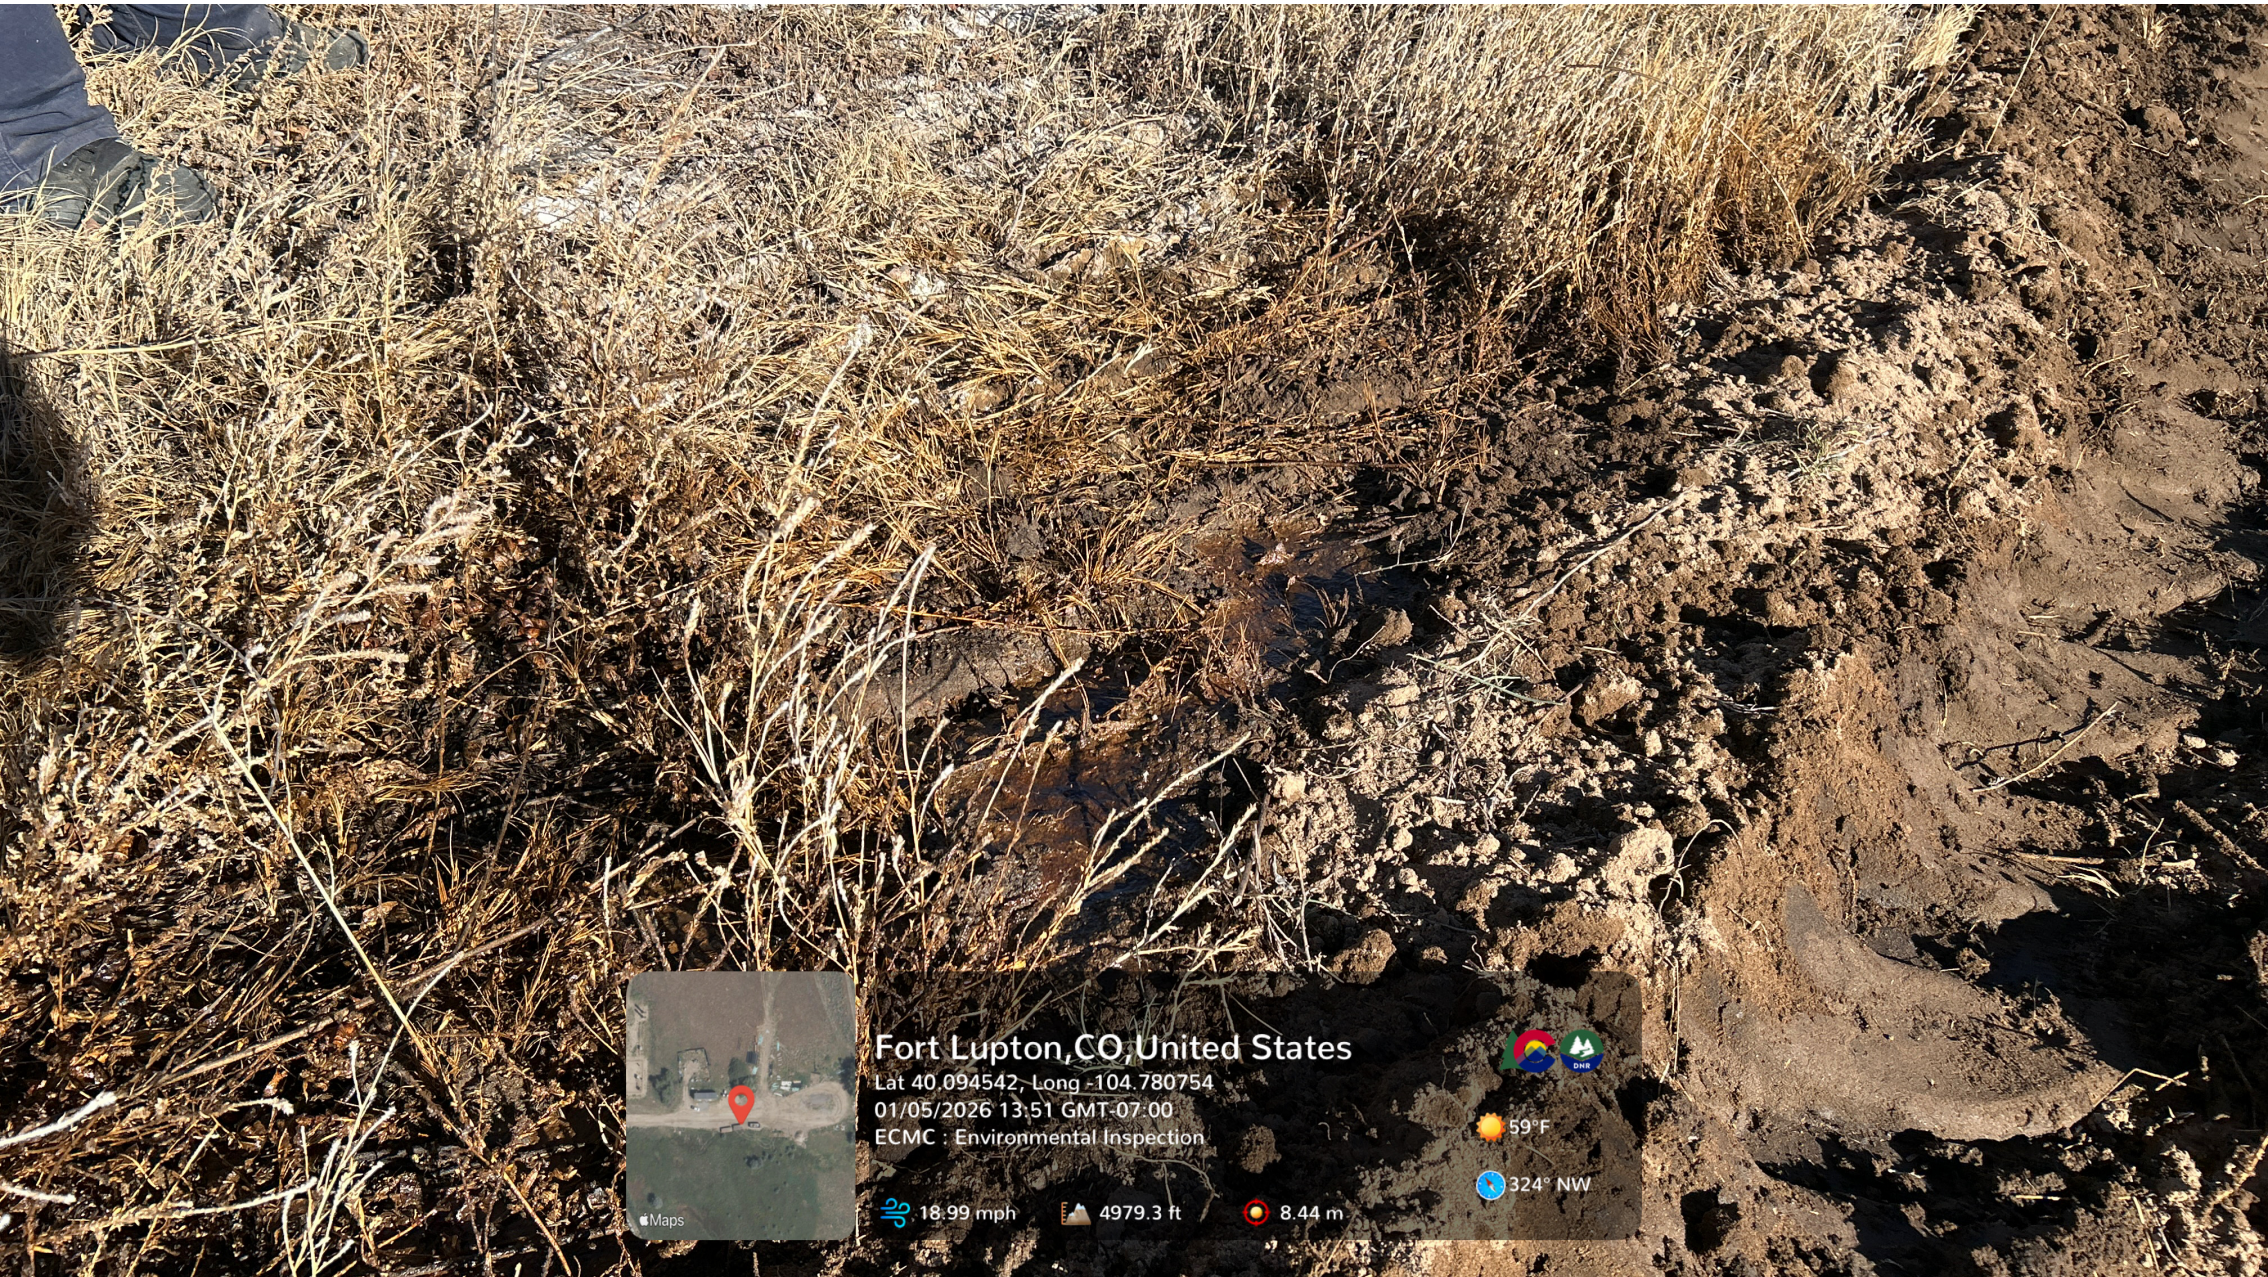
Pooled petroleum hydrocarbon fluid is visible at the spill location; salt crusting is also visible.

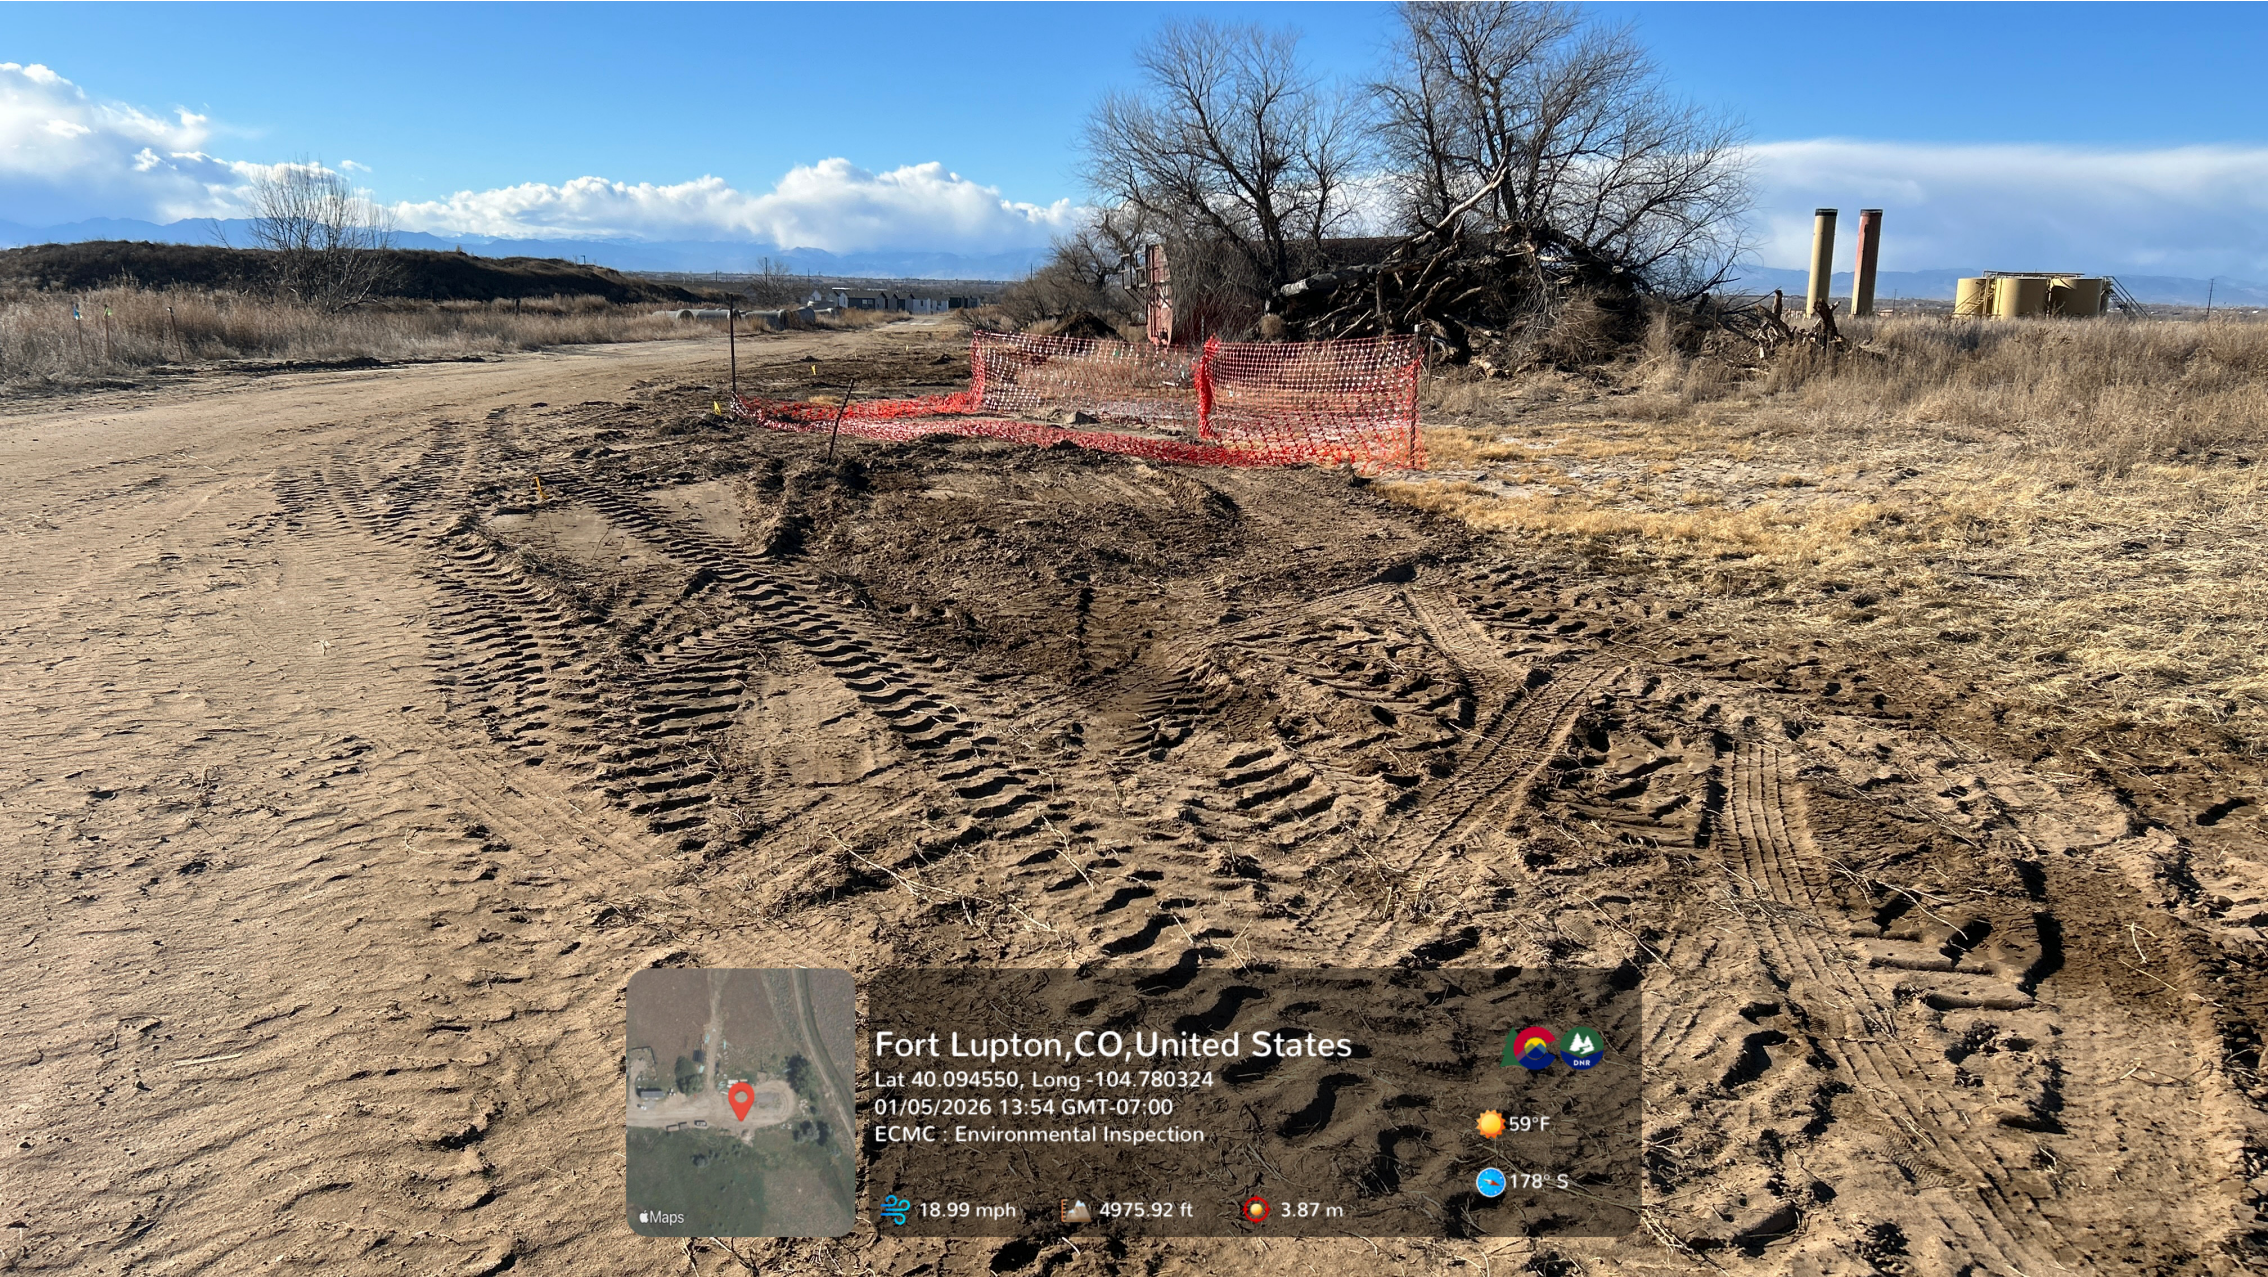
Looking along spill location, where Operator reports the fluid flowed after daylighting.
